**INDIAN LAKE STONE DAM**

**HAMILTON COUNTY  
NEW YORK**

5 **PHASE I INSPECTION REPORT**

1 **NATIONAL DAM SAFETY PROGRAM**

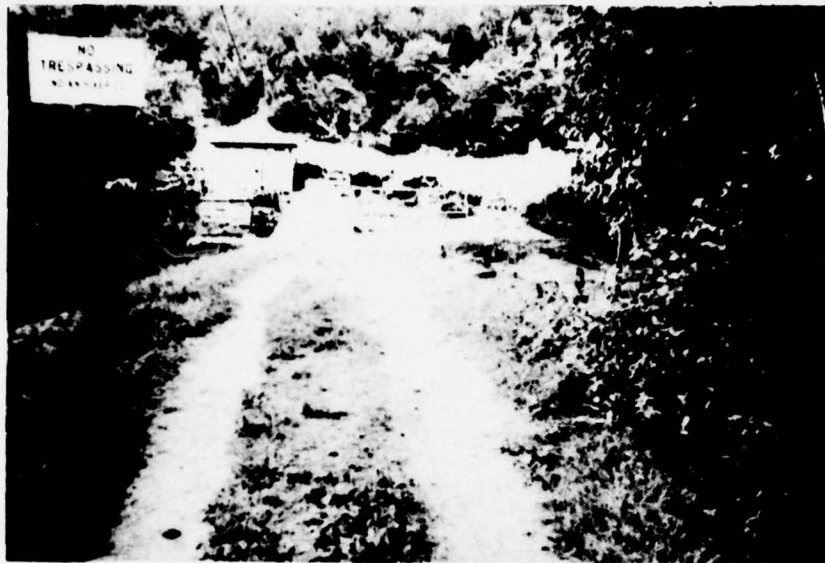
1. View across dam looking north.  
Road surface is on south dam embankment.

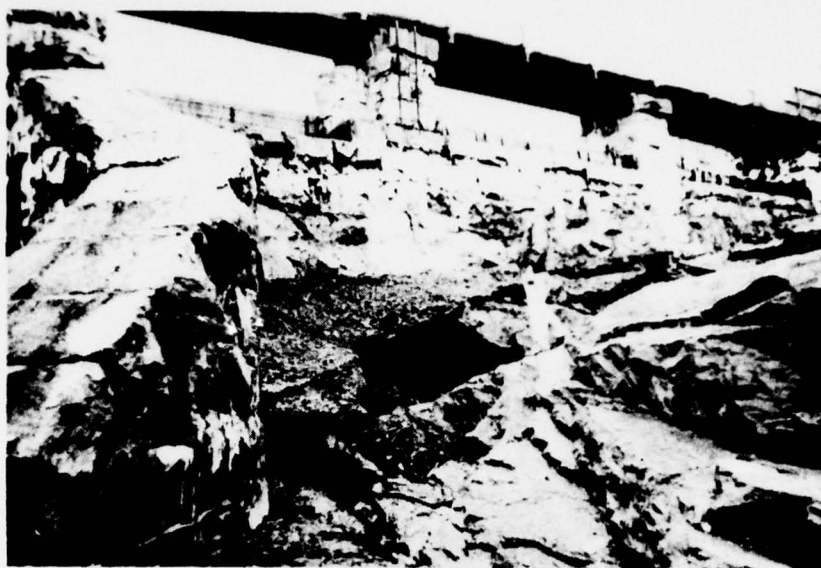
7. A closeup of the encircled eroded spillway channel area shown in Picture #6.

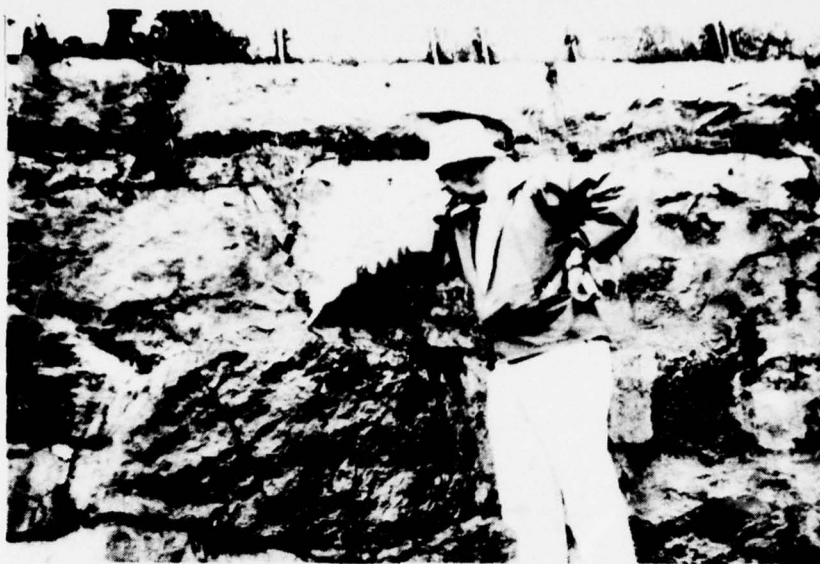
9. Another closeup of spillway facing showing limited seepages through masonry joints.

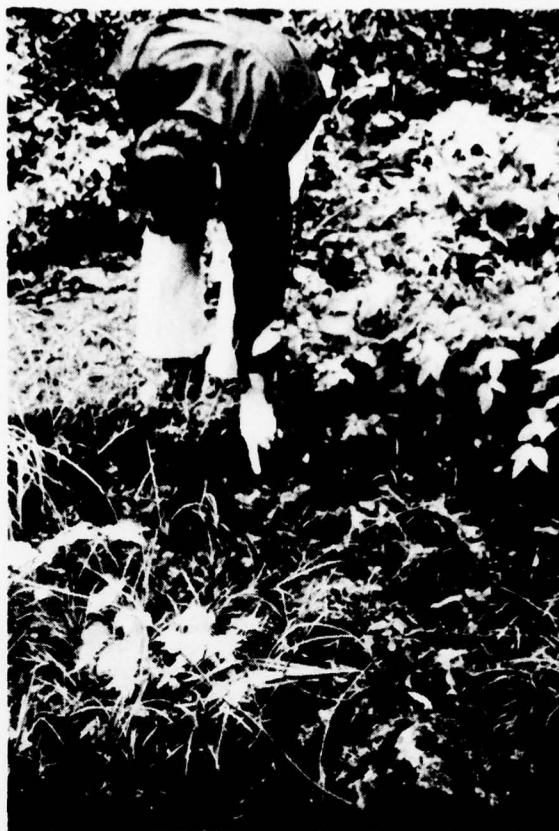
17. Detail of seepage from the ground surface area below headwall. Seepage is occurring over a sizable area. Both under-dam and abutment seepage is suspected.

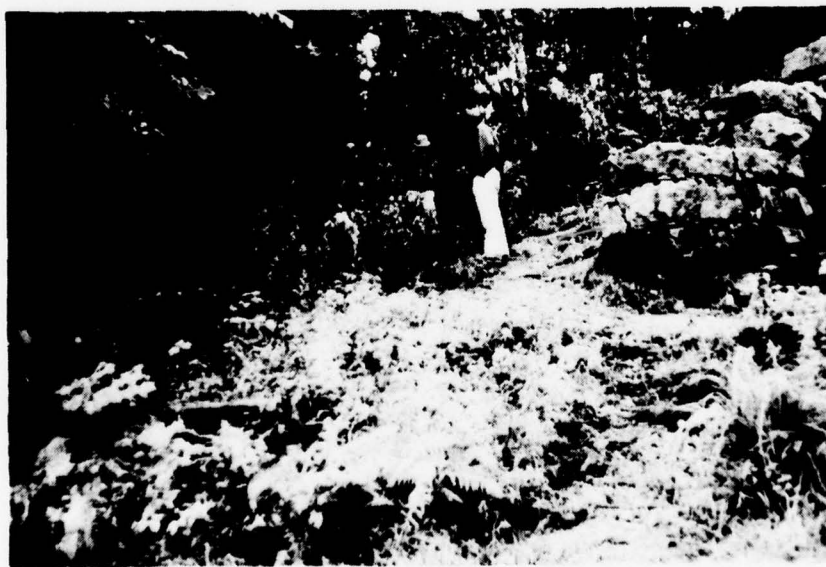
18. Another picture of the seepage area; notice end of headwall. The dam earthen section on the downstream side of the embankment is heavily treed.

The embankment has a large number of trees growing on it which should probably be removed. Seepage may be related to tree growth where seepage paths may have developed along root systems. If this is the case, it may be necessary to make a relatively comprehensive evaluation of alternatives to eliminate the seepage and improve the condition of the embankment.
