**CARGILL RESERVOIR DAM**

**PHASE I INSPECTION REPORT**

**NATIONAL DAM SAFETY PROGRAM**

NY 00086

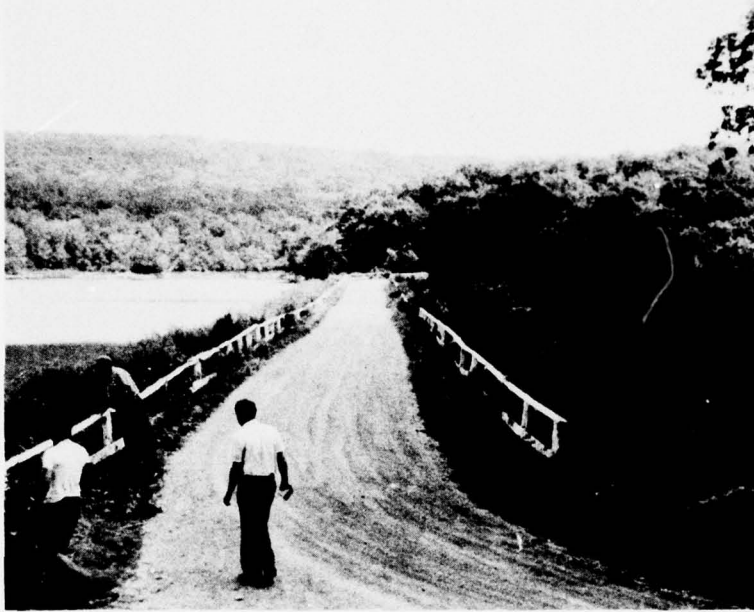
A dense growth of trees and brush cover the upstream and downstream slopes; maintenance at the site appears to be minimal. The trees and brush should be cut near the ground surface and a further investigation made to determine the extent of the root systems before remedial measures can be recommended.

A depression was observed in the dam crest and discolored seepage was noted at or near the downstream toe. After the dense vegetation is cut, it may be possible to detect the source of these potential problem areas.

OVERALL VIEW OF DAM

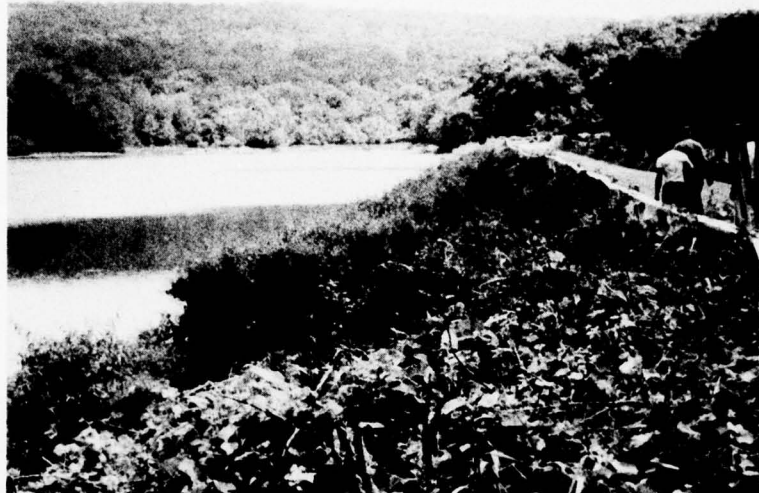
b. Dam - The upstream slope is covered with brush, as well as a large number of twigs and branches, apparently the result of previous cutting operations. Inspection of the riprap revealed no evidence of displacement or erosion of the cobble-size stones. A wooden fence has been constructed on top of a concrete wall which may be an extension of the corewall. The crest of the embankment is depressed for a distance of about 30 feet north and south of the valve chamber. The downstream slope is heavily overgrown with brush and trees as tall as 35 feet. The exact location of the toe of the downstream slope could not be determined during the inspection since the vegetation growing on the downstream slope is indistinguishable from the forest surrounding the reservoir; the visible topsoil on the embankment matches the overburden on the valley slopes. Areas of flow were evident near the center of the stream valley in the vicinity of the downstream toe. These may be springs or seepage drains that are not shown on the plans. An orange-brown stain on the ground surface and a flow measuring weir is evident at each area. Clear water is discharging from a partially buried pipe near the supposed location of the downstream toe near the center of the dam.

The upstream and downstream slopes are overgrown with trees, brush and vegetation. The roots of the large trees on the slopes may be providing seepage paths which could lead to future piping. These trees could be uprooted by high winds removing large amounts of material from the embankment.

UPSTREAM SLOPE

5.2 RECOMMENDATIONS/REMEDIAL MEASURES - The trees and brush growing on the embankment slopes should be cut to root level and removed from the surface of the structure. A further investigation should be made to determine the extent of the root systems before remedial measures can be recommended. After removal of the trees, additional inspections should be conducted to determine the source of seepage and discoloration noted near the downstream toe. The need for a subsurface exploration program, including piezometer installations, should be assessed at that time.

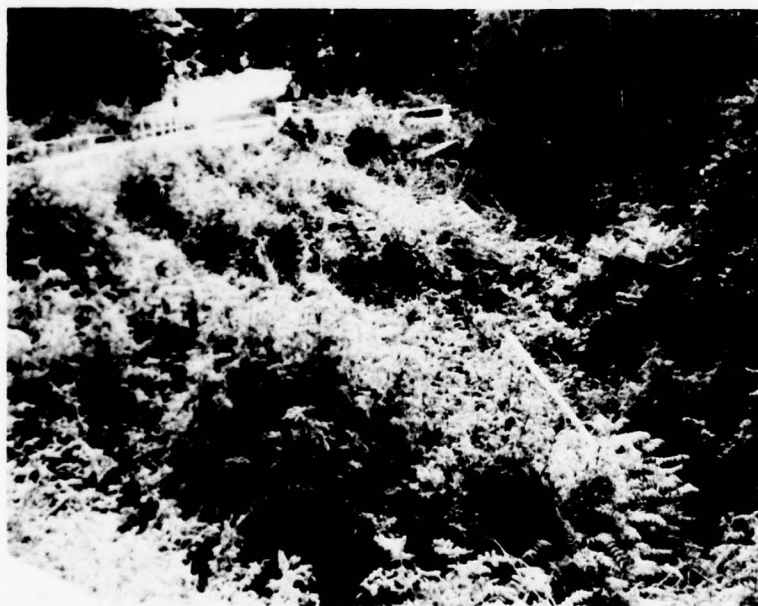
DOWNSTREAM SLOPE

Discolored seepage was noted at  
several locations near the  
downstream toe.

The flow should be monitored to  
detect increased turbidity and a  
study made to determine the  
cause of the seepage.

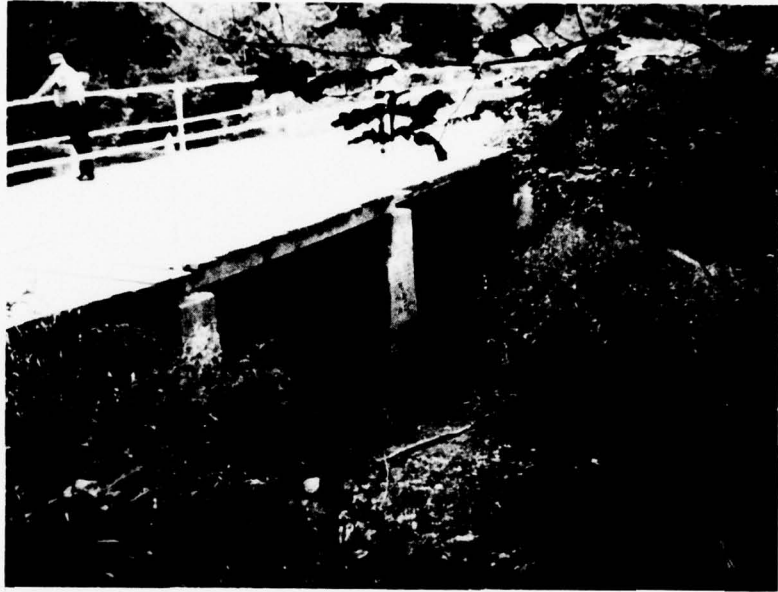
The spillway approach channel is partially clogged with brush and debris. The concrete wingwalls, bridge pier and ogee weir appear to be in good condition. The weir is constructed about 25 feet downstream of the bridge and extends from the training wall to the south abutment. The weir is approximately 5 feet high at the maximum section, with a base width of approximately 8 feet. This spillway configuration is not as shown on the original contract drawings. There is no well-defined outlet channel downstream of the spillway crest. The concrete training wall protecting the embankment from the spillway flow is in fair condition.

BRIDGE OVER SPILLWAY APPROACH

VISUAL EXAMINATION OF	OBSERVATIONS	REMARKS OR RECOMMENDATIONS
CONCRETE WEIR	No problems noted	None
APPROACH CHANNEL	The spillway approach is partially clogged with brush and debris.	This debris should be removed to avoid clogging of the bridge openings.
DISCHARGE CHANNEL A5	The south valley slope acts as the discharge channel; flow is guided downstream away from the embankment toe by a 180 foot long x 4 foot high concrete training wall.	Portions of the channel should be excavated to provide sufficient capacity to prevent overtopping at the training wall.
BRIDGE AND PIERS	A wooden bridge spans the spillway approach channel on two concrete piers. The concrete piers and bridge abutments are in good condition.	None
