CHEMICAL AND METALLURGICAL ANALYSIS OF PROPELLANT STORAGE VESSELS

FINAL REPORT - MARCH 1978 - OCTOBER 1978

BELL AEROSPACE TEXTRON
DIVISION OF TEXTRON, INC.
P. O. BOX ONE
BUFFALO, NEW YORK 14240

FEBRUARY 1979

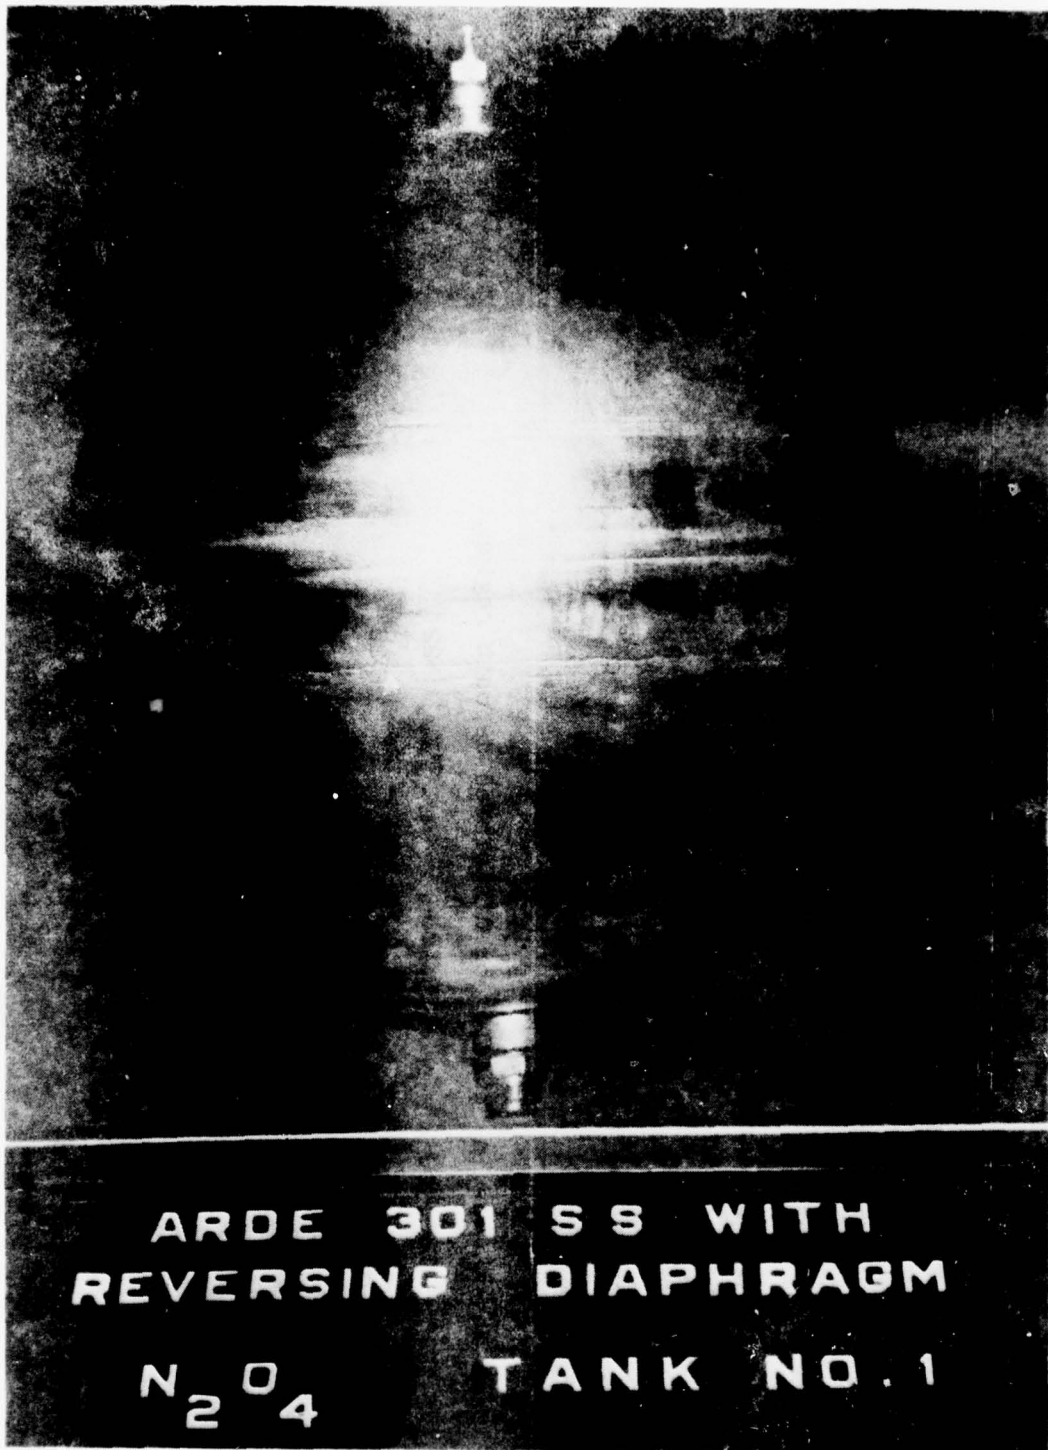
FIGURE 1. TANK NO. 1, AN ARDE CRYOSTRETCHED SPHERE WITH RING STIFFENED DIAPHRAGM. DARK SPOT APPEARS TO BE ARC STRIKE BUT MAY BE LOCAL CORROSION EFFECT.

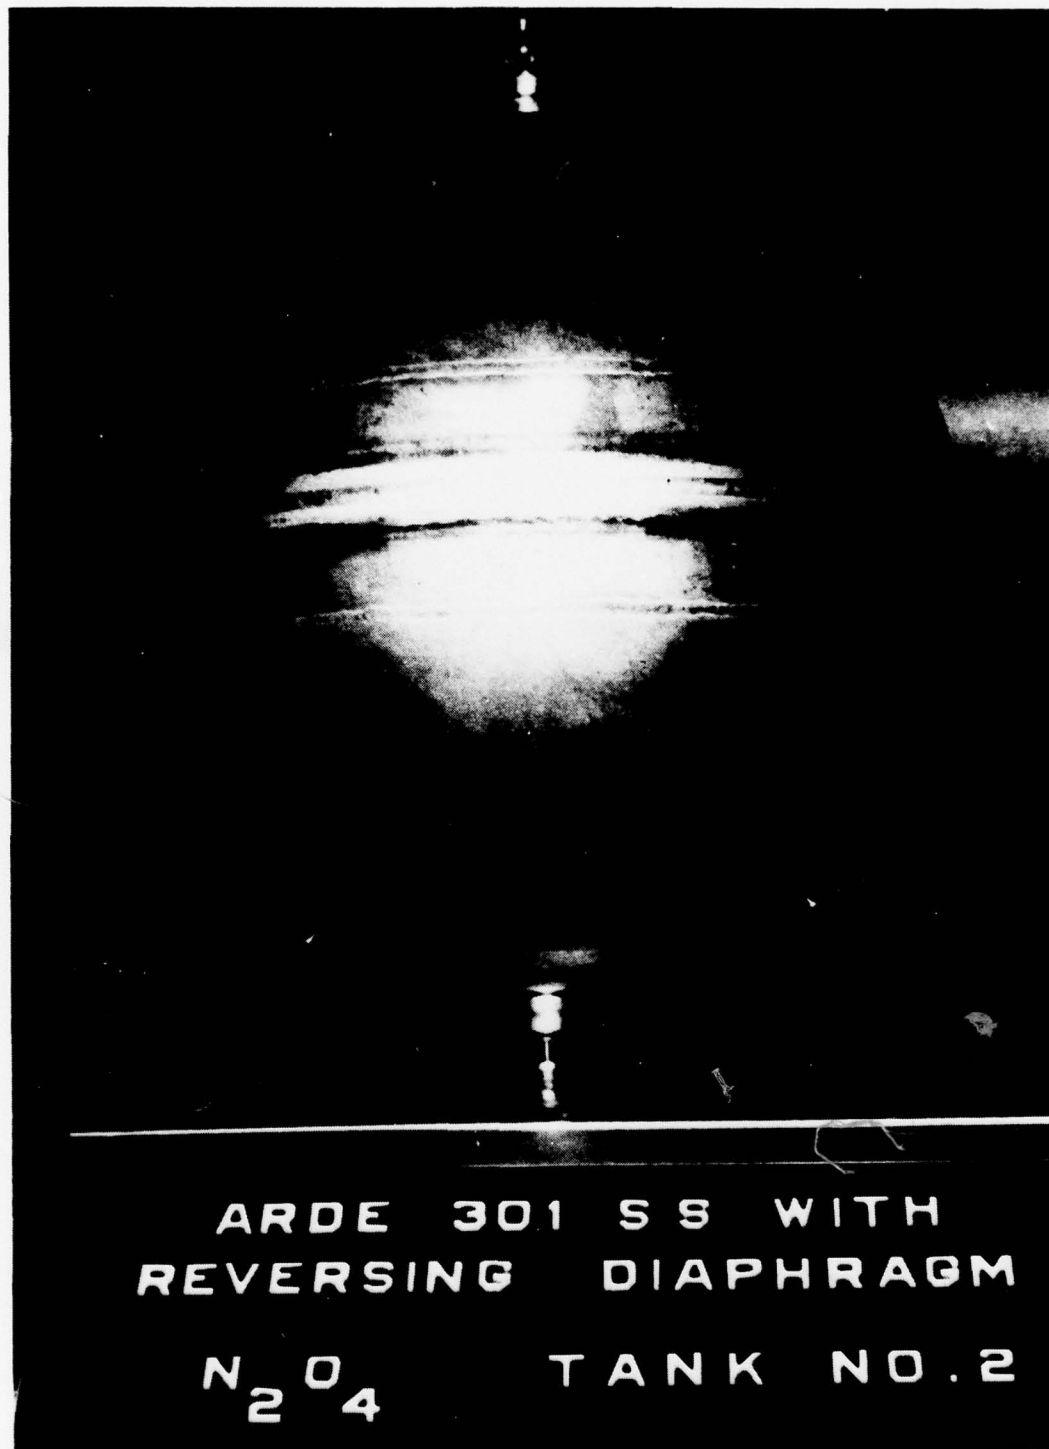
FIGURE 2. TANK NO. 2, AN ARDE CRYOSTRETCHED SPHERE WITH RING STIFFENED DIAPHRAGM. ALL FOUR OF THESE SPHERES SHOW STAINS (AT ARROWS) FROM THE SUPPORT THEY WERE SITTING IN.

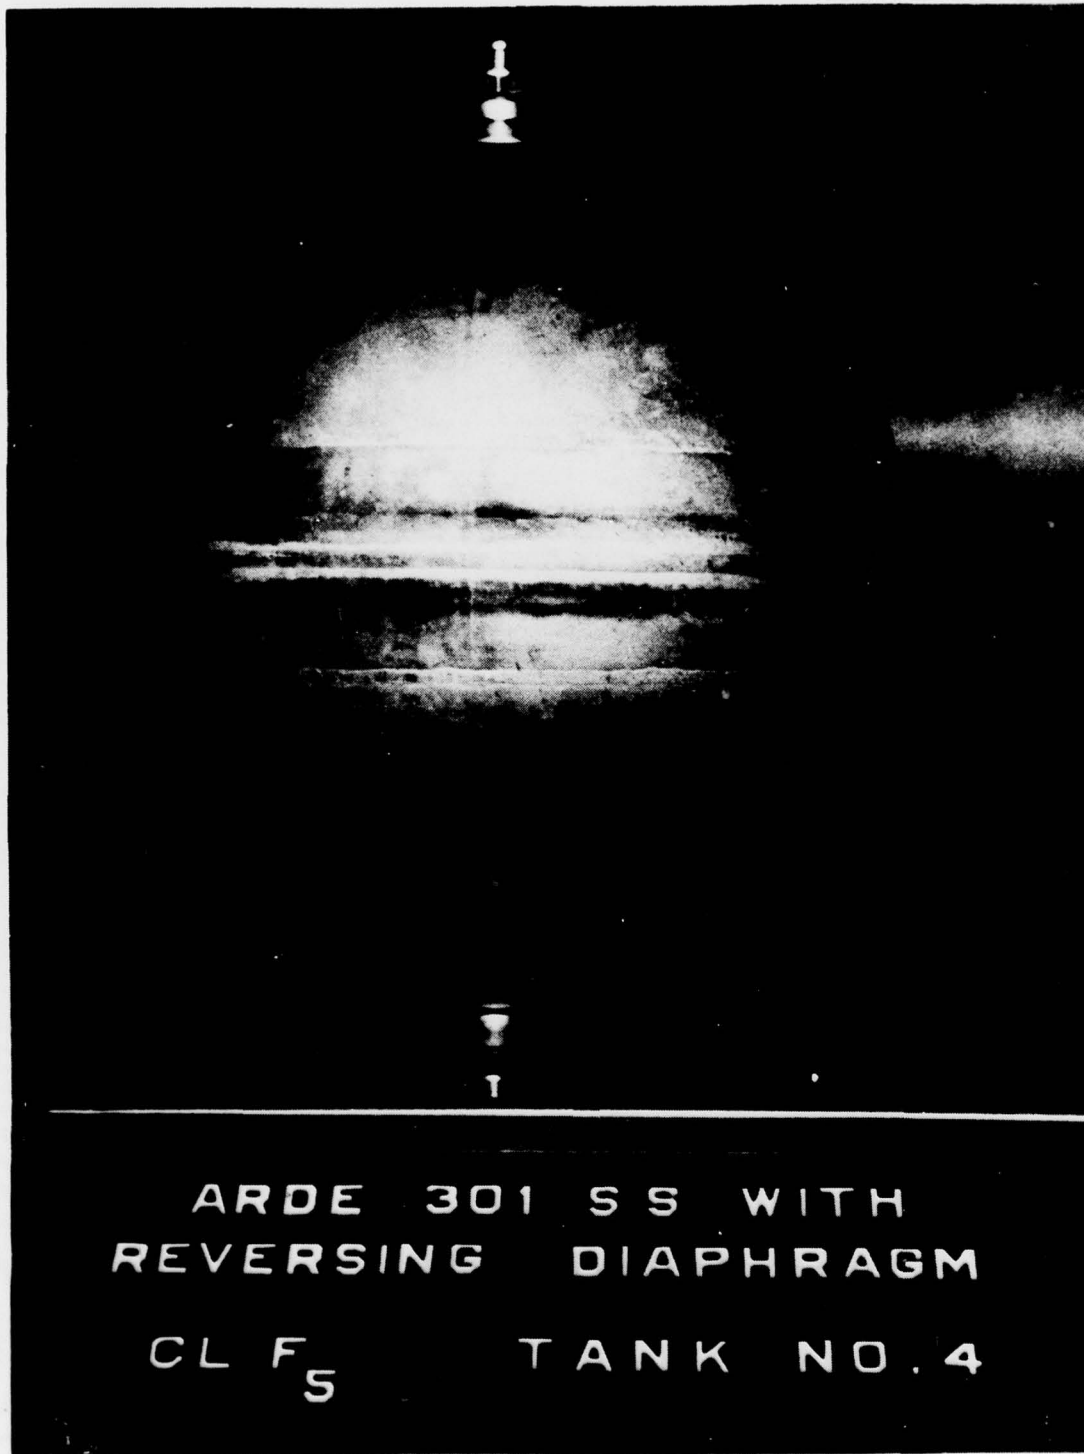
FIGURE 4. TANK NO. 4, AN ARDE CRYOSTRETCHED SPHERE WITH RING STIFFENED DIAPHRAGM SHOWING NO CORROSION OTHER THAN VERY MINOR PITTING AND STAINING.

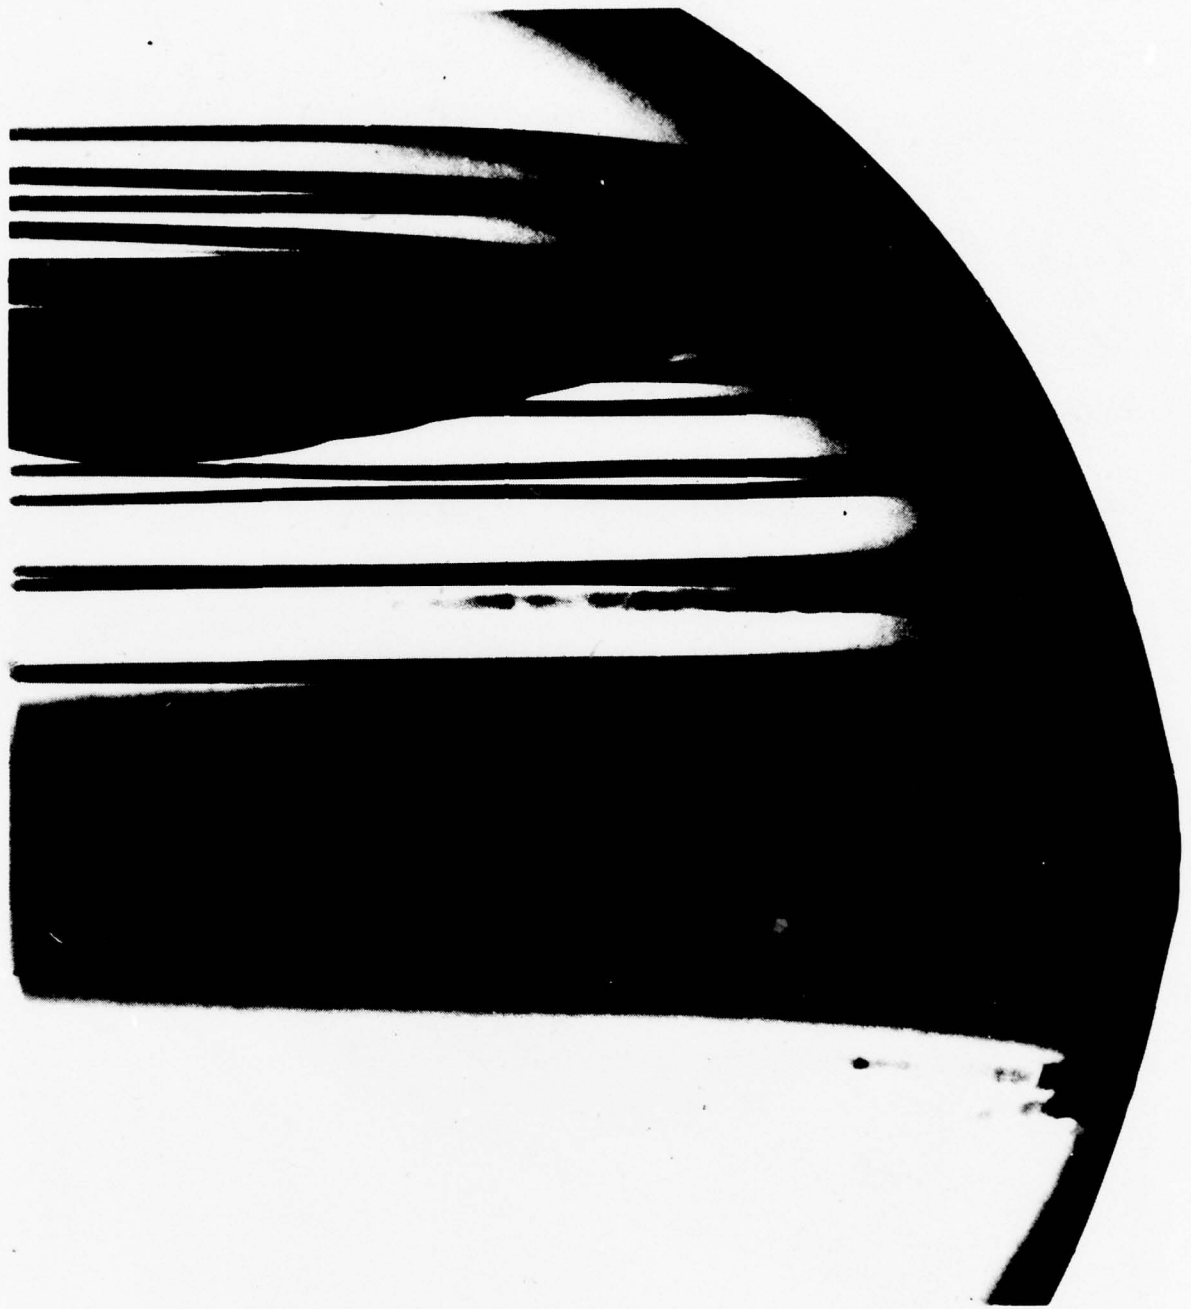
FIGURE 11. CONTACT PRINT OF RADIOGRAPH OF TANK NO. 2, AN ARDE RING STIFFENED DIAPHRAGM TANK IN THE AS-RECEIVED CONDITION SHOWING ONLY PARTIAL EXPULSION.

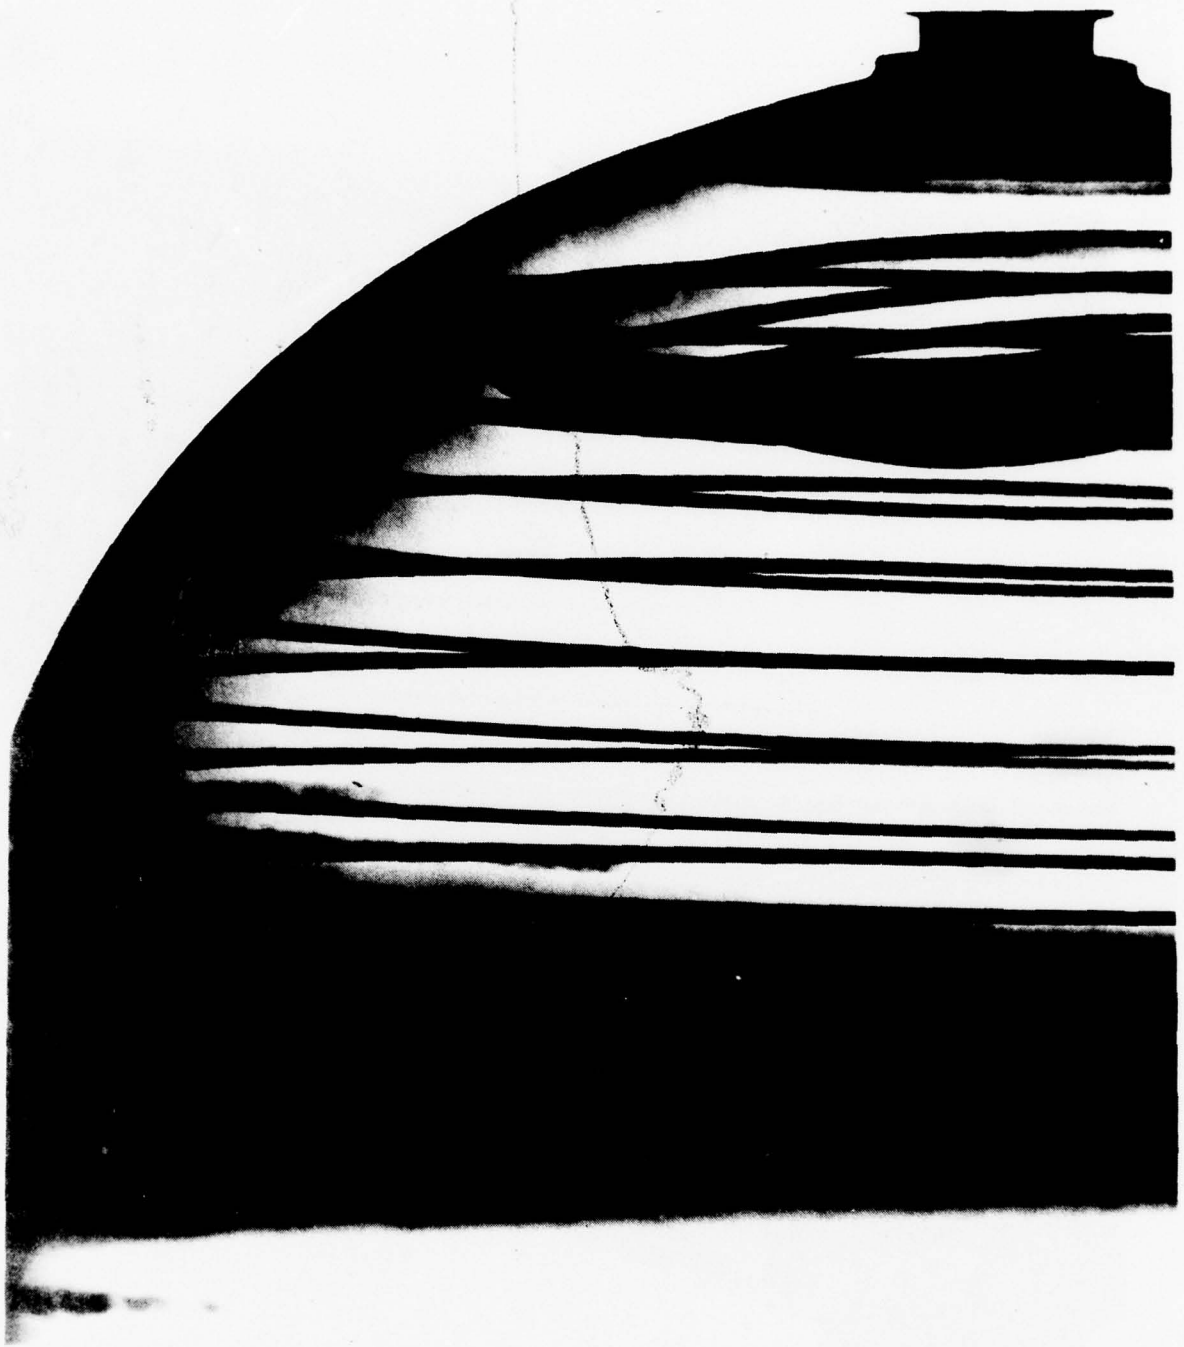
FIGURE 12. CONTACT PRINT OF RADIOGRAPH OF TANK NO. 3. AN ARDE RING STIFFENED DIAPHRAGM TANK, IN THE AS-RECEIVED CONDITION SHOWING ONLY PARTIAL EXPULSION.

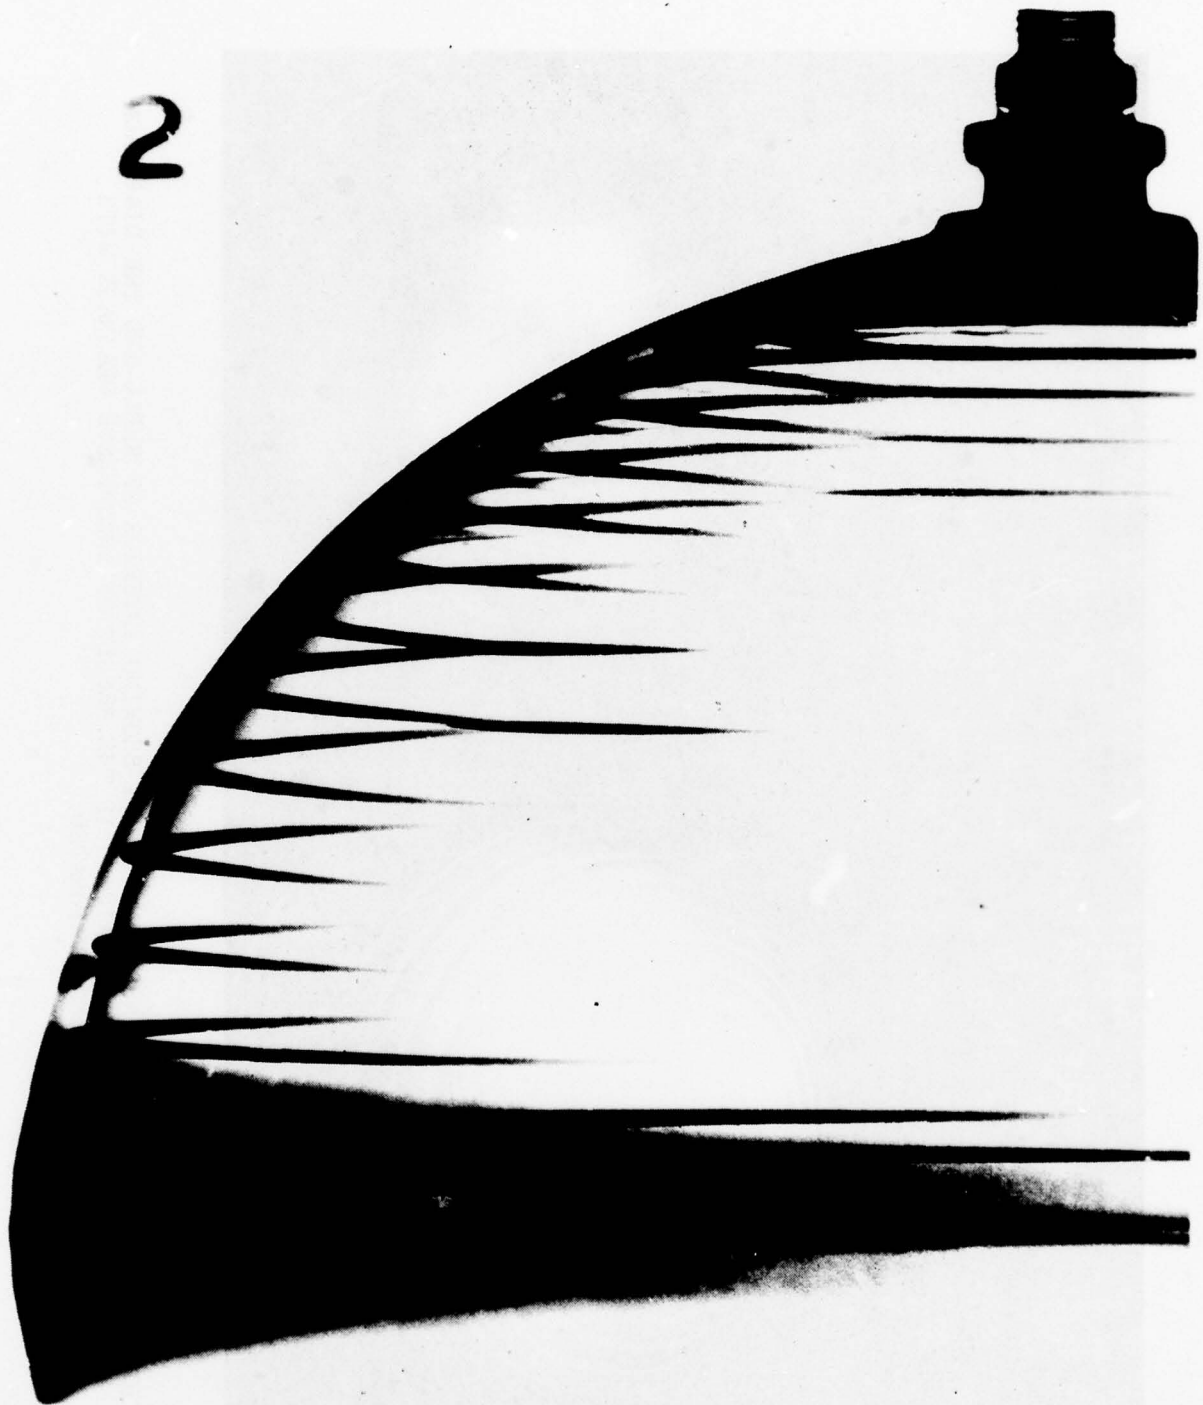
FIGURE 14. CONTACT PRINT OF RADIOGRAPH OF TANK NO. 2 AFTER PRESSURIZED LEAK TEST, SHOWING THAT DIAPHRAGM HAD RETURNED TO ITS ORIGINAL POSITION. DIAPHRAGM LEAK WAS DETECTED IN THIS TEST.

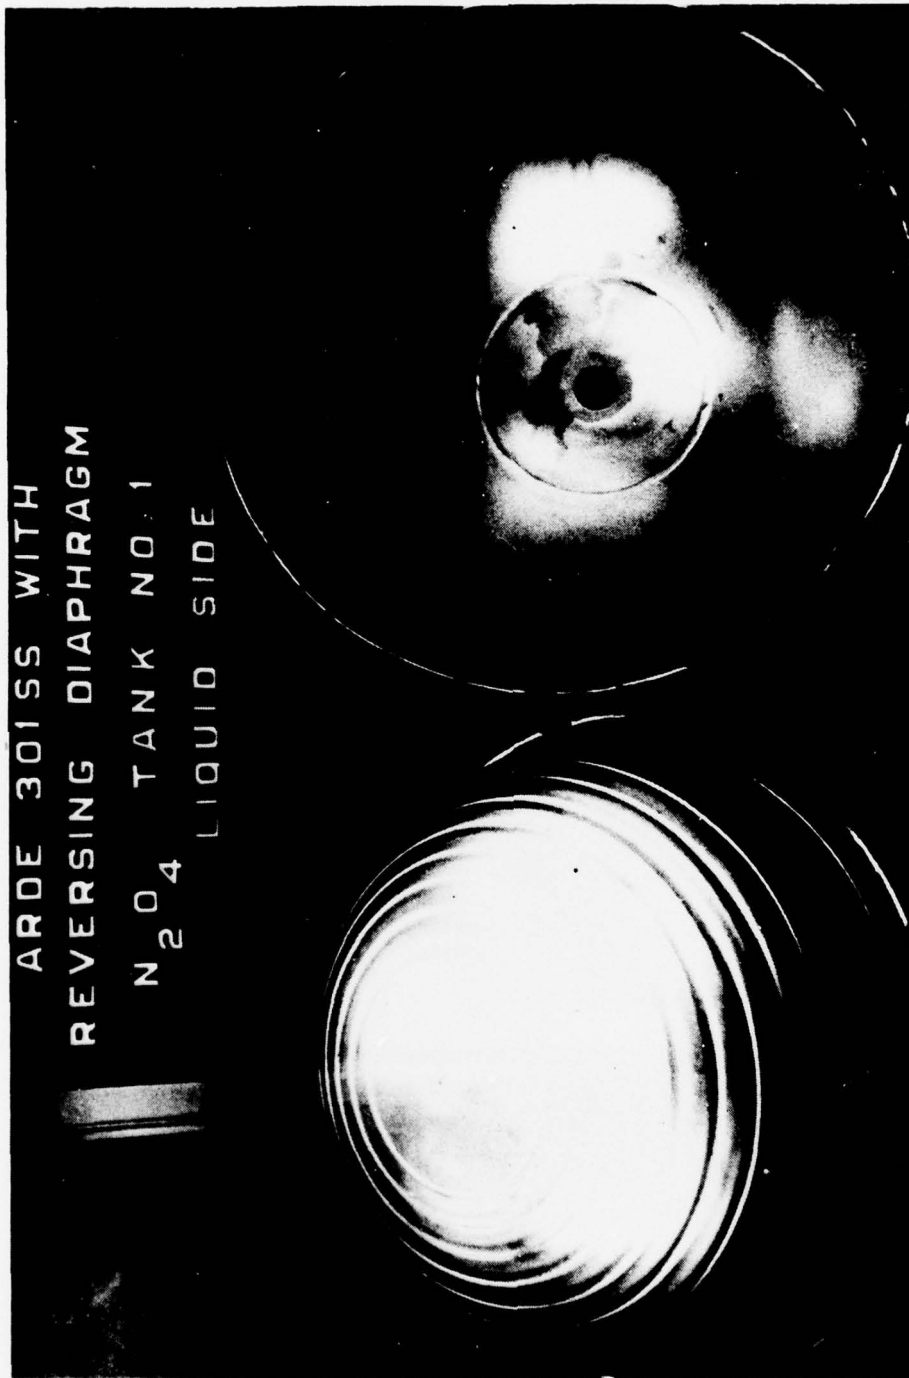
FIGURE 15. LIQUID SIDE OF ARDE TANK NO. 1 SHOWING INTERIOR OF SHELL AND THE DIAPHRAGM AFTER EXPULSION. STAINING IS THE RESULT OF INCOMPLETE DRAINAGE WITH PROPELLANT HAVING EVAPORATED.

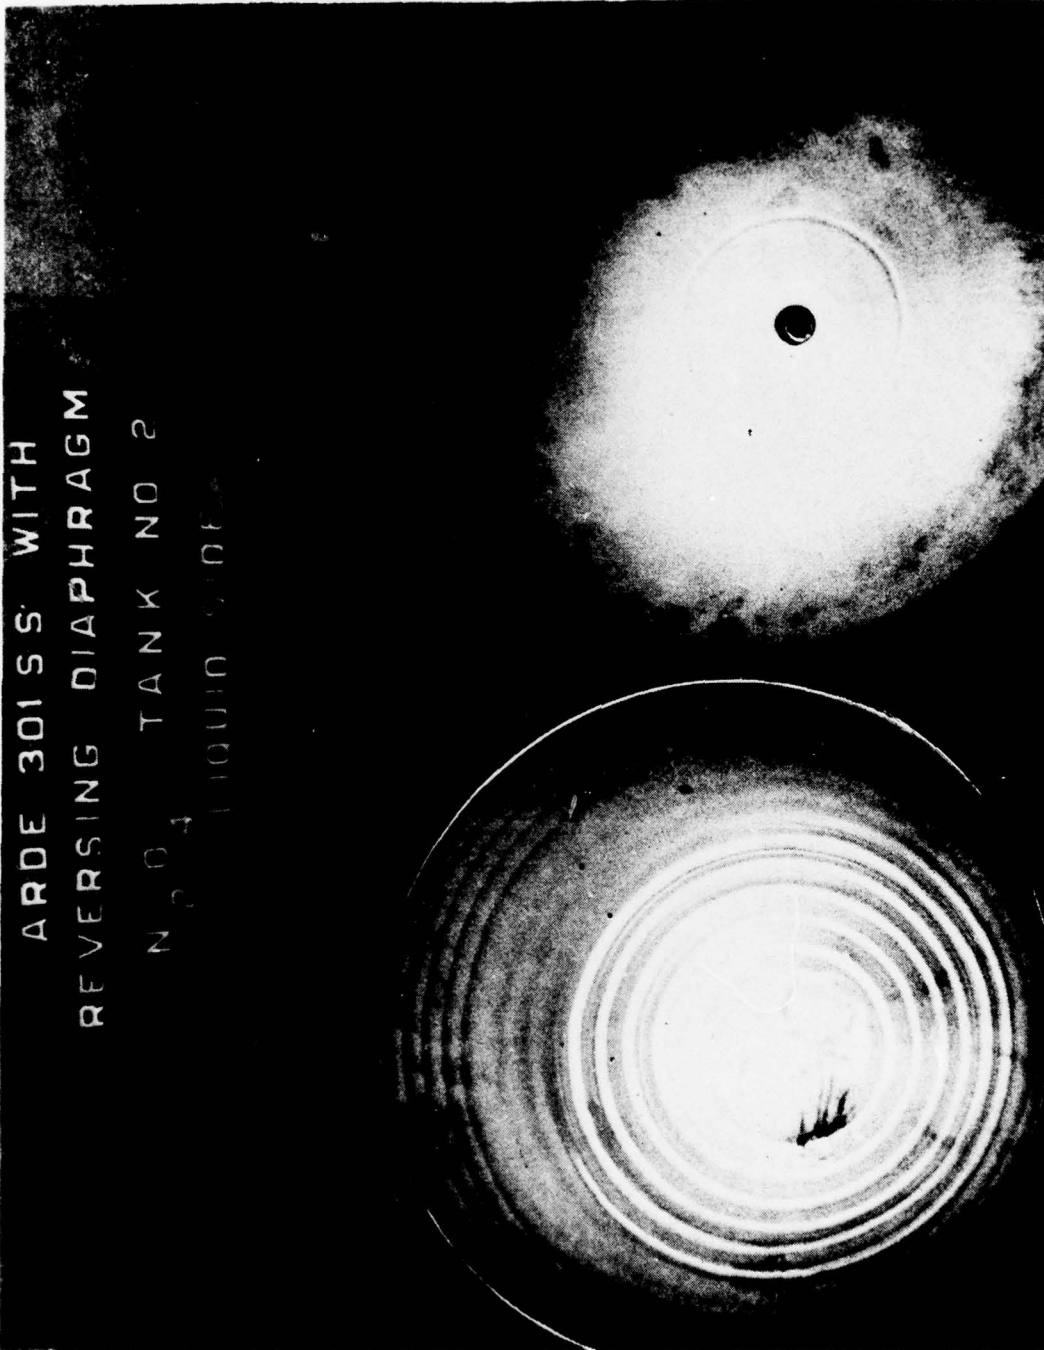
N^o 2 TANK NO 2
LIQUID SIDE

FIGURE 17. LIQUID SIDE OF ARDE TANK NO. 2. THIS DIAPHRAGM CONTAINS PINHOLE
LEAKS IN THE UPPER DEFORMED SECTION OF THE DOME.

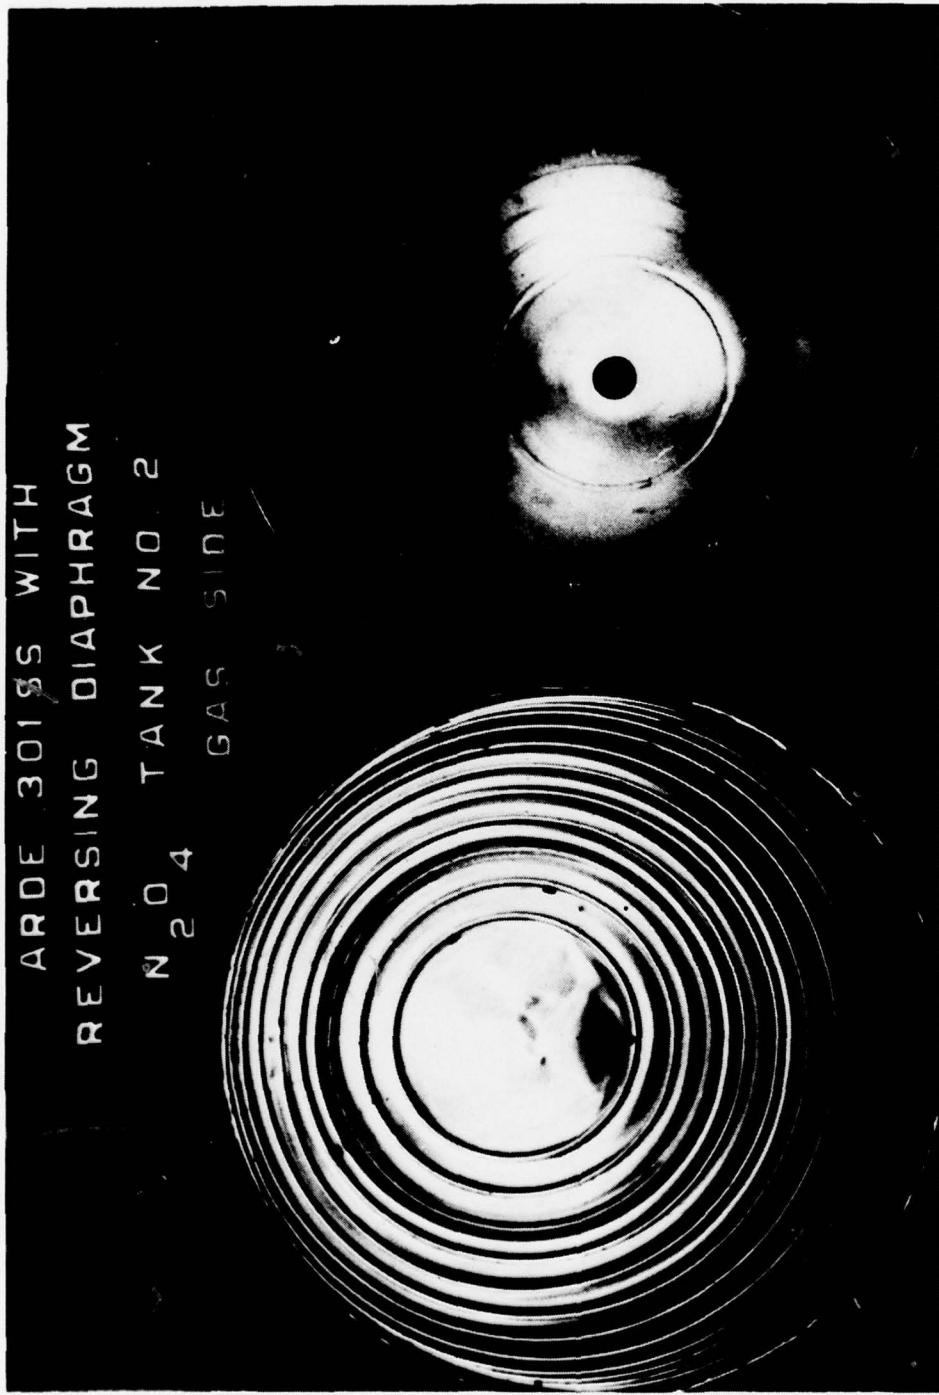
ARDE 301SS WITH
REVERSING DIAPHRAGM
N 204 TANK NO 2
GAS SIDE

FIGURE 18. GAS SIDE OF ARDE TANK NO. 2. STAINS EXIST ON THE SHELL SURFACE AND THE WRINKLING/BUCKLING OF THE DOME IS VISIBLE. THE PINHOLE LEAKS NOT VISIBLE ARE CLOSE TO THE CENTER TOP SURFACE OF THE DIAPHRAGM.

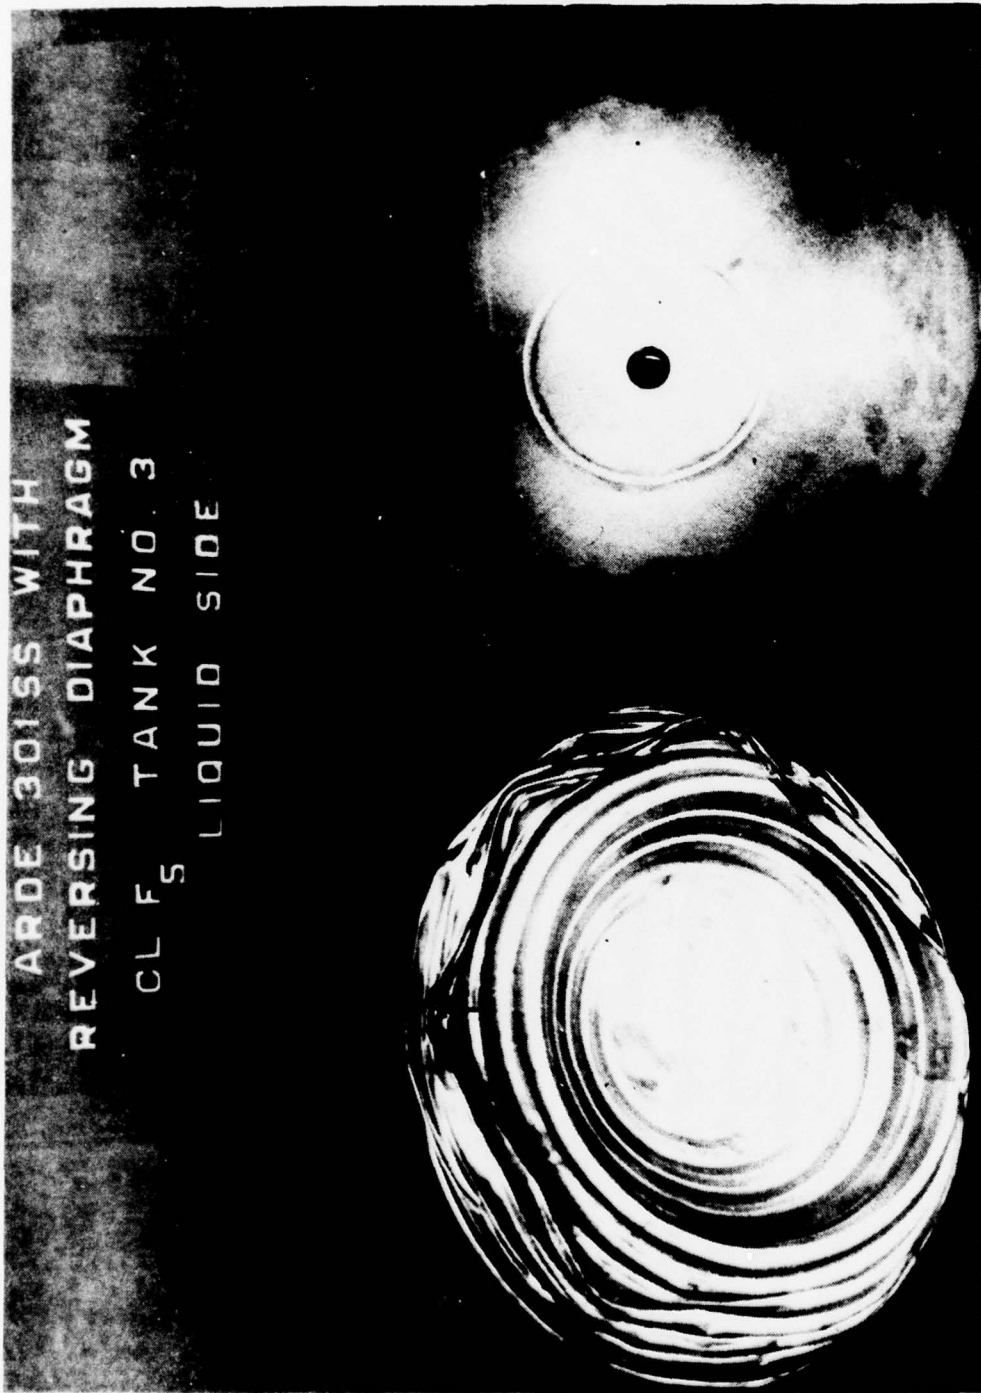
CL F_S TANK NO. 3
LIQUID SIDE

FIGURE 19. LIQUID SIDE OF ARDE TANK NO. 3. THE CONDITION OF THE DIAPHRAGM IS A DIRECT RESULT OF AN ATTEMPT TO REVERSE THE DIAPHRAGM AFTER COMPLETION OF AN EXPULSION TEST. LEAK OCCURRED AT SHARP BUCKLE (ARROW).

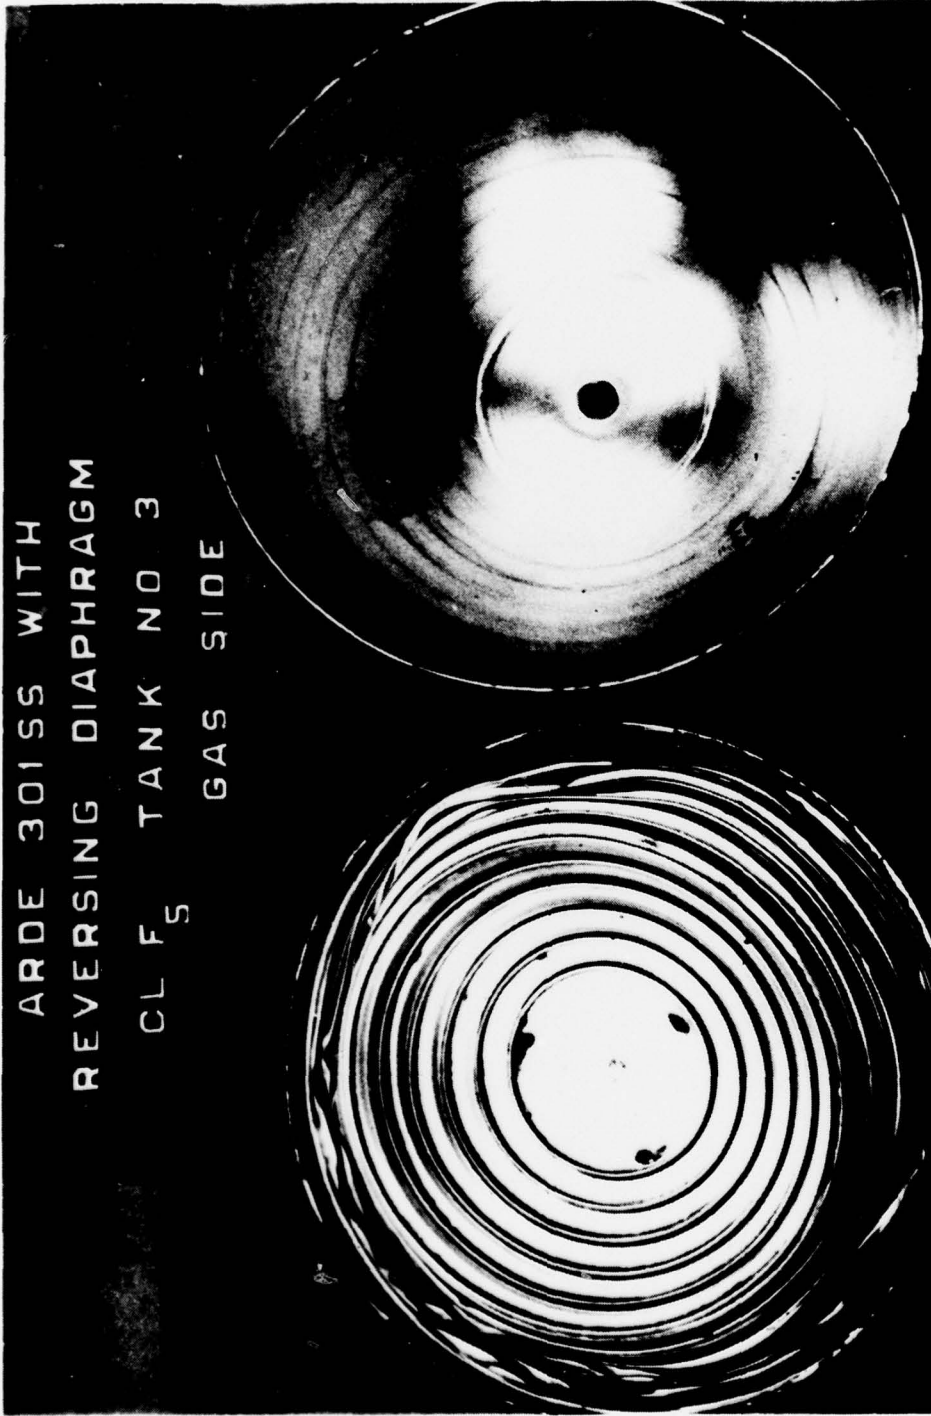
FIGURE 20. GAS SIDE OF ARDE TANK NO. 3. BUCKLING OF THE DIAPHRAGM IS QUITE EVIDENT IN THIS VIEW. THE STAINS IN THE SHELL ARE FROM THE EXPULSION TEST AND ARE NOT ATTRIBUTABLE TO CORROSION.

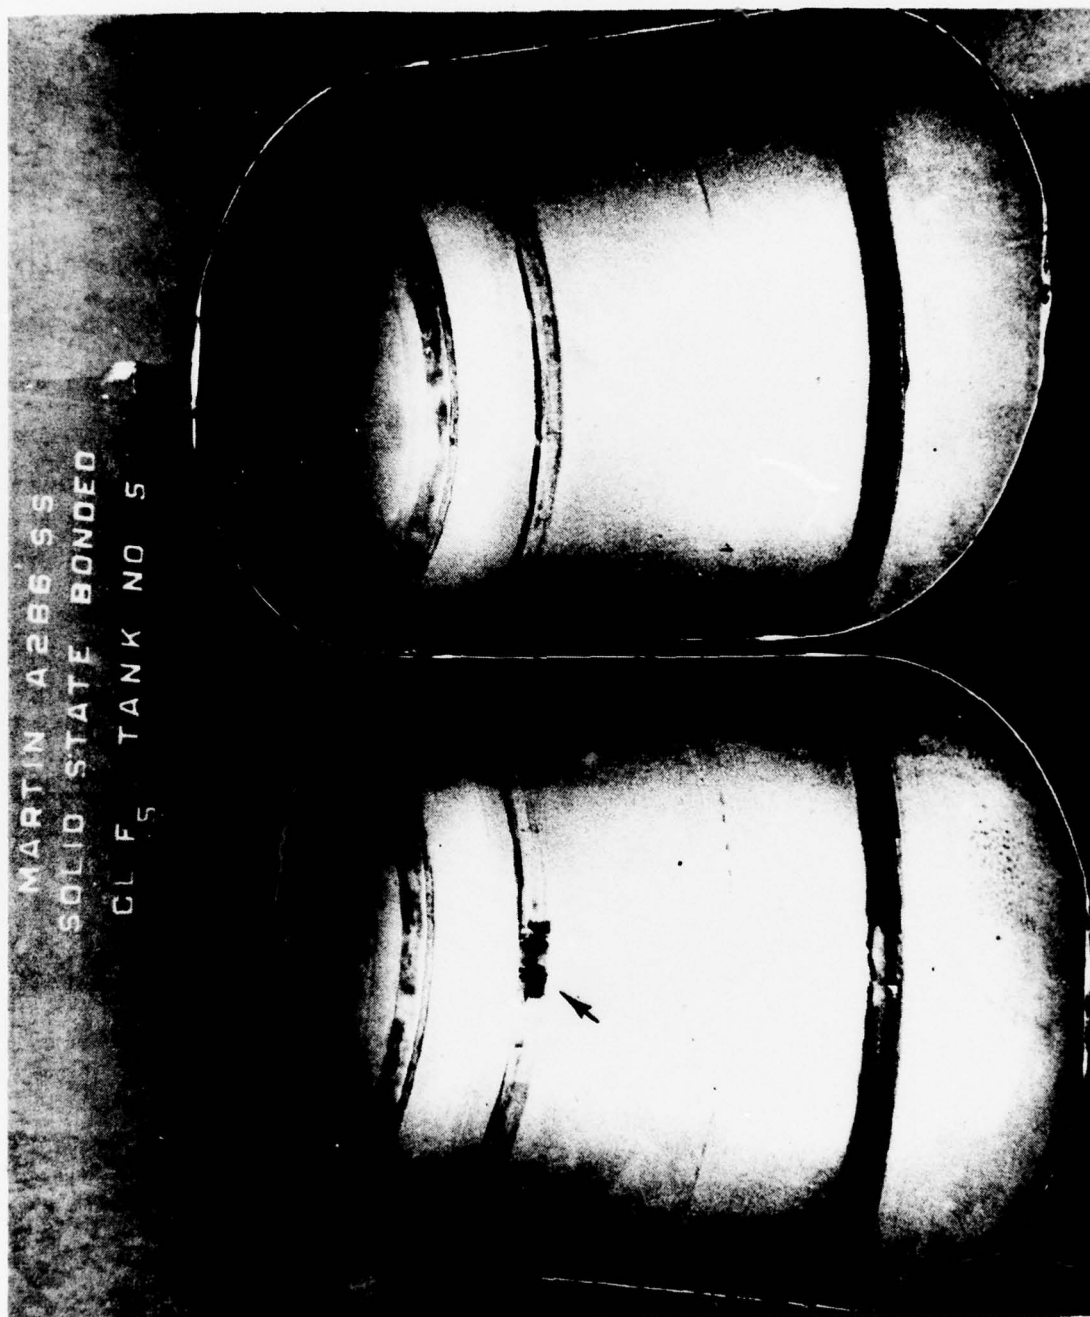
FIGURE 23. . INTERIOR SURFACES OF TANK NO. 5. OVERALL CONDITION OF SURFACE APPEARS TO BE UNAFFECTED BY STORAGE. LOCALIZED AREAS HAVE BEEN MARKED WITH ARROWS WHERE A MORE DETAIL EXAMINATION OF THE SURFACE IS REQUIRED TO ESTABLISH IF CORROSION OCCURRED.

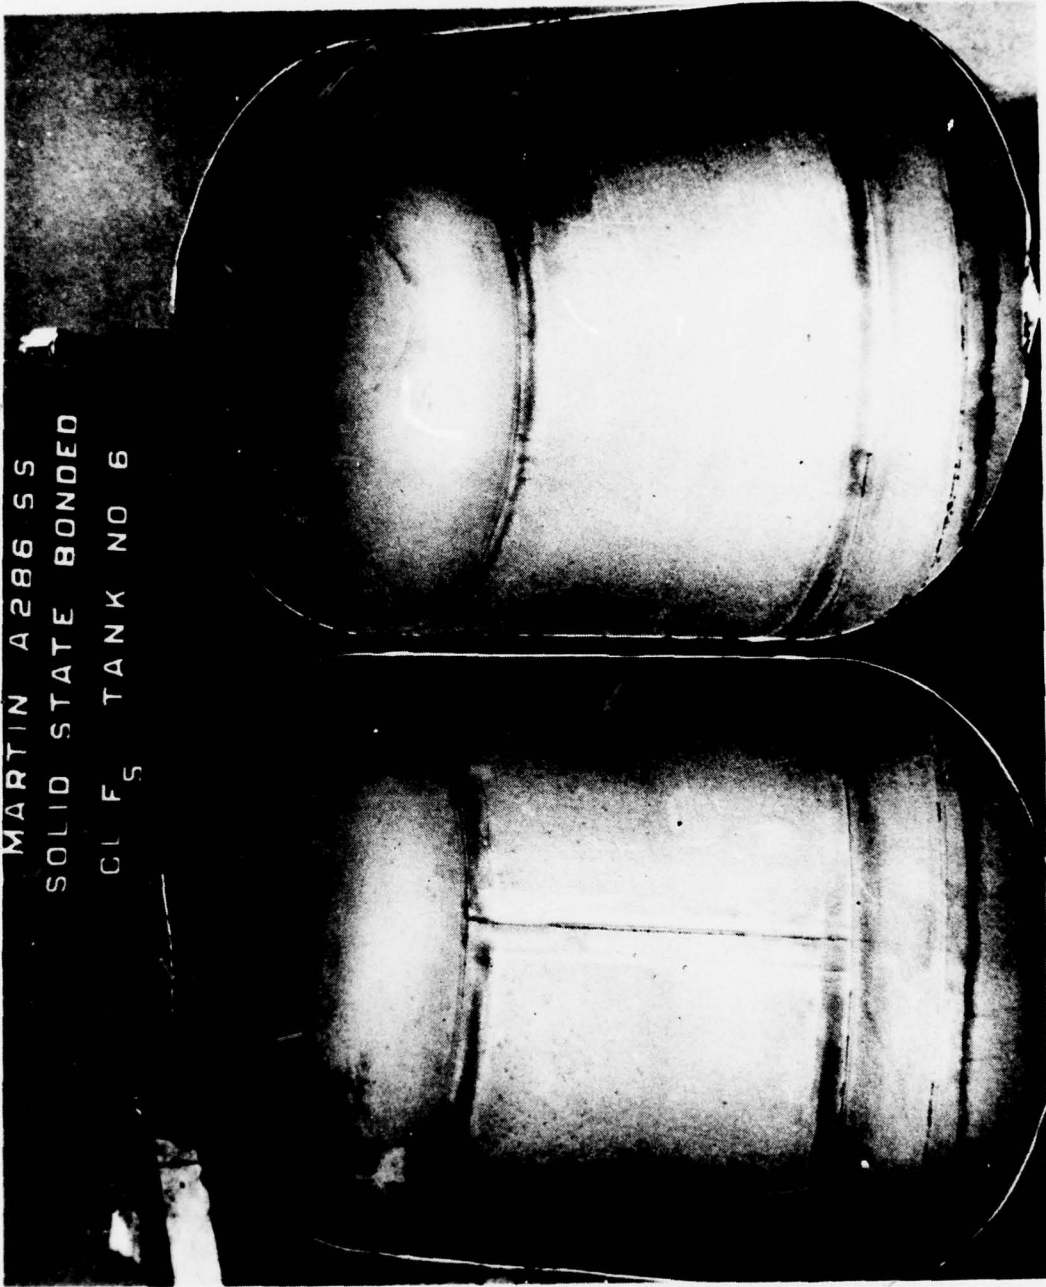
MARTIN A286 SS
SOLID STATE BONDED
CL F₅ TANK NO 6

FIGURE 24. INTERIOR SURFACES OF TANK NO. 6. GENERAL SURFACE CONDITION WAS FOUND TO BE FREE OF STAINS, HOWEVER, SOME PITTING IS PRESENT AROUND PERIPHERY OF UPPER BOSS (RIGHTHAND VIEW OF SHELL). AN ARROW HAS BEEN USED TO SHOW THE AREA OF CONCERN. THIS REGION WILL BE INVESTIGATED IN GREATER DEPTH.

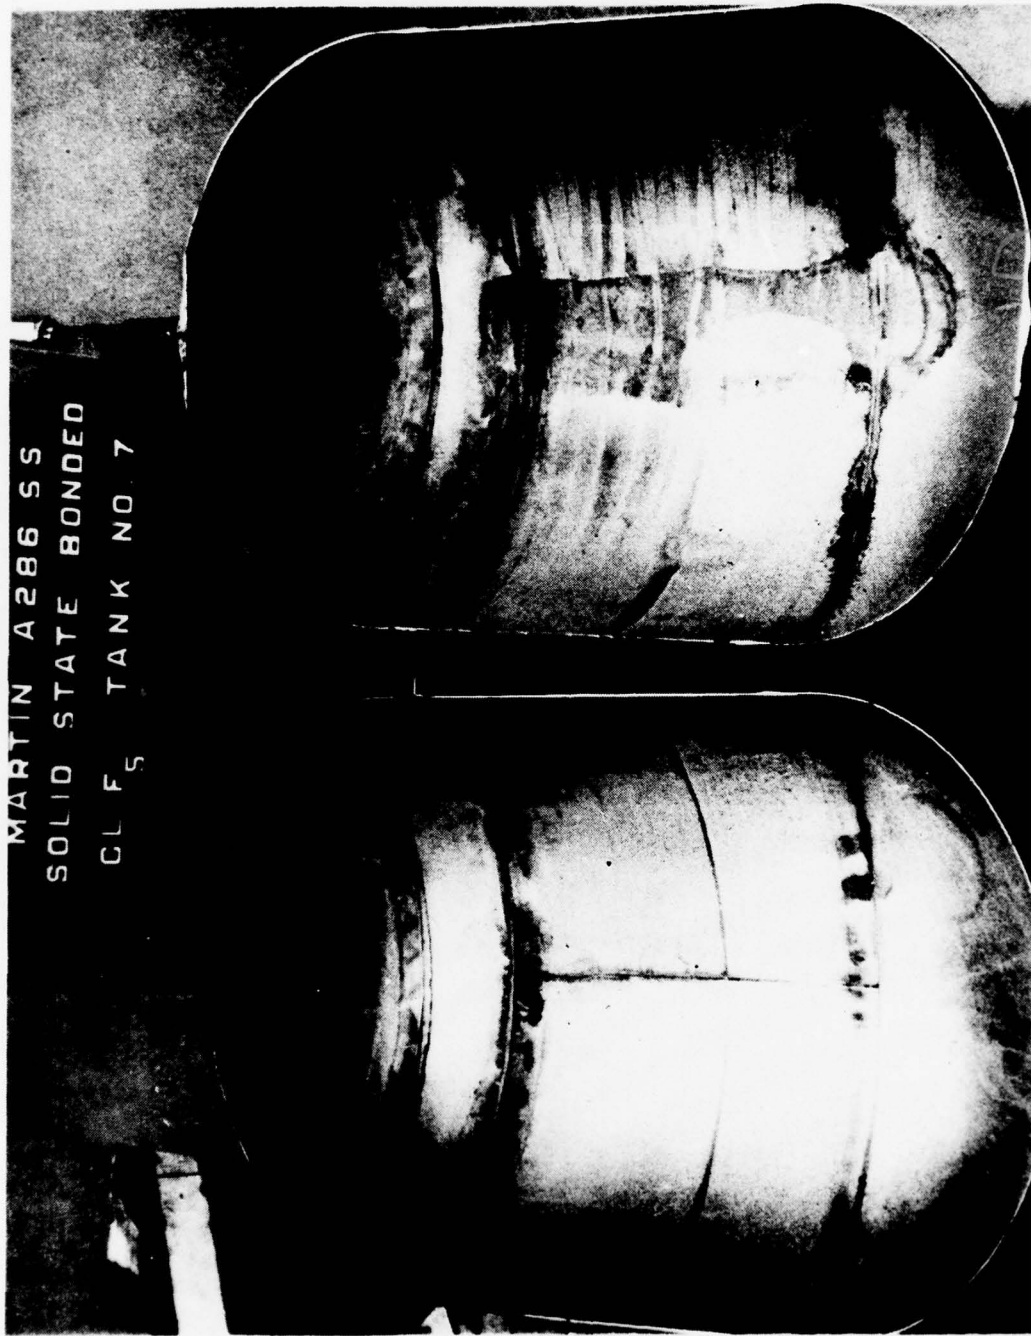
MARTIN A286 SS
SOLID STATE BONDED
CL F₅ TANK NO. 7

FIGURE 25. INTERIOR SURFACES OF TANK NO. 7. STAINING OF THE SURFACE IS ATTRIBUTED TO INCOMPLETE REMOVAL OF ALL PROPELLANT. AFTER UNLOADING TANK LAID ON ITS SIDE AND EVAPORATION OF CL F₅ TOOK PLACE, CAUSING STAINS AND CORROSION OF THE INTERIOR SURFACE. REACTION OF PROPELLANT WITH SURFACE NOT ATTRIBUTABLE TO STORAGE.

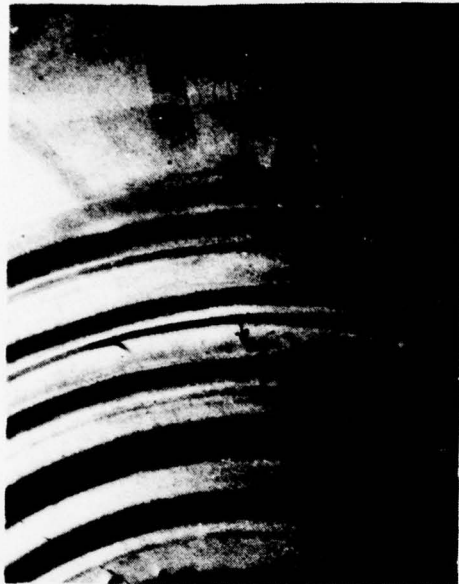
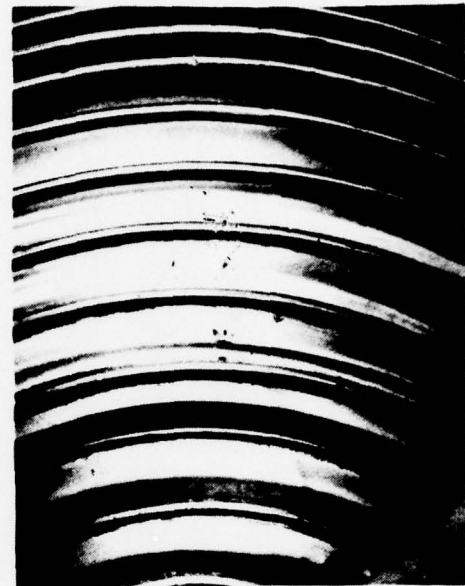
a) Propellant side with several leak sites, detected by soap film bubbling, marked.

b) Gas side with with leak areas marked.

FIGURE 33. VIEWS OF SURFACE OF DIAPHRAGM OF TANK NO. 2 IN REGION WHERE LEAKS WERE DETECTED.

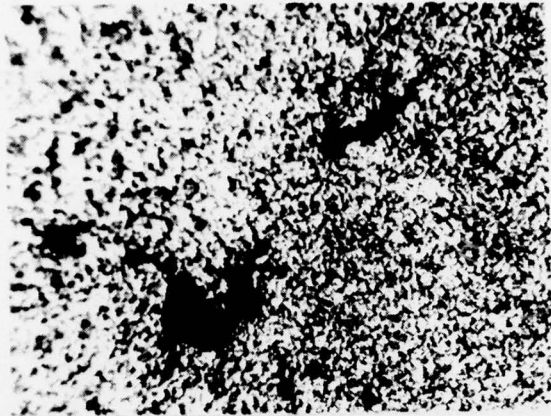
a) Detail view of propellant side surface showing pitted nature of leak area.

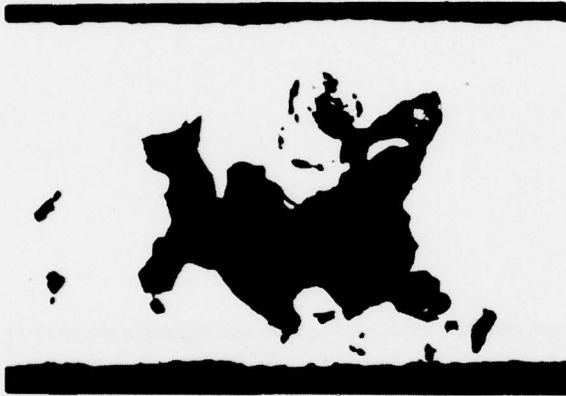
b) Initial observation of internal defect 0.002 inch before first surface evidence.

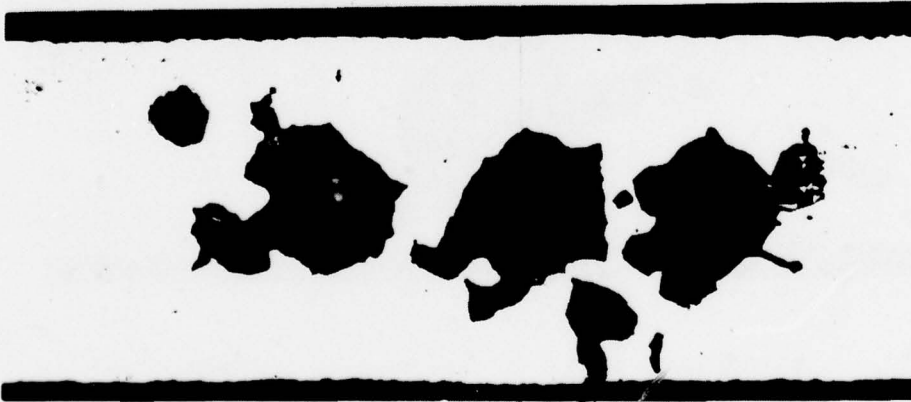
c) Cross section 0.002 inch beyond view (b), where first surface connection is seen.

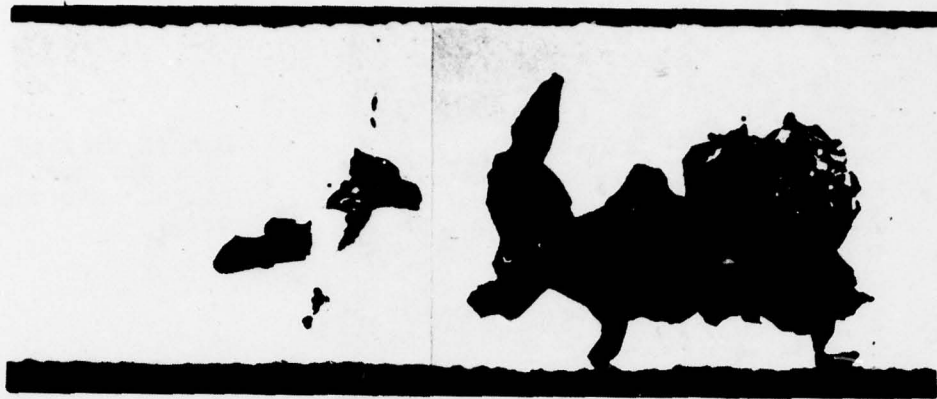
- a) Section 0.0035 inch beyond initial site of corrosion. Total width of internal corrosion at this point is 0.021 inch.
