CHEMICAL AND METALLURGICAL ANALYSIS OF PROPELLANT STORAGE VESSELS

FINAL REPORT - MARCH 1978 - OCTOBER 1978

BELL AEROSPACE TEXTRON
DIVISION OF TEXTRON, INC.
P. O. BOX ONE
BUFFALO, NEW YORK 14240

FEBRUARY 1979

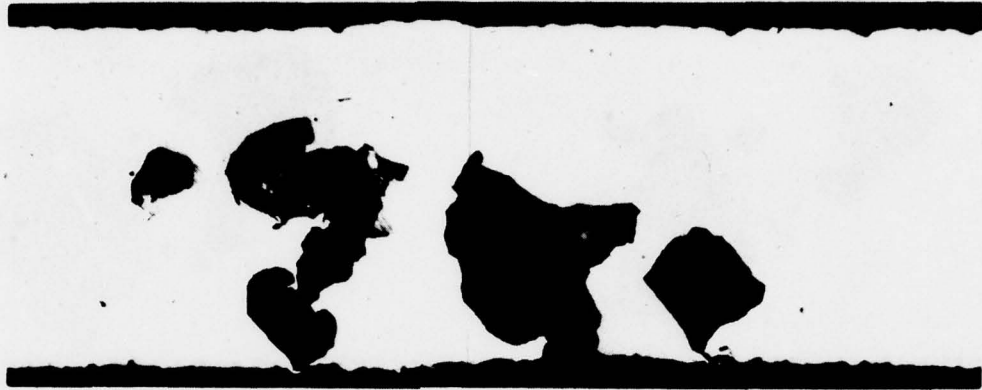
a) Section 0.007 inch beyond start of second pit, view (a) of Figure 36, and 0.025 inch beyond initial corrosion observation.

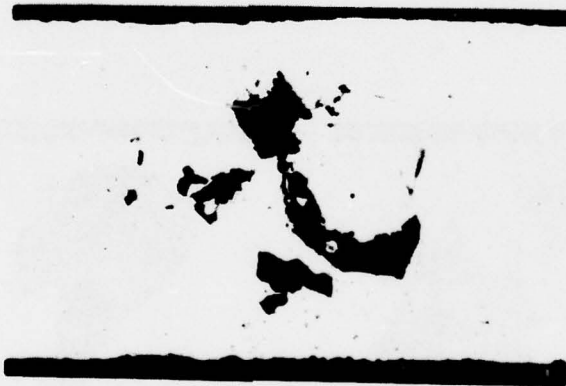
b) Final view of corrosion, 0.030 inch beyond initial indication. In 0.005 inch further progression, metal was sound.

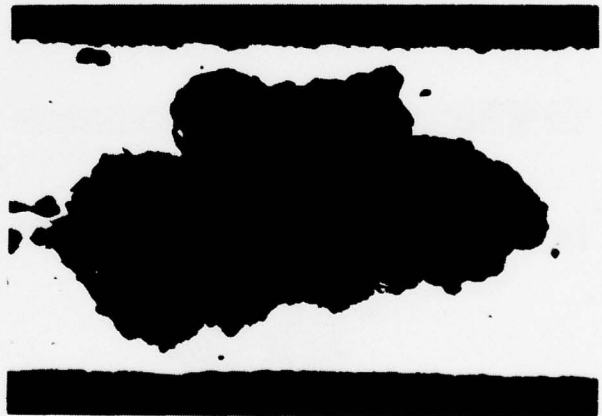
c) Views of pit after polishing 0.010" farther from above views. Pits never penetrated through to interior surface to become a leak.

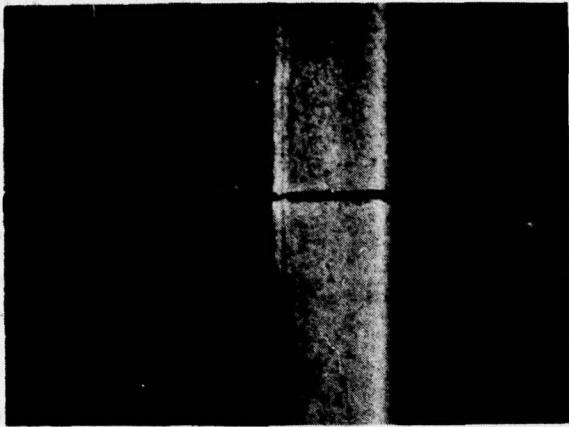
View (a) Mag: 1X View (b) Mag: 15X
Photomicrographs showing the distinct waterline, but also showing that on a magnified scale there was no difference in surface pitting in this region.

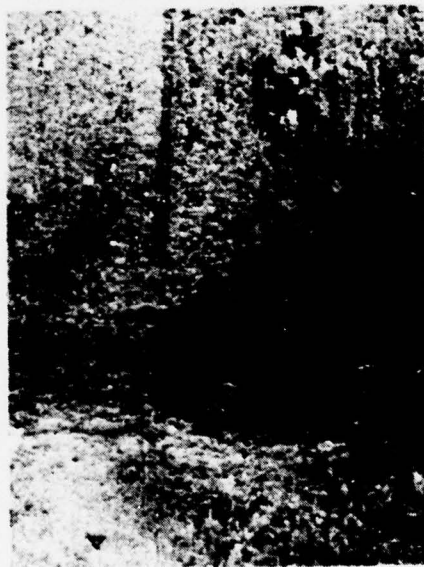
- b) Closeup view of staining around split at bond.

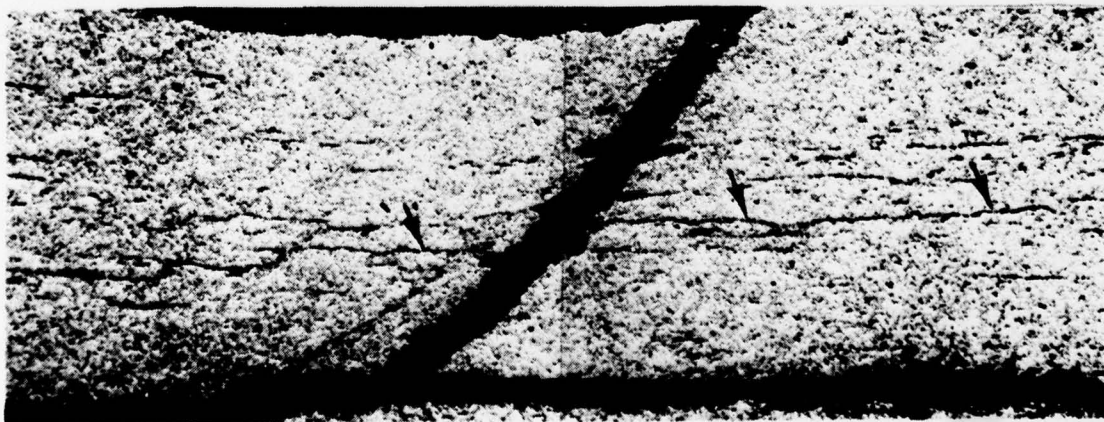
- c) Etched view showing strain effects at arrows along inclusion streaks.

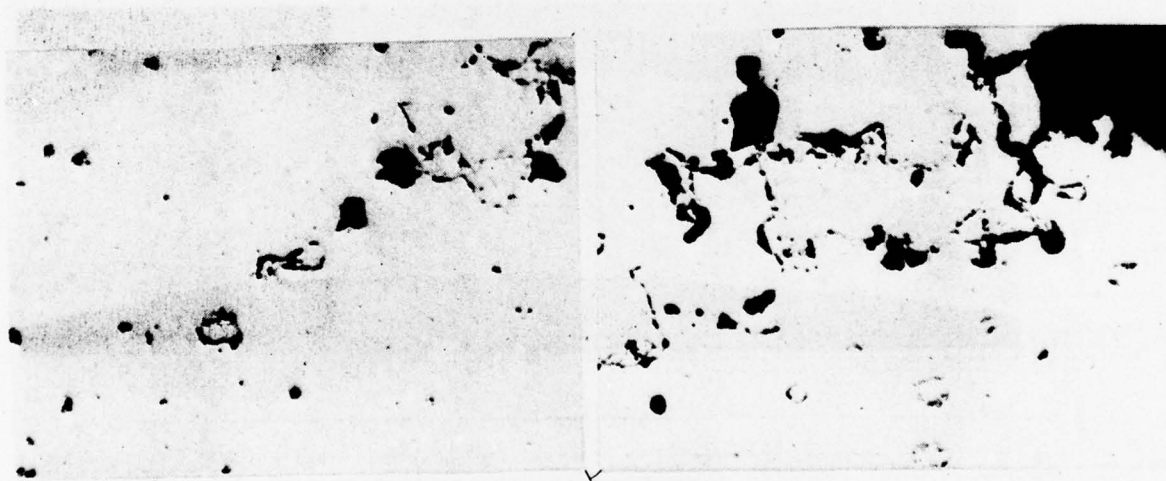
- b) Detail views showing corrosive attack concentrated along intermetallic or inclusion particles.

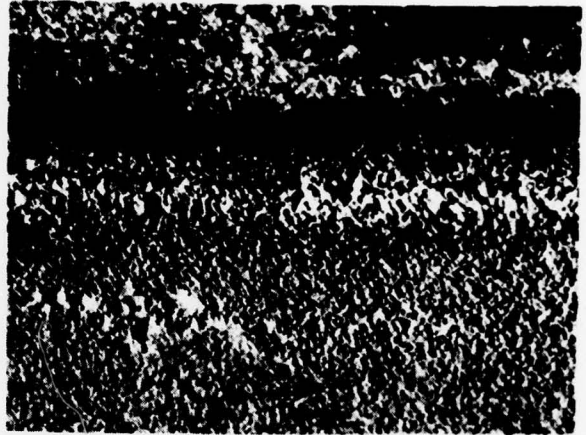
b) Detail view of stain and deposits along bond.

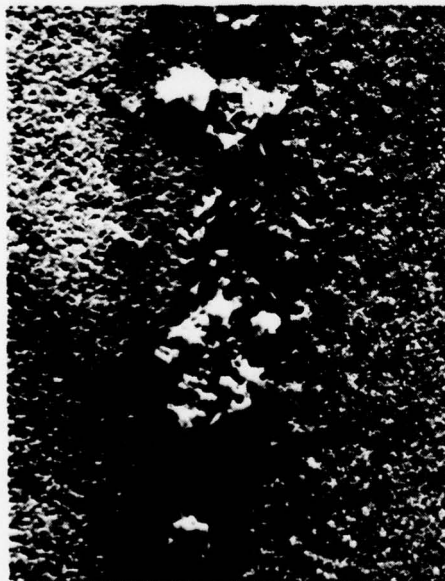
b) Closeup views of stain and deposits.

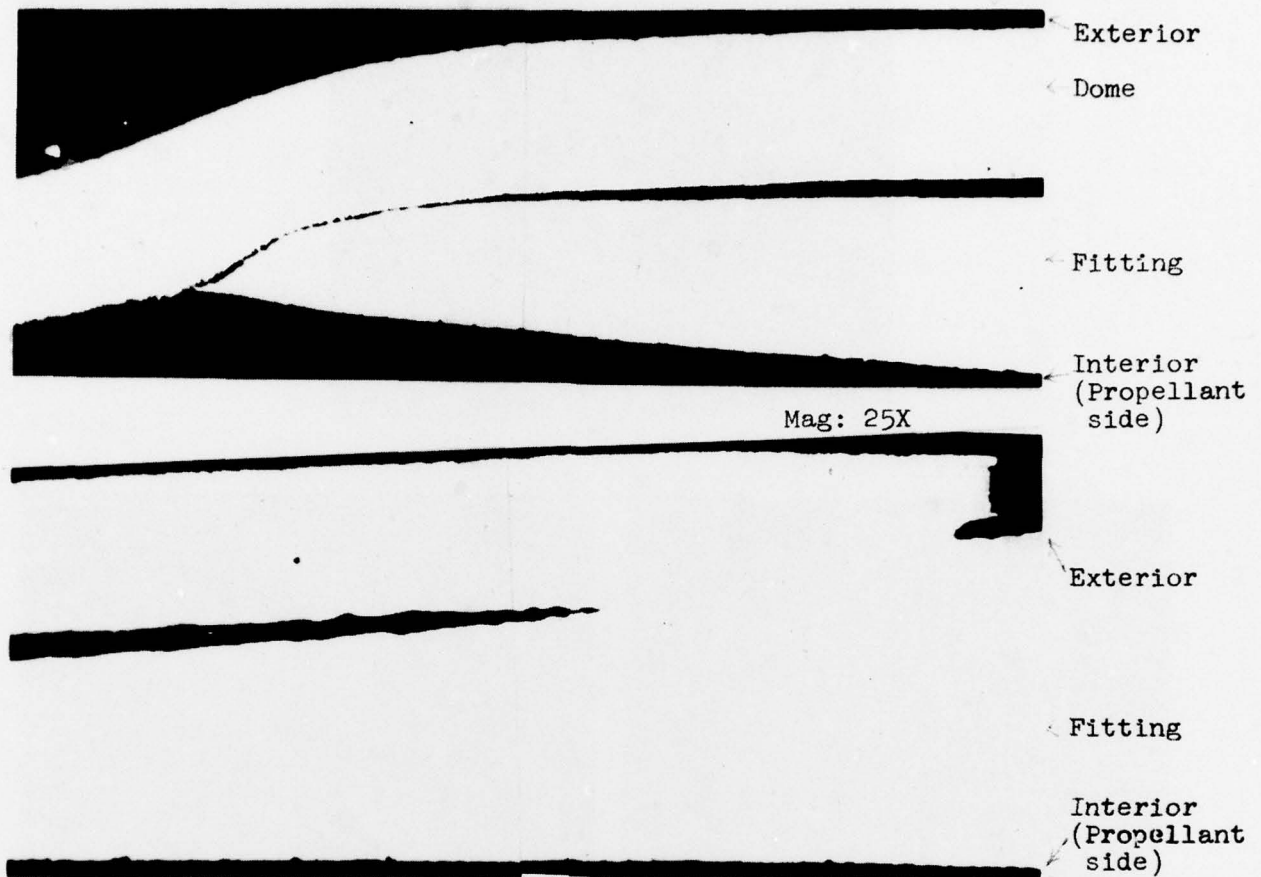
a) Section illustrating extensive cavity along bond, connected to interior, but sealed from exterior.

FIGURE 63. SECTION THROUGH FITTING TO DOME BOND FROM TANK NO. 6 SHOWING CAVITY WHERE CORROSION PRODUCED STAINS AND DEPOSITS OBSERVED IN FIGURE 62.

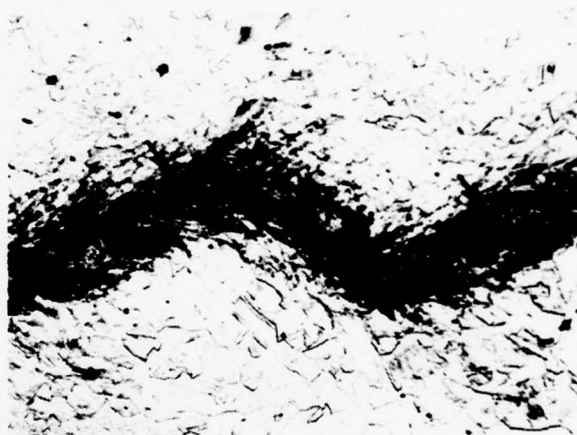
c) Wavy area with melted zones, gas pores and cracks.

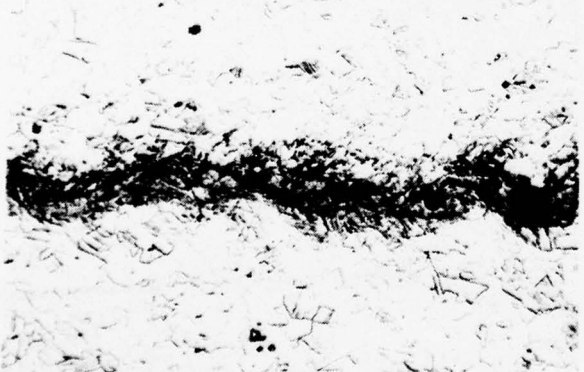
d) Tail-off of wavy area, with melted zones and pores still visible.
