**ASSUNPINK DAM**

**NO. 5**

**NJ 00198**

**PHASE 1 INSPECTION REPORT  
NATIONAL DAM SAFETY PROGRAM**

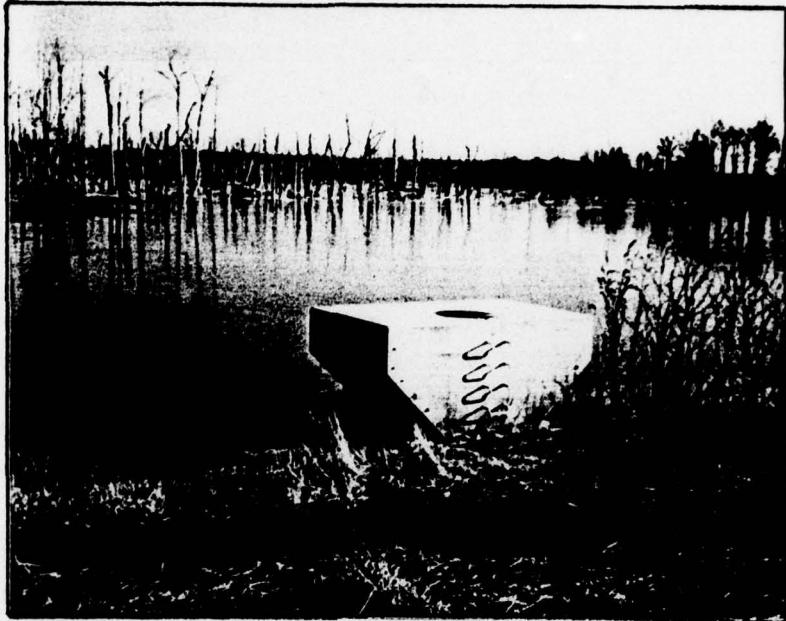
View of intake structure

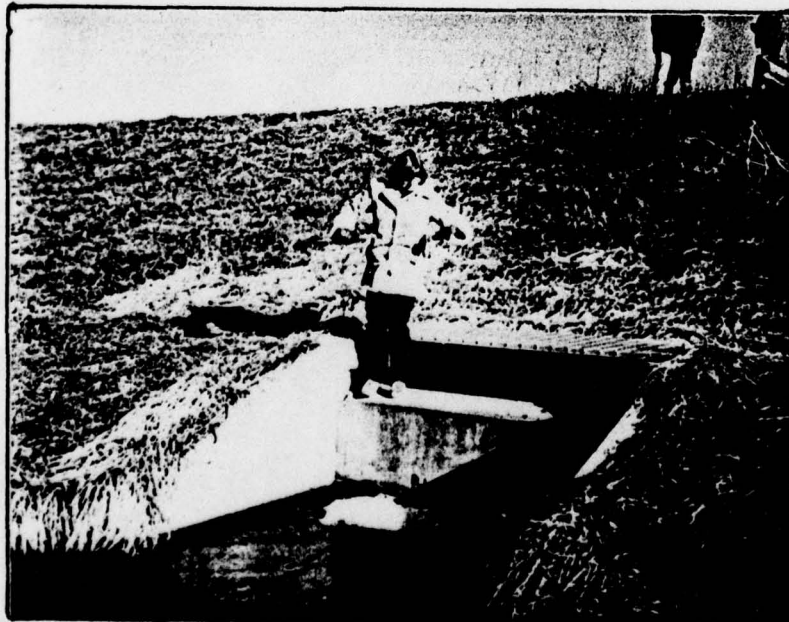
View of outlet structure

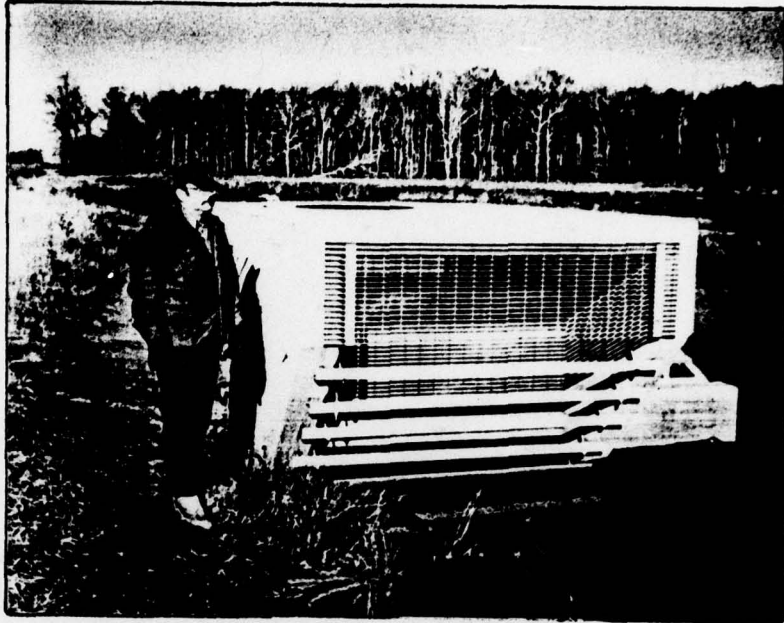
Intake structure

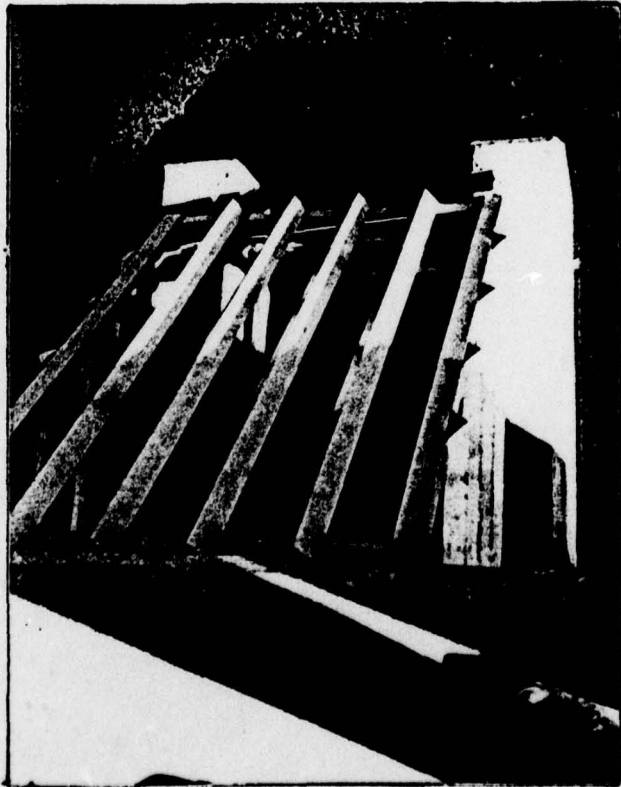
The intake structure was accessible at the edge of the water during the inspection since the lake was 1.5 feet below normal pool. The concrete, grating, and trash racks are in excellent condition although some very light spalling on the lakeside edges of the concrete was noted. Several of the stop logs of the low stage weir had been recently removed by bureau personnel to lower the reservoir to its present pool. The impact basin appeared to be in good condition and functioning as designed. The concrete and safety grate appeared to be satisfactory, and water stains on the concrete indicated that the tailwater was several inches below its normal elevation. The grass covered auxiliary spillway exhibited some vehicle tracks although not as prominently as noted on the dam embankment. This spillway originates in a wooded area near the right abutment, curves around the right end of the dam, and terminates several hundred feet downstream in a small stand of trees. The plans indicated a buried concrete grade beam at the crest of the spillway but this was not located in the field.

Intake structure

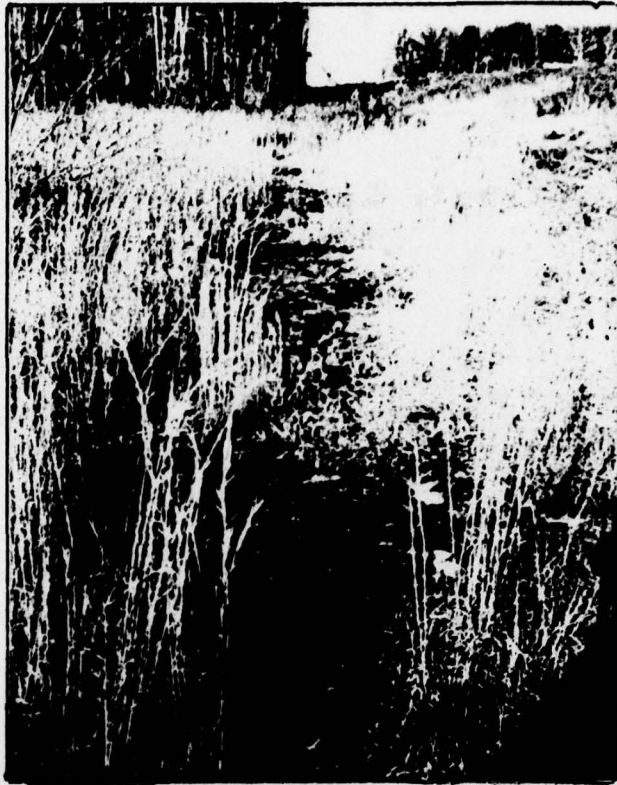
Seepage noted along toe of left  
abutment. (See photo).

View of seepage at toe of embankment
