DELAWARE RIVER BASIN  
FURNACE BROOK  
WARREN COUNTY  
NEW JERSEY

FURNACE BROOK W.S.

DAM NO. 2

PHASE 1 INSPECTION REPORT  
NATIONAL DAM SAFETY PROGRAM

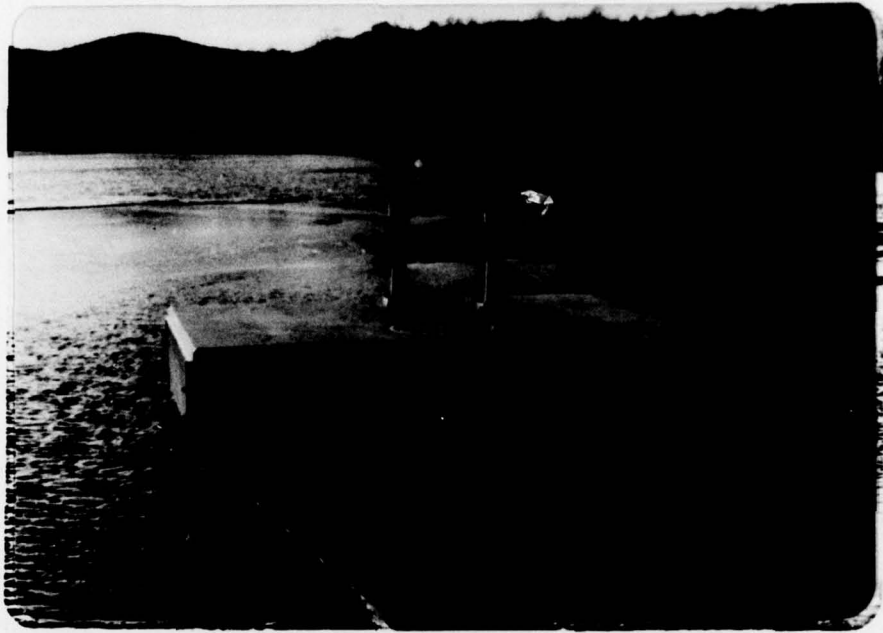
Gate operators at top of  
drop inlet spillway.
