# PAULINS KILL DAM

NJ 00274

## PHASE 1 INSPECTION REPORT<sup>C</sup> NATIONAL DAM SAFETY PROGRAM

May 1979 79 05 14 205

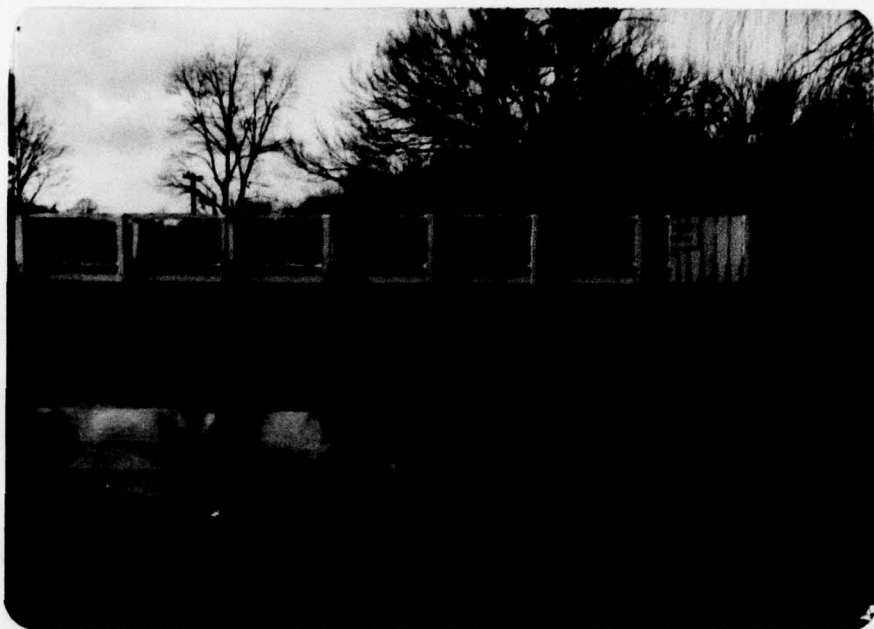
Footbridge and low level gate operator stand at left side of photo. 21 December 1978

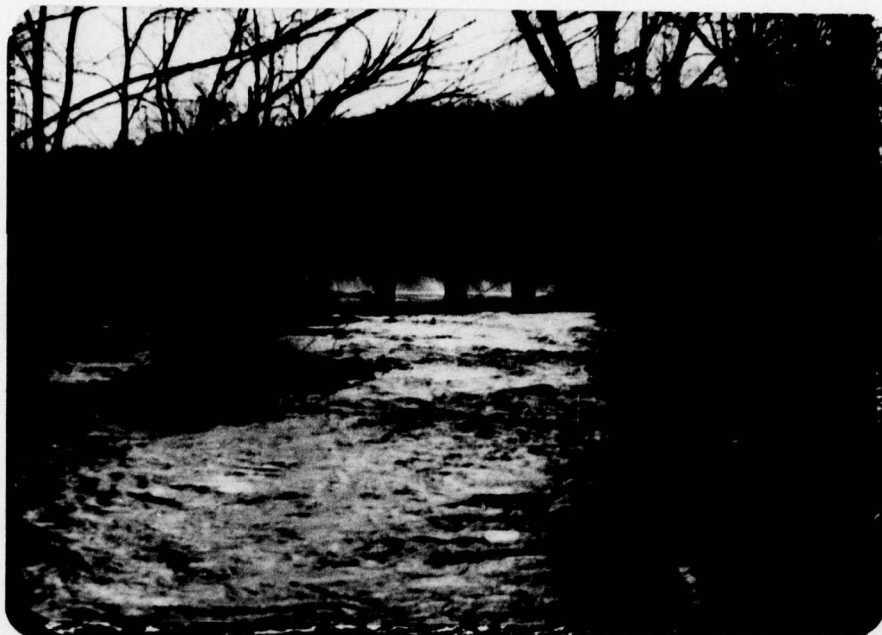
Spillway, Paulins Kill Road Bridge and downstream channel. Looking upstream.
