**STONY BROOK DAM**

**NO. 14**

**NJ 00154**

**PHASE 1 INSPECTION REPORT  
NATIONAL DAM SAFETY PROGRAM**

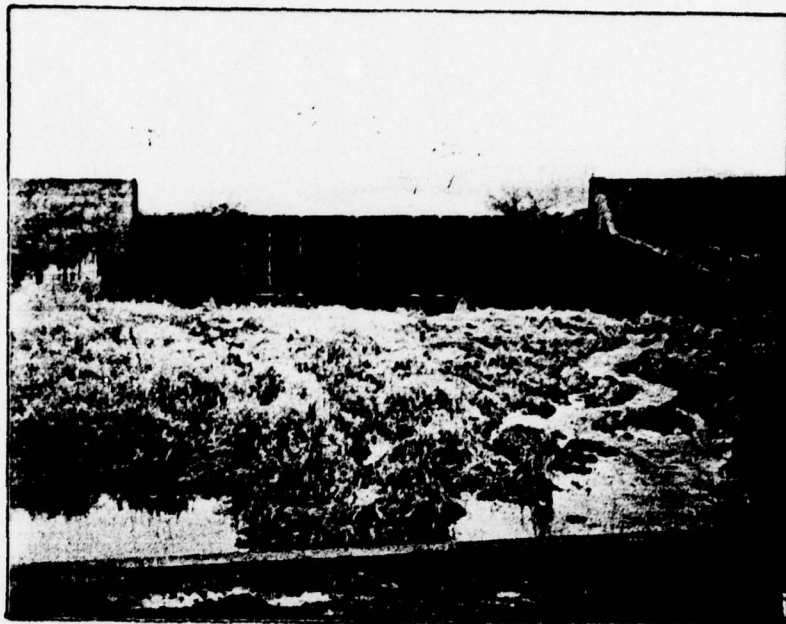
The reinforced concrete spillway appears to be in a satisfactory condition although some superficial spalling was noted on the upper surfaces of the wingwalls. The left and right headwall extensions along the dam axis are slightly offset ( $\frac{1}{2}$  inch) in a downstream direction at the vertical construction joints. Also, both wingwalls are offset in a downstream direction about  $\frac{3}{4}$  of an inch (relative to the sidewalls). However, no serious structural cracking was noted. The stilling apron is constantly under water and not visible during the inspection. However, the face and crest of the weir as well as the buttresses appeared to be in a satisfactory condition. The gate and stem for the 24" RCP drain is in good condition, but the stem wheel is missing. The plans indicate the pipe originates in the upstream thalweg of the original stream (beyond the upstream toe), passes through the left headwall, makes a  $90^\circ$  turn to the right and exits through the left sidewall. An Armco steel sluice gate is mounted on the wingwall. (See appended plans).

Downstream view of spillway structure

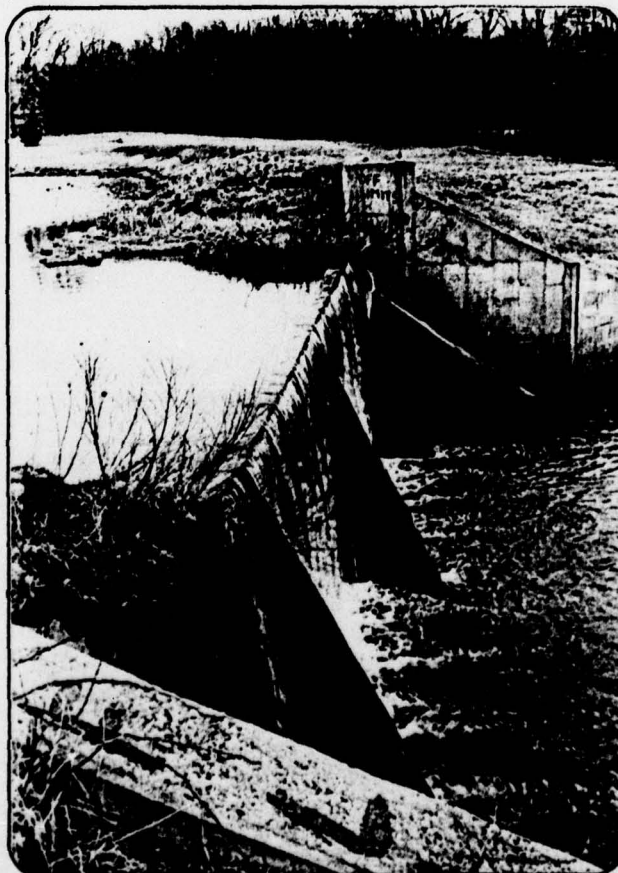
View of spillway structure

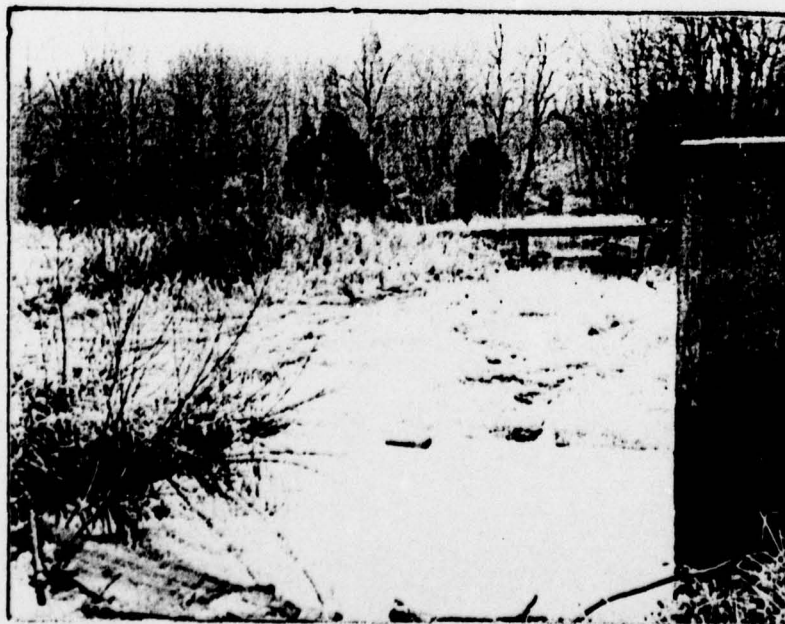
View downstream

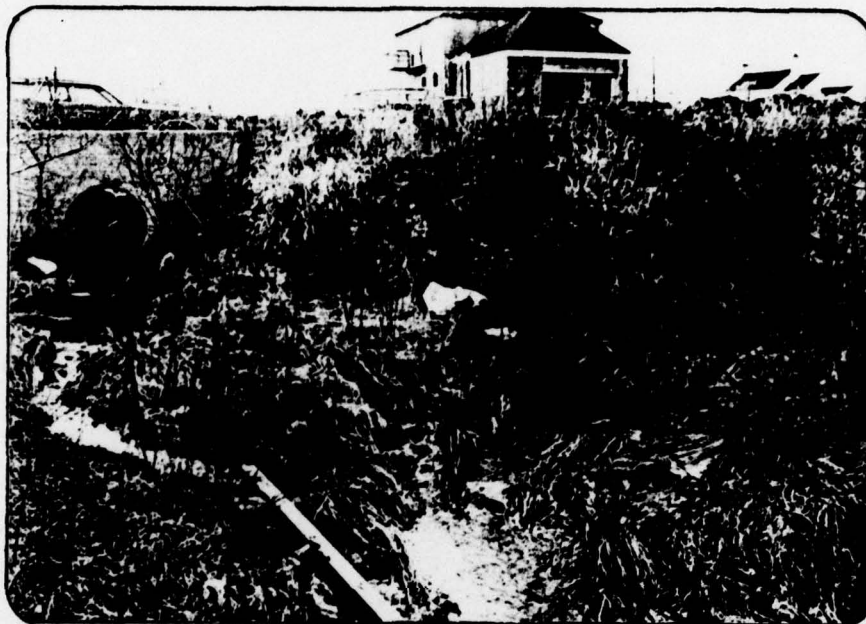
Origin of stream

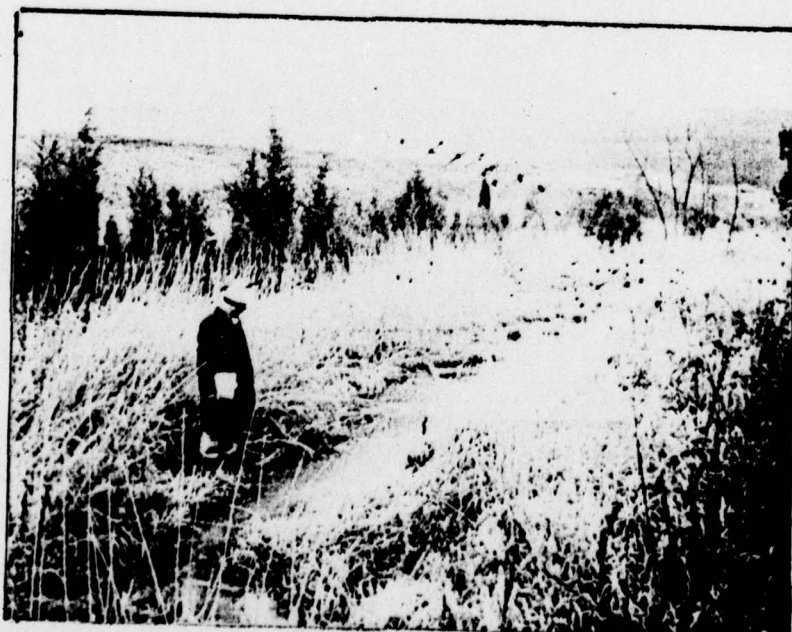
| VISUAL EXAMINATION OF | OBSERVATIONS | REMARKS OR RECOMMENDATIONS |
|---|---|---|
| Downstream Toe | Small stream parallel to face of dam on right side. Swampy growth along toe indicative of a perennial condition. Growth between stream channel and right embankment. | + $\frac{1}{2}$ cfs of flow.<br>Water at ground surface over an extensive area. |
| ANY NOTICEABLE SEEPAGE | Ground damp along toe of right embankment, however this could be caused by the existence of the stream. | Right embankment built across a stream channel which was diverted along the face of the dam. Old stream bed deposits may be acting as a conduit under the dam. Plans indicate removal. |

Stream at toe of dam
