**BUILD 1 OF AN ACCELERATED MISSION TEST
OF A TF41 WITH BLOCK 76 HARDWARE**

*PERFORMANCE BRANCH
TURBINE ENGINE DIVISION*

TECHNICAL REPORT AFAPL-TR-79-2020
Final Report for Period 18 October 1977 - 13 January 1978

AIR FORCE AERO PROPULSION LABORATORY
AIR FORCE WRIGHT AERONAUTICAL LABORATORIES
AIR FORCE SYSTEMS COMMAND
WRIGHT-PATTERSON AIR FORCE BASE, OHIO 45433

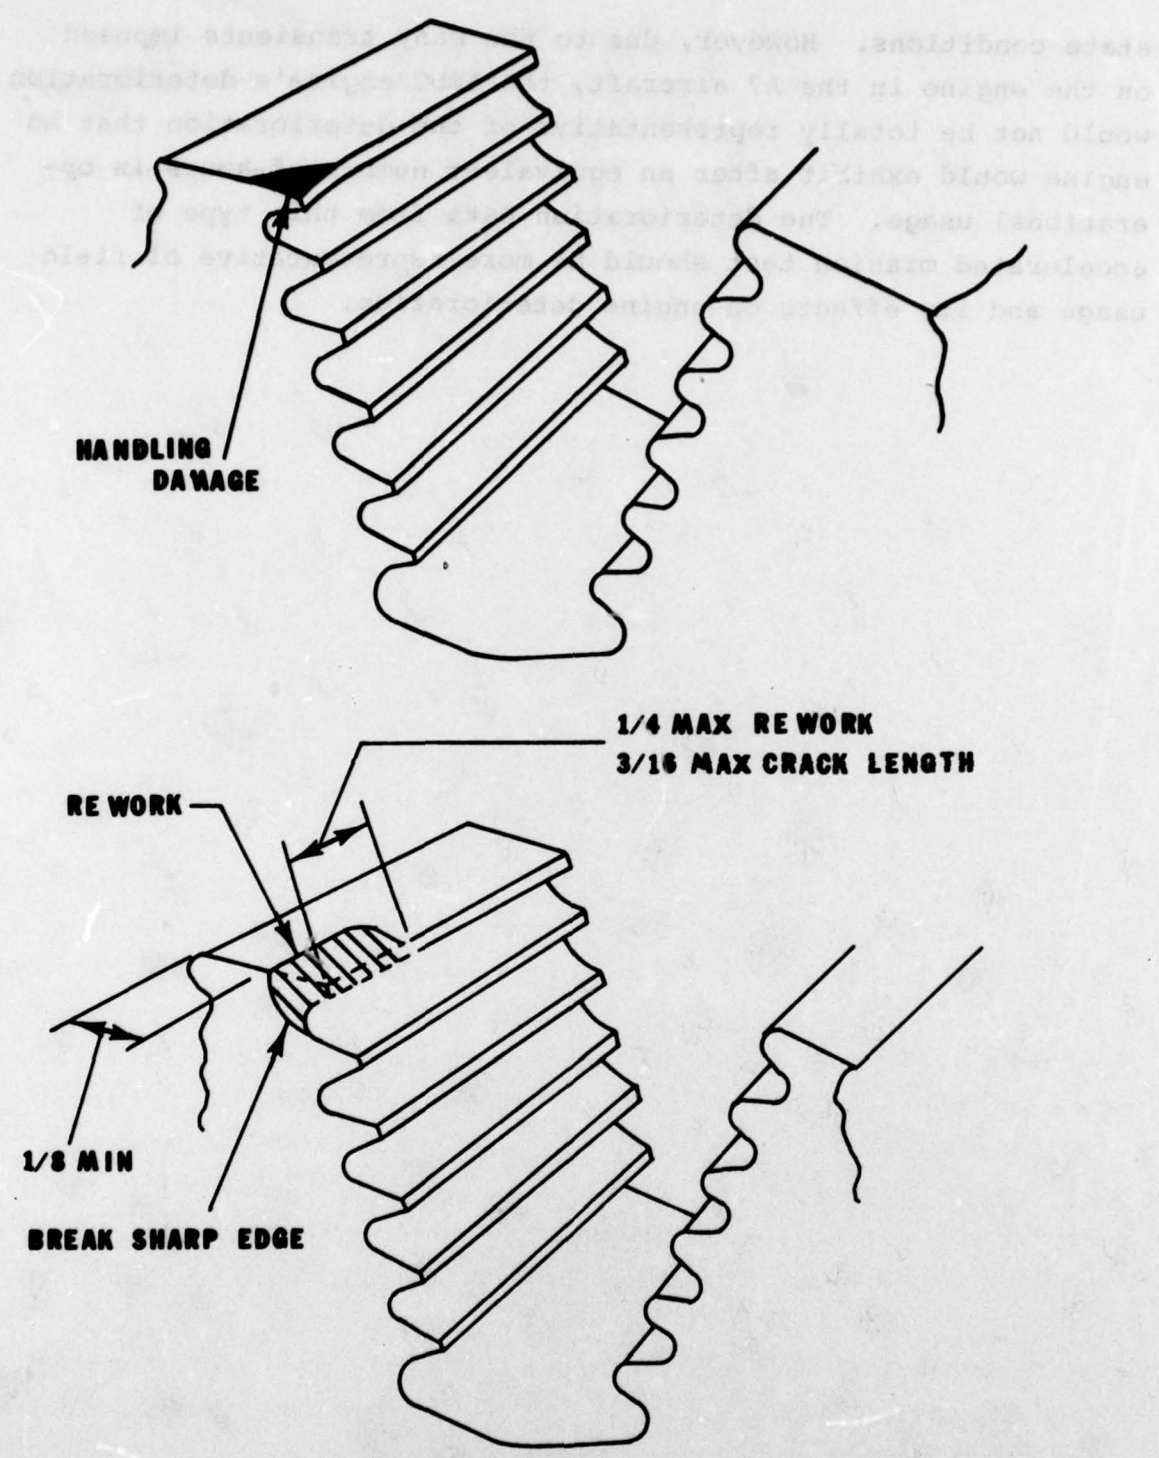
Figure 1 HPT-2 Wheel Handling Damage and Proposed Rework

Second stage high pressure turbine wheels with crack indications on the face and extending along the root radius were first reported in mid-1976. Exhibits were returned to Allison who determined the cause was handling damage during overhaul. A recent review at the Navy's Jacksonville overhaul facility showed that 2/3 of the HPT-2 wheels have this problem. The Air Force is experiencing similar

Allison has proposed a short term solution which consists of a blending rework of the damaged teeth (Figure 1). (The long term solution includes major structural changes, which if accepted will not be ready for several years). A reworked turbine wheel has been run through 52 hours of AMT testing and 48 hours of resonance testing for the initial clearance of this rework procedure. The initial release of this rework allows a maximum of 250 hours service life. In keeping with the 1975 TF41 Executive Review Group's mandate that "there must be very careful testing and verification of the adequacy of repair procedures for the critical hot section of the engine", (Ref. 1) this rework procedure will be verified in this 263 hour AMT test to extend the rework time limit from 250 hours to 450 hours.

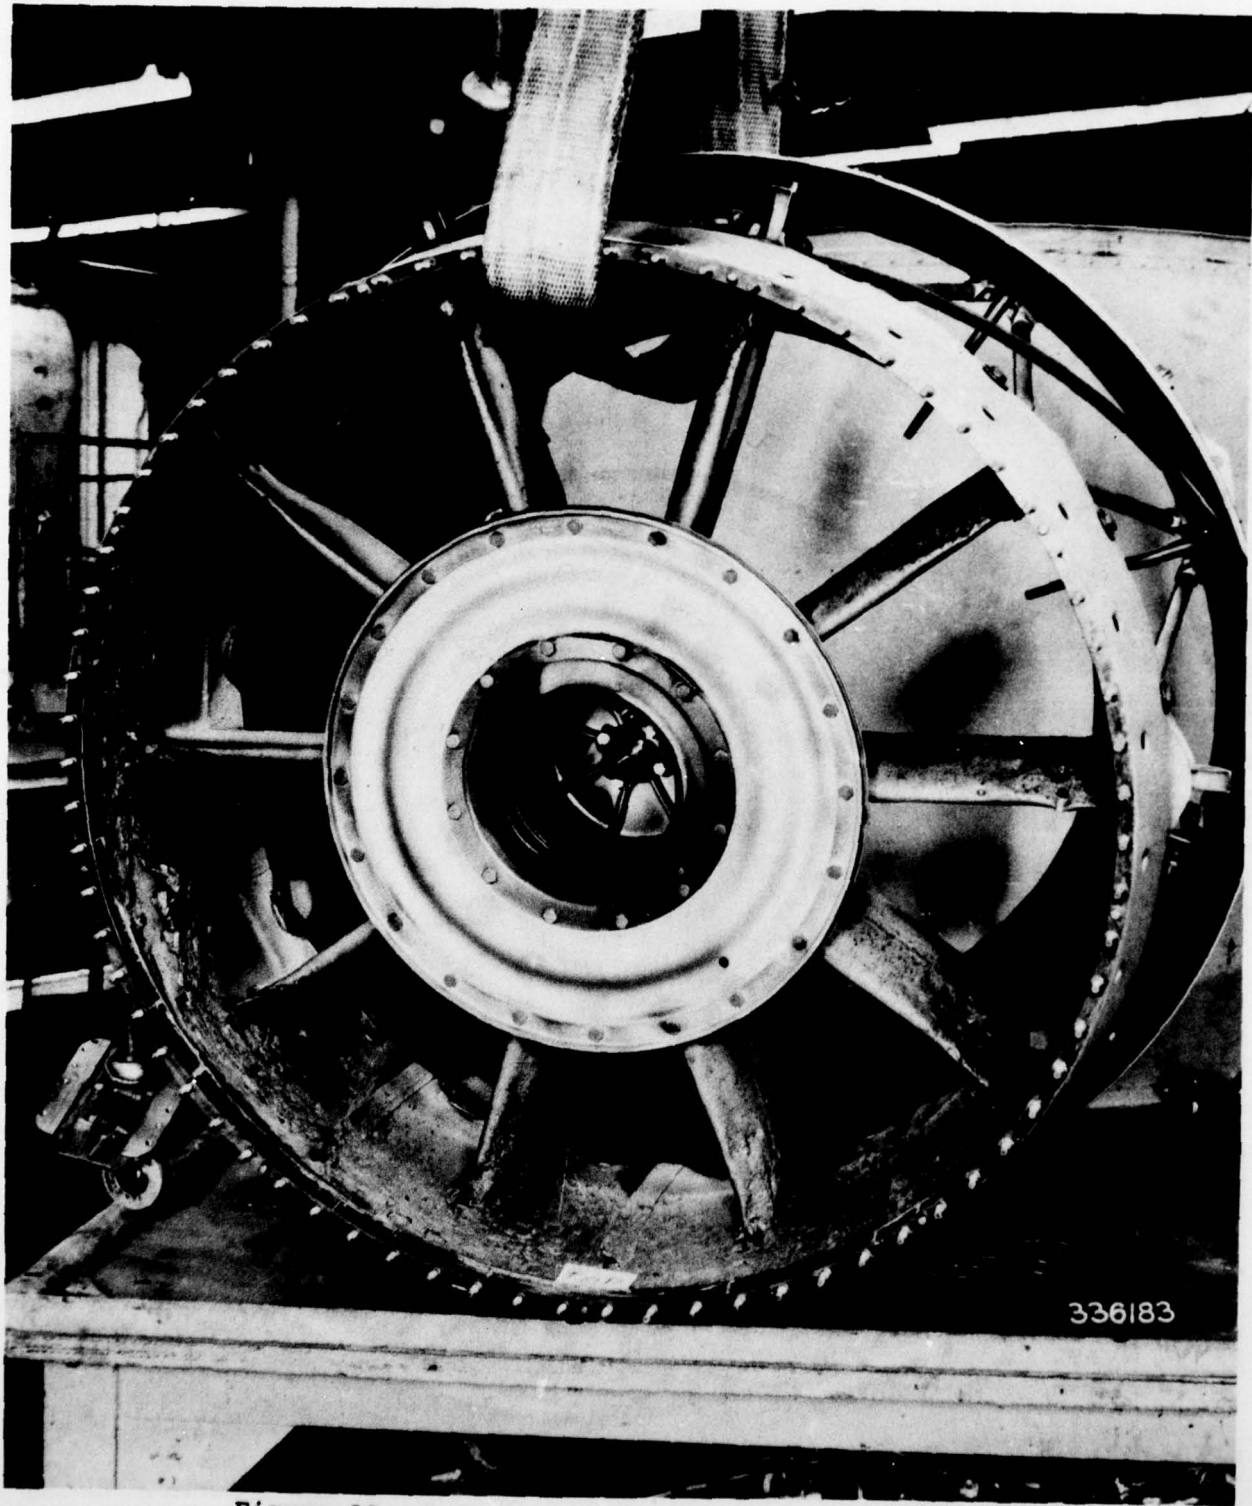
Figure 38 L.P. Turbine Bearing Support Fairing

- Crack in L.P. Turbine Bearing Support Fairing - Two cracks of approximately 2 inches each in length were discovered on the struts at approximately the 2 o'clock and 7 o'clock positions on the fairing during the 100 hour phase inspection. The cracks were repaired by stop drilling and welding.

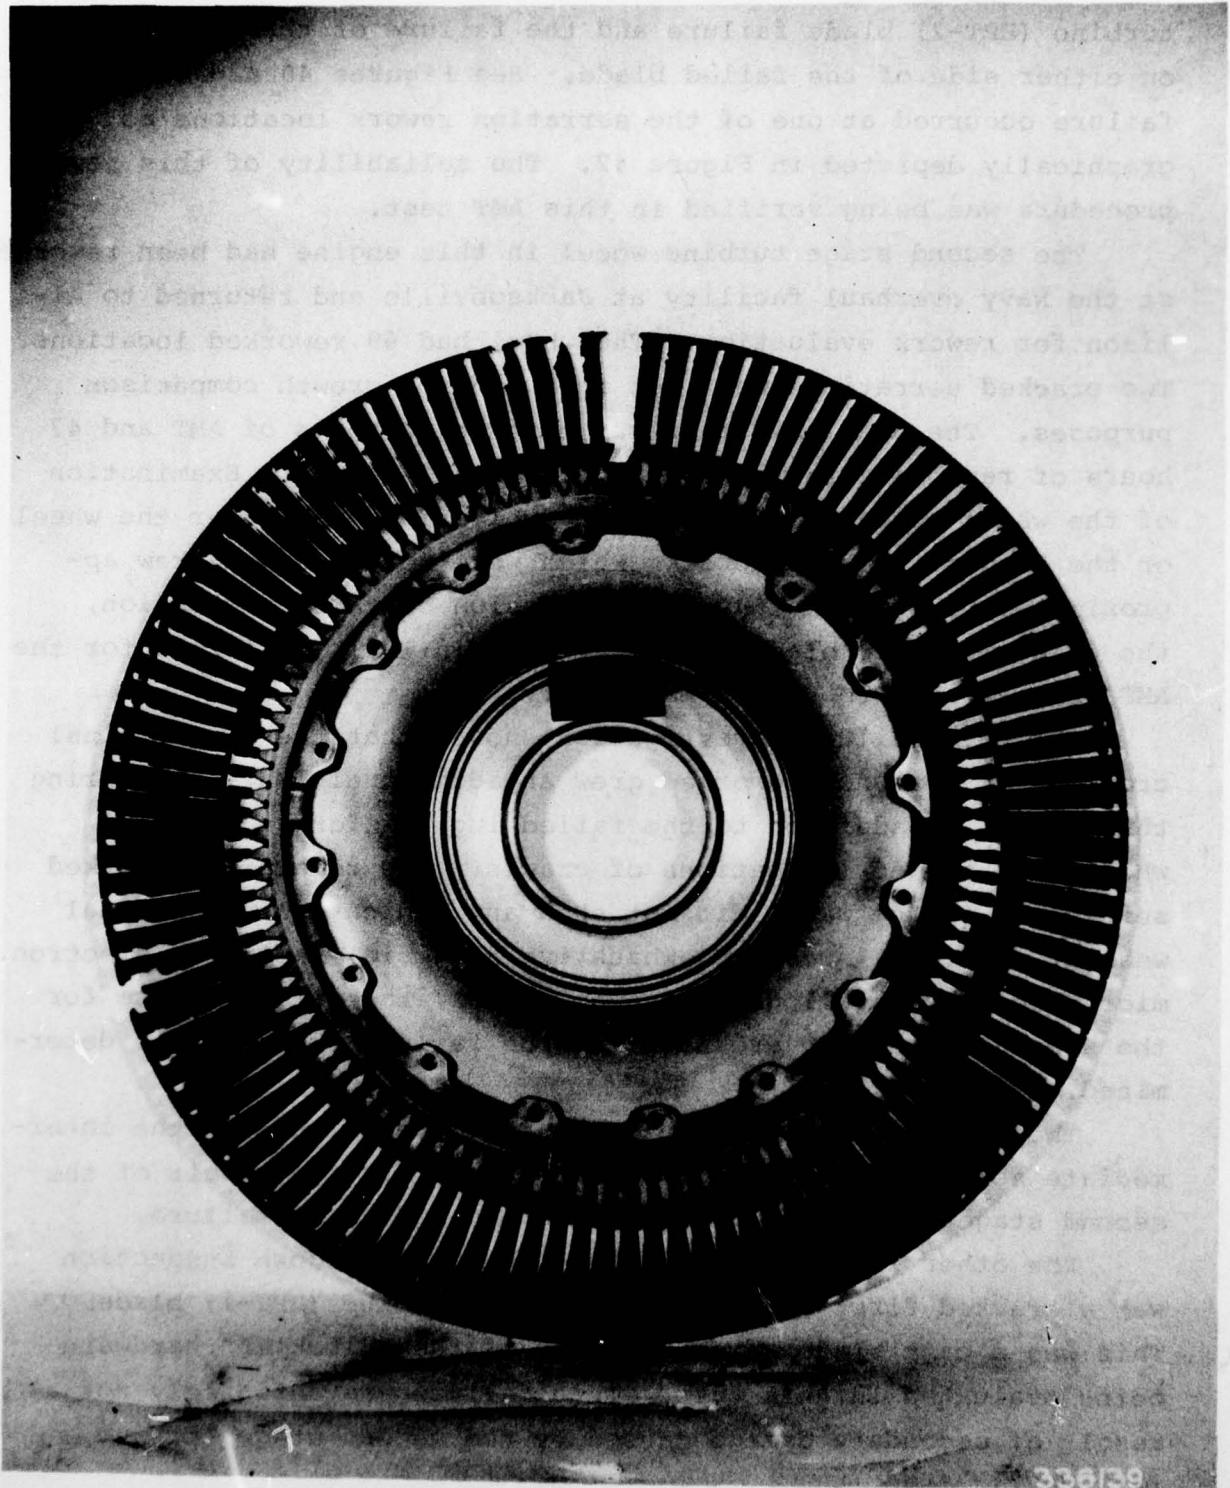
Figure 39 Second Stage H.P. Turbine

- H.P. Turbine (Figures 39 and 40)
 - right-hand blade of #7 paired blades broken off in second stage wheel dovetail
 - second stage wheel dovetail had two pieces of wheel broken off on O.D., one piece on each side
 - H.P. thrust bearing intermediate seal insert seized on H.P. shaft
 - first stage blade - position 57 had fatigue crack failure in bottom serration on the pressure side

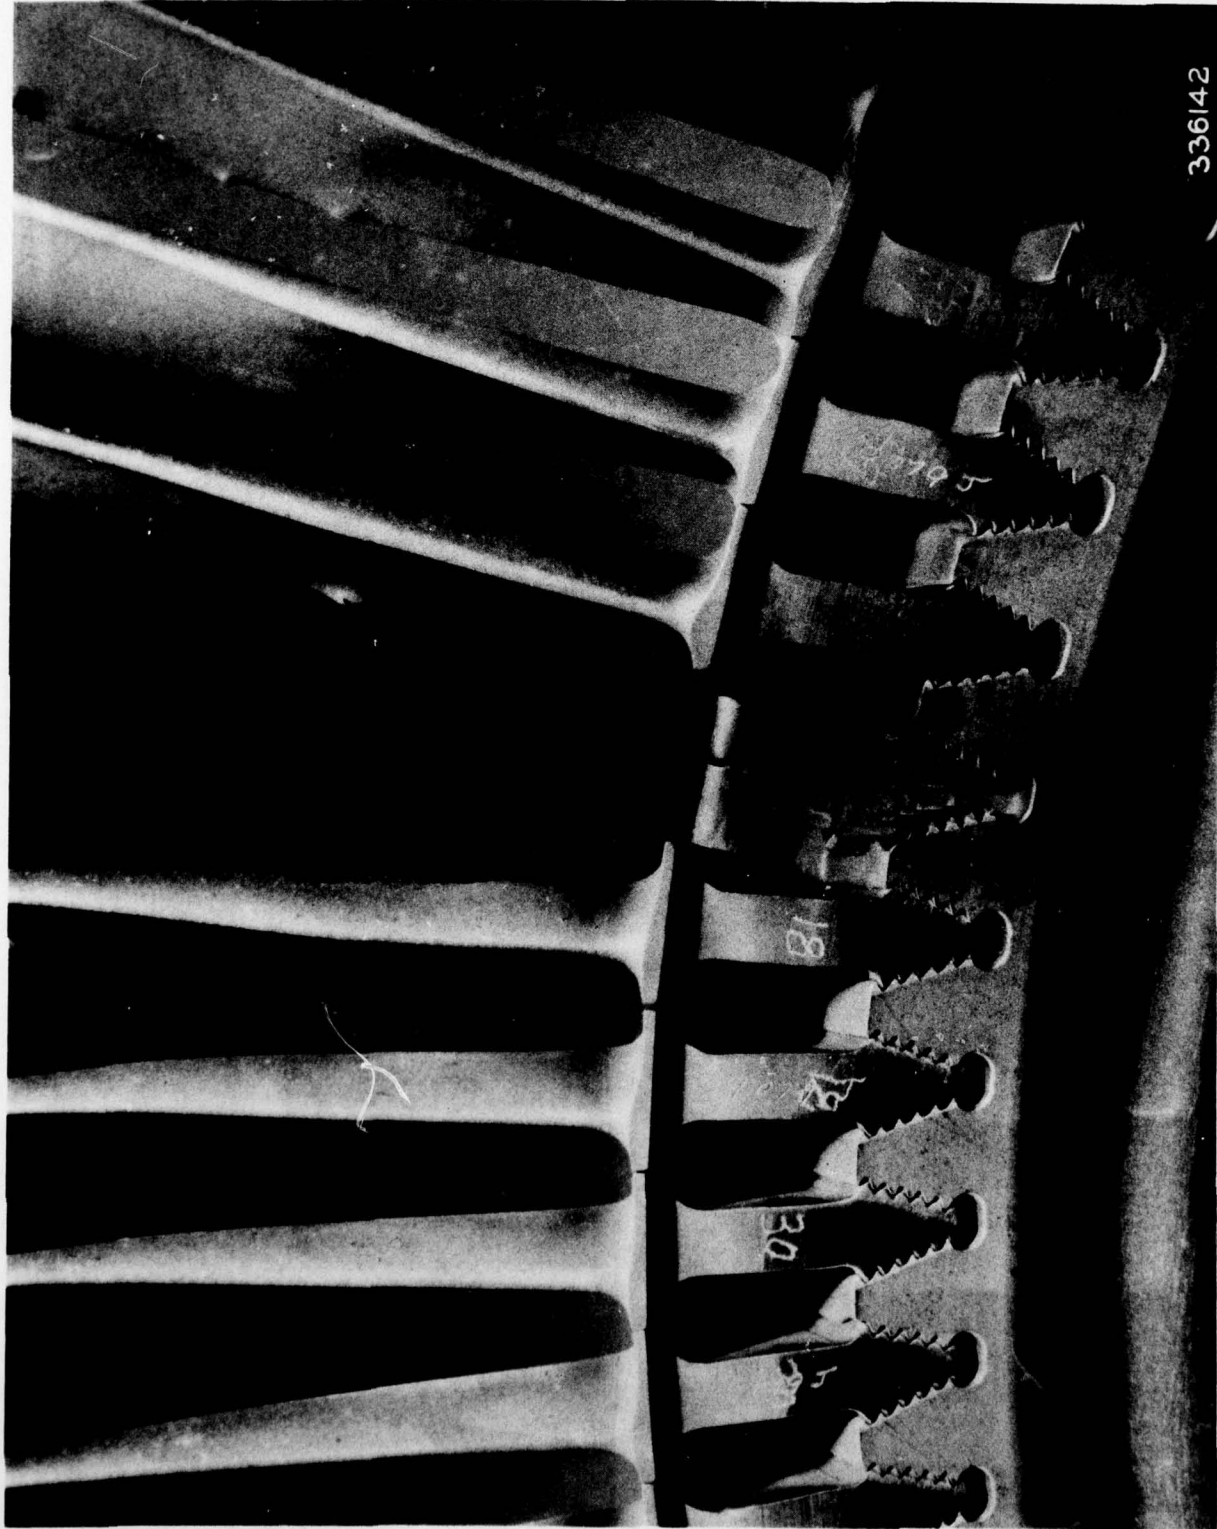
Figure 40 Failure Location - Second Stage H.P. Turbine

The engine failure was due to a second stage high pressure turbine (HPT-2) blade failure and the failure of the wheel lugs on either side of the failed blade. See Figures 40 and 41. The failure occurred at one of the serration rework locations as graphically depicted in Figure 42. The reliability of this rework procedure was being verified in this AMT test.

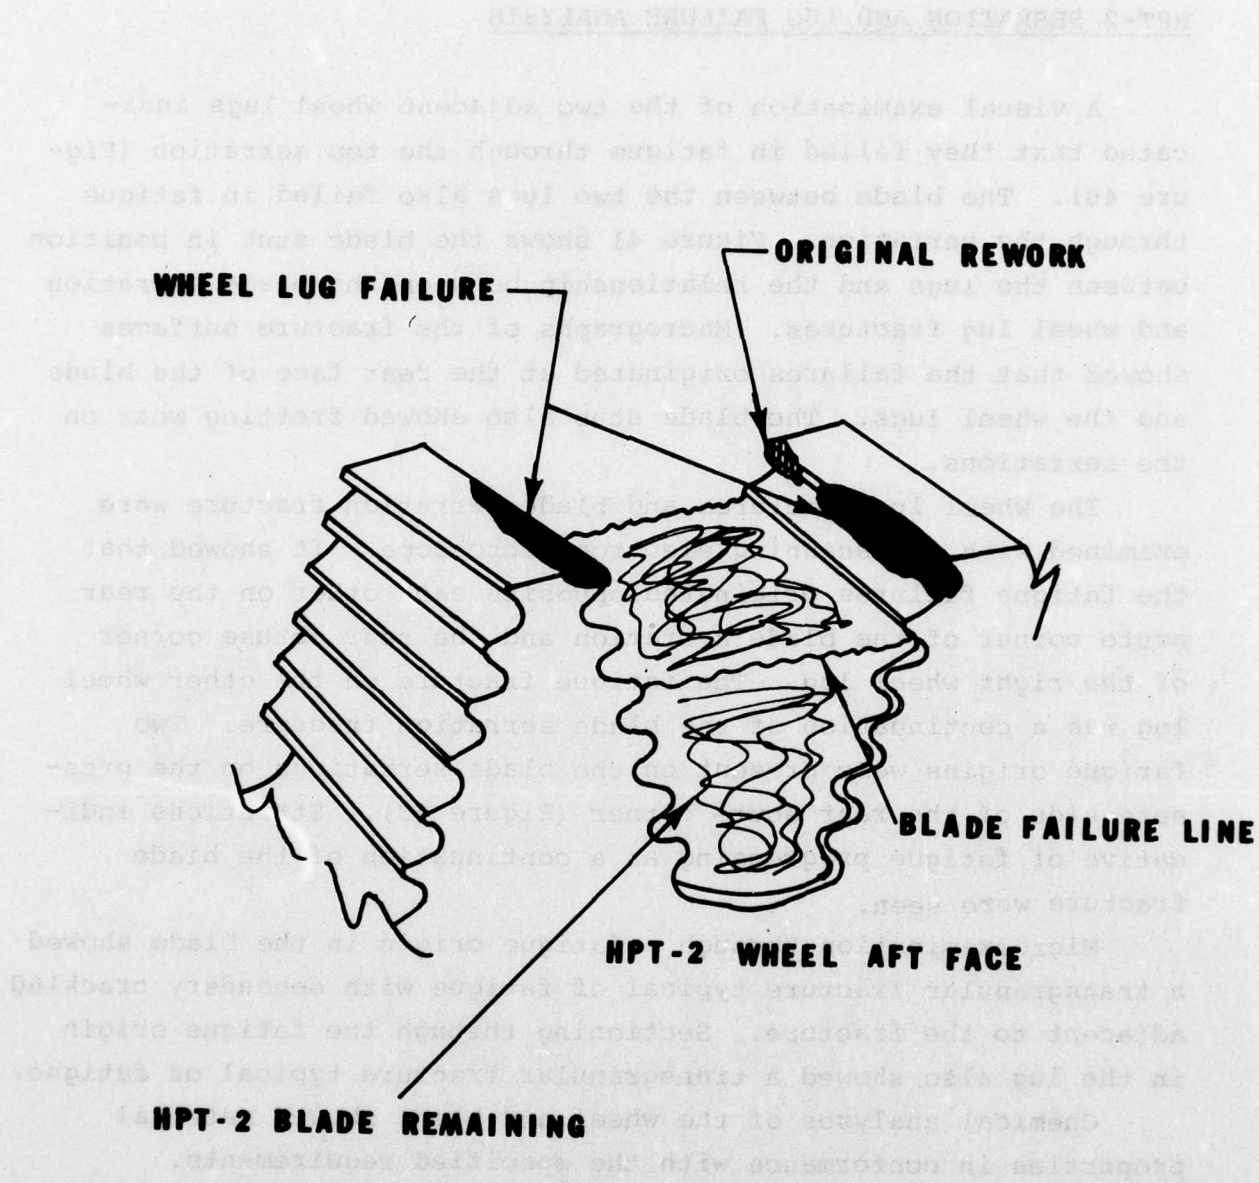
Figure 42 Schematic of Failed Wheel Lug

HPT-2 SERRATION AND LUG FAILURE ANALYSIS

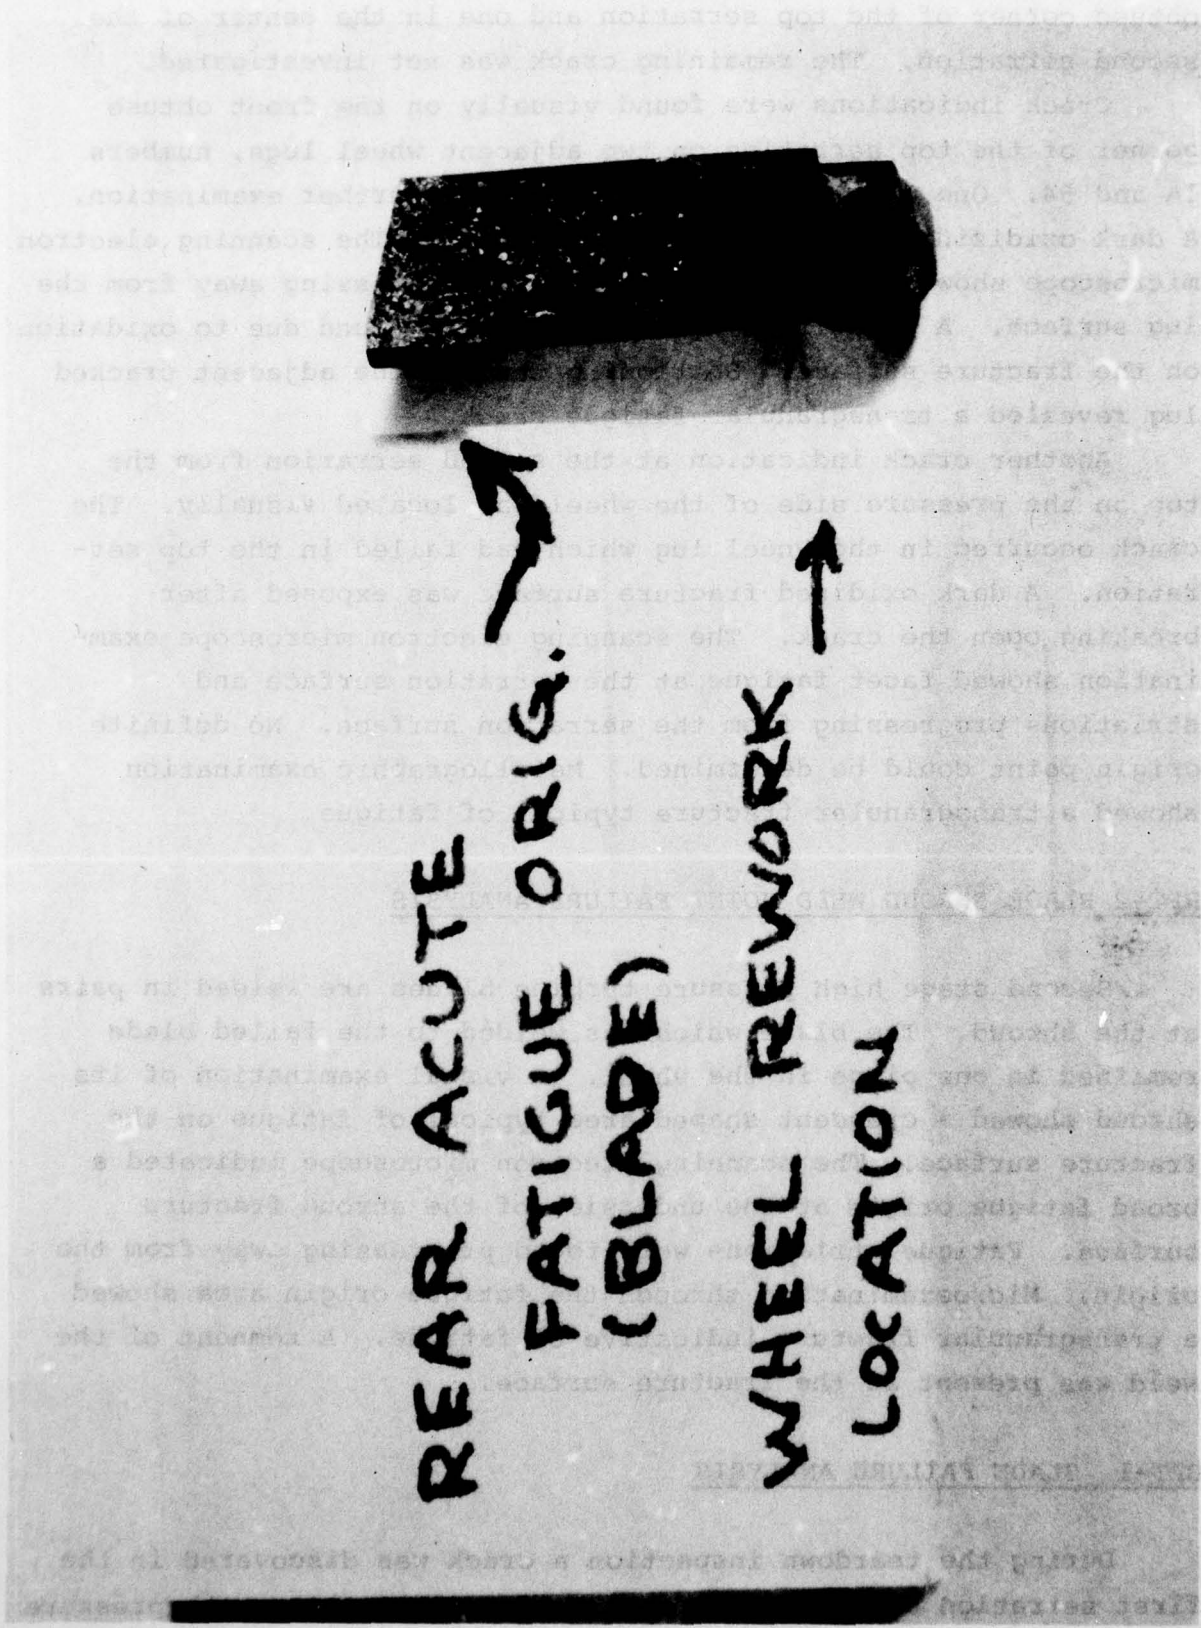
Figure 43 Failure Surface of Remaining Blade Stub

Examination of the wheel showed crack indications on 6 other second stage high pressure turbine wheel lugs. Two of these cracks were "reference" cracks that were left to check growth. Three of the other cracks were confirmed to be fatigue, two in the front

FATIGUE ORIG.
(BLADE)

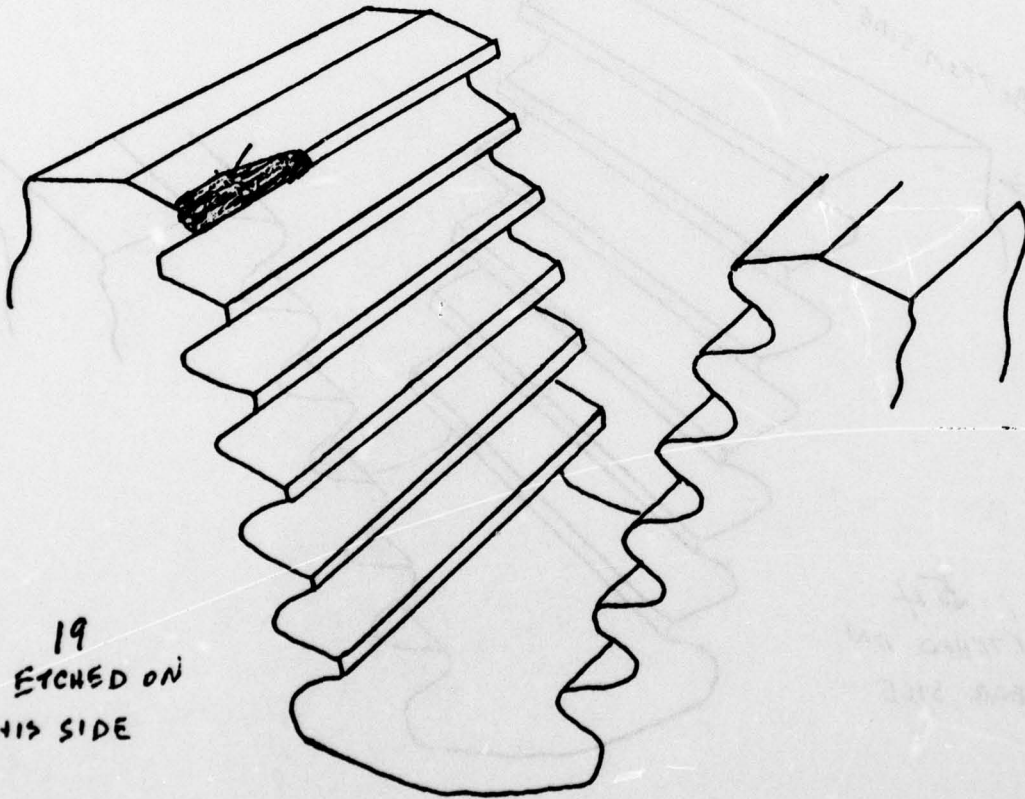
11 INDICATION
-32 IN REWORKED AREA
