**INTERIM FIELD PROCEDURE FOR BOMB
DAMAGE REPAIR -USING CRUSHED ^{Line}STONE FOR
CRATER REPAIRS AND SILIKAL[®] FOR SPALL REPAIRS**

MICHAEL T. McNERNEY
ENGINEERING DIVISION,
RAPID RUNWAY REPAIR SECTION

APRIL 1979

INTERIM REPORT
JUNE 1978 - MARCH 1979

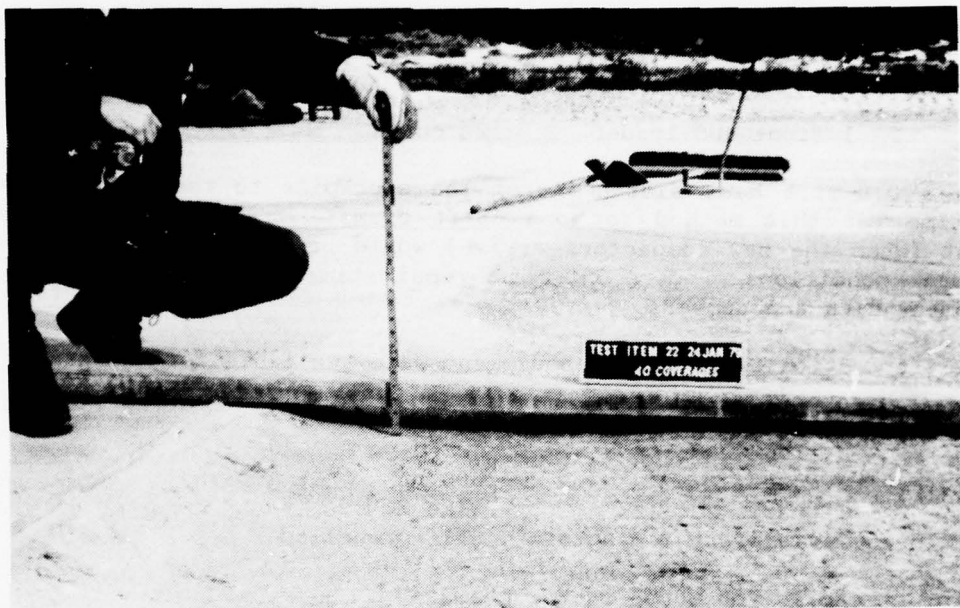
Figure 6
Consolidation of Crushed Stone at Edge of Concrete

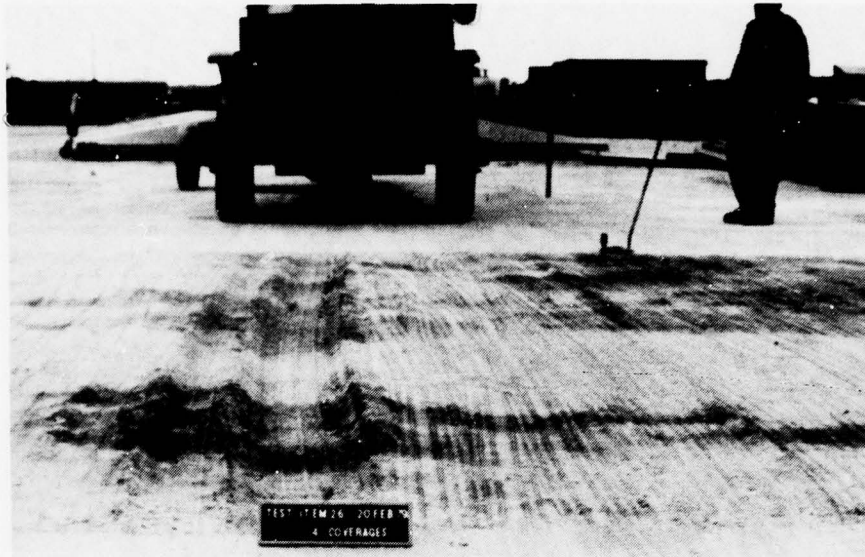
Figure 18
Typical Initial Rutting on Satisfactory Repairs

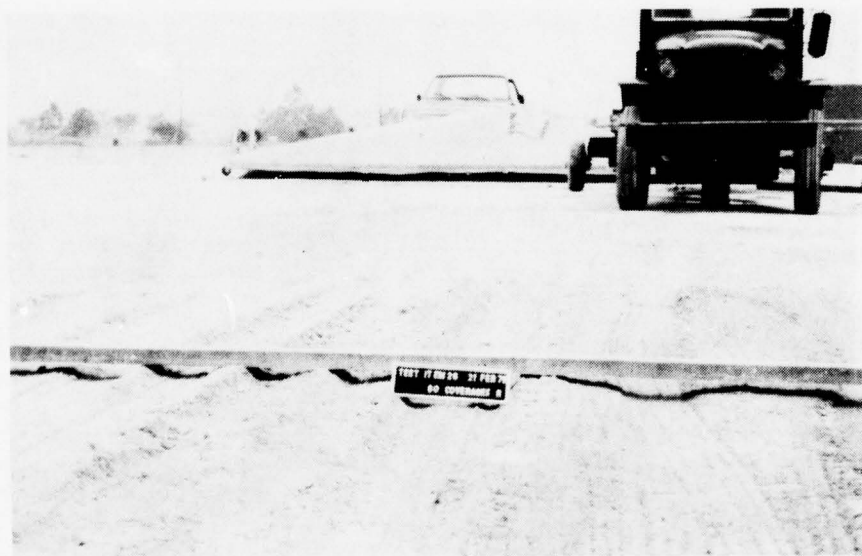
The repair procedure described in this section should withstand 200 passes to 576 passes (60 coverages based on a 120 inch aircraft wander) of F-4 type traffic before an additional repair will be required. From field test experience the repair is most likely to initially fail in rutting around 200 passes. If the rutting can be controlled during this initial period of F-4 traffic, the additional traffic consolidates and densifies the crushed stone an additional 5 lbs/cu ft and the repair will last for an extended period. The repair should be carefully watched during this initial 200 passes and additional material added if rutting exceeds three inches or consolidation (settlement measured from original pavement surface) exceeds two inches. Also during this initial 200 passes additional material should be added anytime the material consolidates (settles) below one inch at the junction of the existing concrete pavement.

Figure 19
Typical Rutting After 60 Coverages (576 Passes)

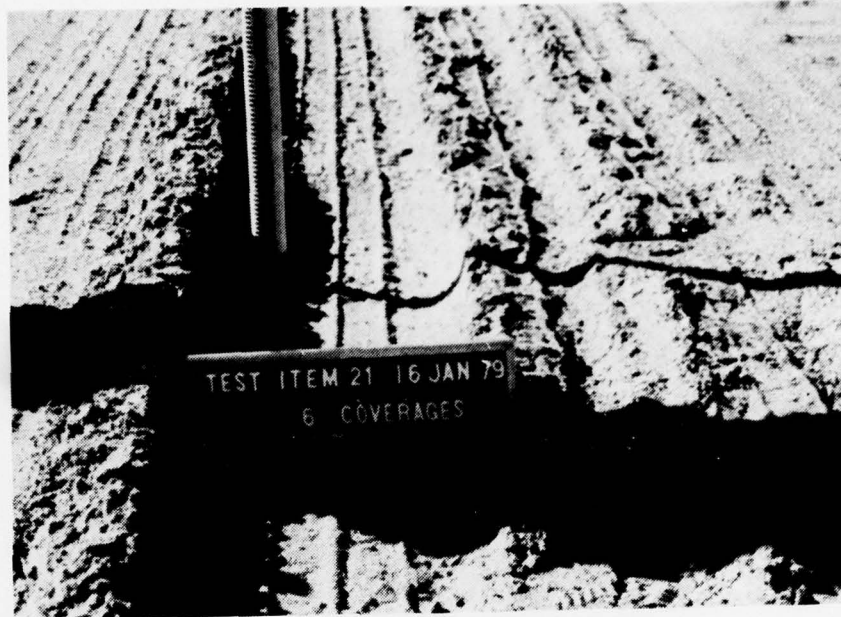
Figure 22
Actual Failure Due to Rutting

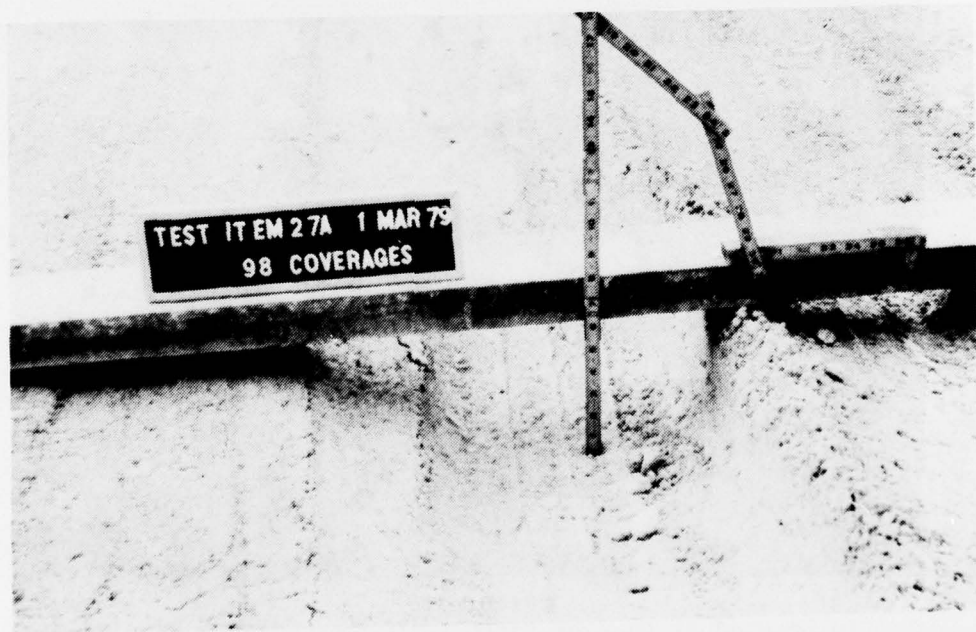
Figure 23
Actual Failure Due to Rutting

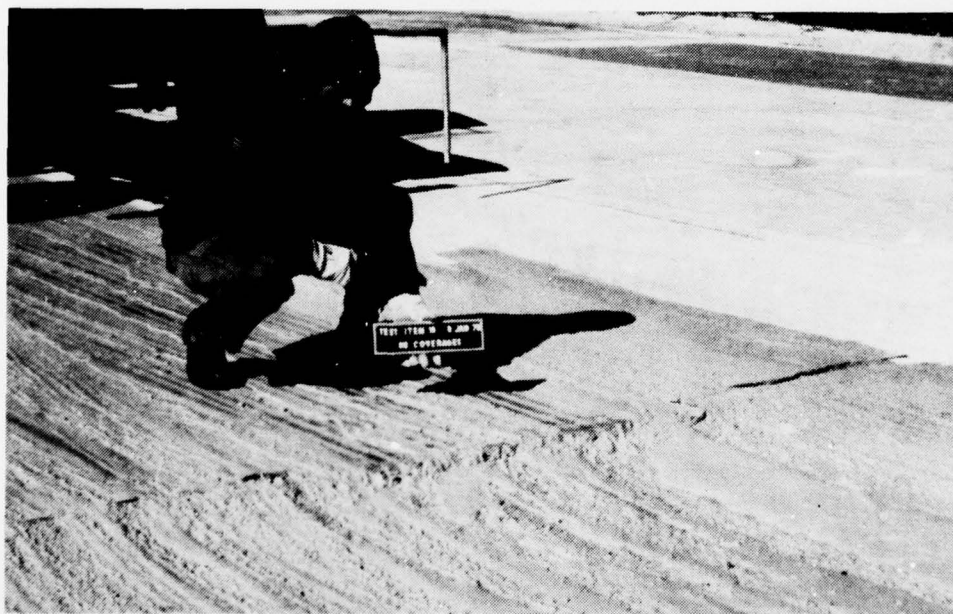
Figure 25
Lip Created at Edge of Patch by Movement of Crushed Stone

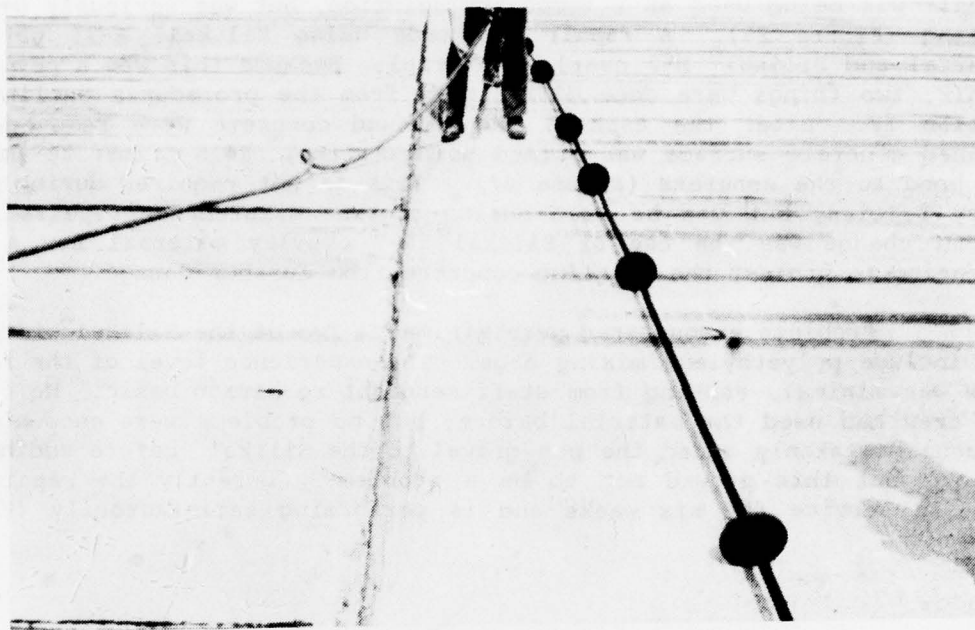
The first repair was to the runway beneath the arresting cable. This particular area is where the BAK-12 arresting cable impacts the runway during every aircraft pass, wearing away the concrete. A cold mix

asphalt was being used as a temporary solution, but was seriously deteriorating (Figure 26). A repair was made using Silikal® R-17 patching material and Silikal® R-7 overlay material. Because this was a permanent repair, two things were done differently from the procedures outlined in Section IV. After the asphalt and unsound concrete were removed, the cleaned concrete surface was primed using Silikal® R41S primer to improve the bond to the concrete (Figure 27). This is not required during emergency repairs, but can be used during routine maintenance repairs. The second change was the use of Silikal® R-7 overlay material for a thin surfacing to protect the existing concrete from further damage.

Figure 26
Spalling Under BAK-12 Arresting Barrier Cable

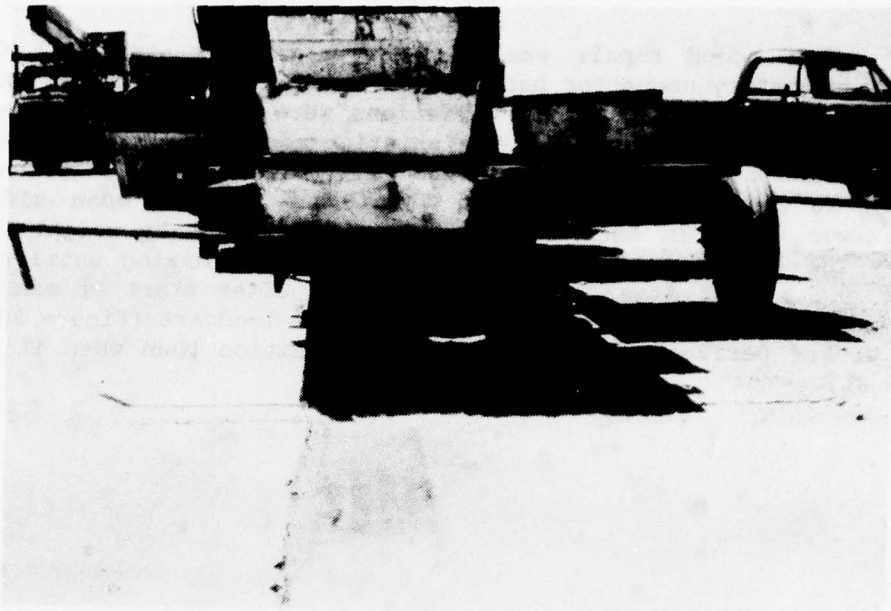
Figure 30
Spall Repair Under F-4 Loadcart Traffic

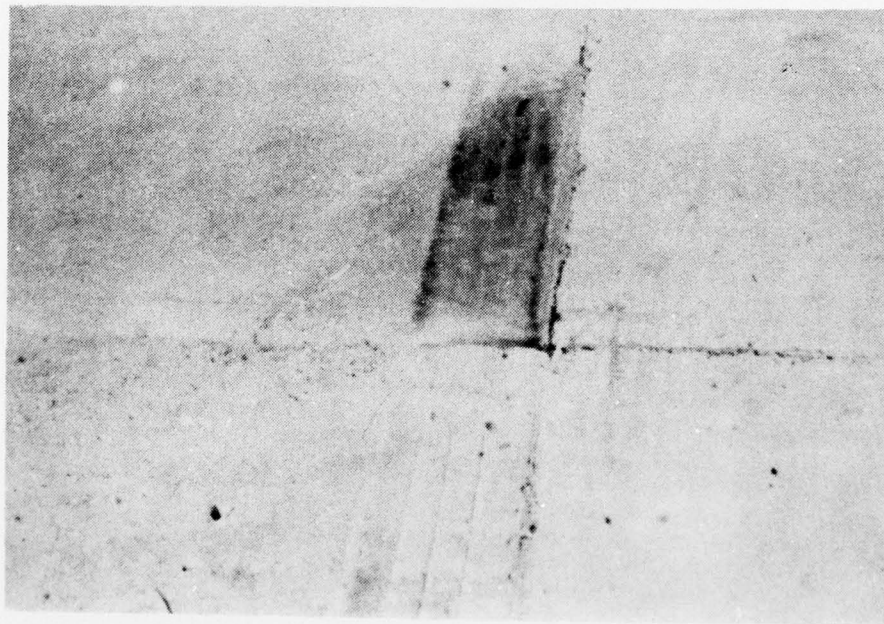
Figure 31
Spall Repair After 20 Passes of F-4 Loadcart Showing
No Damage
