# LAKE WYNONAH DAM

## PHASE I INSPECTION REPORT NATIONAL DAM INSPECTION PROGRAM

JULY 1978

LAKE WYNONAH DAM  
SCHUYLKILL COUNTY, PENNSYLVANIA  
NATIONAL I.D. NO. PA 00702

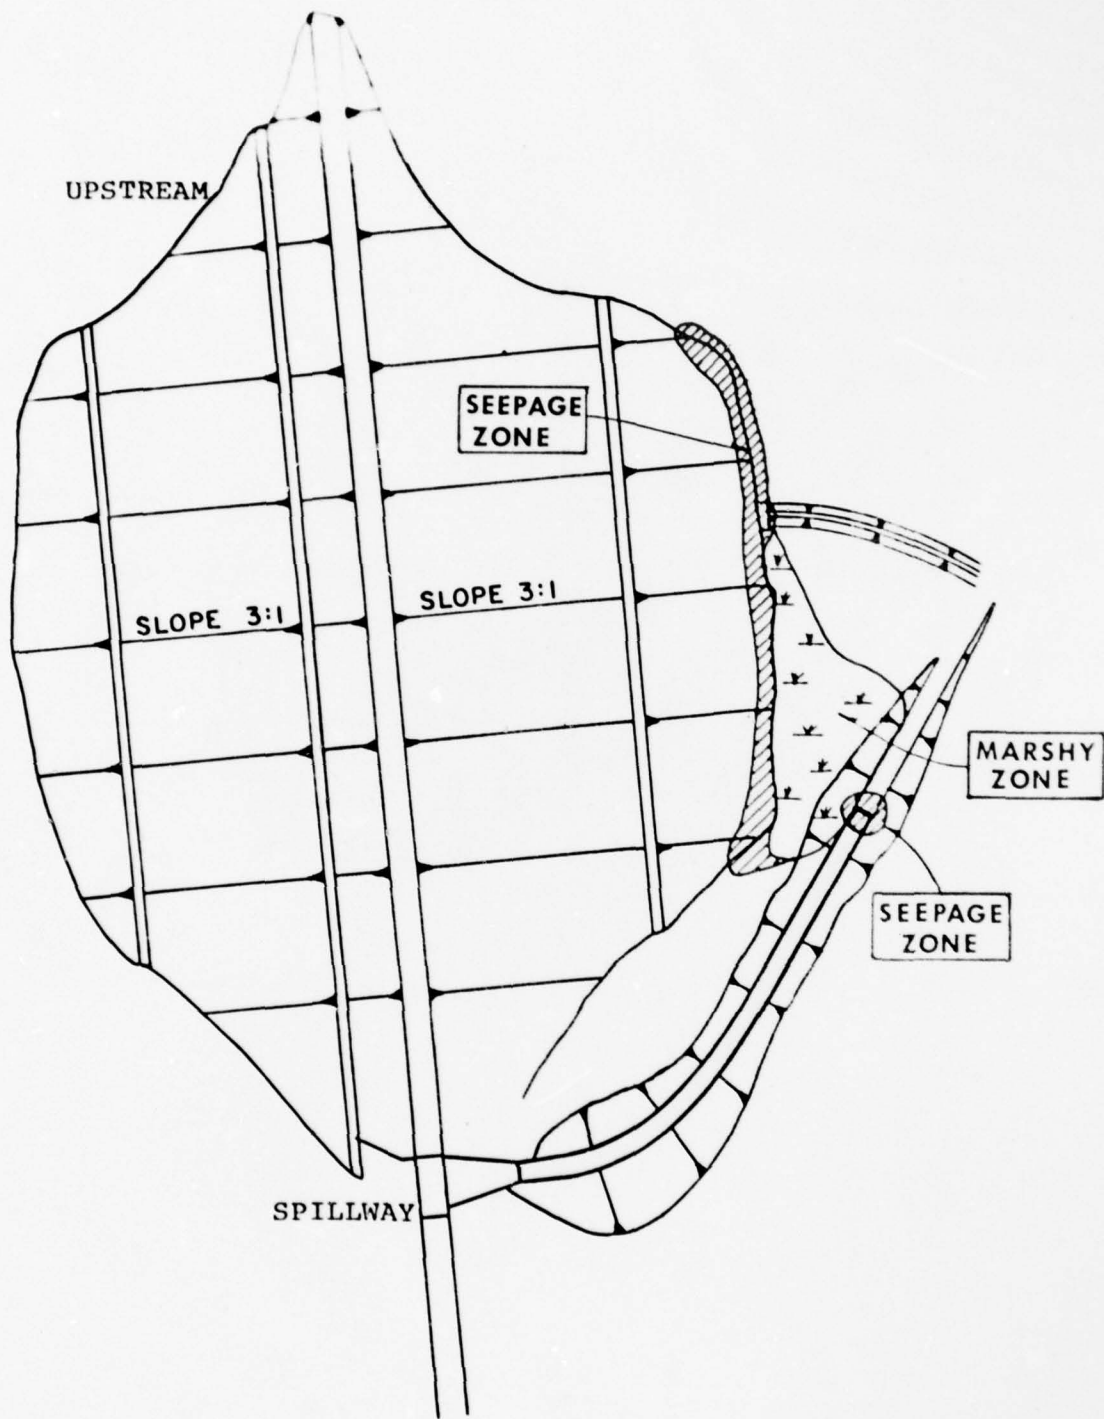
SEEPAGE LOCATION PLAN  
LAKE WYNONAH DAM  
SHEET 5a OF 11

As shown on Sheet 5a, Appendix B, standing water was observed below the downstream toe on the right side of embankment. It is assumed, based on previous inspections, that this standing water has existed for several years and has remained unchanged. Considering the pervious downstream embankment materials and the blanket drain, seepage is expected to occur along the base of the dam and, perhaps, up the slope for a small distance. This seepage does not appear to indicate hazardous conditions, although it should be monitored for rates of change or increases in turbidity.

The visual inspection disclosed no evidence of apparent past or present movements to indicate instability of the dam. The wet areas noted on Sheet 5a, Appendix B are to be expected considering the type of materials and drainage system incorporated in the embankment.

*Note: Due to the type of seepage occurring (sheet flow), the quantity of flow could not be accurately estimated.*

1. The seepage discharging around the pond drain outlet works and adjacent areas should be monitored for increases in flow or changes in turbidity.
2. Considering the quantity and locations of seepage through the embankment, it is recommended that a series of piezometers be installed perpendicular to the dam axis through the maximum embankment section to delineate the phreatic profile. The profile should be evaluated by a registered professional engineer.

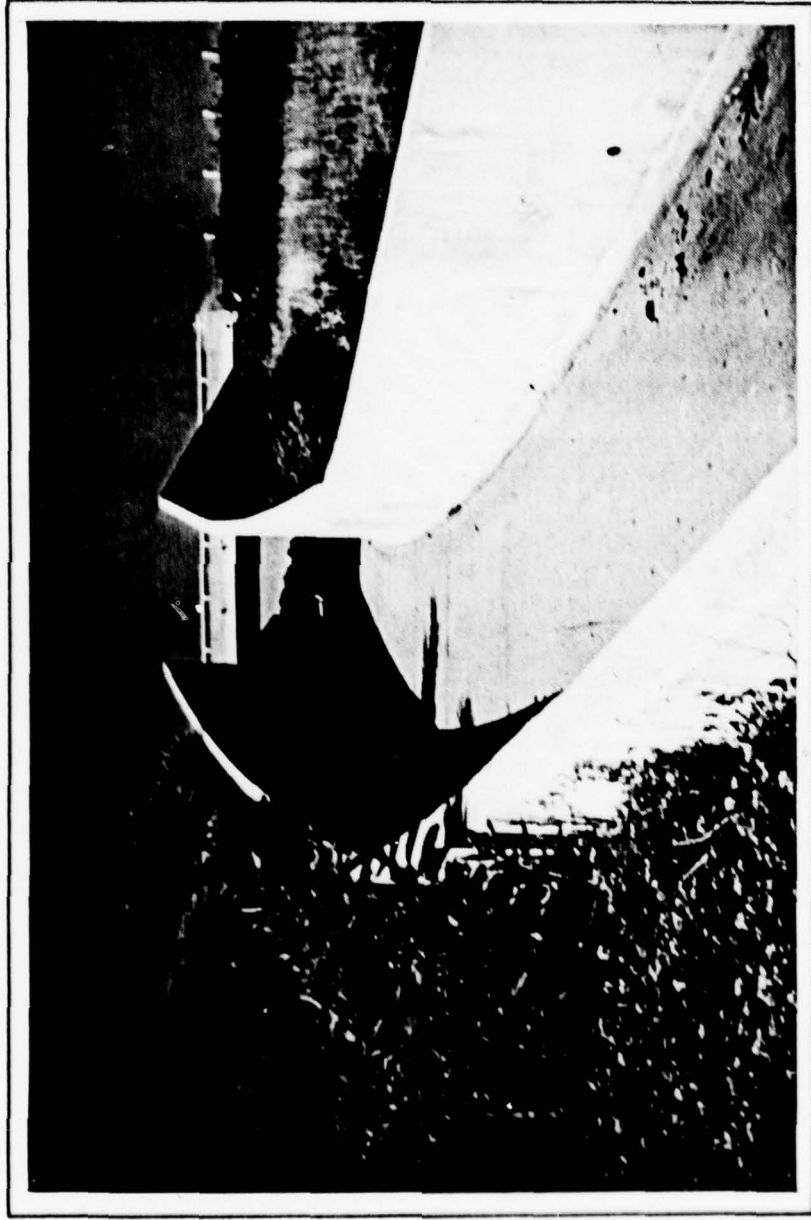
PRINCIPAL SPILLWAY CHUTE LOOKING UPSTREAM

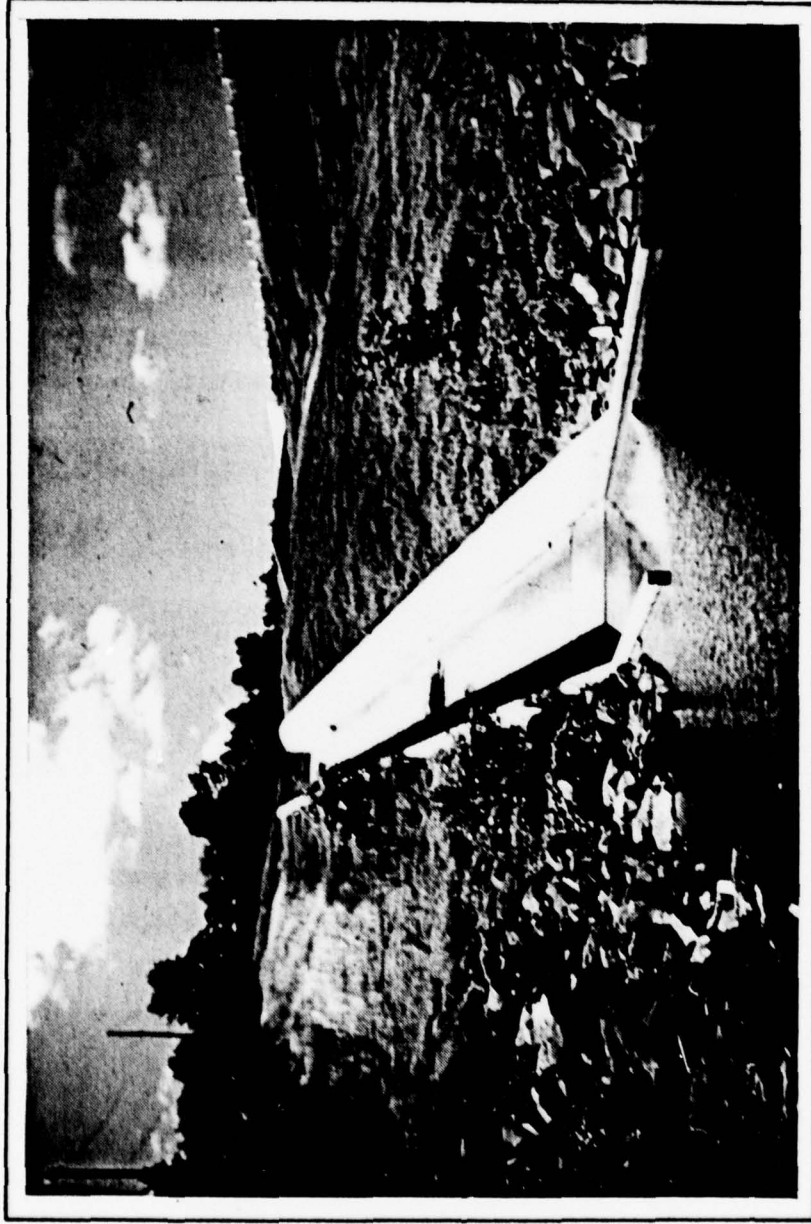
PHOTOGRAPH NO. 5

PRINCIPAL SPILLWAY CHUTE OUTLET AND  
STILLING BASIN. CLEAR SEEPAGE DISCHARGES  
AT BASE OF CHUTE THROUGH GRAVEL AND PIPES

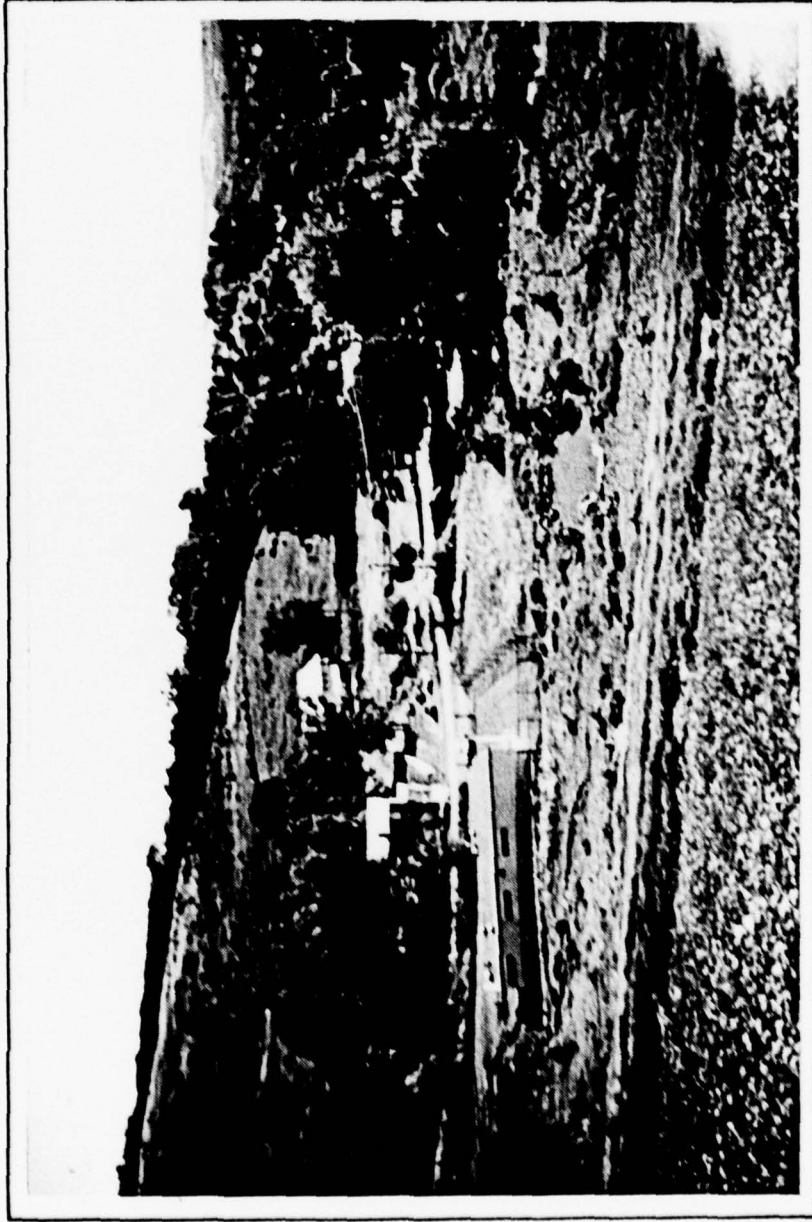
f. Downstream Conditions. Approximately 250 feet downstream from the axis of the dam, discharge flows through a 4.8 by 30 foot bridge under LR 53007. This bridge is expected to be flooded when discharge from the dam is equal to or greater than 1400 cfs. In the immediate area of this bridge are three homes which would be flooded when the depth of flow is 2 feet over the bridge. These three homes and attendant structures together with the sewage plant immediately upstream of the bridge would be destroyed in case of failure.

VIEW LOOKING DOWNSTREAM FROM CREST  
OF DAM. NOTE HOMES AND  
SEWER PLANT SUBJECT TO FLOODING

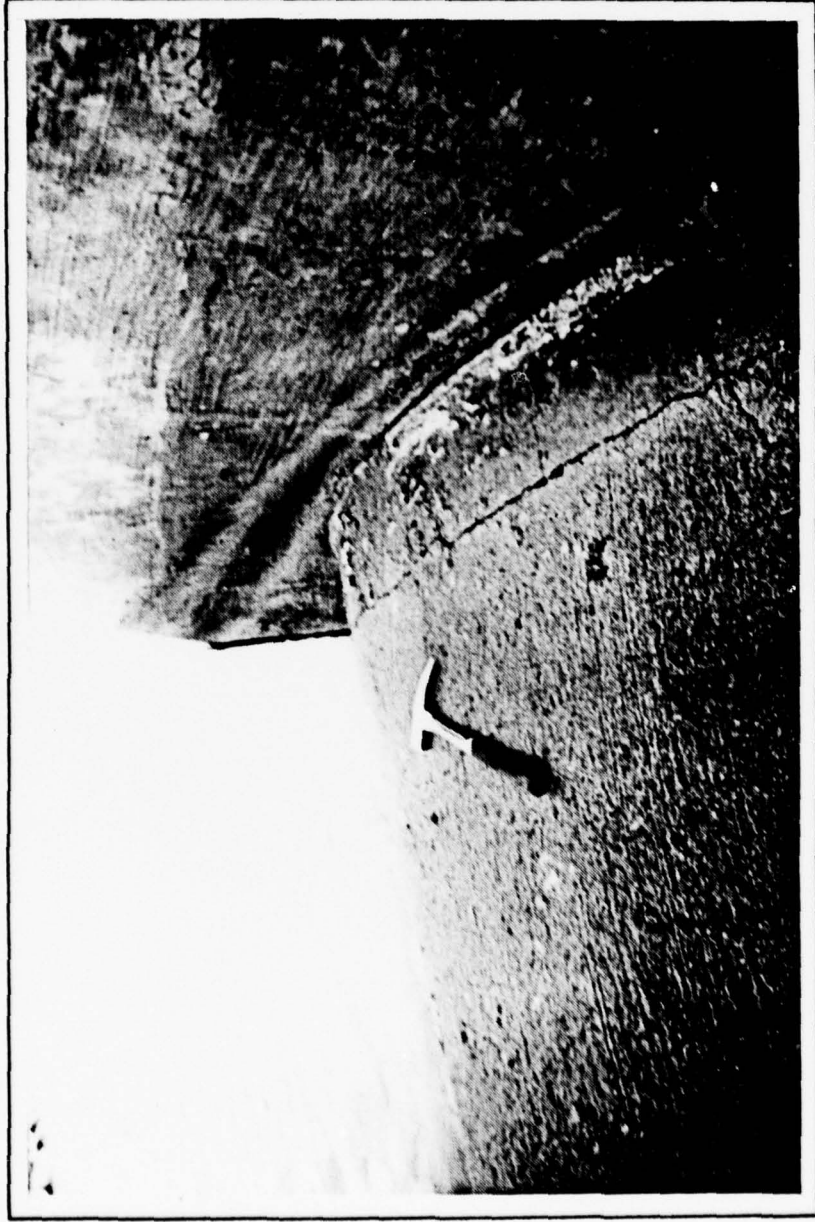
P H O T O G R A P H   N O .   7

2. Spillway. The spillway weir was observed to be in relatively good condition. However, there were some cracks noted along the left retaining wall and horizontal cracks located along the left side of the weir. Signs of past seepage were noted through many of the cracks. The approach channel retaining walls have rotated. See Photograph No. 8. This movement was observed during a State inspection performed in September, 1977; and the State inspector recommended that the movement be monitored. Along the spillway chute several diagonal cracks and occasional vertical cracks, generally located between construction joints, were observed. Occasional wall rotations were also observed between construction joints. At the base of both chute spillway walls fillet concrete was noted to be deteriorated and broken at several locations. Sections of the fillet concrete up to 2 or 3 feet long were dislocated and scattered along the chute. It is apparent that this fillet was never bonded to the chute slab or the retaining wall or separation cracks were also noted at the base and sides of the fillet along the entire chute.

V I E W   O F   C R A C K E D   O G E E   S E C T I O N  
A D J A C E N T   T O   L E F T   W I N G   W A L L .  
H O R I Z O N T A L   C R A C K S   W E R E   N O T E D   F U R T H E R  
D O W N   T H E   W E I R .   N O T E   H I G H   W A T E R  
M A R K S   O N   T H E   W I N G W A L L

4. Cracks along the weir chute walls and chute slab should be monitored; and if seepage is observed through these joints, the joints should be sealed.
5. The boat marina, located upstream of the emergency spillway, should be assessed and appropriate measures taken to minimize the possibility of the docks or boats floating downstream and clogging the spillways during storms.

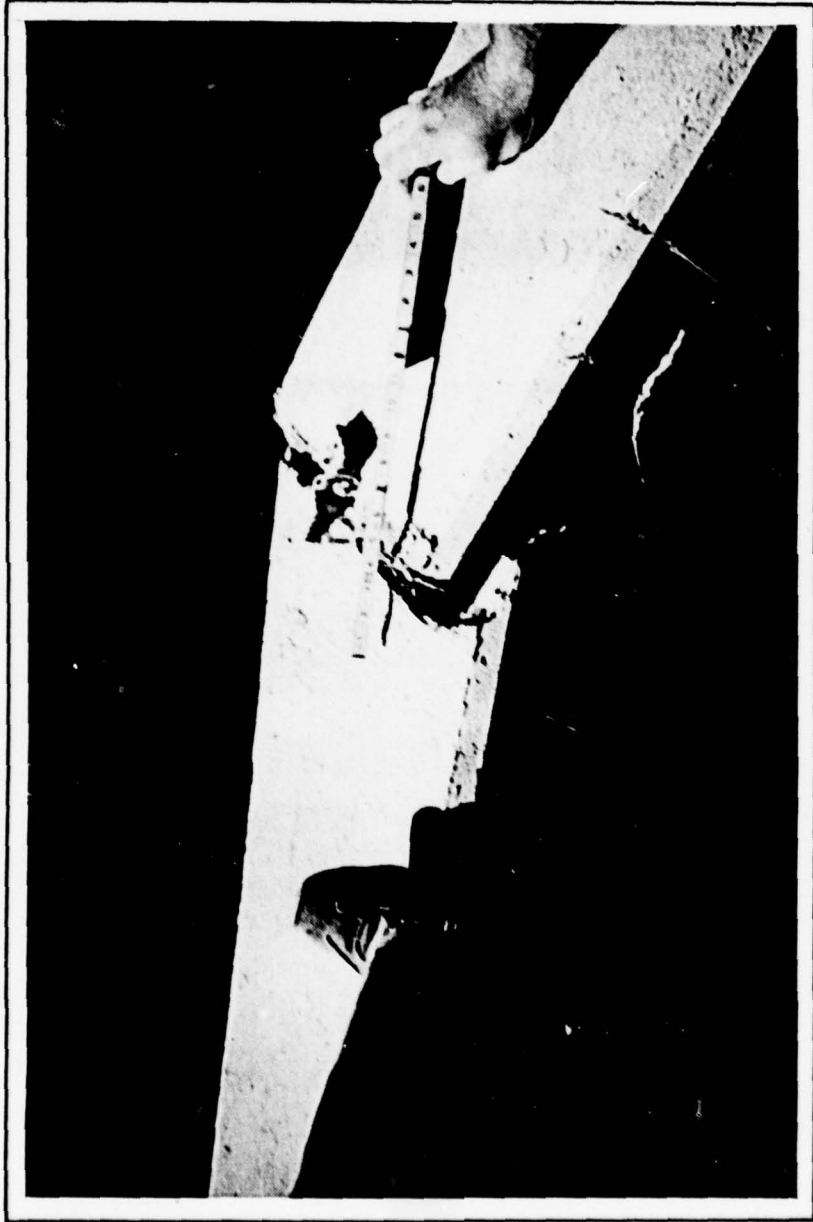
The cracking and rotation noted on the spillway channel walls is undesirable but is not considered to be indicative of potentially unstable conditions. Wall rotation should be monitored regularly. A review of the calculations revealed that the ACI code when compared to Soil Conservation Service requirements does not provide sufficient temperature and shrinkage reinforcing steel for hydraulic structures. This accounts for the cracks.

DISPLACEMENT OF WINGWALLS AT  
CONSTRUCTION JOINTS WERE NOTED  
AT SEVERAL LOCATIONS ALONG THE  
SPILLWAY CHUTE

3. Rotations noted along the spillway chute retaining walls should be periodically monitored. Should excessive deflections be observed as determined by a registered professional engineer, appropriate remedial measures should be taken.

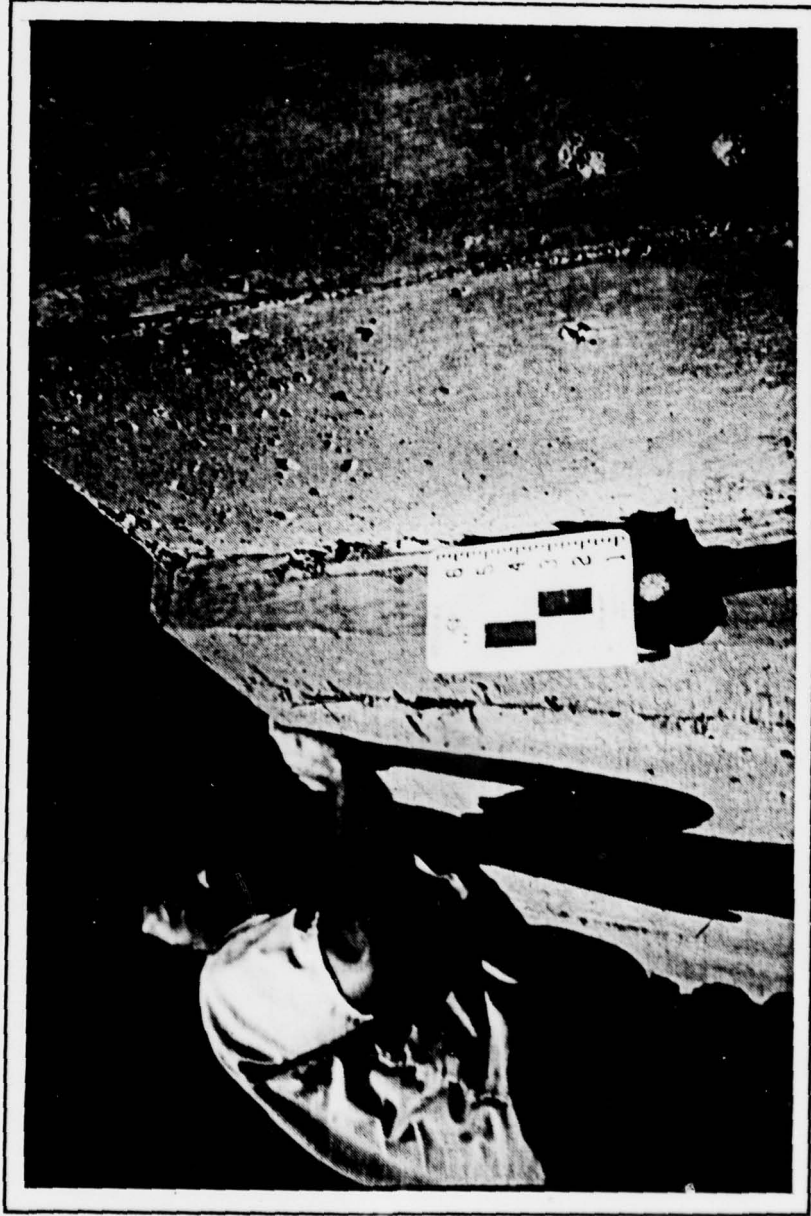
DISPLACED WINGWALL ALONG CHUTE SPILLWAY

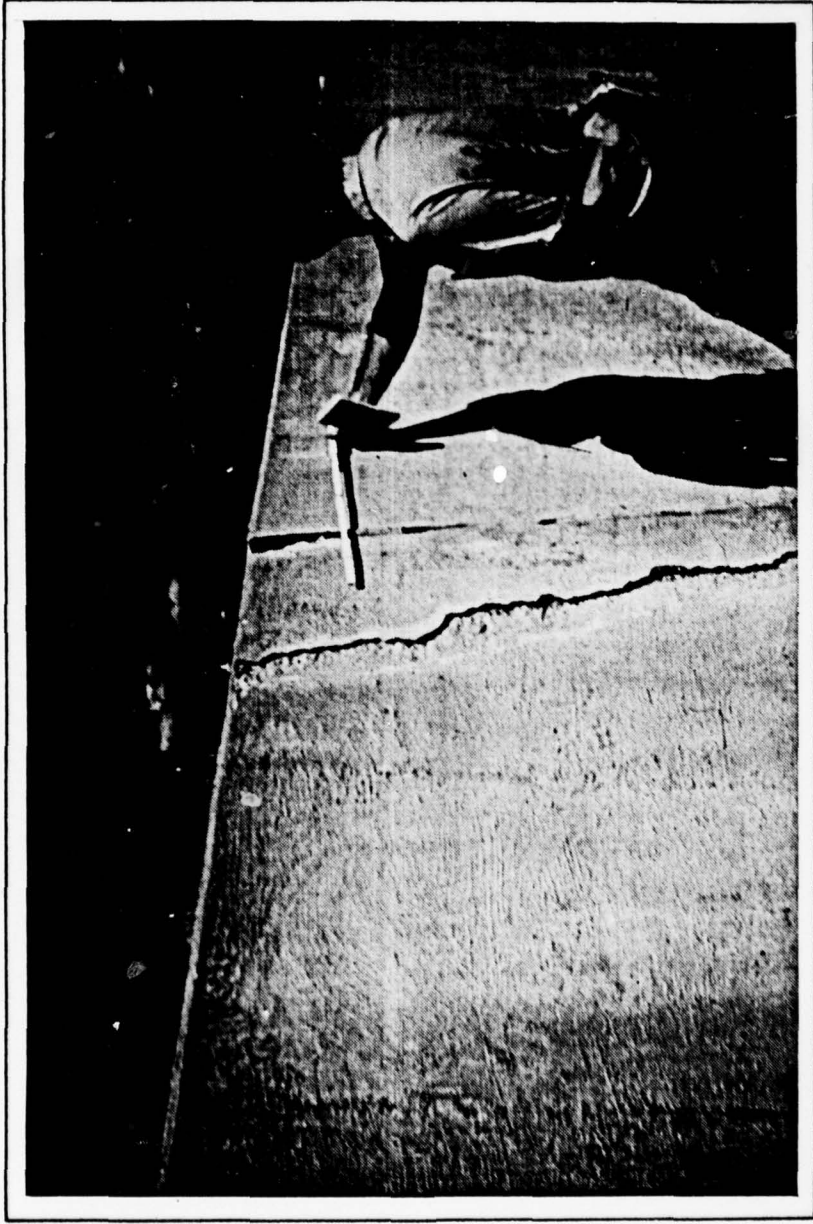
b. Design and Construction Data. Available design data associated with the structural and stability calculations of the spillway were assessed and found to be reasonable. It is noted that there was not enough steel in the spillway walls to prevent shrinkage cracks, but this does not affect the stability of the wall.

CRACKED WINGWALL ALONG SPILLWAY CHUTE

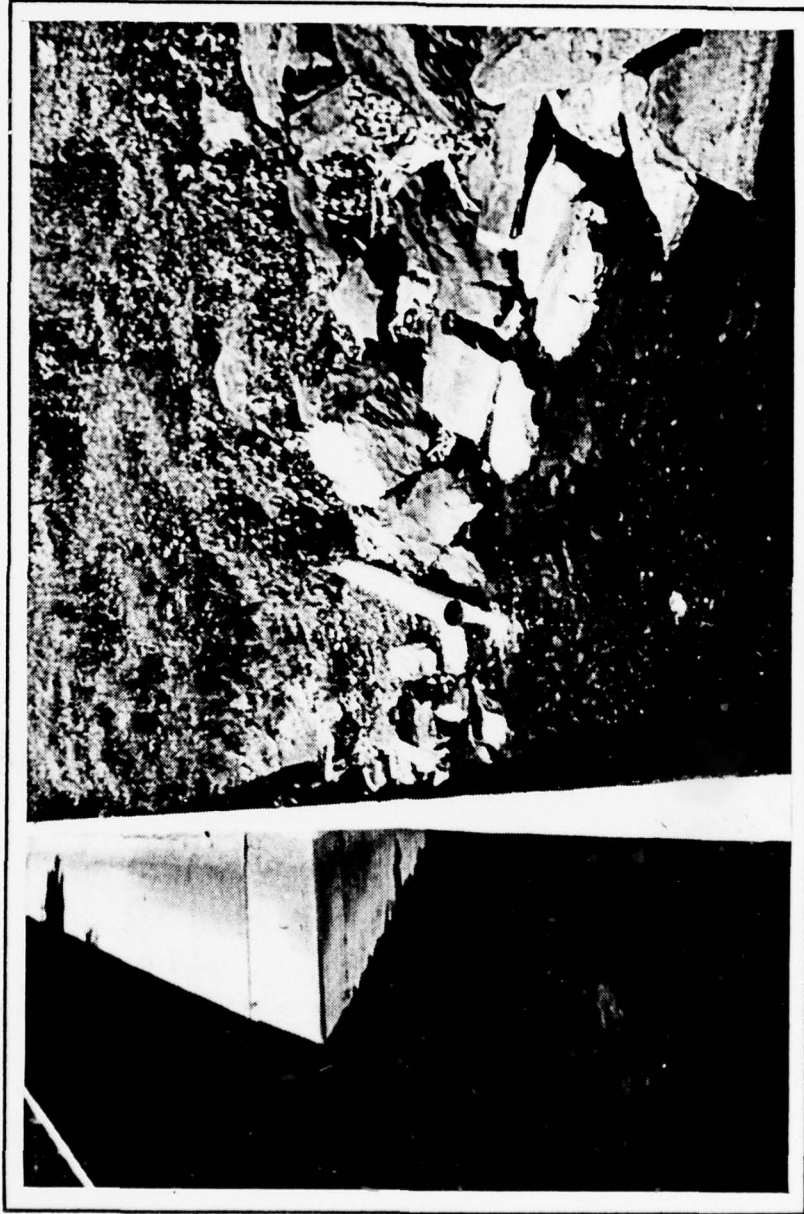
CONTROLLED SEEPAGE THROUGH 6" PLASTIC  
PIPE AT BASE OF CHUTE SPILLWAY  
(LEFT SIDE). VIEW LOOKING UPSTREAM

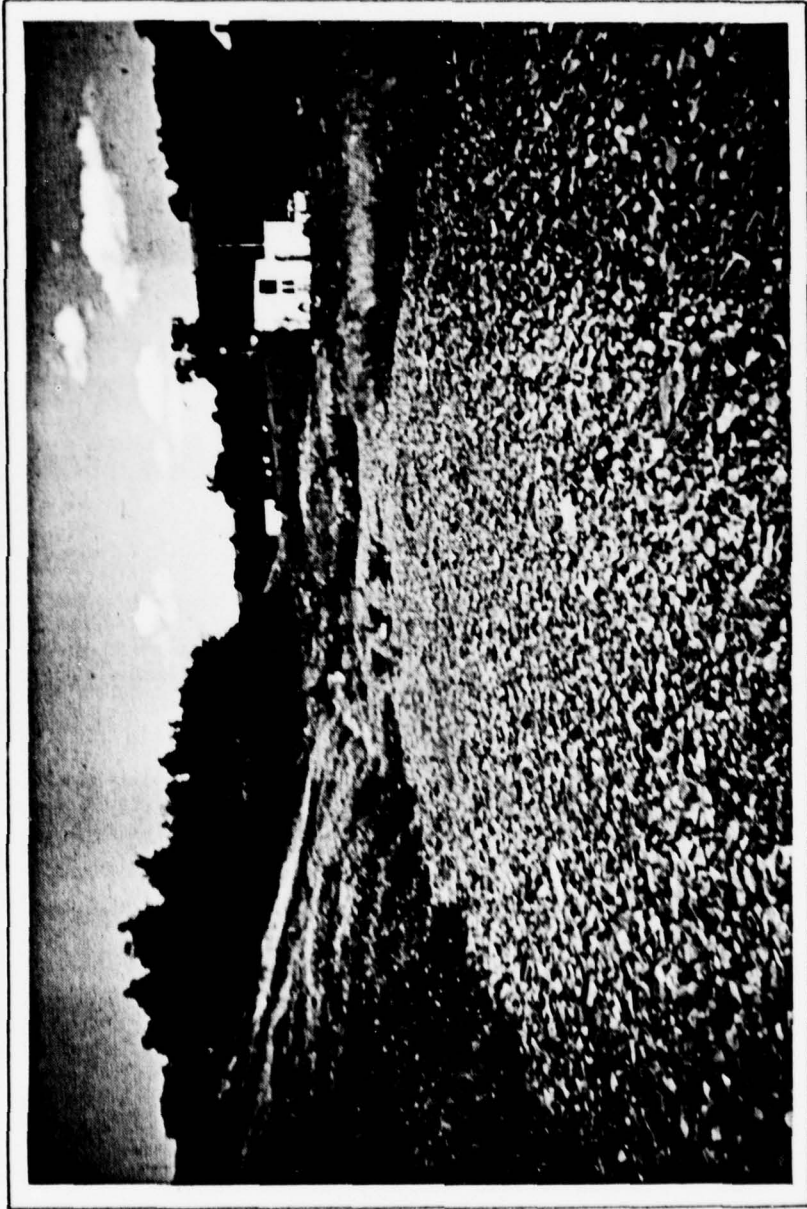
PHOTOGRAPH NO. 12

VIEW OF GRAVEL BLANKET LOOKING  
TOWARDS LEFT ABUTMENT AT BASE  
OF DAM. NOTE SEWAGE  
TREATMENT PLANT IN BACKGROUND
