CORE CREEK DAM
BUCKS COUNTY, PENNSYLVANIA
NATIONAL I.D. NO. PA 00802

PHASE I INSPECTION REPORT
NATIONAL DAM INSPECTION PROGRAM

WOODWARD-CLYDE CONSULTANTS
5120 Butler Pike
Plymouth Meeting, Pennsylvania 19462

11 June 1978

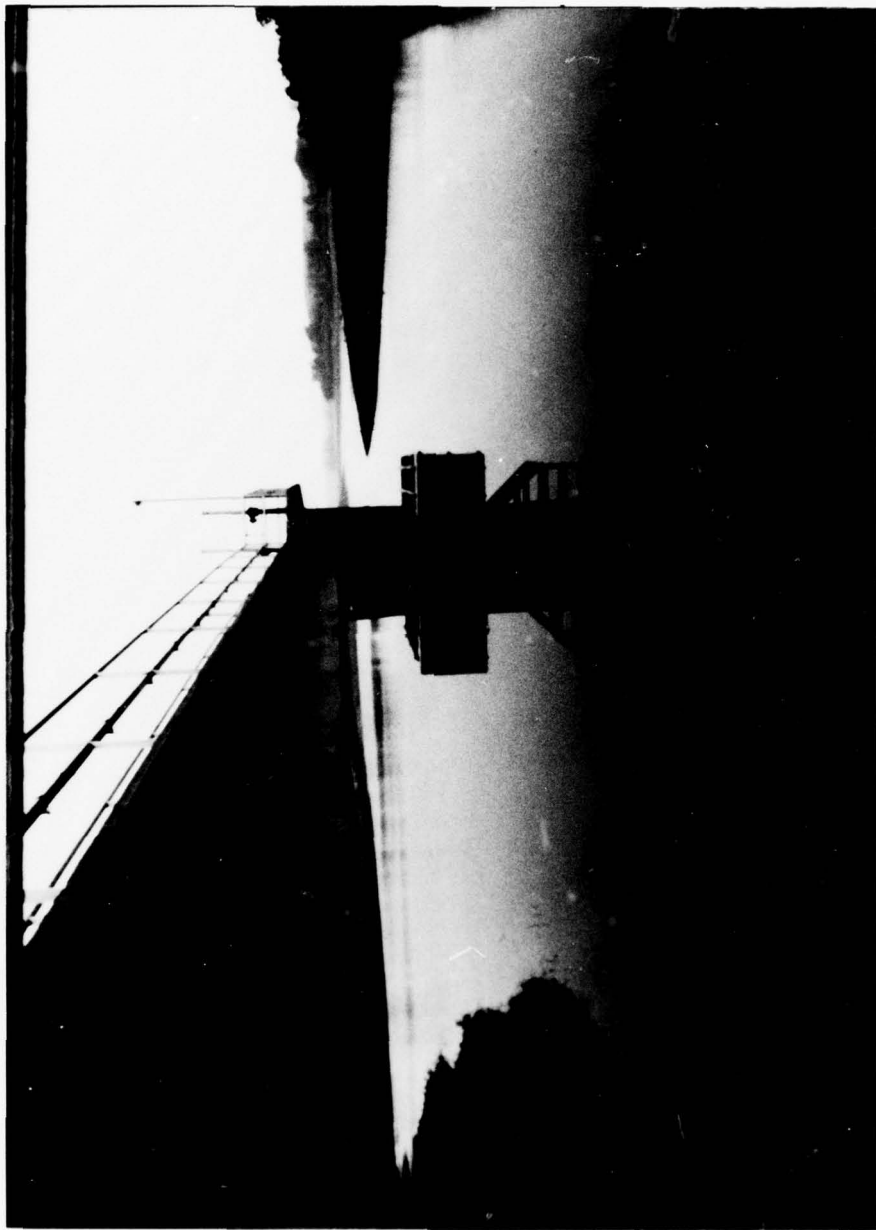
PHOTO NO. 1

VIEW OF INTAKE RISER. TWO LOWER GATED INTAKES CAN
BE SEEN WITH TRASH RACKS.

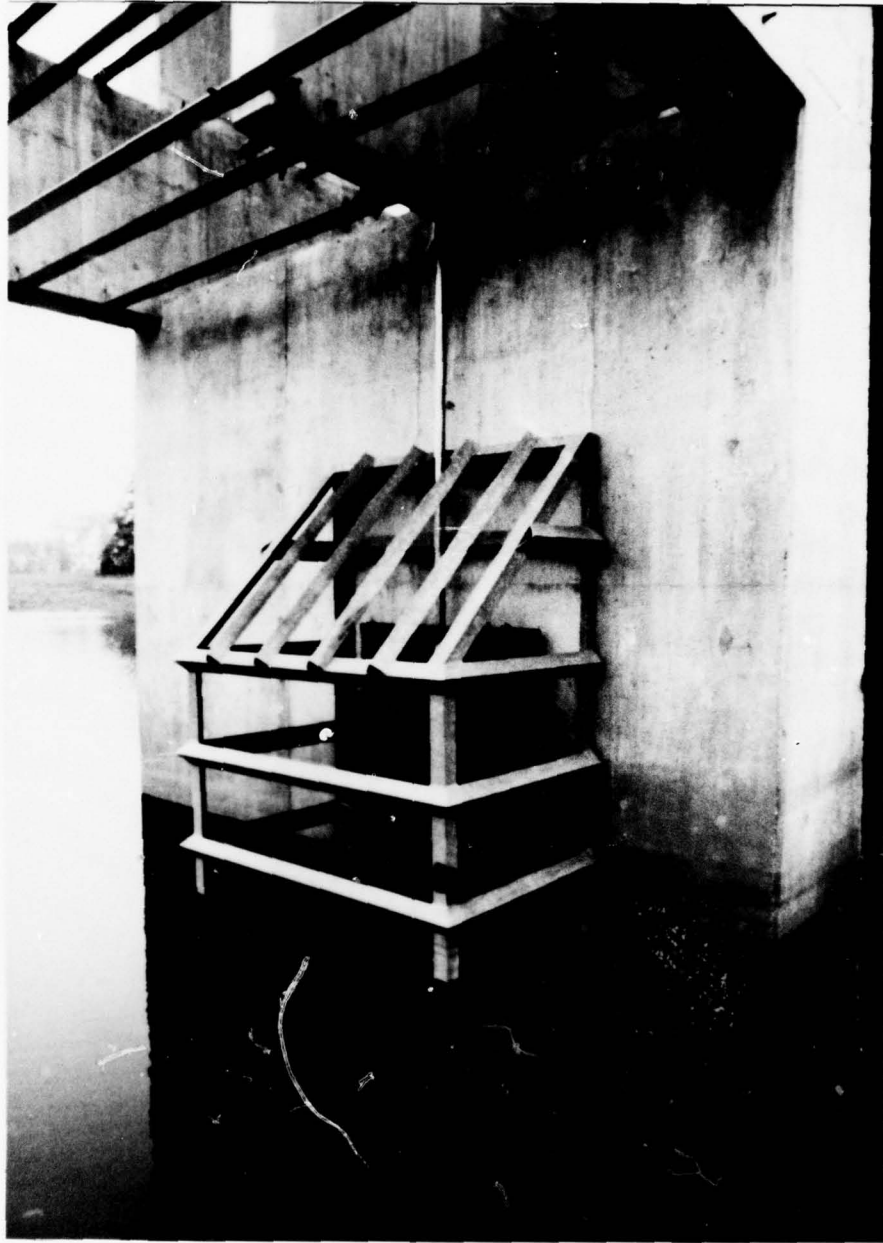
PHOTO NO. 2

CLOSE-UP VIEW OF LOWER INTAKE SLUICE GATE.

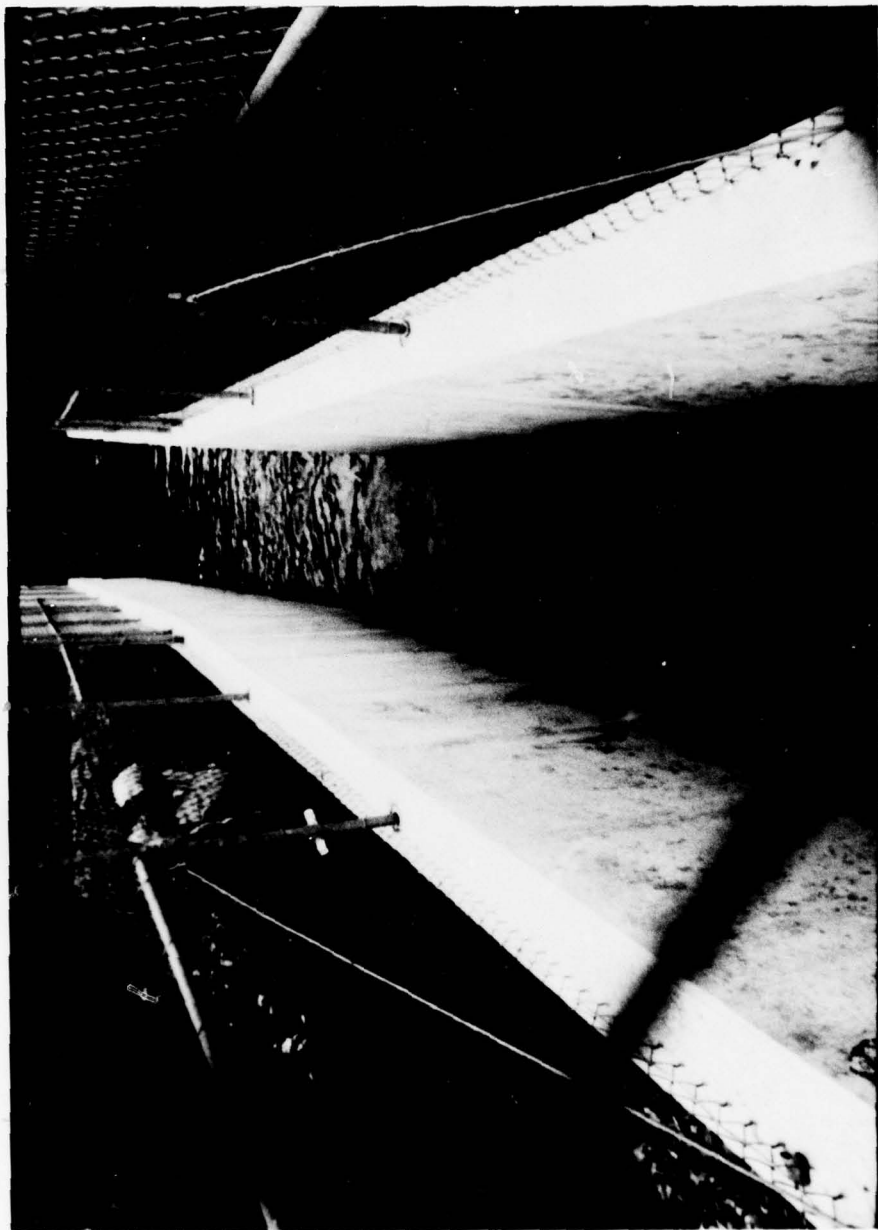
PHOTO NO. 4

LOOKING DOWNSTREAM INTO SAF STILLING BASIN.

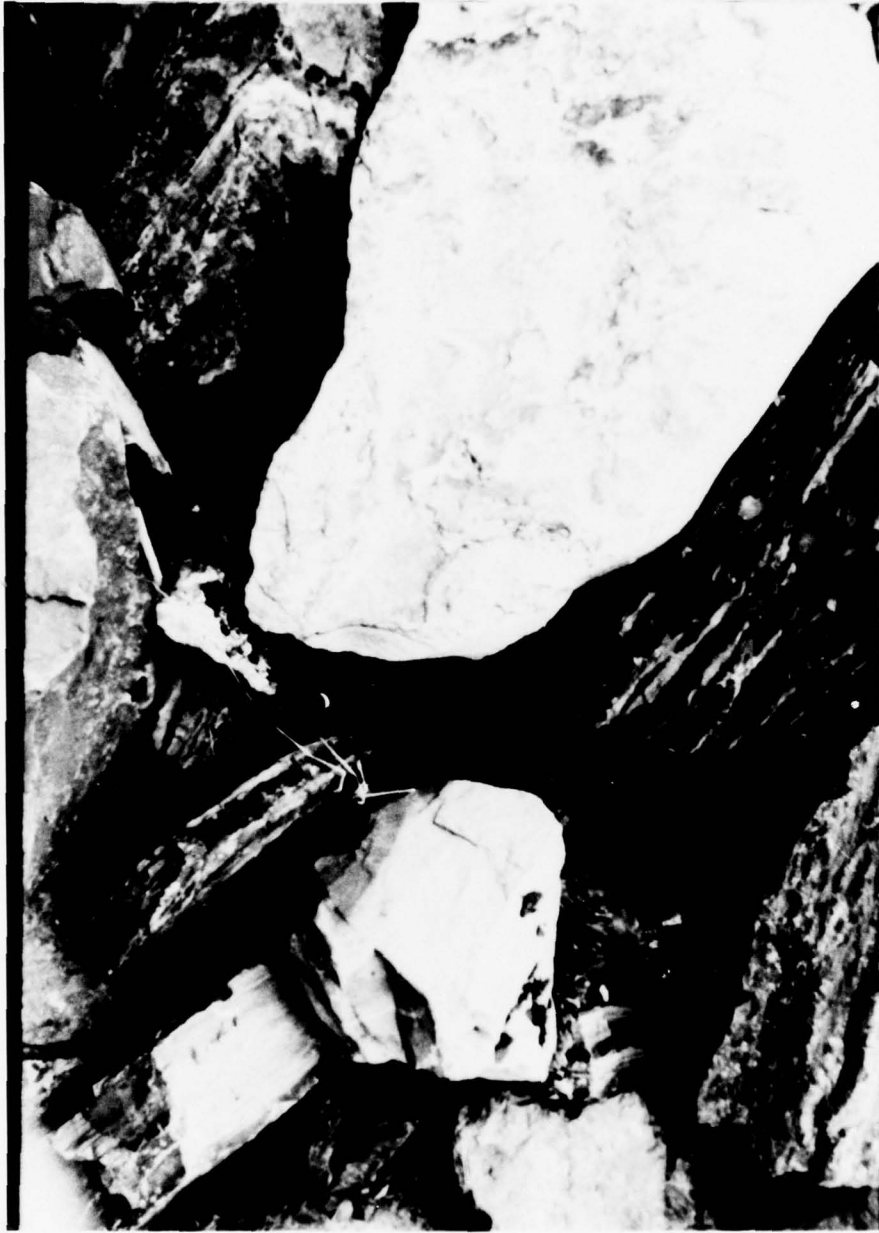
PHOTO NO. 8

The inspection of the riprap slope revealed that some of the riprap appears to be susceptible to slaking with time. The riprap gradation also appears questionable in that it is very large with sizes that range up to 6' x 5' x 3'. The filter bedding beneath the riprap does not appear to be compatible with the larger rock. It was also observed that the density and distribution of the rock matrix is poor with many voids and loose rocks. A review of the SCS drawings shows that the riprap slope was designed to be 2-feet thick. Considering the size of the rock observed during the inspection, it is obvious that the riprap does not meet specifications. The specified rock size could not be located in the contract documents or on the construction drawings.

a. Visual Observations. The visual observations did not indicate any existing embankment stability problems. However, a potential maintenance problem of the riprap slopes is evident in that the oversize rock contains many voids and not compatible with the underlying filter material. It is believed that long-term wave action against the riprap would eventually wash the finer filter material allowing the riprap to creep or slide down the embankment slope. Erosion was also observed at the junction between the abutment and the embankment. At the upstream face this is manifested in the form of erosion gullies at this juncture. At this location the filter bedding is beginning to wash from under the riprap causing the riprap to slide into the gullies. These areas should be regraded, the filter bedding replaced and a suitable riprap protection placed at this contact zone.

RIPRAP FAILURES	Some riprap appears as if it would be conducive to slaking. Riprap may fall into reservoir due to erosion of left abutment and embankment junction. Needs protective cover. The riprap gradation appears questionable in that it is very large with sizes up to 6'X5'X3'. Filter bedding does not appear to be compatible with the riprap. The density and compaction of the rock matrix is poor (many voids and loose rock).

VIEW OF RIPRAP ON UPSTREAM SLOPE. NOTE FINE AGGREGATE
FILTER LAYER BETWEEN RIPRAP.

- (1) The Owner should develop an operational procedure to follow in the event of an emergency.
- (2) A formal procedure of observation and warning during periods of high precipitation should be developed and implemented. This should include monitoring of bridges downstream.
- (3) A maintenance inspection checklist should be developed to help insure that all critical items are inspected on a periodic basis.
- (4) The upstream riprap slope should be repaired to minimize future maintenance problems. This can be accomplished by choking the large riprap with 6 to 10 inch stone and reworking the slope.
