MAUCH CHUNK LAKE DAM

PHASE I INSPECTION REPORT
NATIONAL DAM INSPECTION PROGRAM

SEPTEMBER 1978

MAUCH CHUNK LAKE DAM
CARBON COUNTY, PENNSYLVANIA
NATIONAL I.D. NO. PA 00605

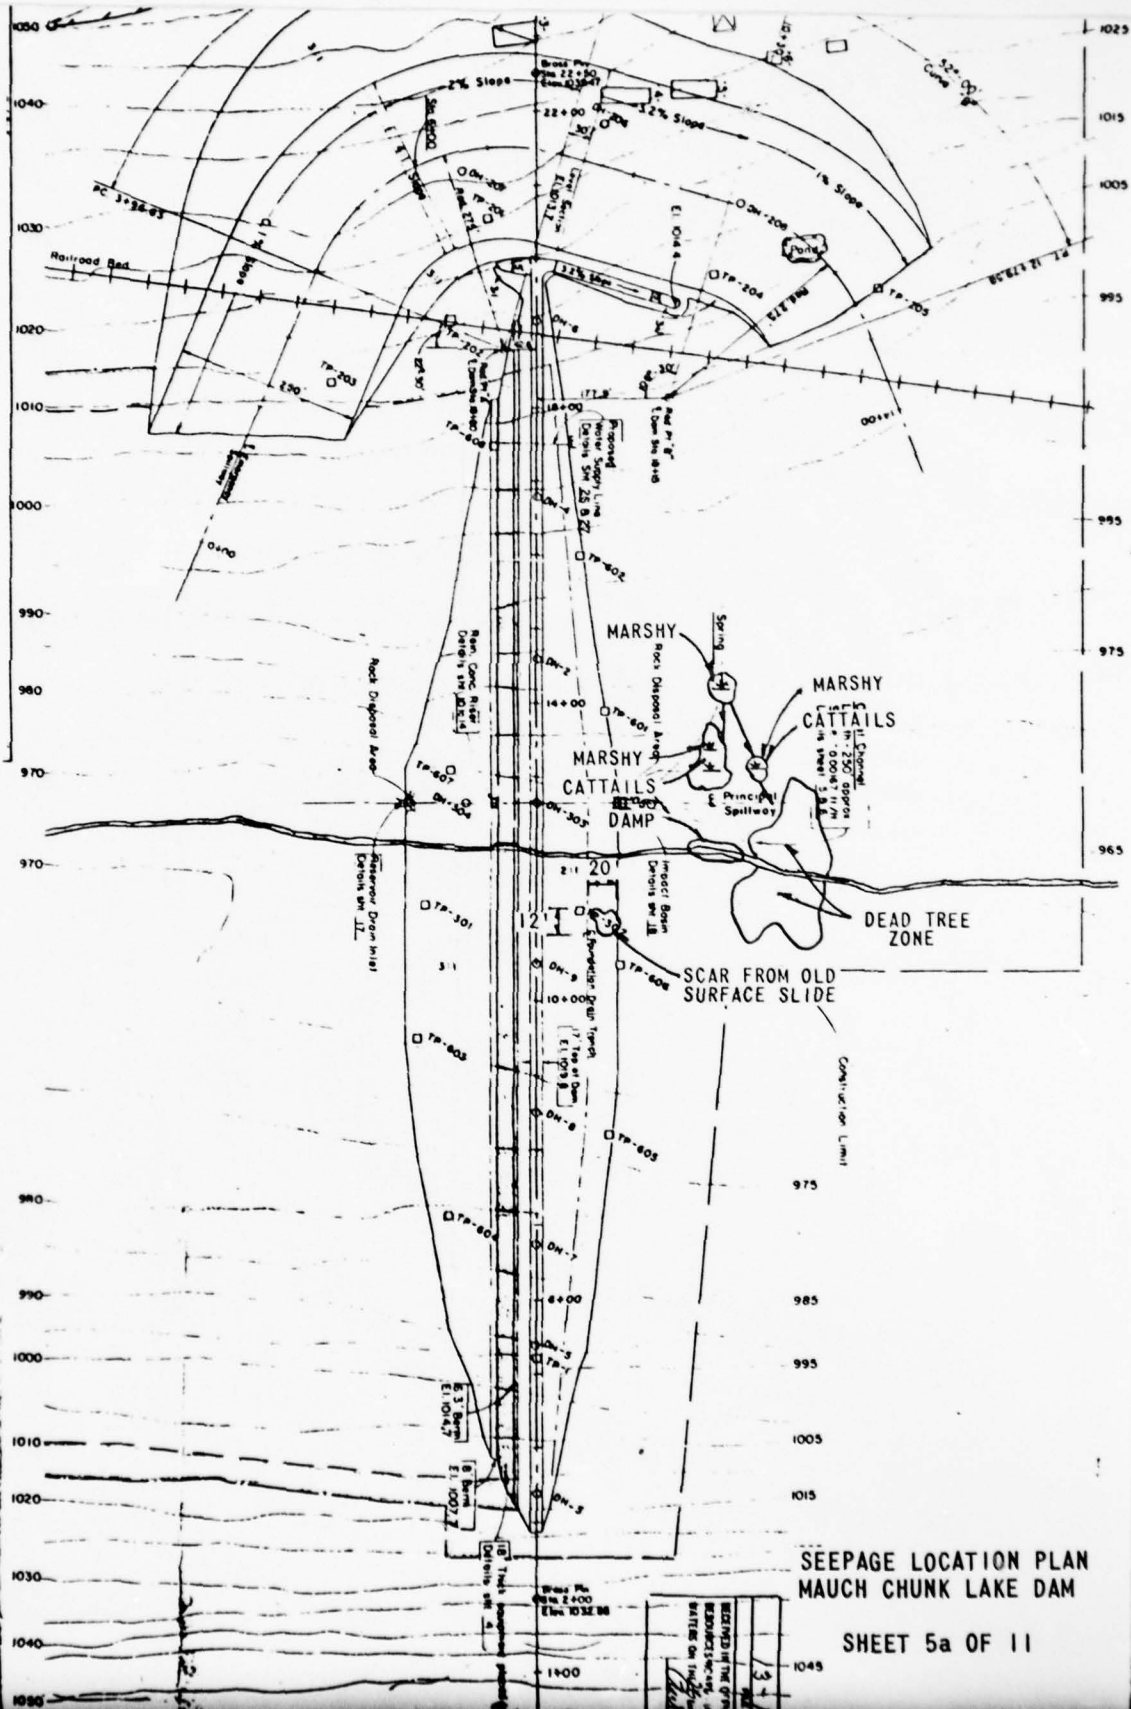
SEEPAGE LOCATION PLAN
MAUCH CHUNK LAKE DAM

Since the filling of the reservoir, a wet zone has emerged approximately 300 feet downstream from the impact basin. This zone, as shown on Sheet 5a, is delineated by an area of dead trees. *Original geologic and soils investigation disclosed the flood plain to be a swamp and there were many springs on the abutments. Field permeability tests in test holes on the left side of the flood plain indicated permeability rates in the range of 60 feet per day through highly fractured and jointed sandstone. Therefore, this seepage and marshy area could have developed as a result of the hydrostatic forces from the reservoir. Park personnel reported that the marshy zones located to the left of the discharge basin have remained unchanged since construction.*

Further downstream, a zone of dead trees was noted. See sheet 5a of 11, Appendix B. The surrounding ground is marshy and presently contains some cattails. It is assessed, based on the visual inspection, construction photographs, and discussions with Park representatives, that this zone probably developed since filling of the reservoir. Therefore, this area should be carefully monitored for changes in flow rates or turbidity.

Similarly, the marshy area designated by the dead trees downstream of the emergency spillway should be monitored periodically. Although it is impractical to monitor flows in this area, it is recommended that the area be regraded and drained so the overall condition of the area can be periodically monitored for any gross changes in flow rates or turbidity. The area should be checked for concentrated flows which may lead to piping.

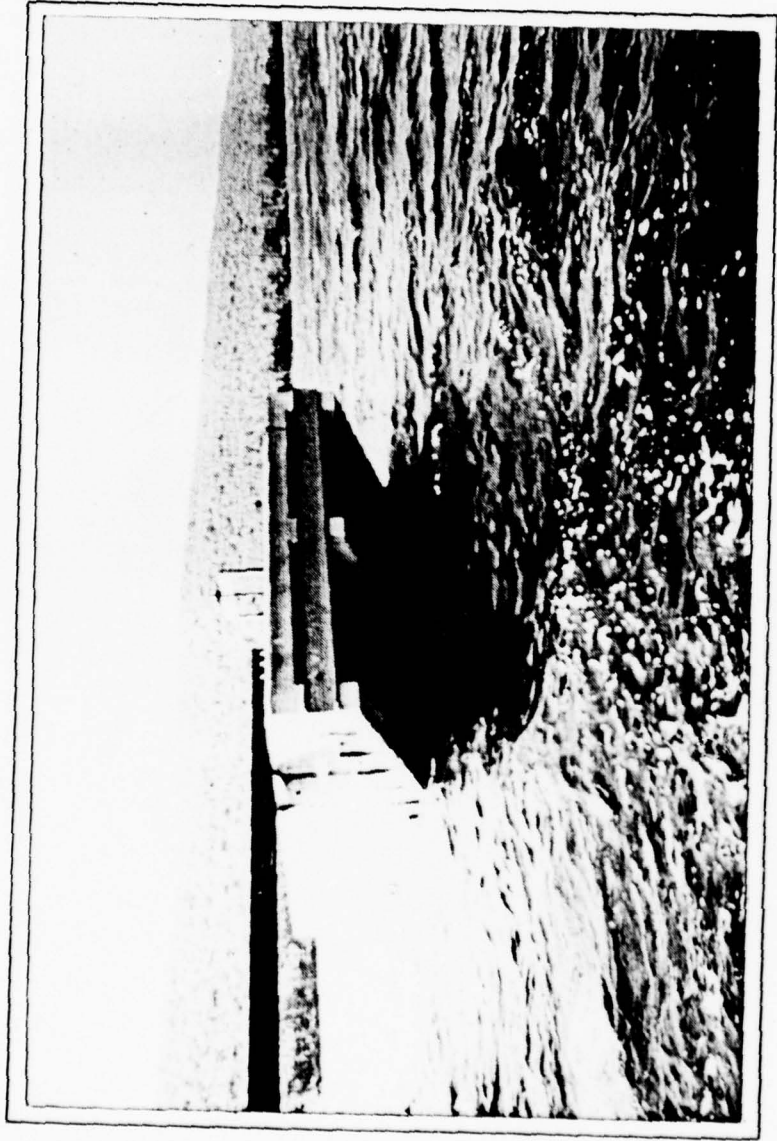
PHOTOGRAPH NO. 1

PRINCIPAL SPILLWAY

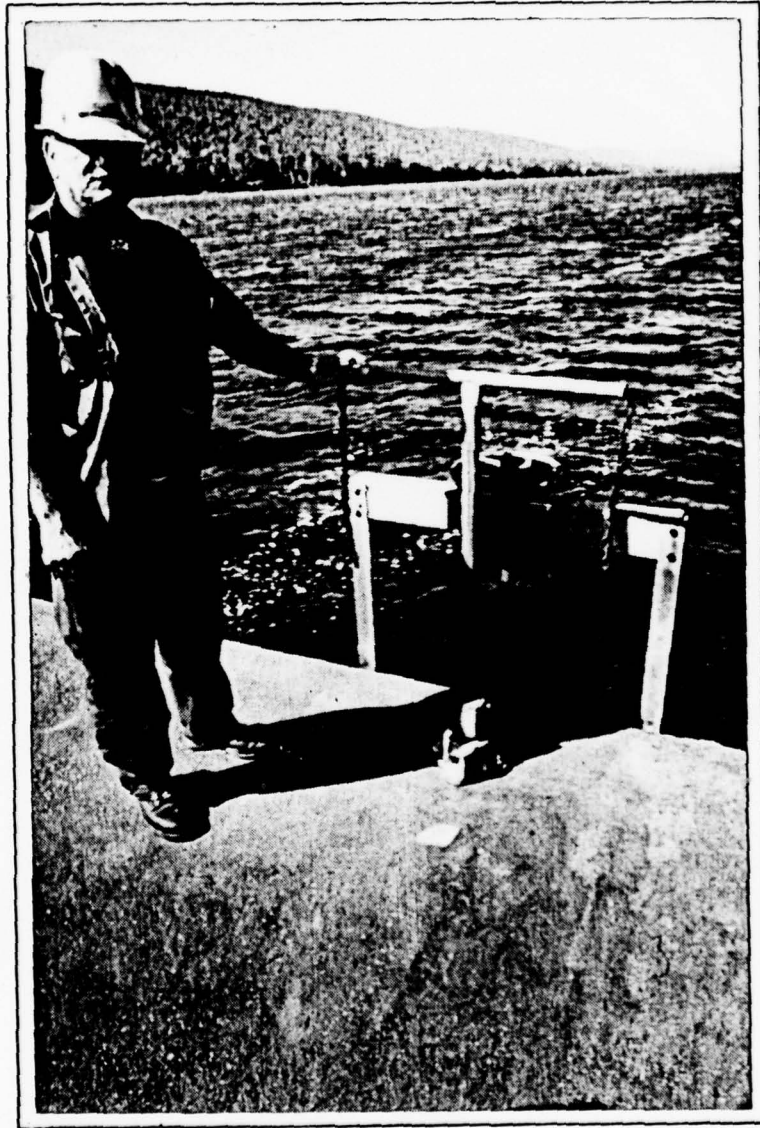
PHOTOGRAPH NO. 2

POND DRAIN VALVE LOCATED
ON TOP OF PRINCIPAL SPILL-
WAY RISER.

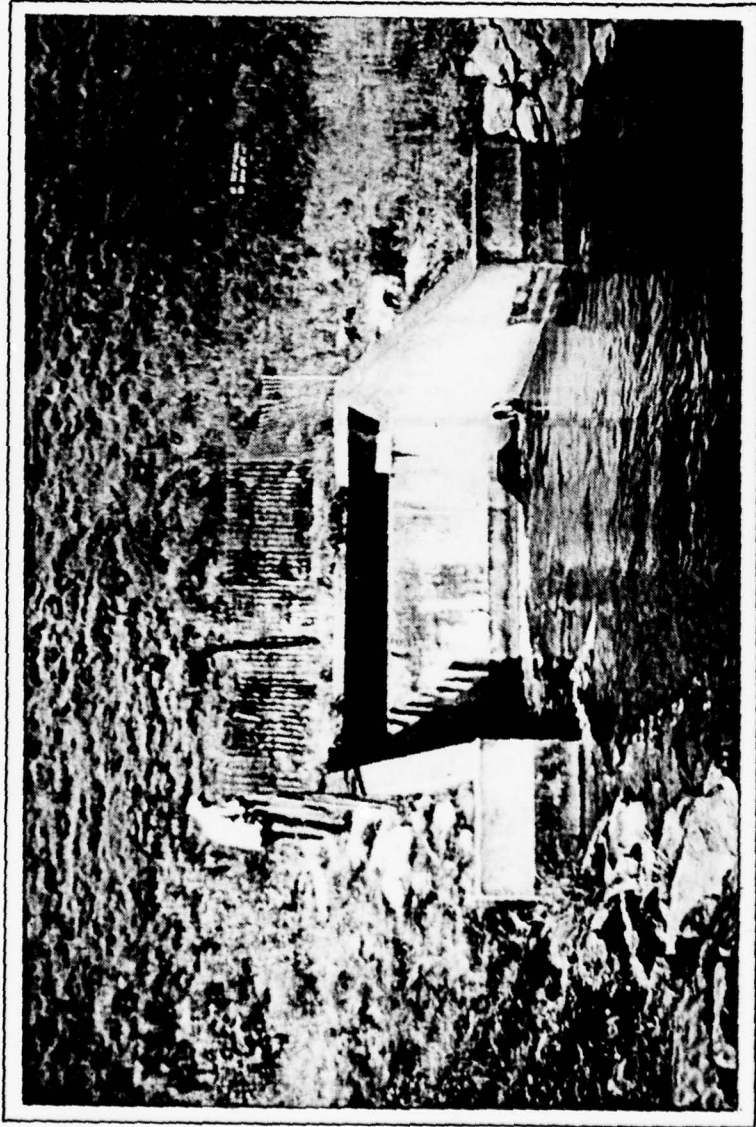
PRINCIPAL SPILLWAY OUTLET STRUCTURE. NOTE
SEEPAGE OUTLET PIPES FOR TOE DRAIN SYSTEM.

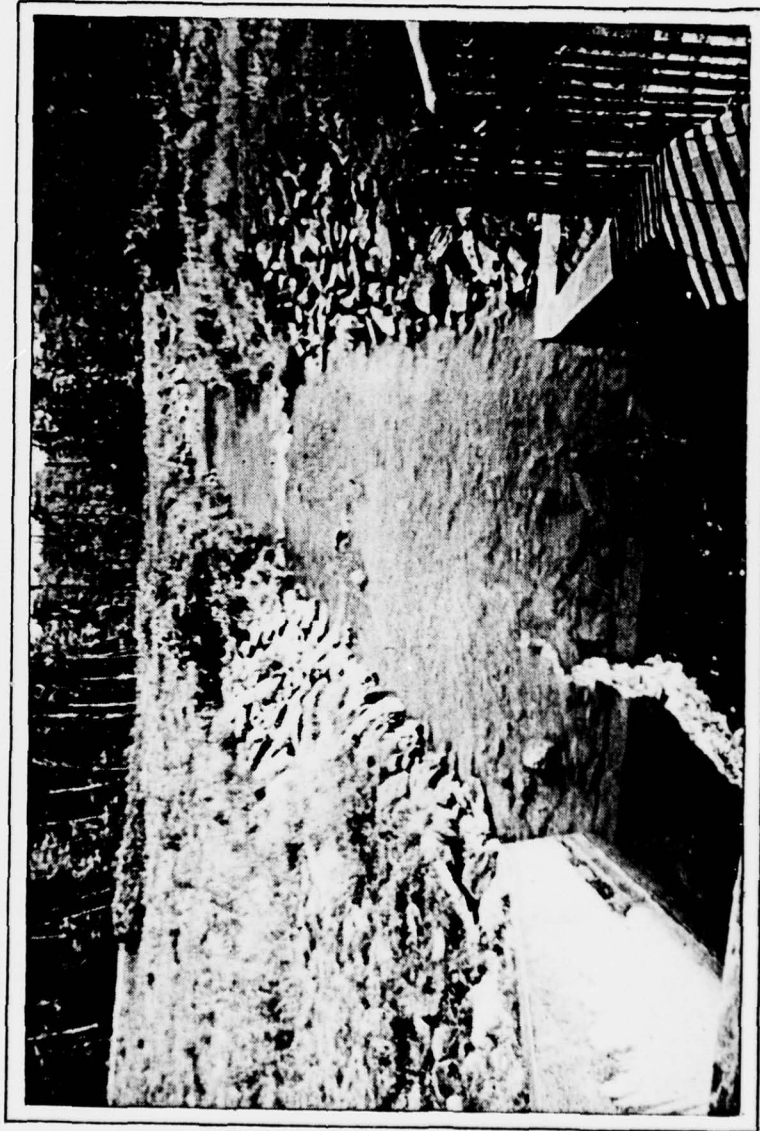
As discussed in Appendix B and in Section 3, marshy zones were noted on the left side of the principal spillway discharge channel, and further downstream along the channel. Discussions with Park representatives and a review of the records indicate that these seepage zones were noted before construction and that the dam was relocated 125 feet upstream to avoid the seepage. Although the reports indicate that these zones existed before construction of the dam, it is not known if the flow rates have increased since the reservoir has filled. The water should be collected and monitored for changes in rates or in turbidity.

VIEW OF PRINCIPAL SPILLWAY DISCHARGE CHANNEL, NOTE CATTAILS TO THE LEFT OF THE DISCHARGE CHANNEL.

a. Facilities. It is recommended that the marshy areas located to the west of the principal spillway discharge channel be graded and drained. This drainage should be periodically collected and checked for changes in flow rates or changes in turbidity.

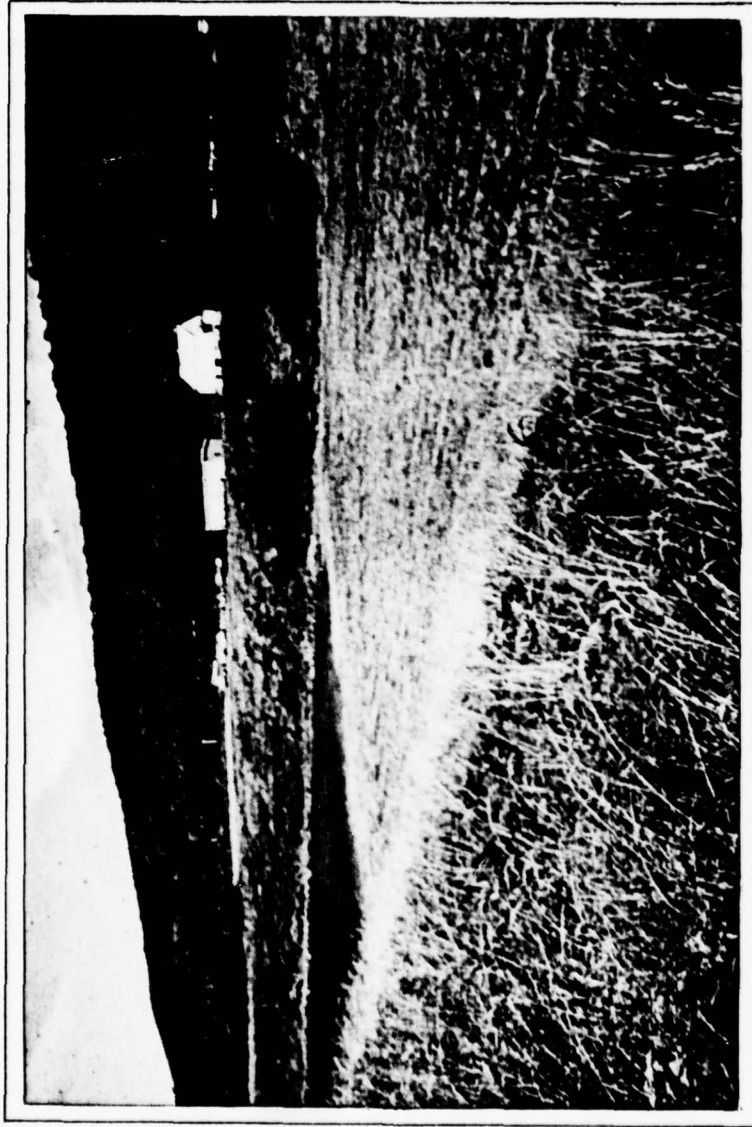
PHOTOGRAPH NO. 6

APPROACH CHANNEL TO EMERGENCY
SPILLWAY.

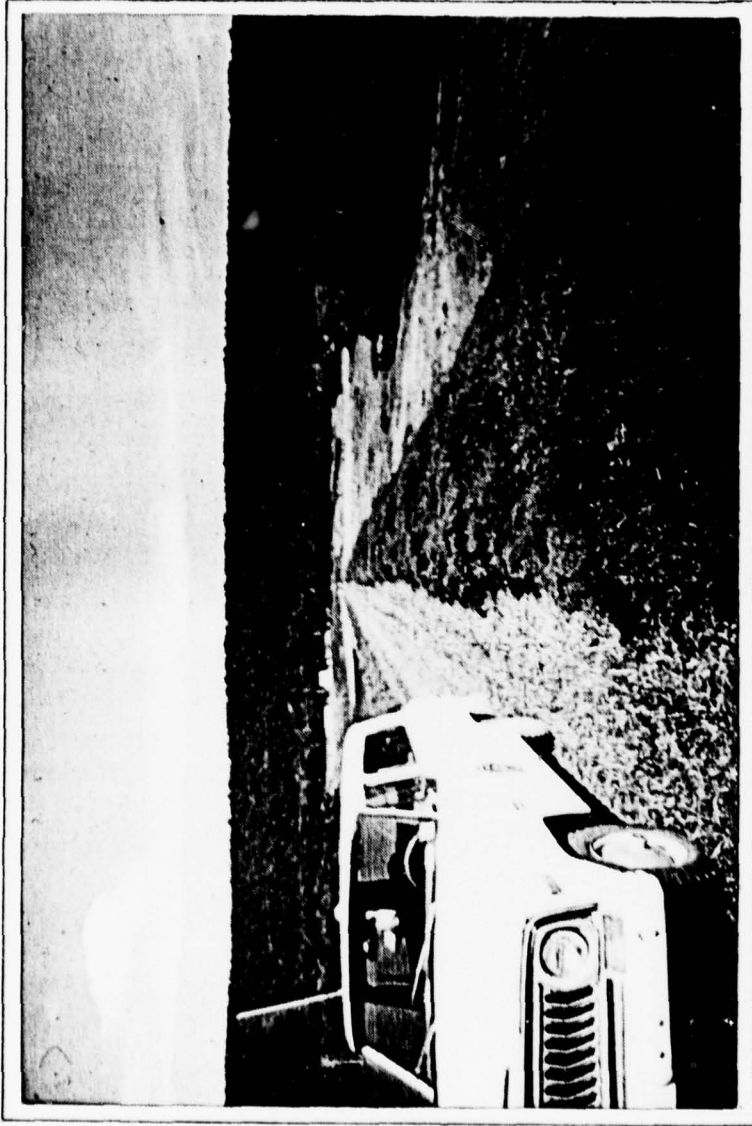
PHOTOGRAPH NO. 9

VIEW OF DOWNSTREAM SLOPE. NOTE
DENSE COVER OF CROWNVETCH.

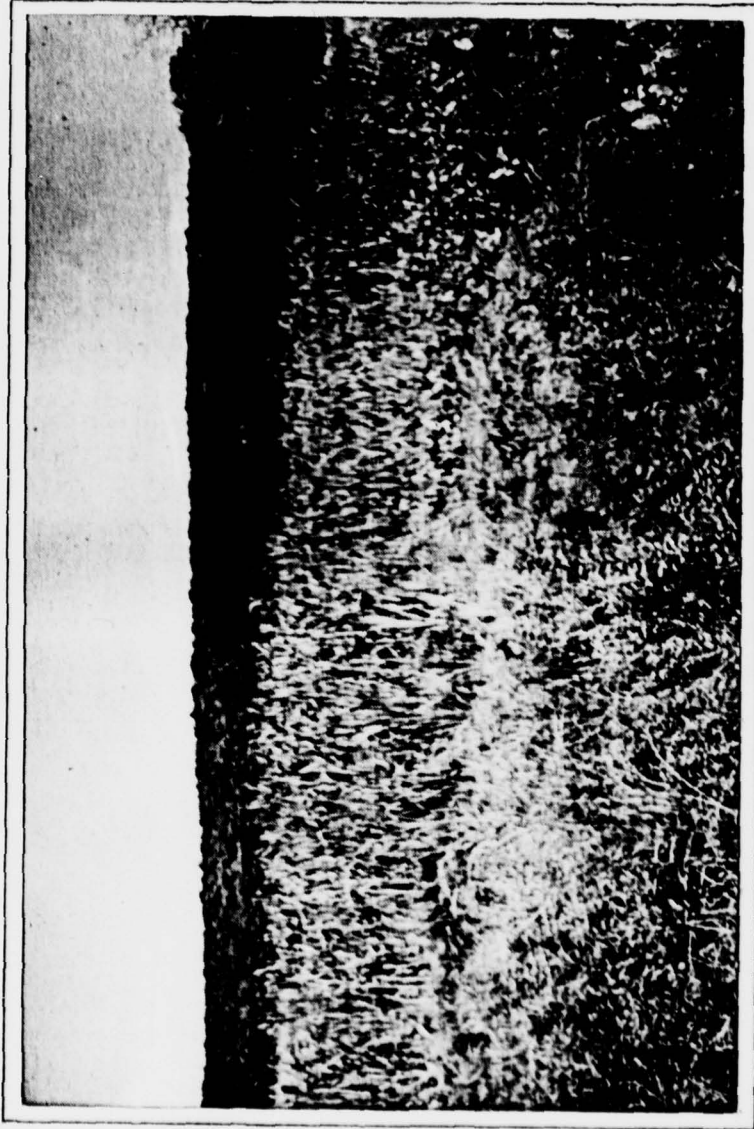
VIEW OF CATTAILS DENOTING SEEPAGE
ZONES. SEE SHEET 5a, APPENDIX B
FOR LOCATIONS.

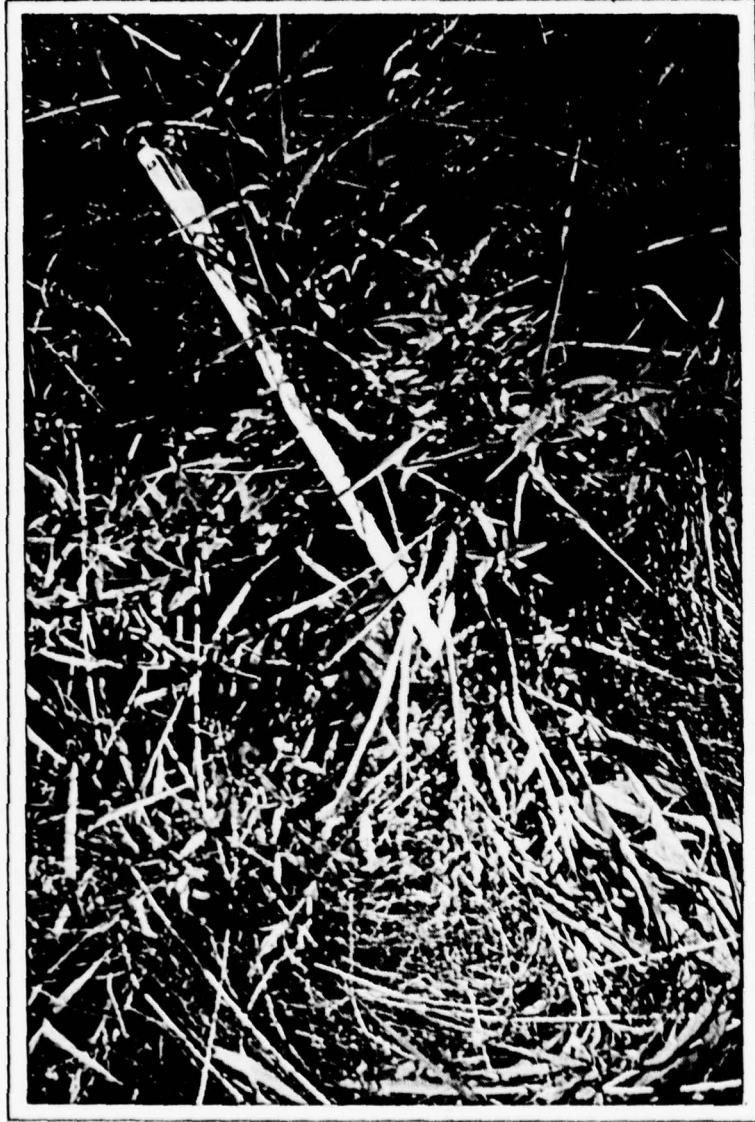
PHOTOGRAPH NO. 11

CLOSEUP OF SEEPAGE SOURCES WITHIN
MARSHY AREAS DOWNSTREAM OF DAM.
SEE SHEET 5a, APPENDIX B FOR
LOCATIONS.

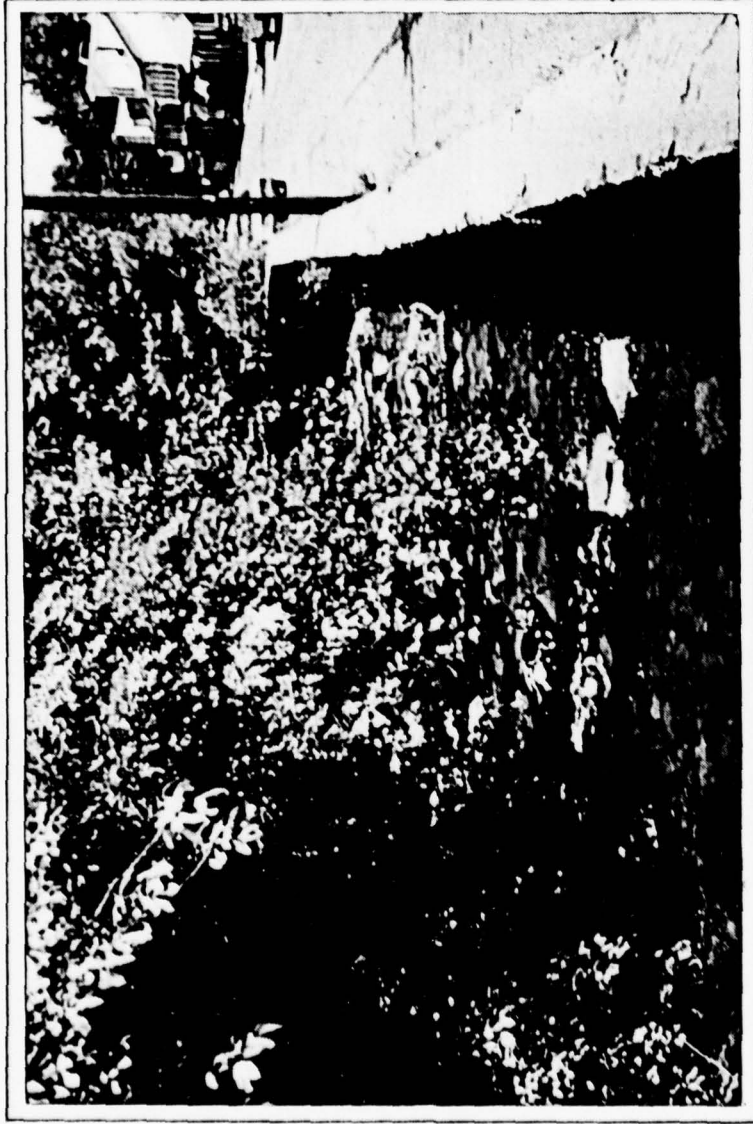
PHOTOGRAPH NO. 14

The flood plain below the dam is a swamp, unchanged from the original geologic and soils investigation report. The flood plain is approximately 200 feet wide. The channel banks are roughly 2 feet high, with side slopes ranging from near vertical to 1:1. Further downstream, Mauch Chunk Creek flows through the town of Jim Thorpe, which would be flooded in the event of high flows or failure of the dam. Photograph 14 of Appendix D shows a typical view of the Mauch Chunk Creek through Jim Thorpe, Pennsylvania.

TYPICAL VIEW OF MAUCH CHUNK CREEK
AS IT PASSES THROUGH JIM THORPE,
PENNSYLVANIA.
