**BROWN DAM  
NJ 00117**

**PHASE 1 INSPECTION REPORT  
NATIONAL DAM SAFETY PROGRAM**

PHASE I REPORT  
NATIONAL DAM INSPECTION PROGRAM

State Located New Jersey  
County Located Salem  
Coordinates Lat. 3940.2 - Long. 7528.7  
Stream Salem River  
Date of Inspection 10 January 1979

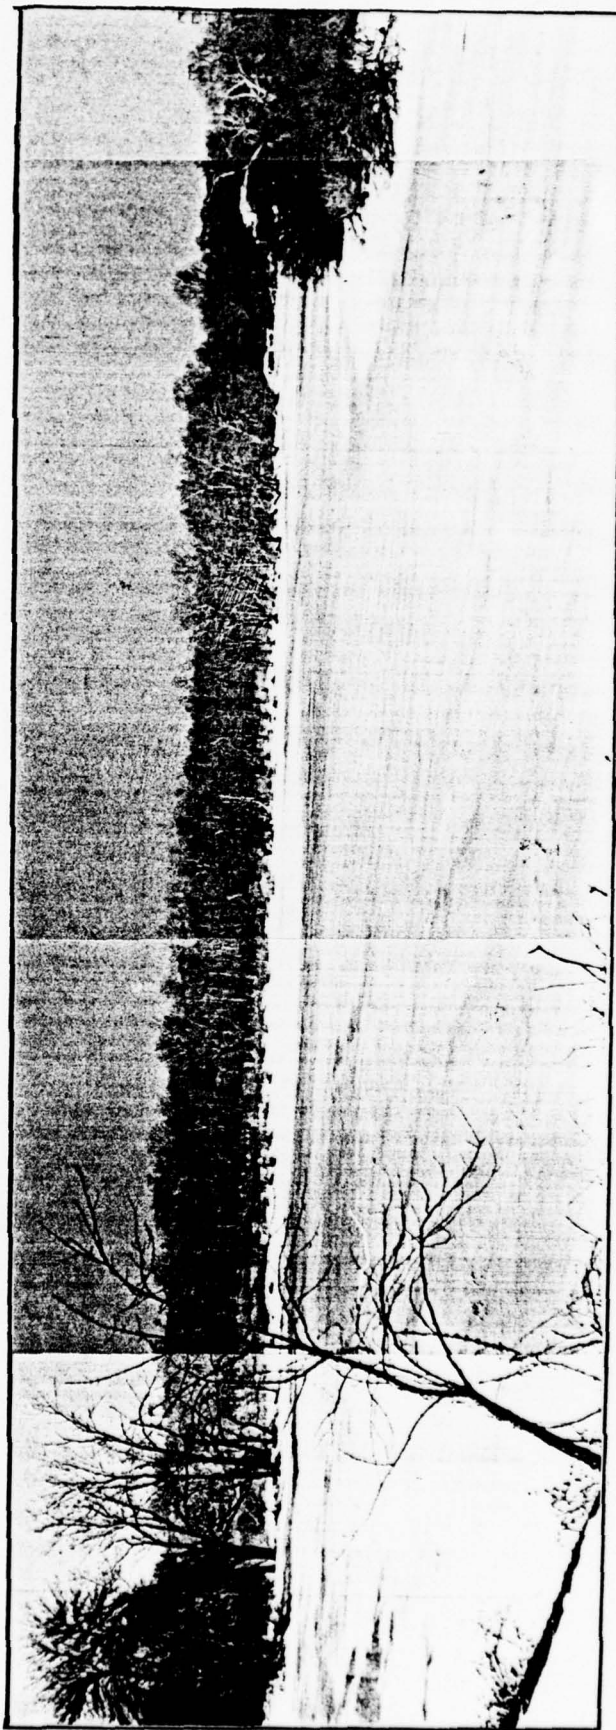
View upstream from dam

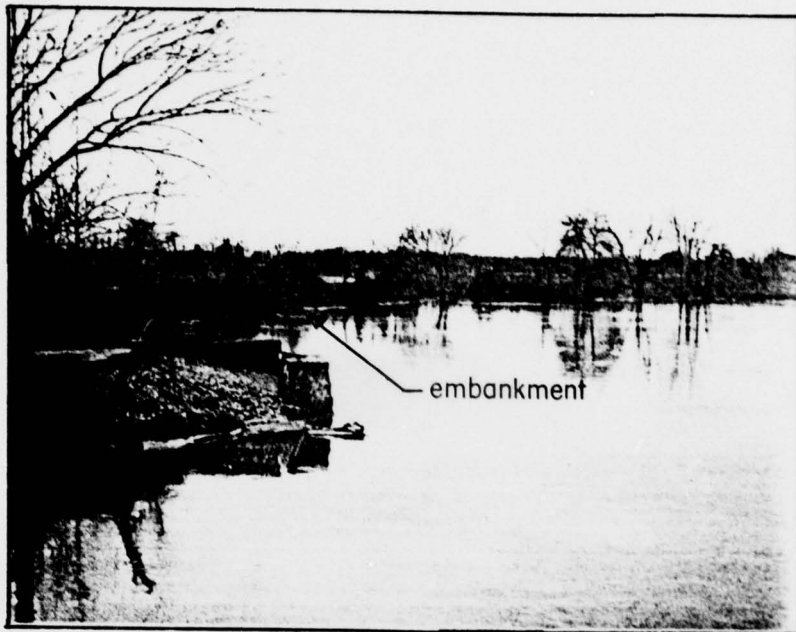
East end of dam

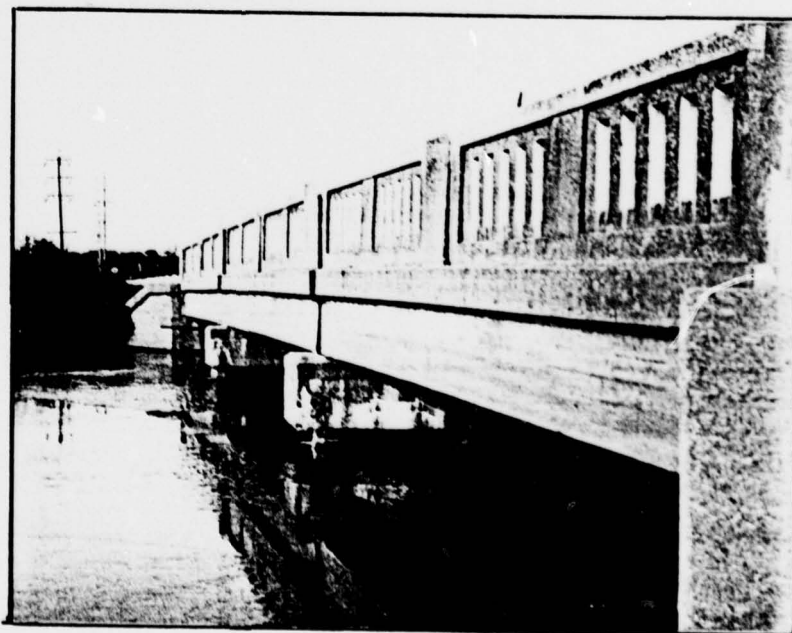
County bridge over Salem River at East end of dam

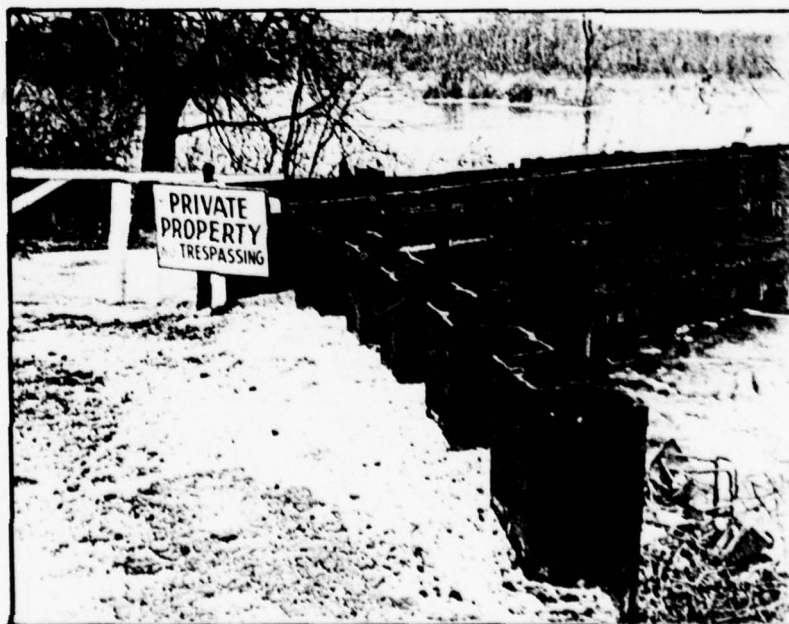
Steel sheeting at left spillway abutment

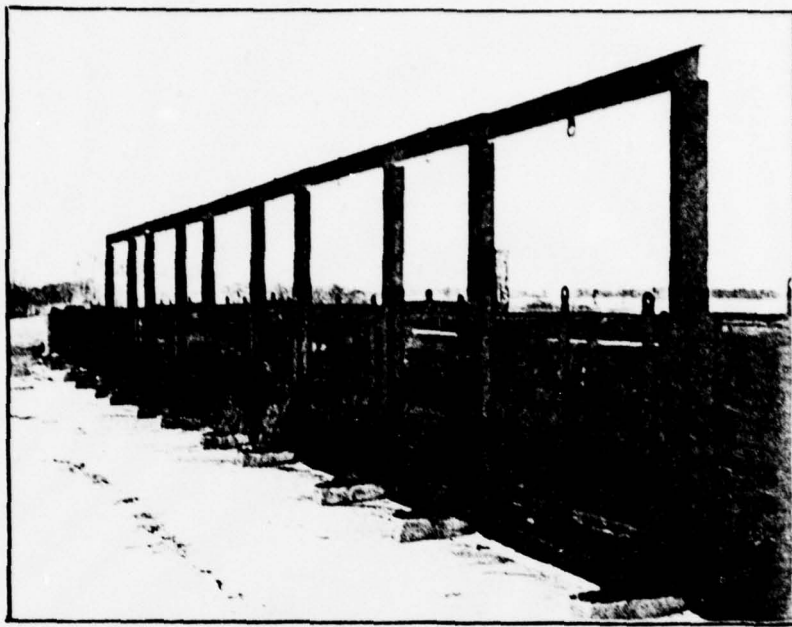
Hoist brackets for flashboards

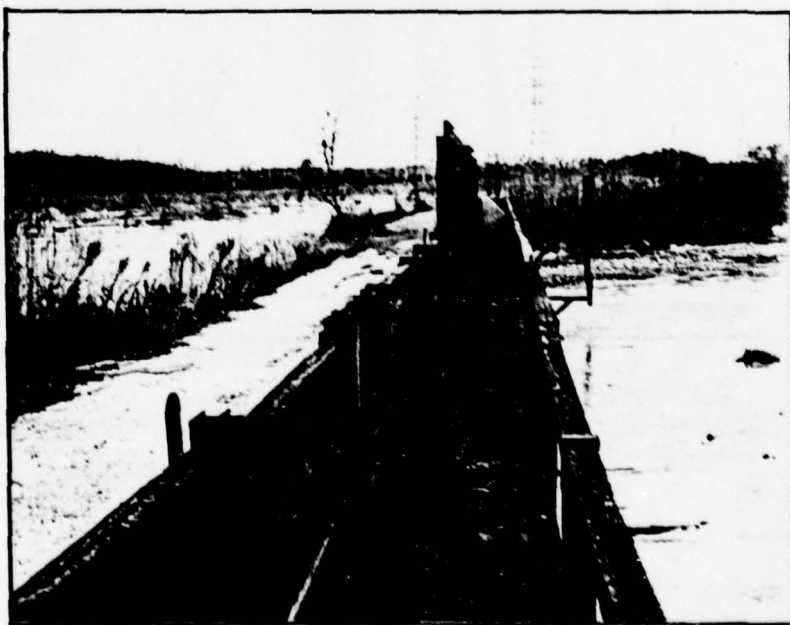
View East along catwalk
