DELAWARE RIVER BASIN  
LAHAWAY CREEK, OCEAN COUNTY  
NEW JERSEY

# PROSPERTOWN DAM

## NJ00455

### PHASE 1 INSPECTION REPORT NATIONAL DAM SAFETY PROGRAM

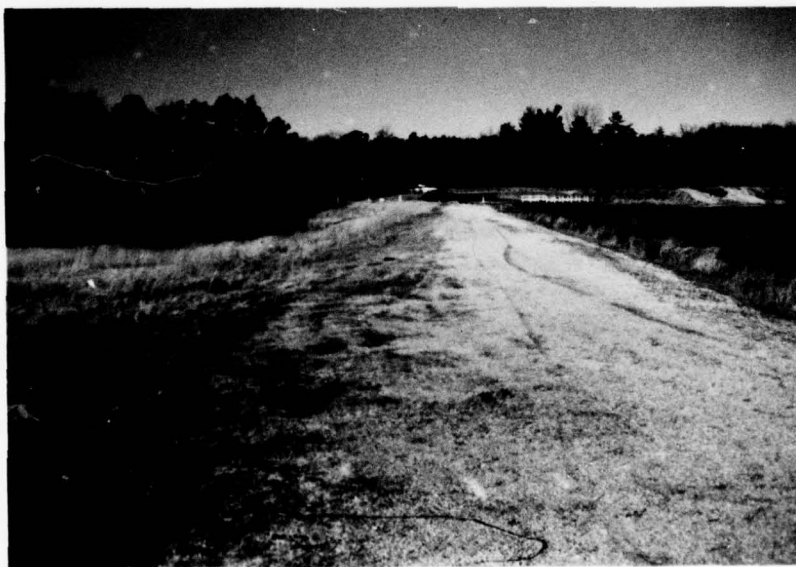
Erosion was observed at the north end of the embankment crest at the edge of an asphalt paved parking area. Pavement was undermined and breaking off at this boundary.

PHOTO 2  
CREST OF DAM
