PASSAIC RIVER BASIN
CANOE BROOK, ESSEX COUNTY
NEW JERSEY

CANOE BROOK RESERVOIR NO. 2 DAM NJ 00526

PHASE 1 INSPECTION REPORT NATIONAL DAM SAFETY PROGRAM

79 05 14 210
April, 1979

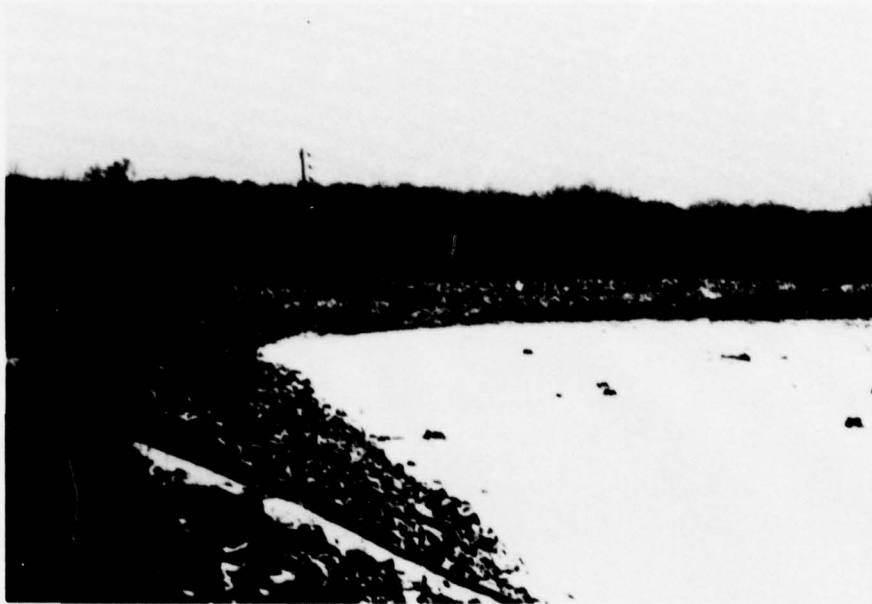
Visual inspection of the dam indicated the embankment to be in good overall condition and without any critical signs of distress. Erosion due to wave action is a continuing problem in certain areas of the inboard slope of the embankment, and there are other erosion problems and damage of the crest and slopes due to foot traffic. The width of the crest is inordinately narrow in places.

Photo 1 - Southeastern shoreline in area subject to most severe wave action. (11-29-78)

2. Erosion scars and areas of missing riprap on the embankment should be repaired as soon as possible.
3. The maximum operating level of the reservoir should be reviewed in light of future surveys of top of dam elevations.
4. Frequent vegetation removal should become a continuing maintenance operation.
5. Seepage and stability analyses of the dam should be made in the near future.
6. A downstream warning system in connection with Canoe Brook Reservoir No. 1 Dam should be established as soon as possible.

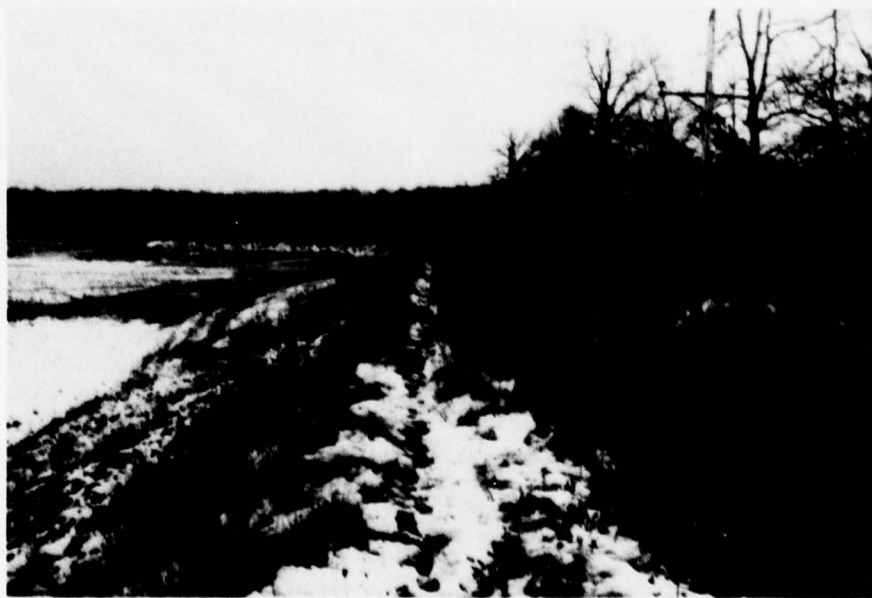
The embankment appears to be in generally good condition. Slopes are reasonably uniform and the in-board riprap, with minor exceptions, is well maintained. Wave action has cut the southeastern embankment to a minor degree. No vertical deflections in the crest could be detected, but the crest in some places is only about 3 feet wide, possibly due to erosion.

Photo 2 - Southern embankment, showing wave-cut inboard slope. (11-29-78)

Irregularities and eroded surfaces on the crest and slopes should be repaired as soon as possible.

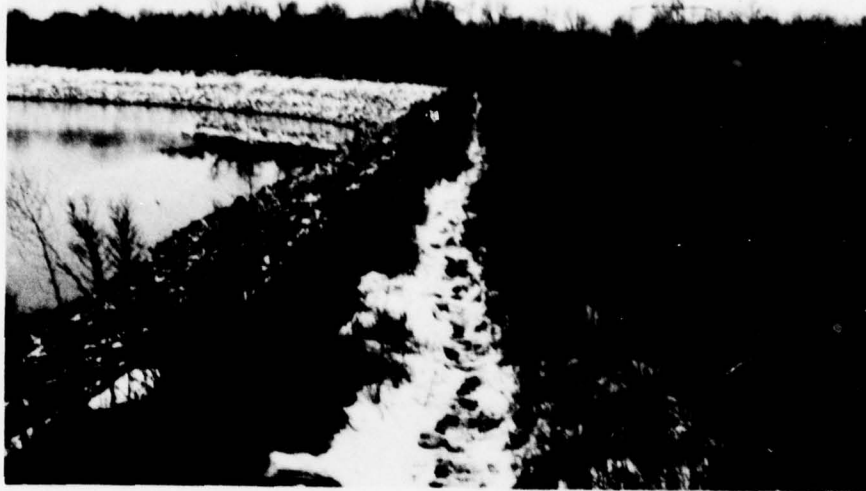
Photo 3 - Northwestern embankment looking west,
showing narrow crest width. (11-29-78)

1. Repair any erosion scars, deformations and settlement areas as indicated by a survey of the embankment, so that the embankment top elevation, width of top and angle of slope conform to the original design.

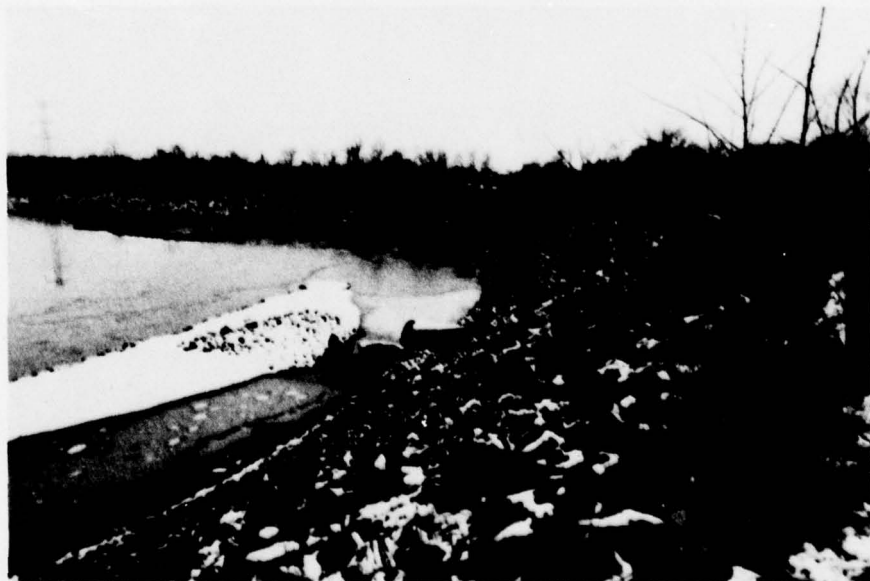
Photo 6 - Inlet of 48-inch transfer pipeline
connecting Canoe Brook Reservoirs Nos. 1 and 2.
(11-29-78)

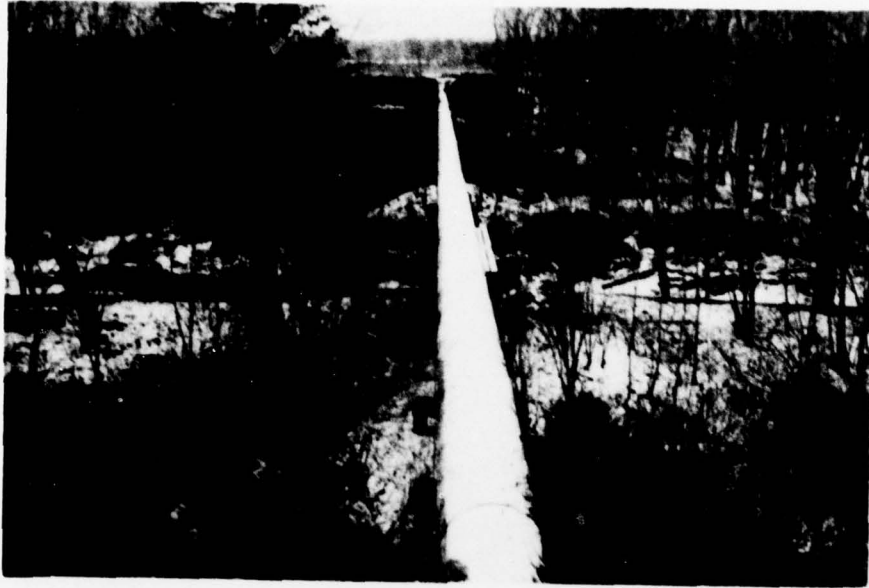
Photo 7 - Elevated portion of 48-inch transfer pipeline, looking toward Canoe Brook Reservoir No. 1. (11-29-78)

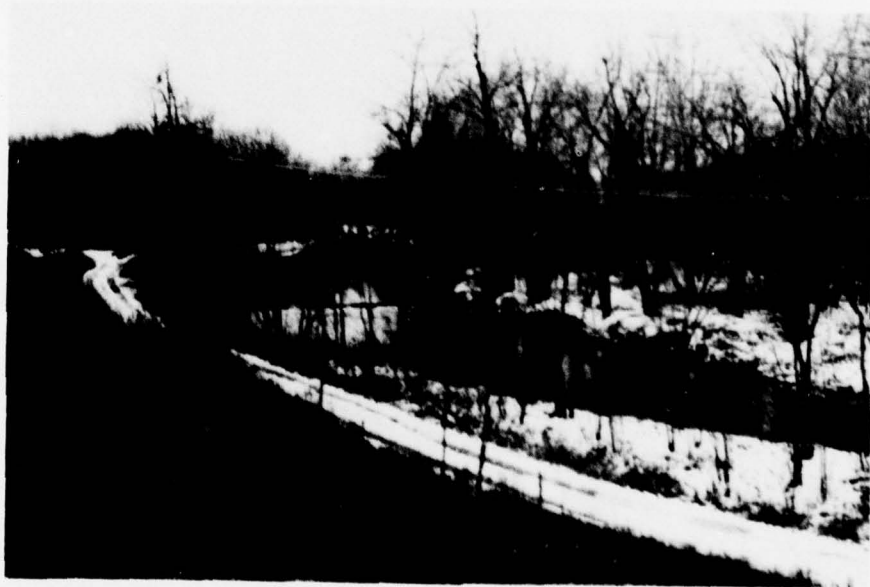
Photo 8 - Passaic River at intake structure. Pump station to left of weir. (11-29-78)

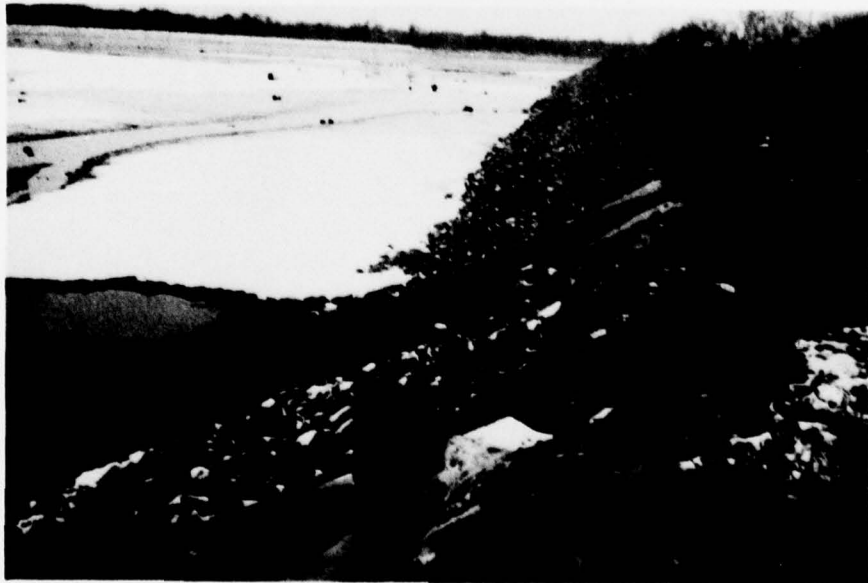
Photo 10 - Outlet pipes for return flow of
washwater from treatment plant filters.
(11-29-78)
