SCHUYLKILL RIVER BASIN
INDIAN RUN CREEK, BERKS COUNTY
PENNSYLVANIA
ID NO. PA.00713

BIRDSBORO RESERVOIR

PHASE I INSPECTION REPORT
NATIONAL DAM INSPECTION PROGRAM

SEPTEMBER 1978

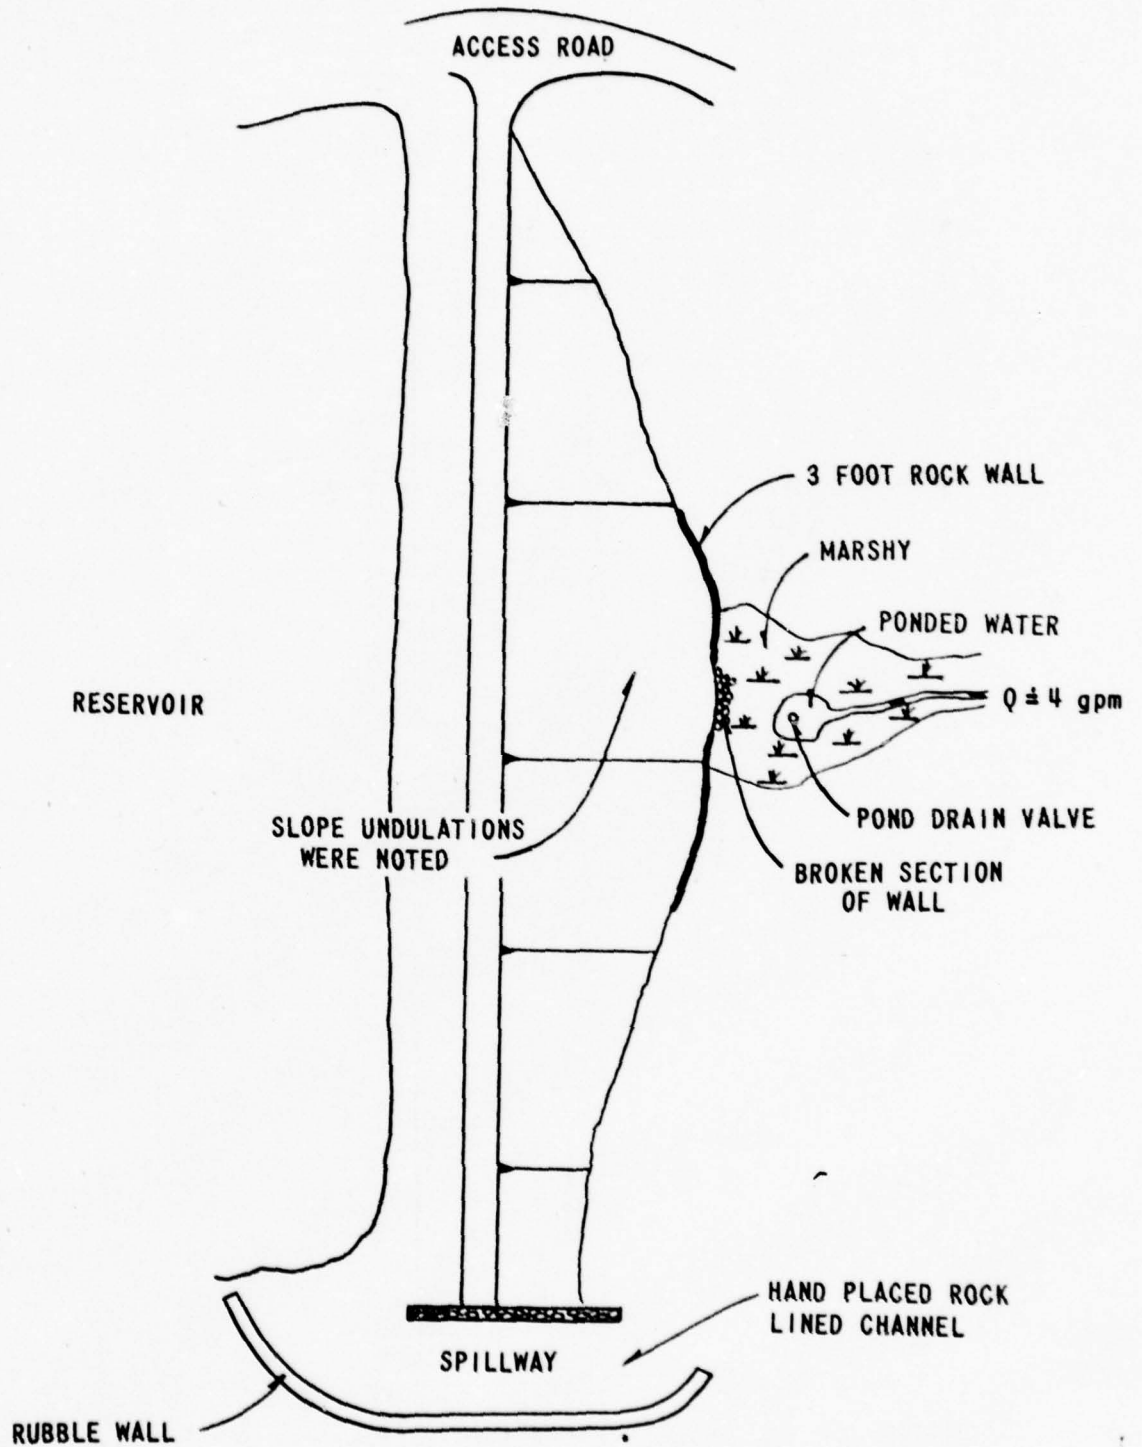
SEEPAGE LOCATION PLAN
 INDIAN RUN DAM
 (BIRDSBORO RESERVOIR)

An area as shown on sheet 5a is marshy and contains standing water. Seepage flow was judged to be on the order of four to five gpm. The pond drain valve stem was located at the base of the dam in the marshy area. As discussed on sheet 4, dampness was noted on the downstream slope of the embankment.

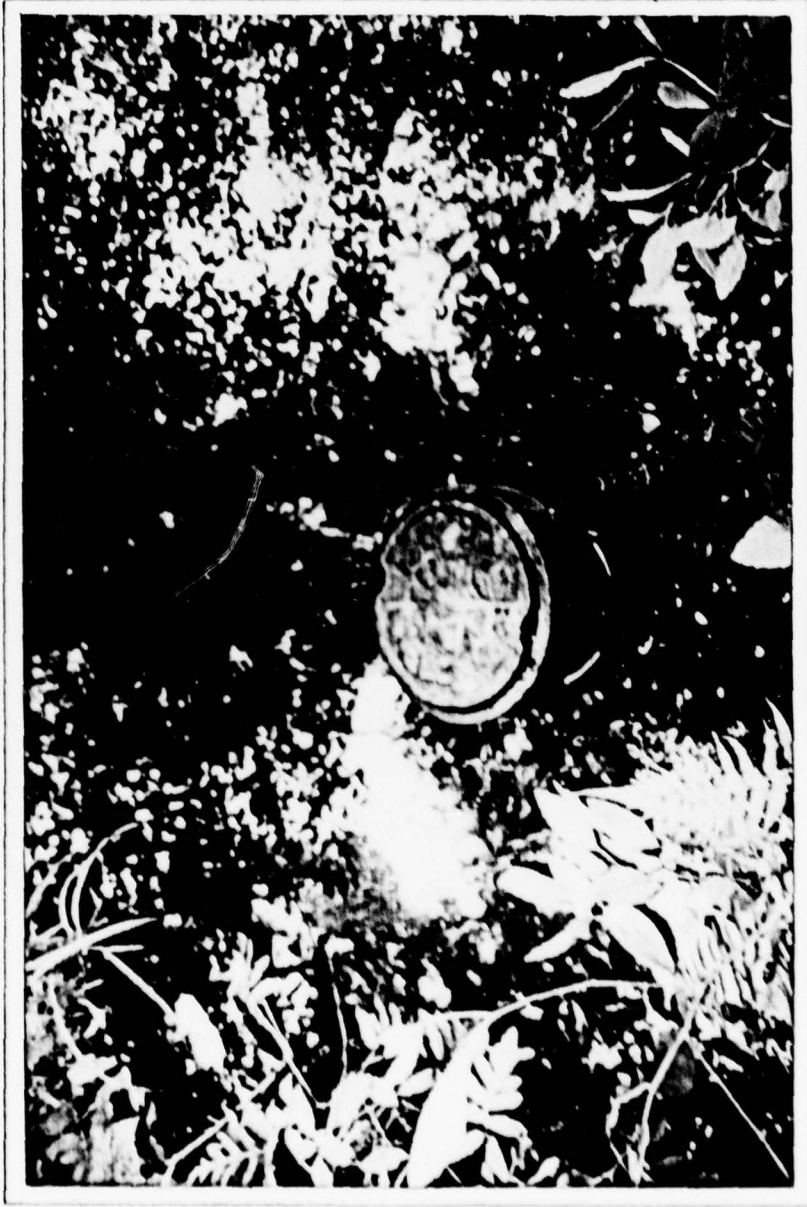
POND DRAIN VALVE LOCATED IN POOL OF
WATER JUST BEYOND DOWNSTREAM TOE.
SEE SHEET 5A, APPENDIX B.

1. The pond drain system should be checked to insure that the reservoir can be drained in the event of an emergency.
2. The water at the base of the dam is considered undesirable and should be checked by a registered professional engineer to determine if it is a natural marsh area or seepage through the dam or foundation. This can be accomplished by regrading the toe of the dam and evaluating the seepage locations. If underseepage is determined to be occurring, an inverted filter blanket should be installed.
3. The intake structure should be inspected for debris and integrity.
4. The water supply pipe should be fitted with a valve at the control tower. This will enable the flow to be cut off in the event the pipe develops a leak within the embankment.

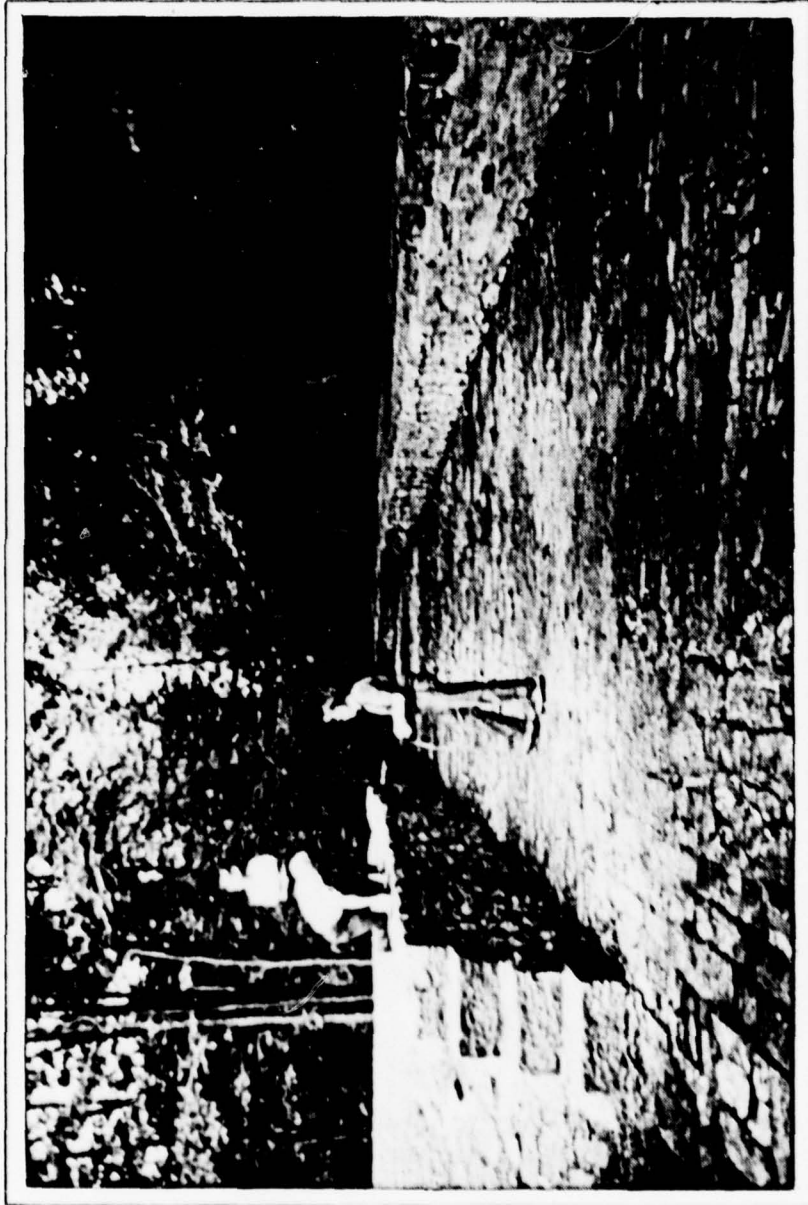
PHOTOGRAPH NO. 3

LOOKING DOWNSTREAM OF THE SPILLWAY
CHANNEL.

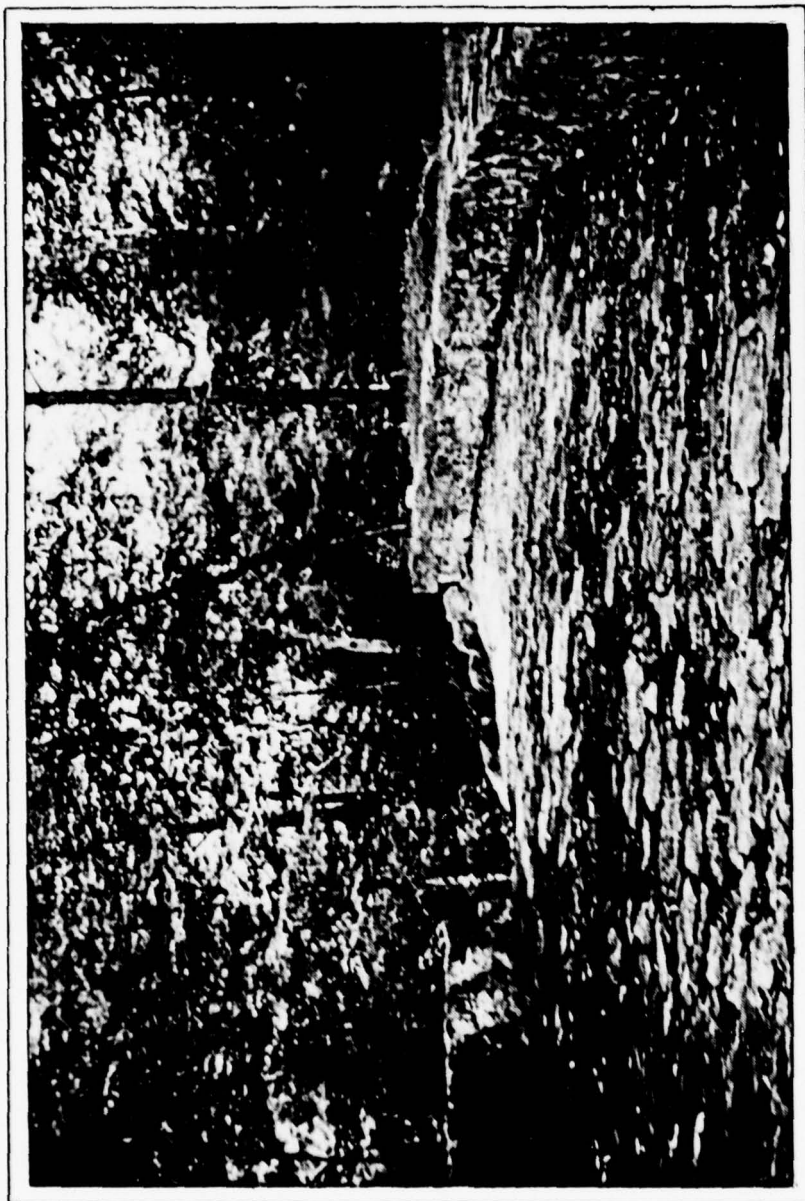
PHOTOGRAPH NO. 6

DISCHARGE CHANNEL *The hand placed rock channel is in good condition. The end of the channel was damaged during Tropical Storm Agnes (June 1972) and was repaired using concrete in lieu of the hand placed rock. Currently, discharge passes along the left side of the channel where minor erosion is occurring. This area should be inspected after severe storms.*

SPILLWAY EXIT INTO THE NATURAL STREAM
CHANNEL. LOWER SECTION OF SPILLWAY
WAS RECONSTRUCTED WITH CONCRETE AFTER
BEING DAMAGED BY TROPICAL STORM AGNES,
JUNE 1972.

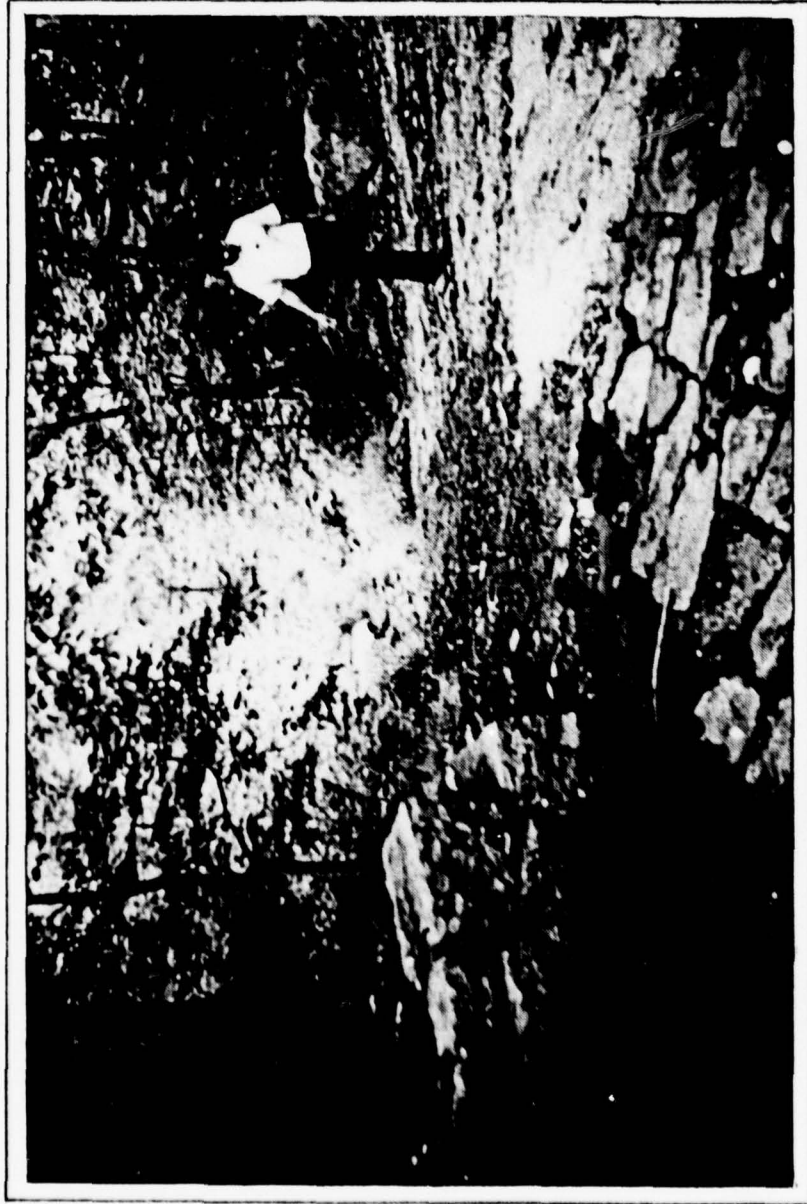
REFERENCE INFORMATION ON PHOTOGRAPH
NUMBER 6, NOTE CONCRETE REPAIRS.

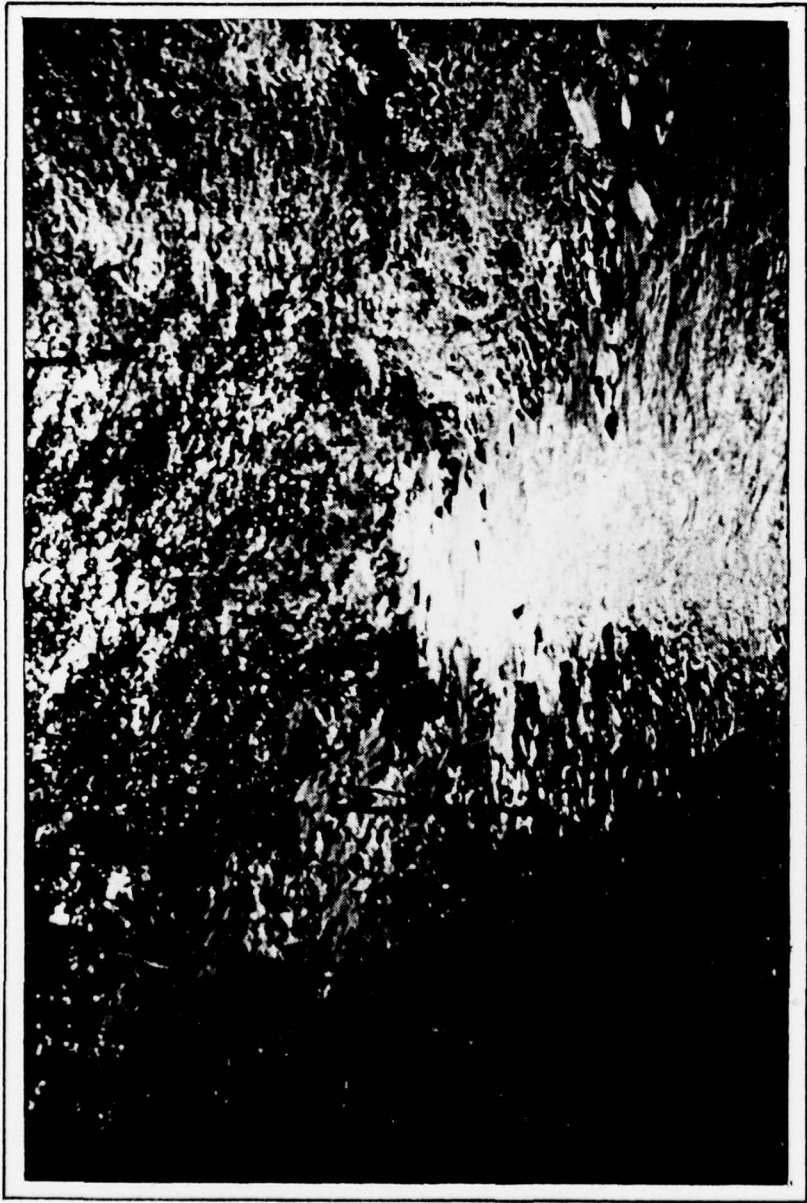
PHOTOGRAPH NO. 12

TYPICAL VIEW OF DOWNSTREAM CHANNEL.
