ASHLAND DAM

**PHASE I INSPECTION REPORT
NATIONAL DAM INSPECTION PROGRAM**

SEPTEMBER 1978

ASHLAND DAM
SCHUYLKILL COUNTY, PENNSYLVANIA
NATIONAL I.D. NO. PA 00659-
671

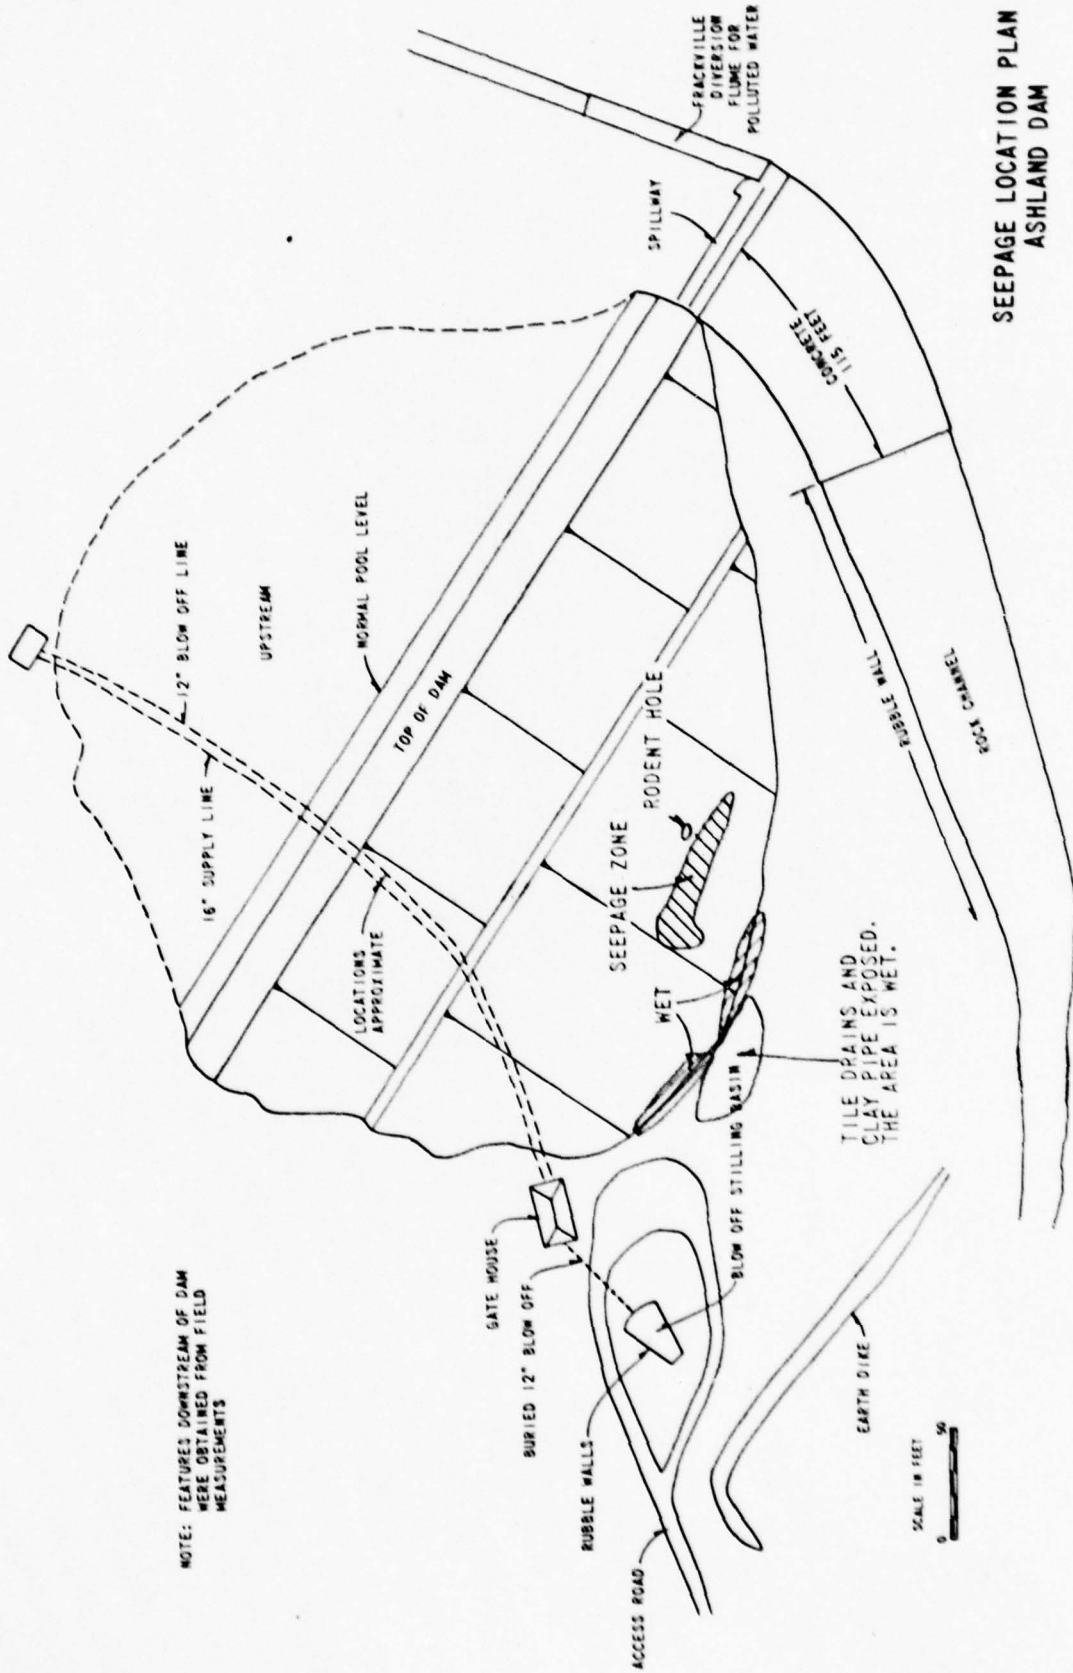
Seepage was noted downstream along the embankment as shown on Sheet 5a, Appendix B. This seepage was also noted during a 1939 inspection and, based on the observations at that time, there appears to be no significant increase in the seepage rates since that inspection. However, this seepage is undesirable and should be monitored. The downstream toe area was damp and marshy along the right abutment as shown on Sheet 5a of Appendix B. Evaluation of this area showed the terra-cotta pipe and the tile drains installed in 1938 to control downstream toe leakage were functioning.

5. The rodent hole noted as shown on Sheet 5a, Appendix B should be filled.

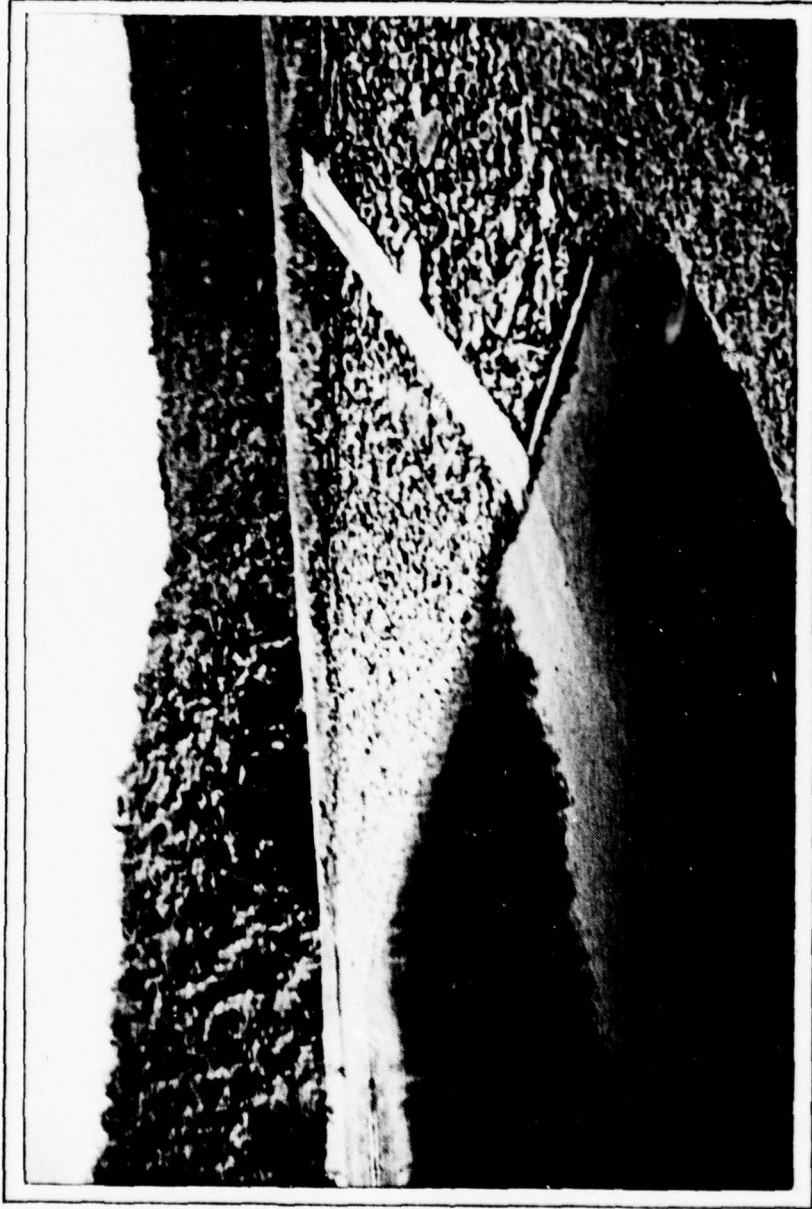
PHOTOGRAPH NO. 1

The upstream riprap was inspected above the water line and observed to be in good condition with no signs of movement or significant deterioration. Embankment/abutment contacts were inspected and observed to be in good condition.

VIEW OF UPSTREAM SLOPE. NOTE GOOD
CONDITION OF RIPRAP AND STAFF GAGE.

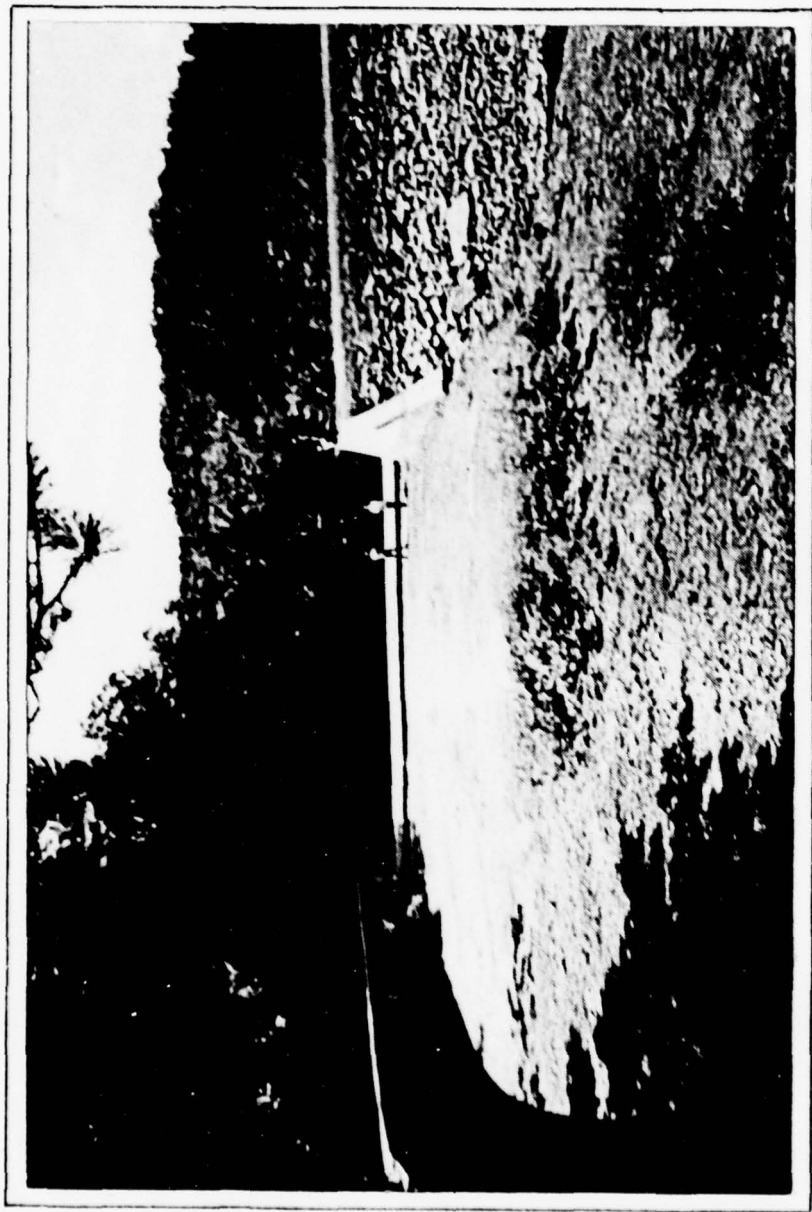
PHOTOGRAPH NO. 2

2. Spillway: The approach channel to the spillway was inspected and the concrete wall was found to be in good condition on both the left and right abutments. The spillway crest was also inspected and there were no signs of significant deterioration, spalling or other features that would be detrimental to the performance of the spillway. Some minor spalling was noted, but had been satisfactorily

APPROACH CHANNEL TO EMERGENCY
SPILLWAY.

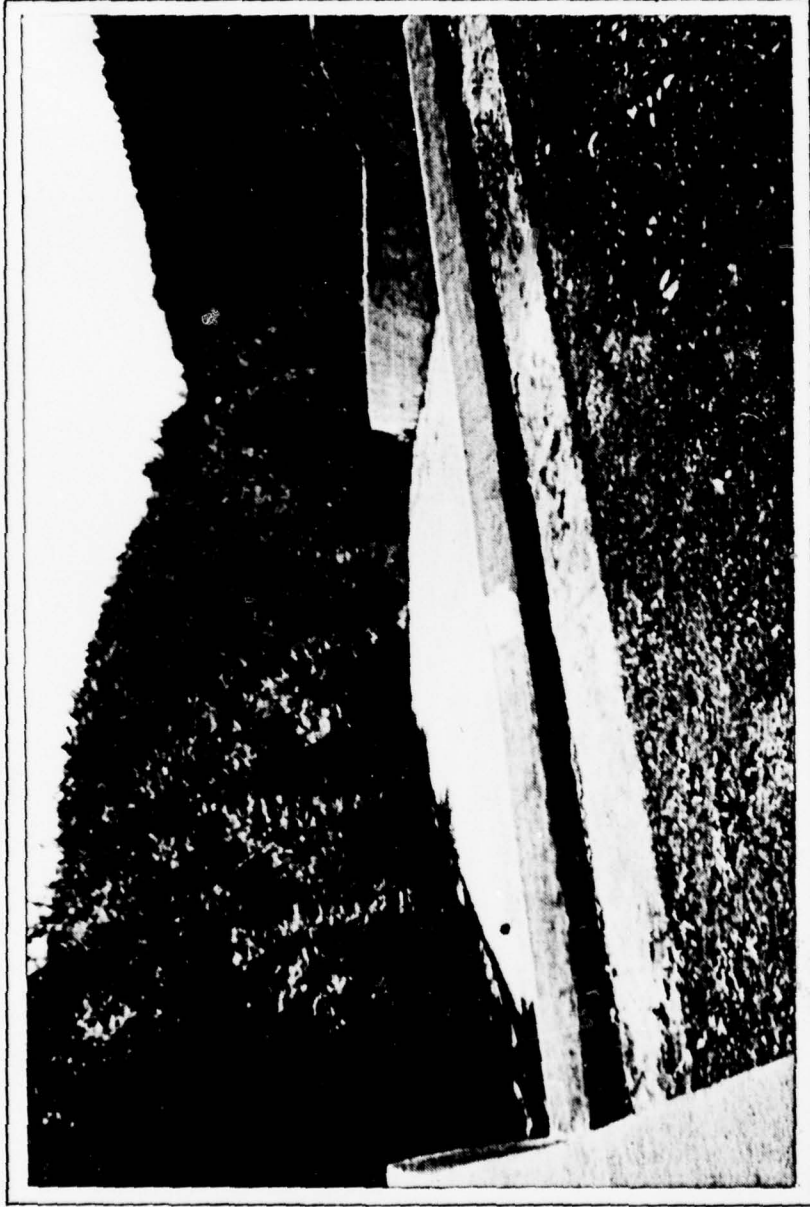
PHOTOGRAPH NO. 3

EMERGENCY SPILLWAY CREST.

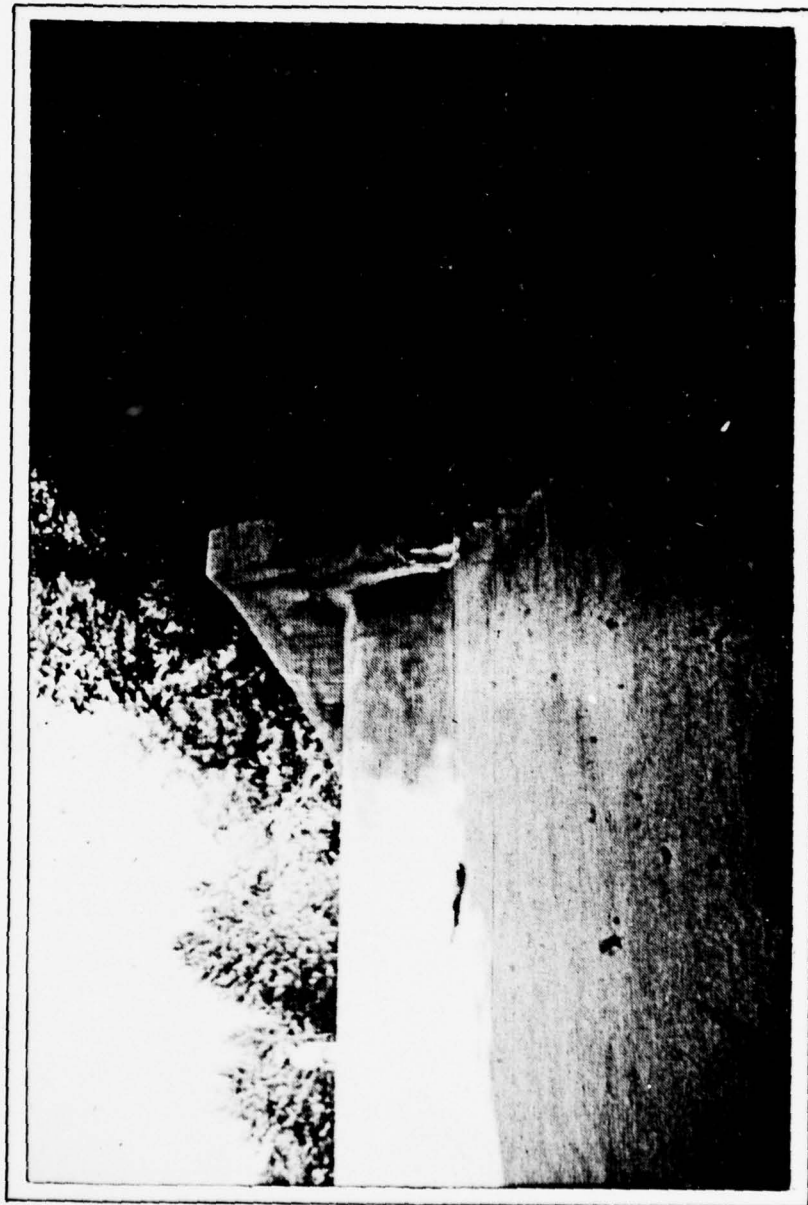
VIEW LOOKING UPSTREAM TOWARDS CREST
OF EMERGENCY SPILLWAY. NOTE OUTFLOW
FROM DIVERTED CHANNEL. POLLUTED
STREAM IS DIVERTED AROUND RESERVOIR
VIA THIS CHANNEL.

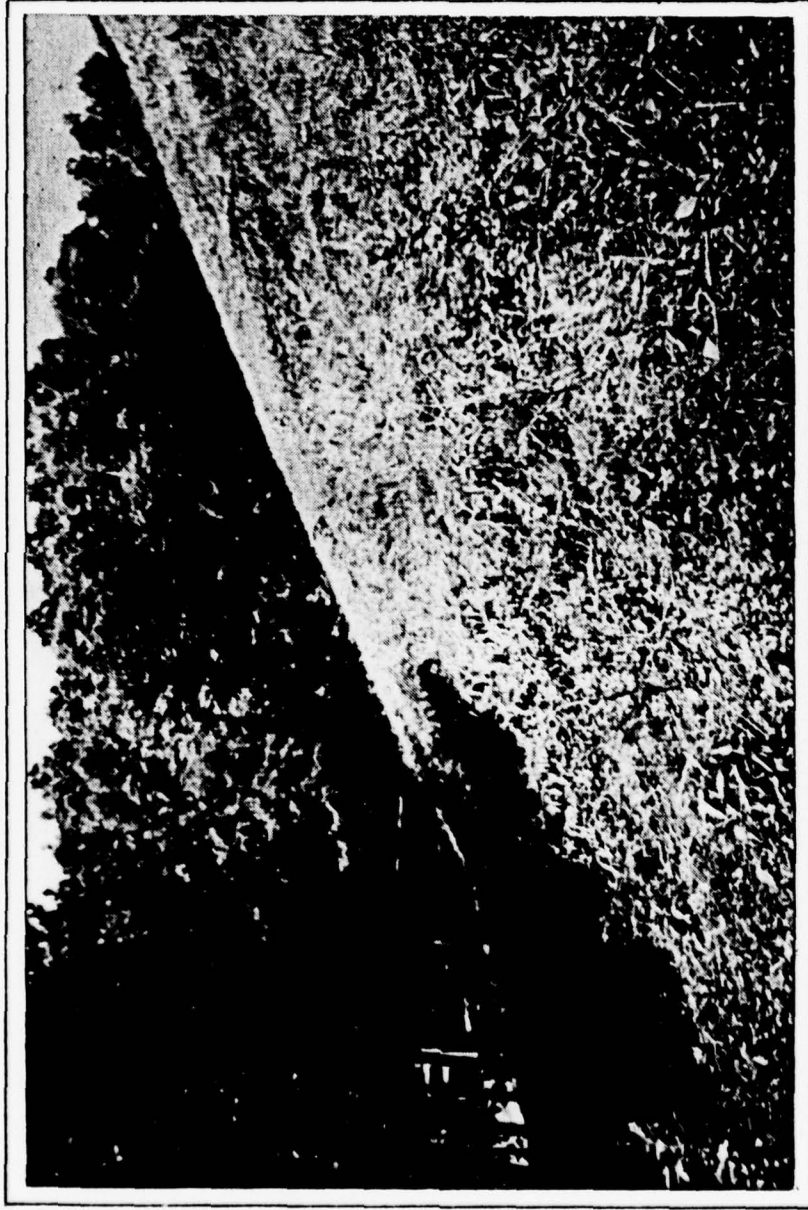
VIEW OF DOWNSTREAM SLOPE LOOKING
TOWARDS RIGHT ABUTMENT. SEEPAGE
IS LOCATED IN THE FOREGROUND.
SEE PHOTOGRAPH NO. 9.

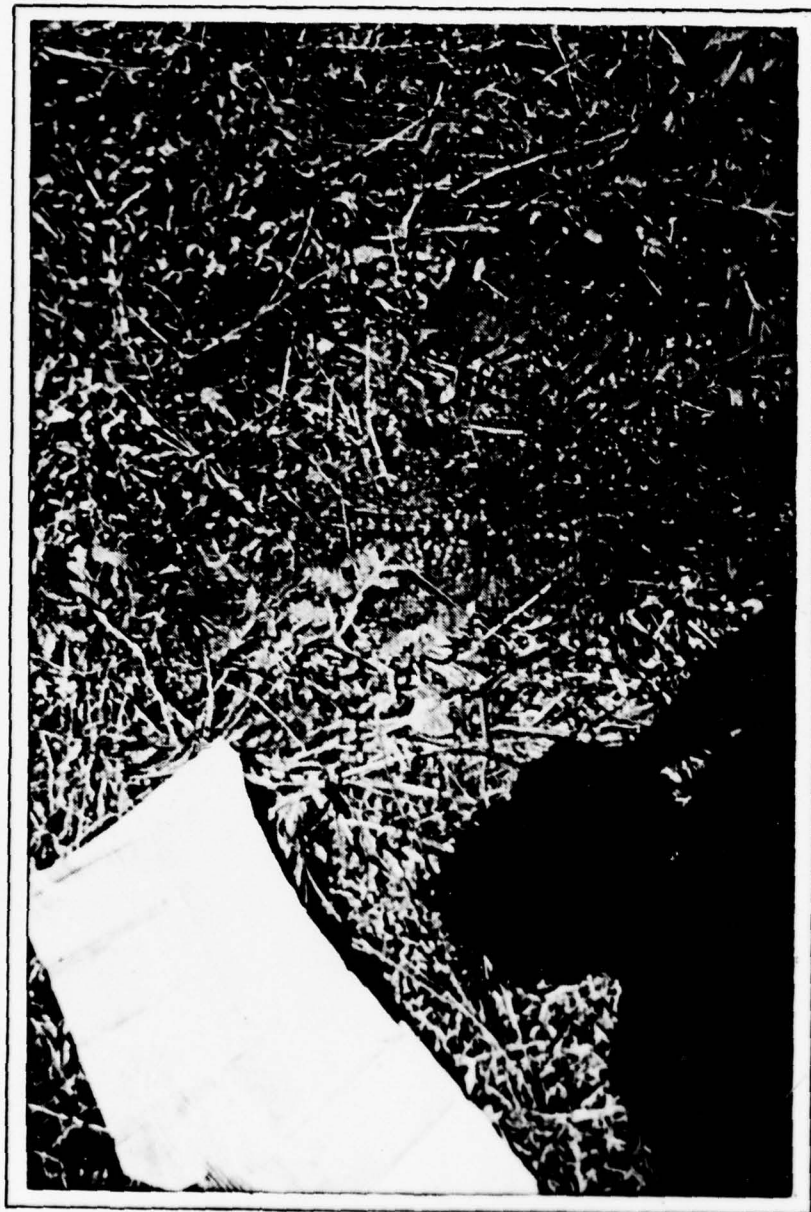
PHOTOGRAPH NO. 9

Yes. Tile drains are functioning but seepage is collecting over the tiles at the toe of the left abutment. See sheet 5a and photographs in Appendix D.

SEEPAGE NOTED THROUGH DOWNSTREAM
SLOPE. SEE SHEET 5a OF APPENDIX
B FOR EXACT LOCATION.

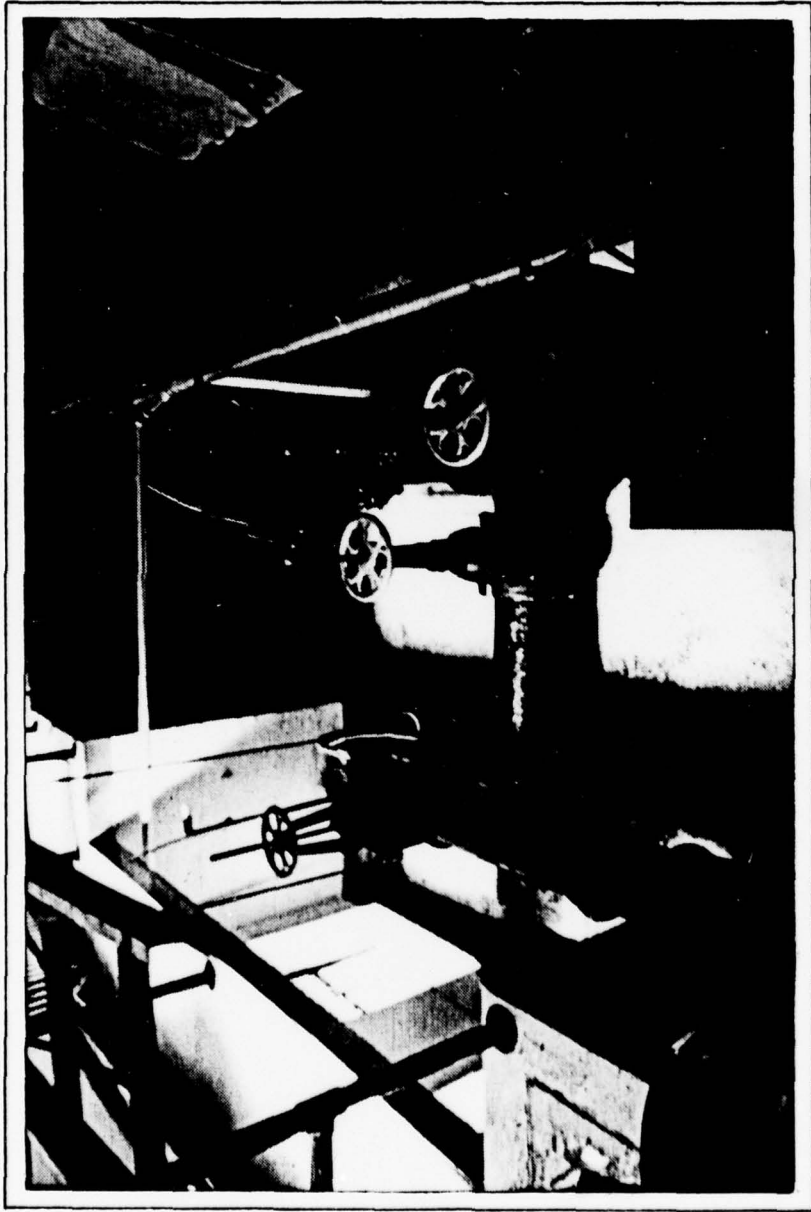
PHOTOGRAPH NO. 11

There are no written maintenance procedures for the dam. Since the dam was completed in 1925, there are no records to indicate that the blow-off or water supply pipes have been checked. The portions of the pipe located in the treatment building are periodically cleaned, painted and are kept in very good condition. The valves were also inspected and found to be clean, well lubricated and operating properly.

WATER SUPPLY CONTROL VALVES ARE
LOCATED IN CONTROL HOUSE.

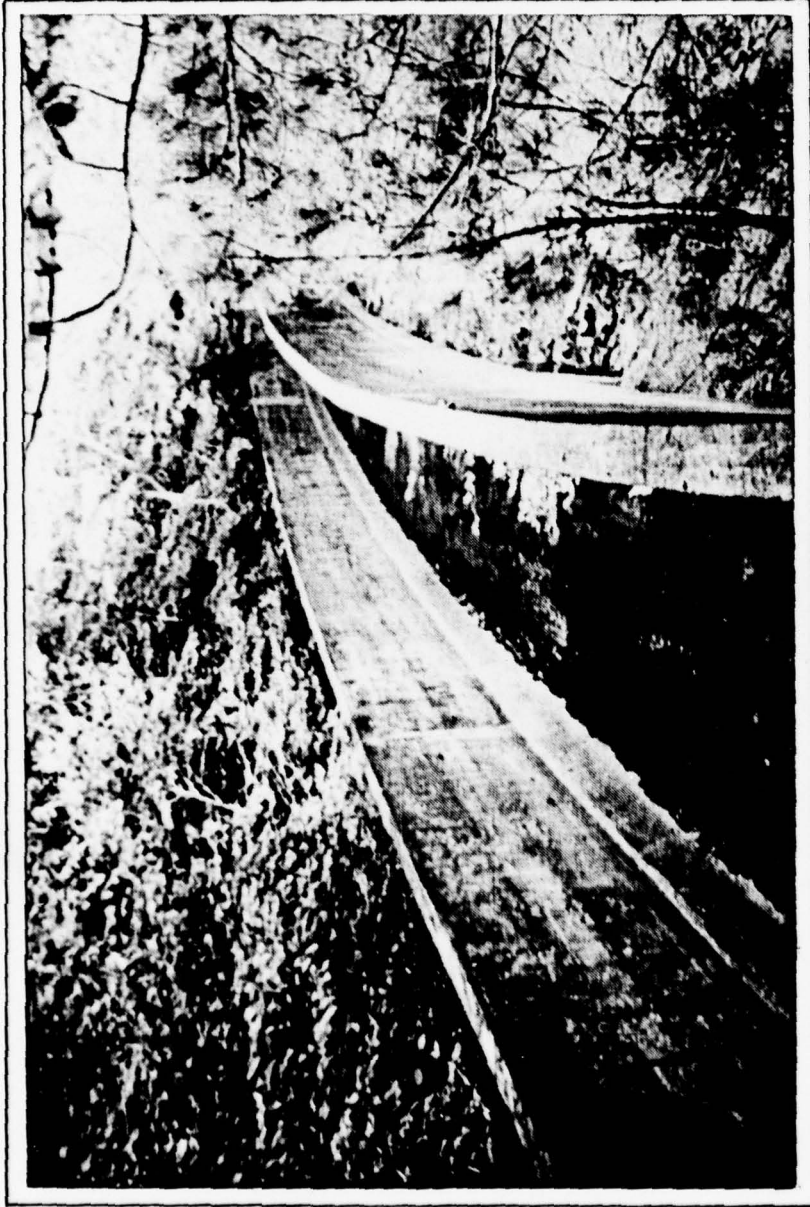
PHOTOGRAPH NO. 12

CONCRETE DIVERSION CONDUIT USED
TO TRANSFER POLLUTED WATER AROUND
THE RESERVOIR.
