6 National Dam Safety Program. New Dam  
(NDI-PA-503), Ohio River Basin, Tributary  
of St. Patricks Run, Washington County,  
Pennsylvania. Phase I Inspection Report,

PHASE I REPORT  
NATIONAL DAM INSPECTION PROGRAM

NAME OF DAM: New Dam  
STATE LOCATED: Pennsylvania  
COUNTY LOCATED: Washington  
STREAM: A tributary of St. Patrick's Run (secondary tributary of  
Raccoon Creek  
DATE OF INSPECTION: November 29 and December 20, 1978

PHASE I REPORT  
NATIONAL DAM INSPECTION PROGRAM  
NEW DAM  
NDI I.D. NO. PA-503  
DER I.D. NO. 63-2

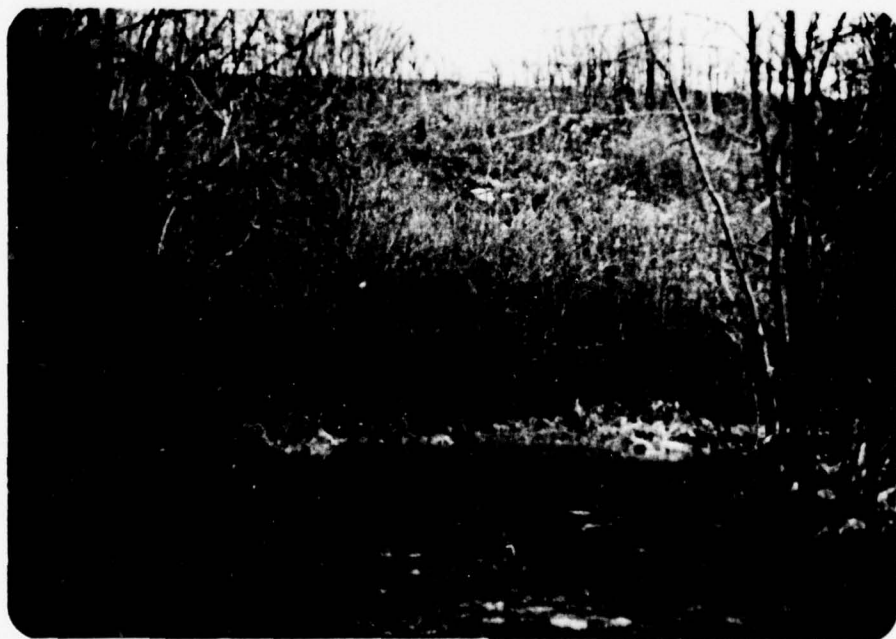
Downstream Face

In general, the condition of the embankment is considered to be poor. The embankment is covered with trees and brush 10 to 15 feet high and up to three inches in diameter. The overgrowth prevented adequate inspection of the downstream face of the dam. There is no direct line of sight from abutment to abutment. The presence of ponded water along the downstream toe of the dam suggests underseepage when reservoir levels are high. However, on the date of inspection, no signs of seepage were observed from the ponds.

(1) Embankment. As discussed in Section 3, the field observations did not reveal major signs of distress, such as cracks, bulges, or subsidence. Although some ponded water was observed on the downstream toe, it appeared that no seepage was associated with these ponds. It should be noted that the reservoir was essentially empty on the date of inspection. The dam was impounding a pond with a surface area of approximately 2 to 3 acres at a level 31 feet below the crest level. Therefore, the dam was not inspected under normal conditions. It is probable that conditions may have been obscured which would otherwise be detectable if the dam were inspected under normal operating stages.

1. Have the dam and appurtenances evaluated by a professional engineer either for orderly abandonment and breaching of the dam or for repairs and restoration of the outlet works and embankment and enlargement of the spillway to provide adequate spillway capacity. If the owner decides to breach or remove the dam, additional hydrologic and hydraulic studies should be performed to evaluate the downstream effects of this action.

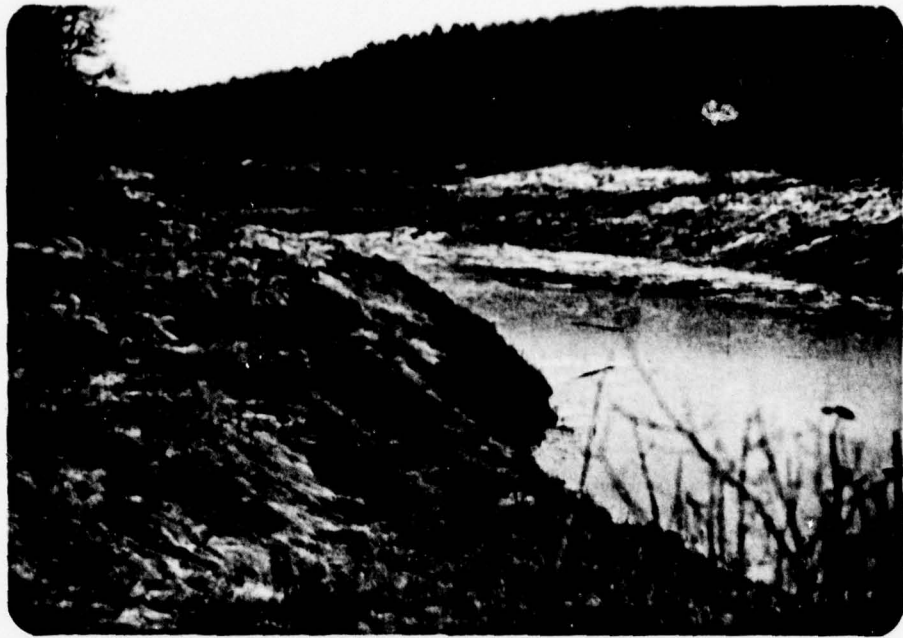
Photograph No. 1  
Reservoir.
