**SCHUYLKILL RIVER BASIN  
ANTIETAM CREEK, BERKS COUNTY  
PENNSYLVANIA**

**ID NO. PA. 00716**

# LAKE ANTIETAM DAM

## PHASE I INSPECTION REPORT NATIONAL DAM INSPECTION PROGRAM

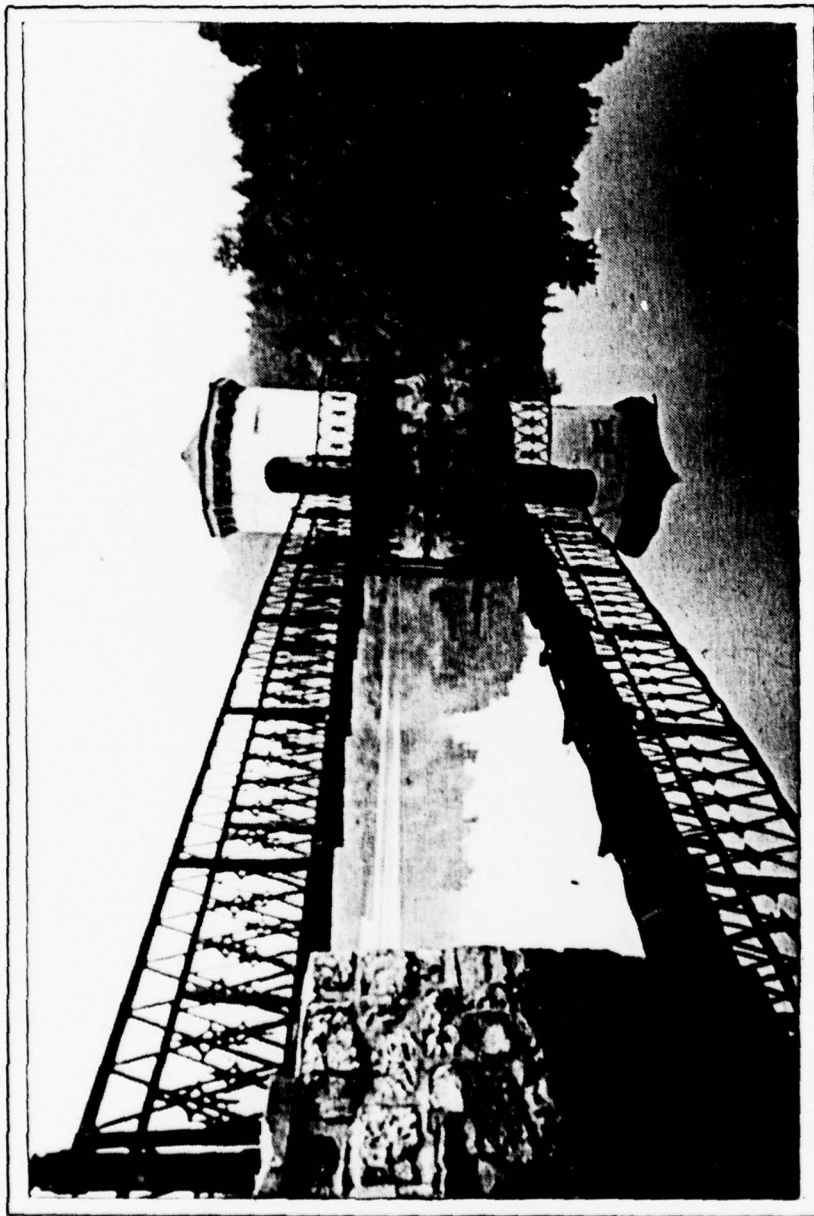
PHOTOGRAPH NO. 1

OVERVIEW OF ACCESS BRIDGE AND WATER  
SUPPLY CONTROL TOWER.

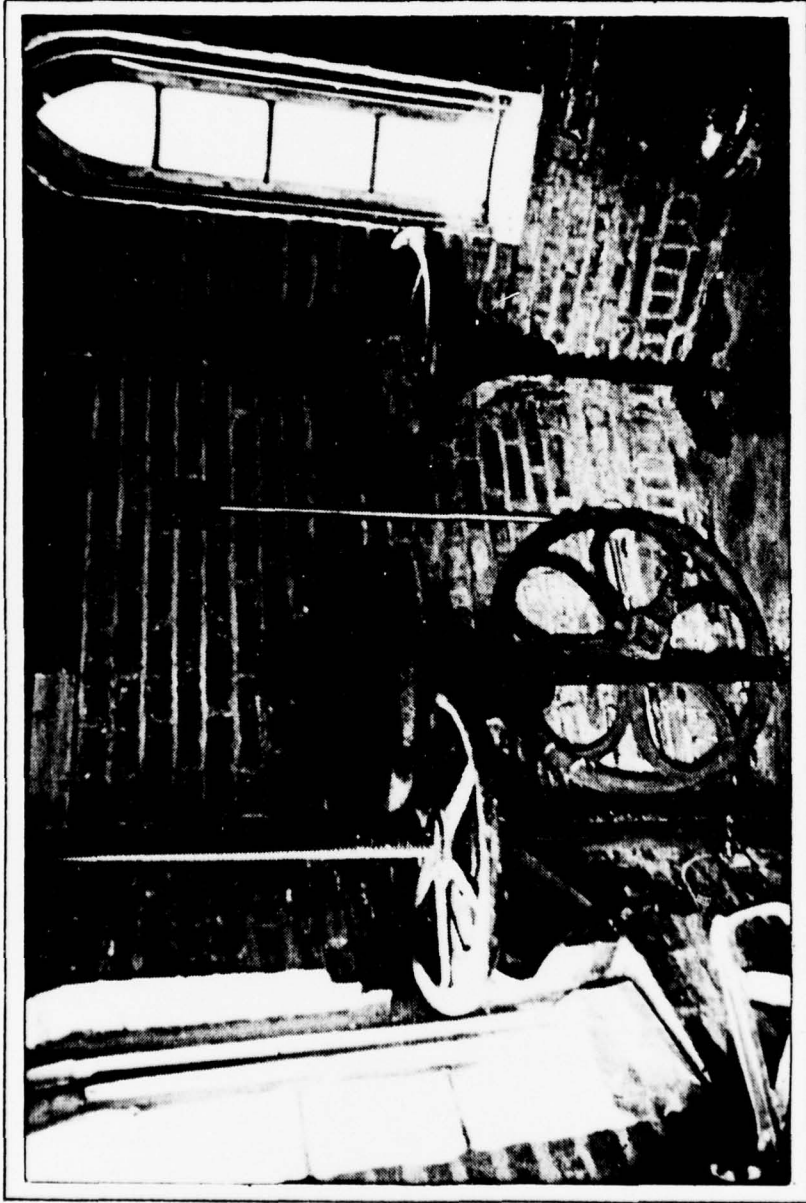
PHOTOGRAPH NO. 2

2. Outlet Works. As previously described, the principal water supply outlet works have not functioned for many years, and it is assumed that all valves are inoperable. The Owner's representative indicates that the pond drain located through the base of the dam, and controlled by a valve at the downstream toe, is operated twice per year. Records indicate that this valve requires two men to operate. This valve was not exercised during the inspection. The valve was coated with rust, the interior of the valve house leaks, and there is water up to the top of the pipe. It is believed that during the winter, ice could freeze this valve rendering it totally inoperable in the event that it is necessary to lower the reservoir.

VIEW INSIDE CONTROL TOWER. GATE  
VALVES ARE NON FUNCTIONAL.

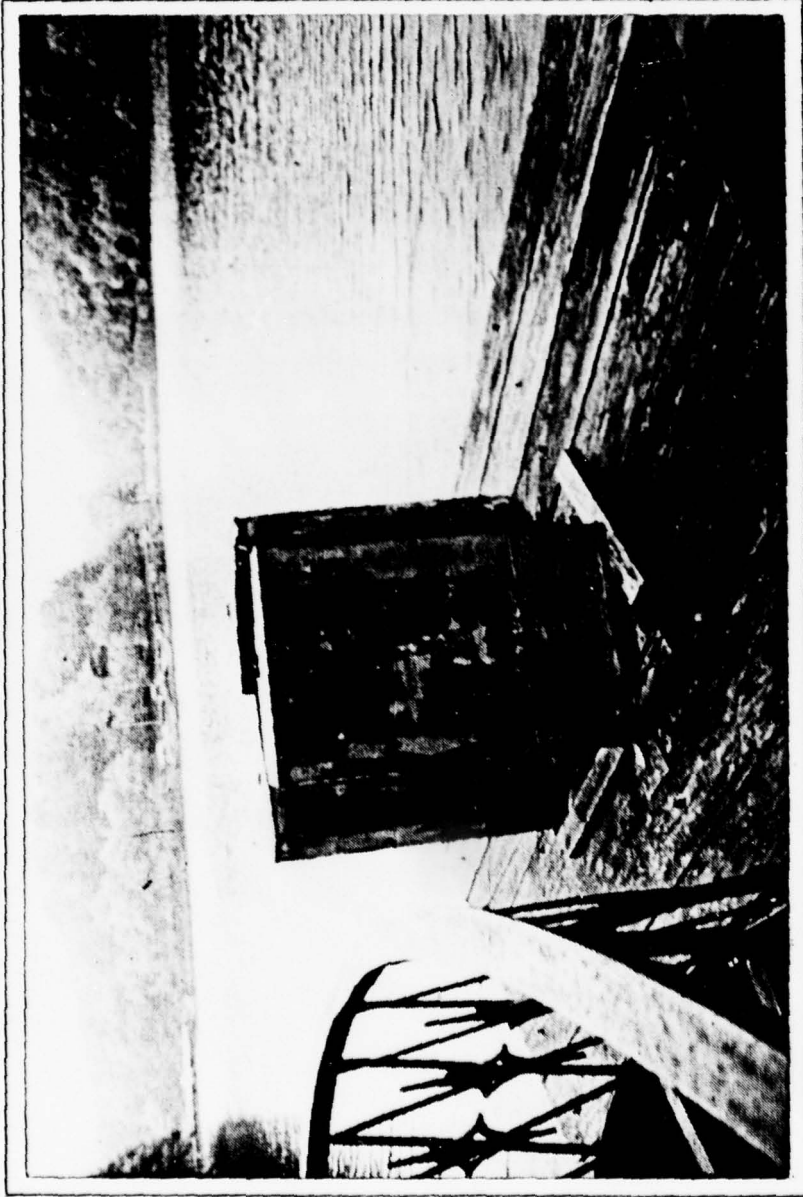
PHOTOGRAPH NO. 3

VIEW OF THREE GATE VALVES INSTALLED  
ABOUT 1914. THEIR PURPOSE IS  
UNKNOWN.

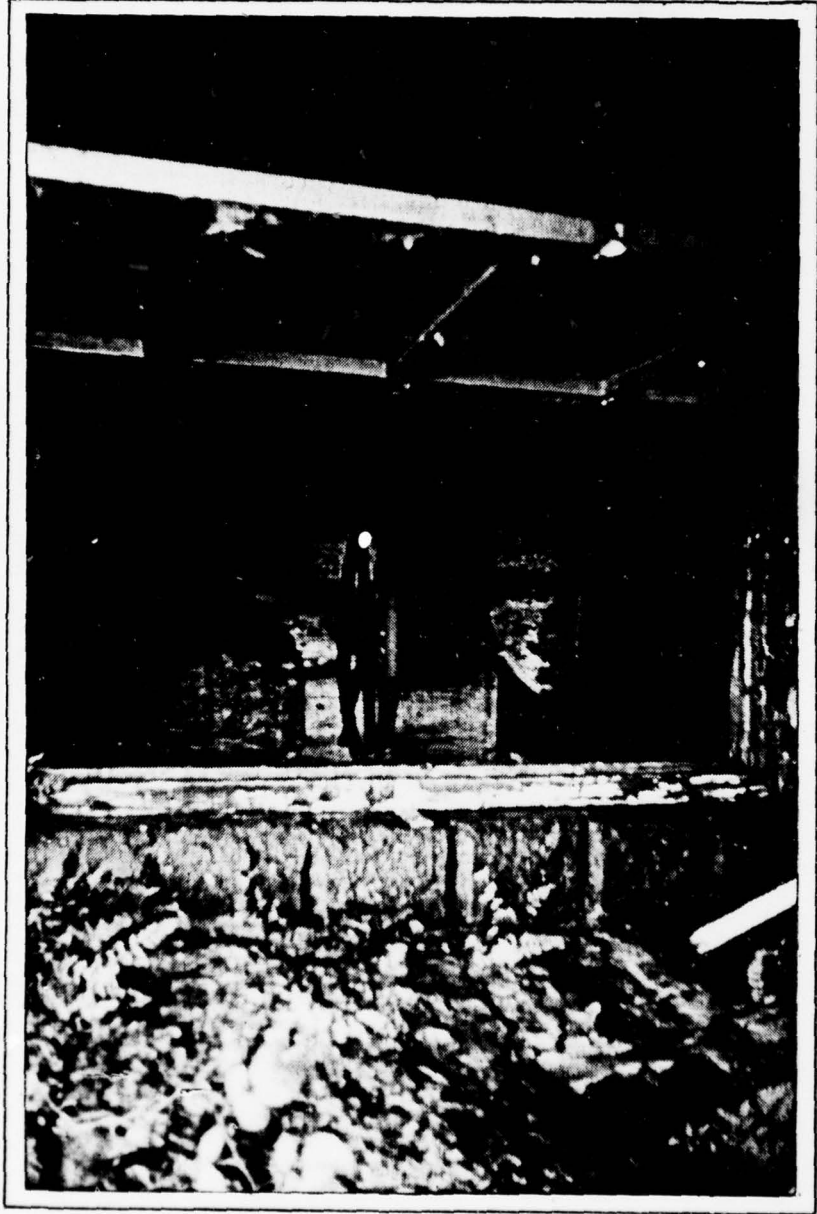
The pond drain valve was inspected and assessed to be in poor condition. The base of the valve house is flooded with water to the doorsill, covering about one half of the pipe. In the winter, this water could freeze, rendering the system inoperable. The gear mechanisms are rusted and the system does not appear to be very well maintained.

VIEW OF GATE HOUSE AND POND DRAIN  
VALVE.

2. The valve should be cleaned, lubricated and restored to an operable condition so that it functions properly in the event of an emergency.
3. The spillway stability should be reassessed by a registered professional engineer and rehabilitated in accordance with the engineer's recommendations. This rehabilitation would include restoration of the channel walls and realignment of the spillway crest and possibly anchorage of the spillway capstone.

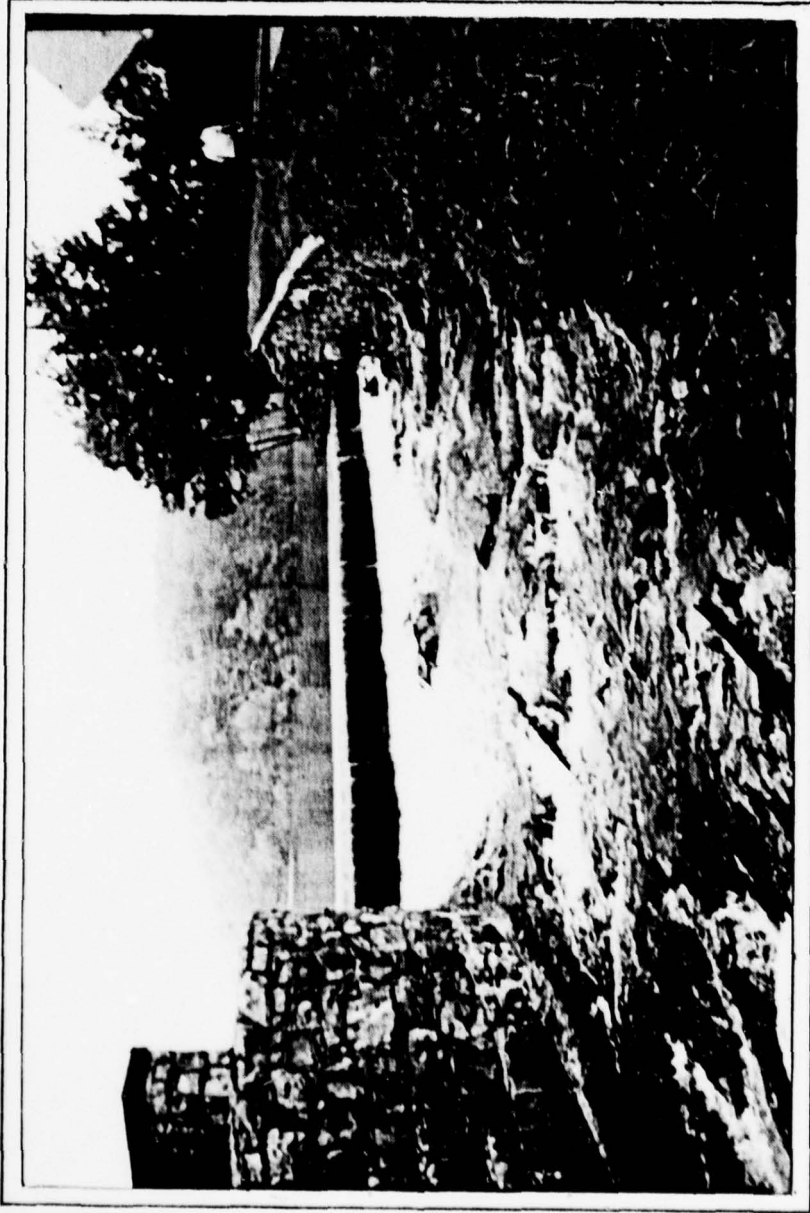
PHOTOGRAPH NO. 5

The spillway consists of a rubble masonry wall topped with a granite capstone. Its total height is approximately 5 feet and the length is 66 feet. The upstream portion of the spillway contains a concrete apron. The downstream channel is cut into natural rock. The channel makes a 65° deflection to the south around the dam and necks down to 30 feet between the dam and the existing highway at the end of the spillway. The alignment of the spillway cap appears to bow downstream slightly. The vertical profile, however, looks very good. An open joint was observed between the cap and the upstream concrete apron. A detailed inspection of the spillway indicated that the base joint below the cap in the main masonry wall is fractured and deteriorated. At a few local spots the joint was open to a depth of approximately 4 inches. Also, the front edge of the cap protrudes beyond the face of the masonry wall. The supporting wall appears to be in good condition. It is judged that the cap was probably displaced due to high flows or possibly ice forces against the cap.

The emergency spillway was assessed to be in fair condition. Deterioration was noted along the rock joints and the mortared riprapped walls. Distortion of the spillway crest cap was also observed. It is assessed that this cap distortion is probably associated with ice forces or high flows over the spillway. Some minor distortions were observed along the rubble walls which are not judged to be signs of imminent instability. These walls should be reassessed and repaired as necessary, together with the spillway cap.

VIEW OF SPILLWAY LOOKING UPSTREAM.

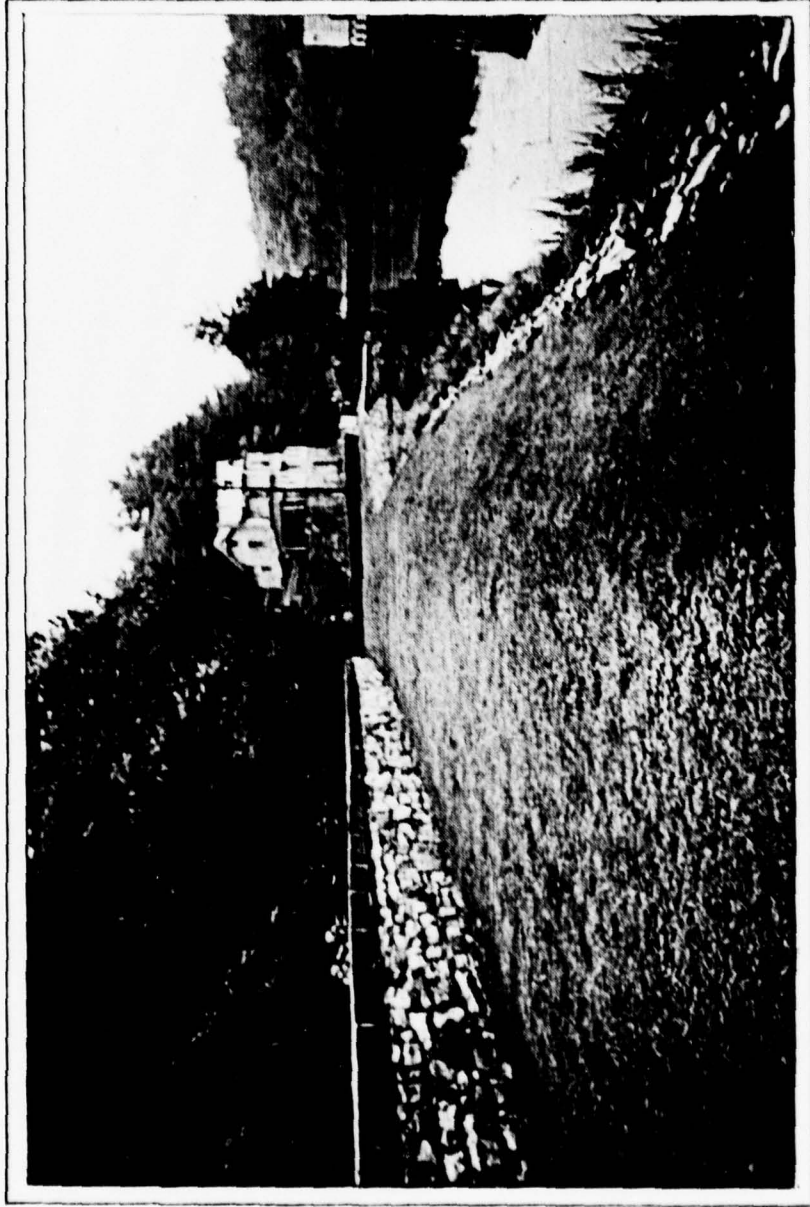
OVERVIEW OF DAM LOOKING FROM SPILLWAY  
TOWARDS RIGHT ABUTMENT.

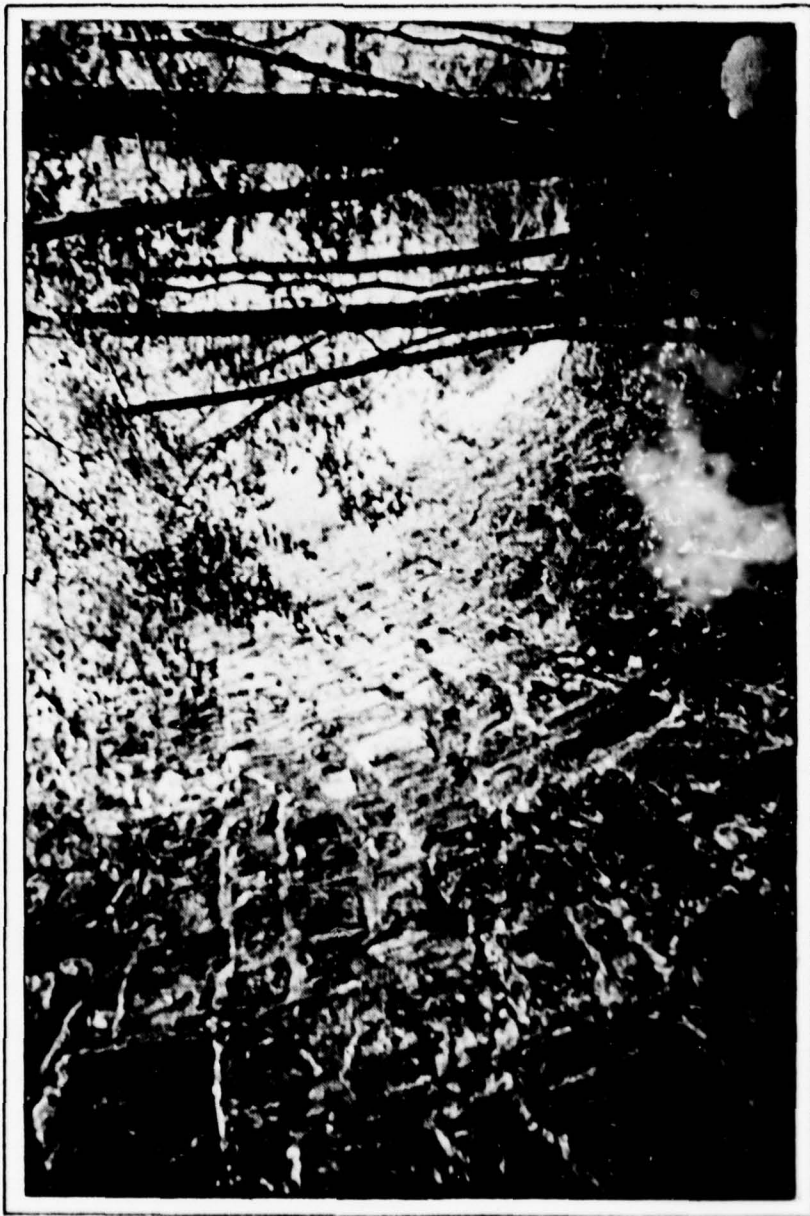
b. Dam. The horizontal and vertical alignment of the dam appears to be good. There is no evidence of displacement or settlement. The downstream face showed considerable deterioration of the masonry joints. In several locations the joints were open to a depth of approximately 12 inches. Due to the steepness of the downstream face, only the joints between the masonry blocks could be inspected. The downstream face was wet from a point approximately 15 to 20 feet below the top of the parapet wall, and small seeps were visible running through many of the joints. All seeps appeared to be clear.

VIEW OF DOWNSTREAM SLOPE OF DAM.

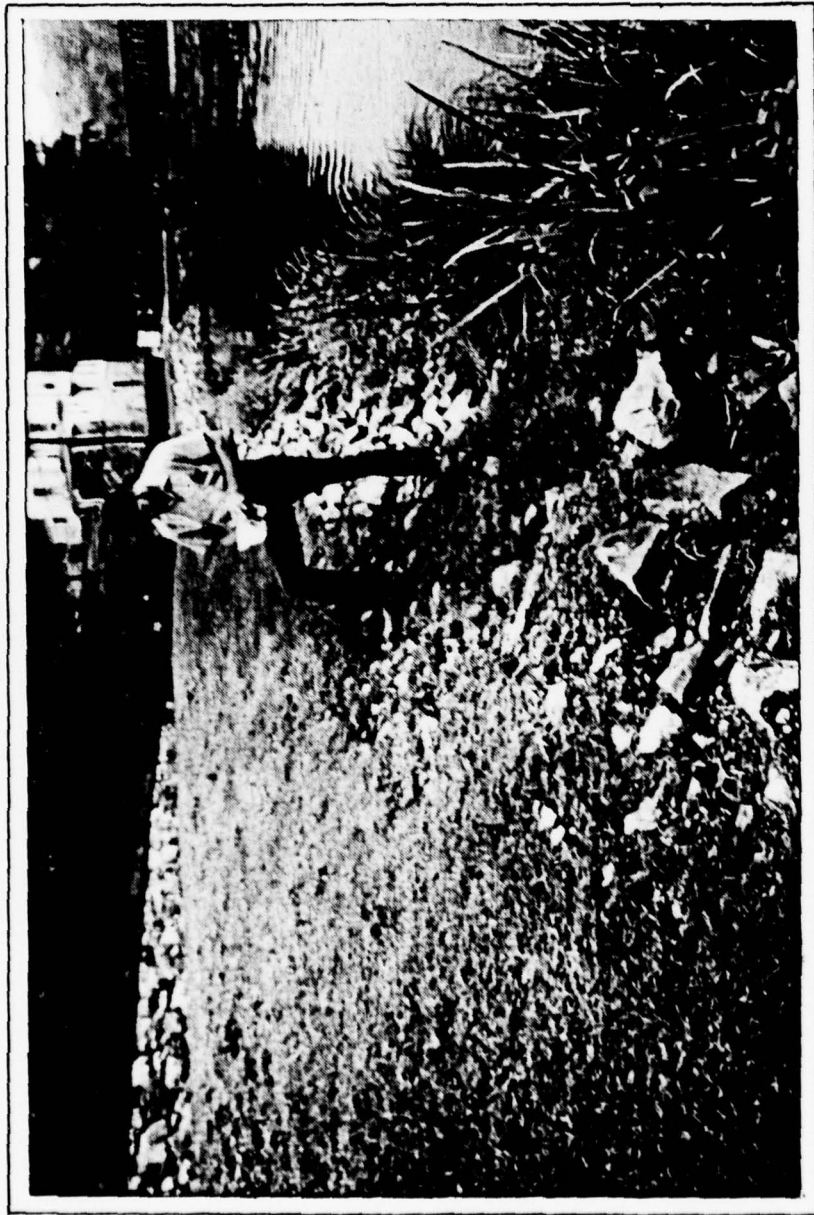
PHOTOGRAPH NO. 13

SMALL SCARP NOTED IN UPSTREAM  
SLOPE, THE SAME SCARP WAS NOTED  
IN A PHOTOGRAPH TAKEN IN 1970.

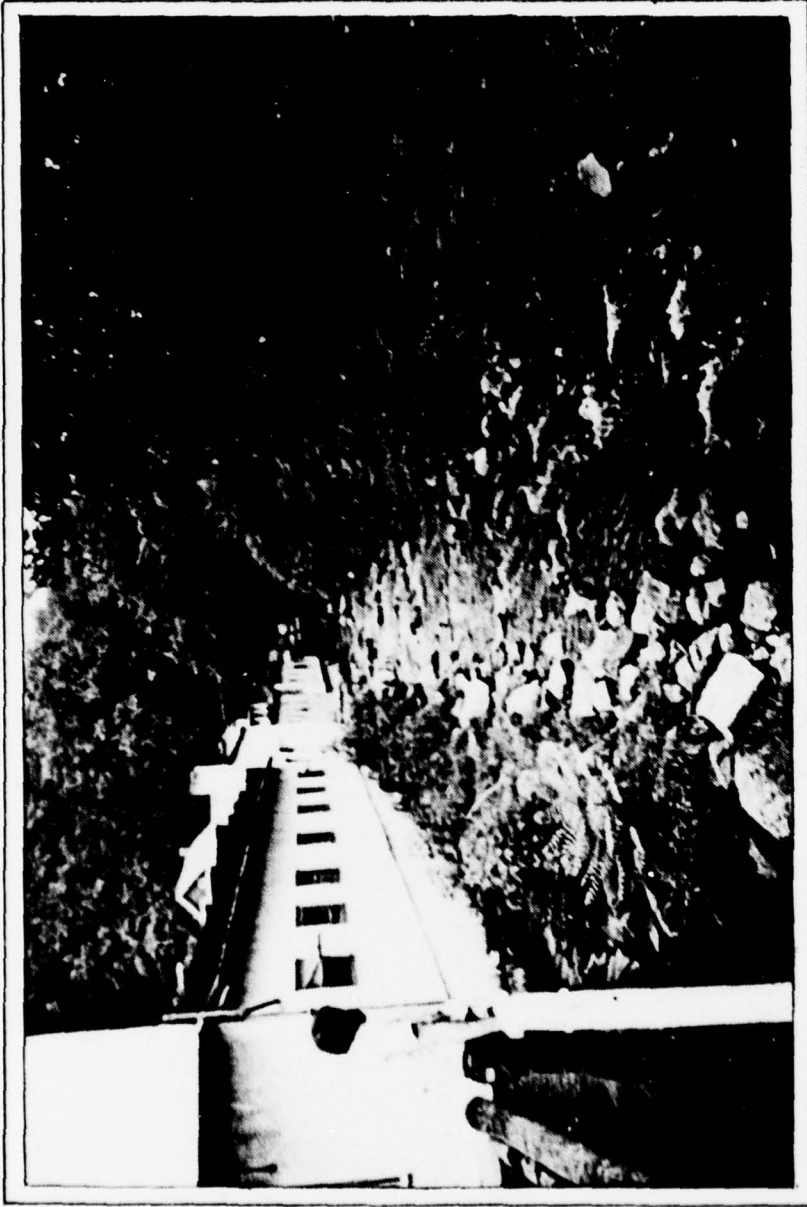
PHOTOGRAPH NO. 16

VIEW LOOKING UPSTREAM AS CREEK  
ENTERS THE TOWN OF STONY CREEK  
MILLS.
