IRONWORKS DAM

PHASE I INSPECTION REPORT NATIONAL DAM INSPECTION PROGRAM

IRONWORKS DAM
BUCKS COUNTY, PENNSYLVANIA
NATIONAL I.D. NO. PA 00789

PHASE I INSPECTION REPORT
NATIONAL DAM INSPECTION PROGRAM
IRONWORKS DAM
NATIONAL ID #PA 00789
DER NO. 9-137

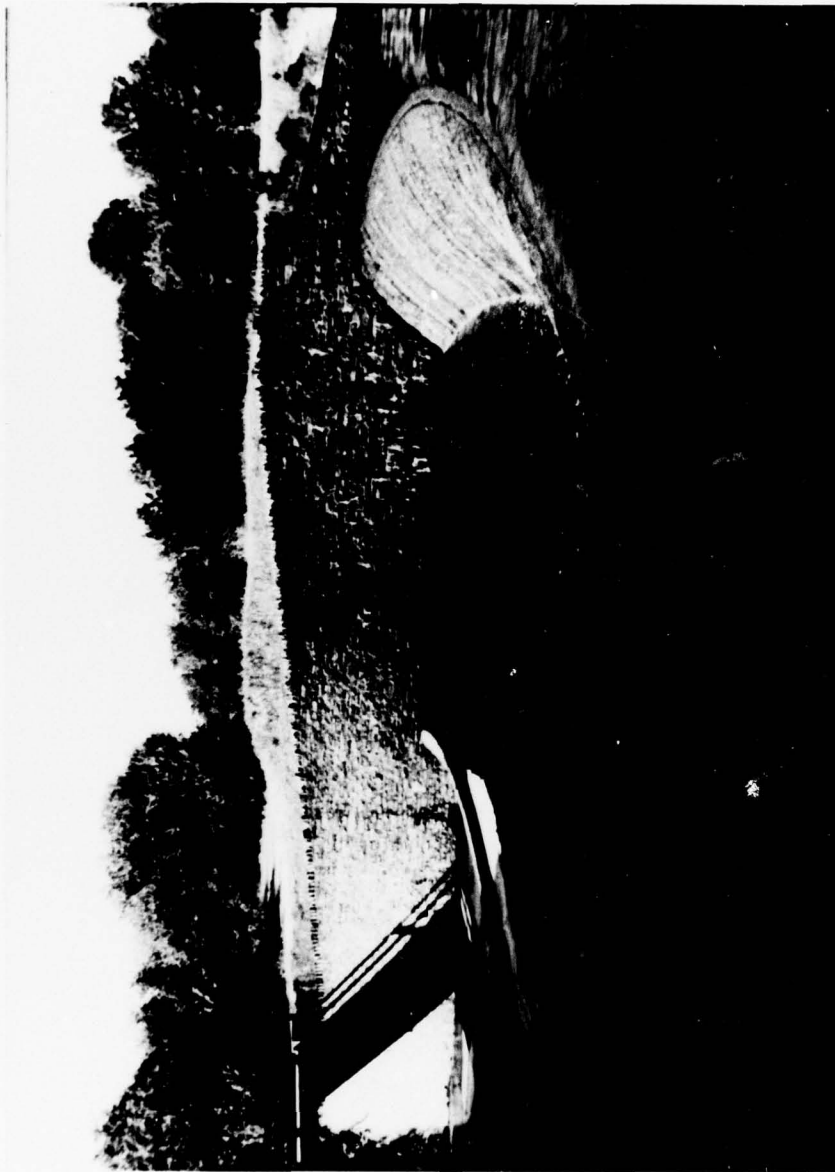
PHOTO NO. 2

LOOKING DOWNSTREAM OVER PRINCIPAL SPILLWAY FROM RIGHT
ABUTMENT (W/S) OF DAM. NOTE BRIDGE ON LEFT SIDE OF
PHOTO.

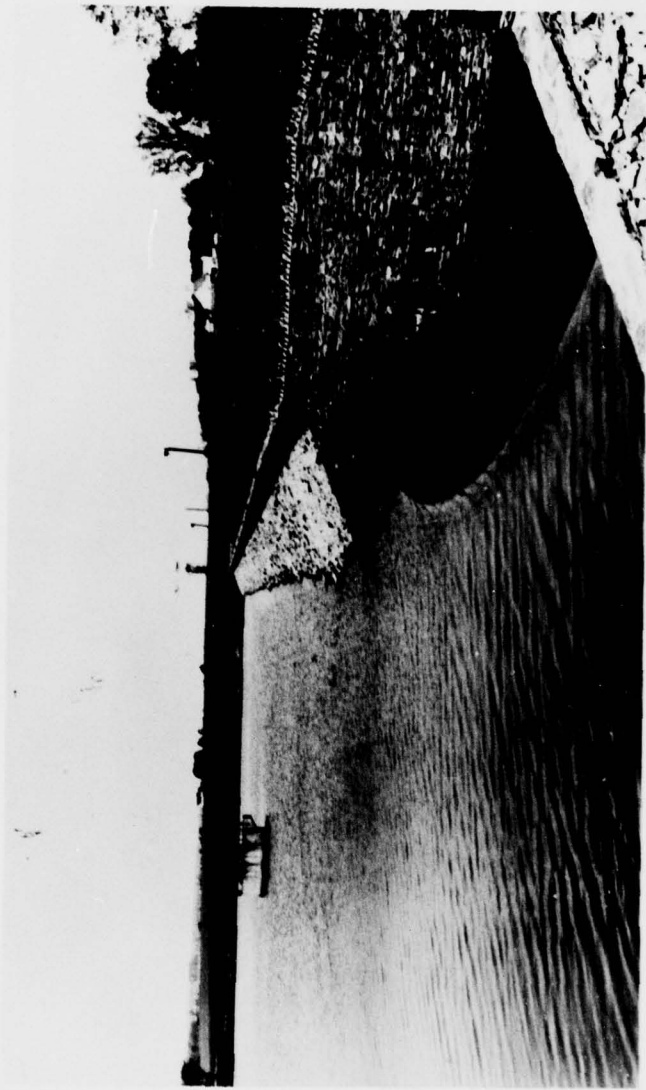
PHOTOGRAPH SHOWS THE FINISHED RIPRAP SLOPE WHICH TERMINATES AT THE BASE OF THE PARAPET WALL. COMPARE THE FINISHED SLOPE SHOWN HERE WITH PHOTOGRAPH NO. 7 WHICH SHOWS THE SETTLEMENT OBSERVED DURING THE INSPECTION.

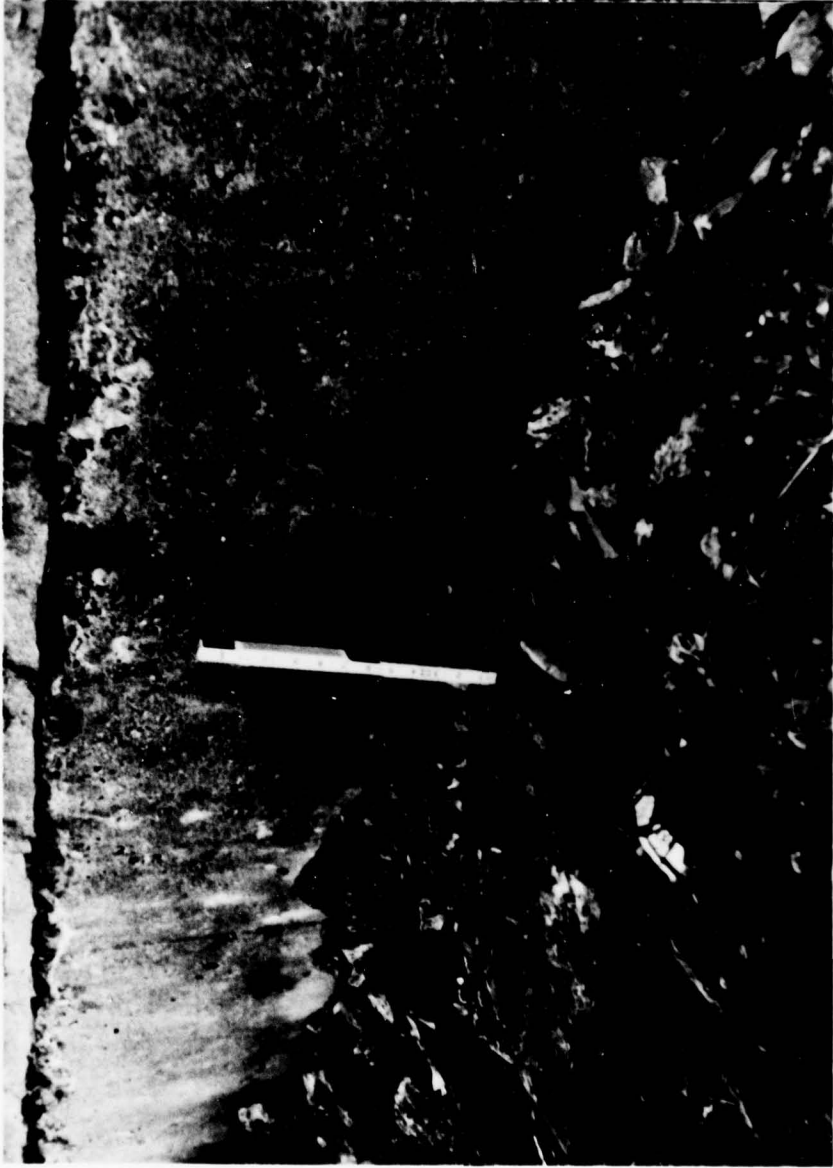
PHOTO NO. 9

CLOSE-UP VIEW OF SETTLEMENT ON THE UPSTREAM SIDE OF THE
CONCRETE CUTOFF WALL. APPROXIMATELY 18 INCHES OF SETTLE-
MENT WAS NOTED HERE.
