LEVEL II
DELAWARE RIVER BASIN
HAYNES CREEK TRIBUTARY
BURLINGTON COUNTY
NEW JERSEY

MISHE - MOKWA DAM

NJ 00419

PHASE 1 INSPECTION REPORT NATIONAL DAM SAFETY PROGRAM

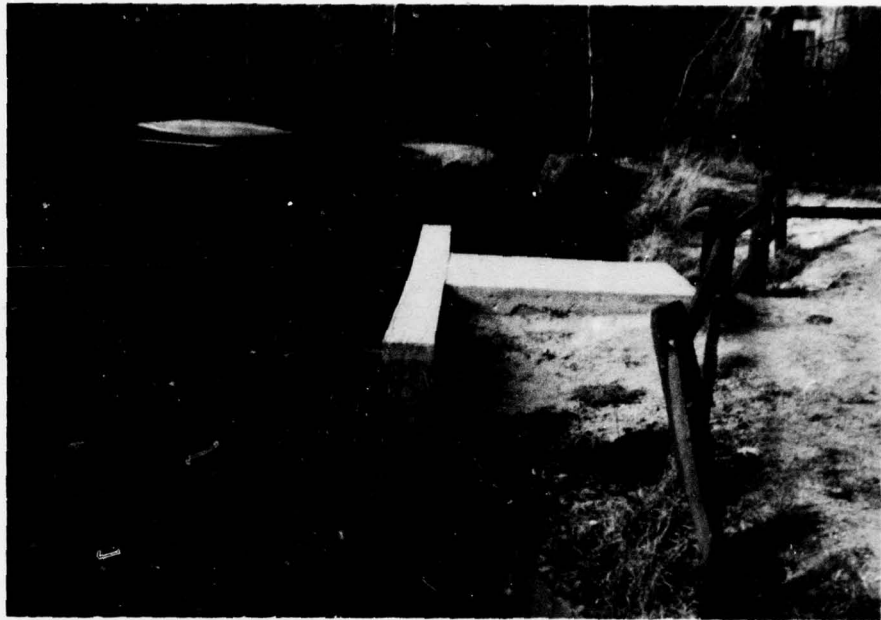
PHOTO 1
SPILLWAY

The crest of the spillway appeared uniformly aligned although a major part of it was submerged by overflow at the time of inspection. Water was flowing over the concrete weir section of the spillway and, therefore, the condition of much of the structure was not clearly observed. In general, the concrete as well as the steel grate and timber stoplogs appeared to be in good condition.

The spillway appears to be in good condition. However, in the near future, it should be thoroughly inspected and renovated by sand blasting, grouting where needed and coating with epoxy.

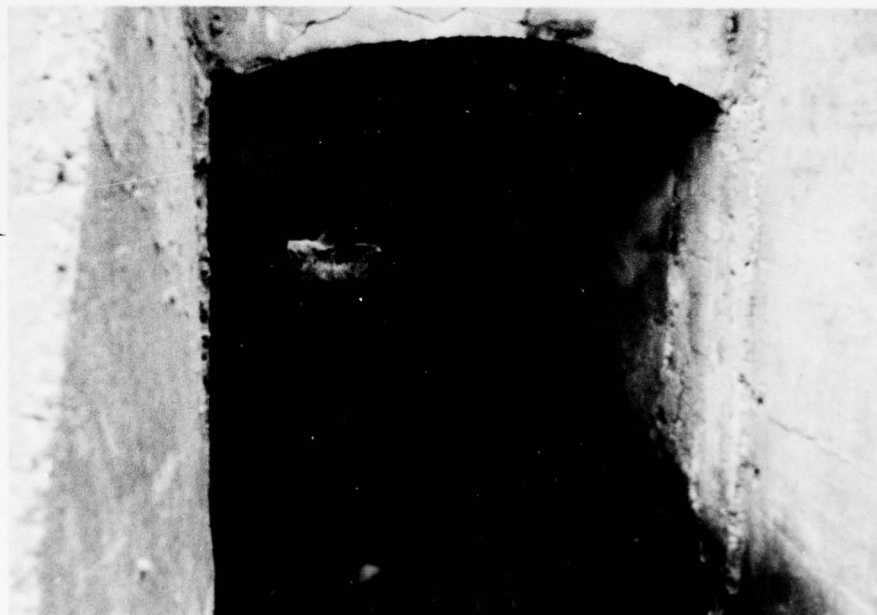
PHOTO 4

SPILLWAY DISCHARGE CULVERT.

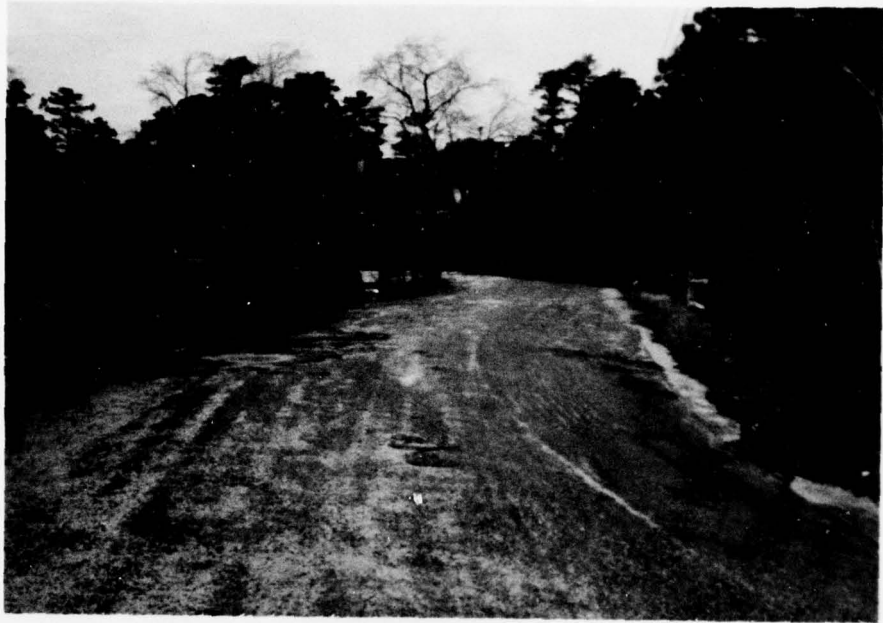
The dam embankment crest appeared to be level, with a slightly curved horizontal alignment. A paved road lies on the crest and was found to be in good condition.

PHOTO 9
ROAD ON CREST OF DAM.

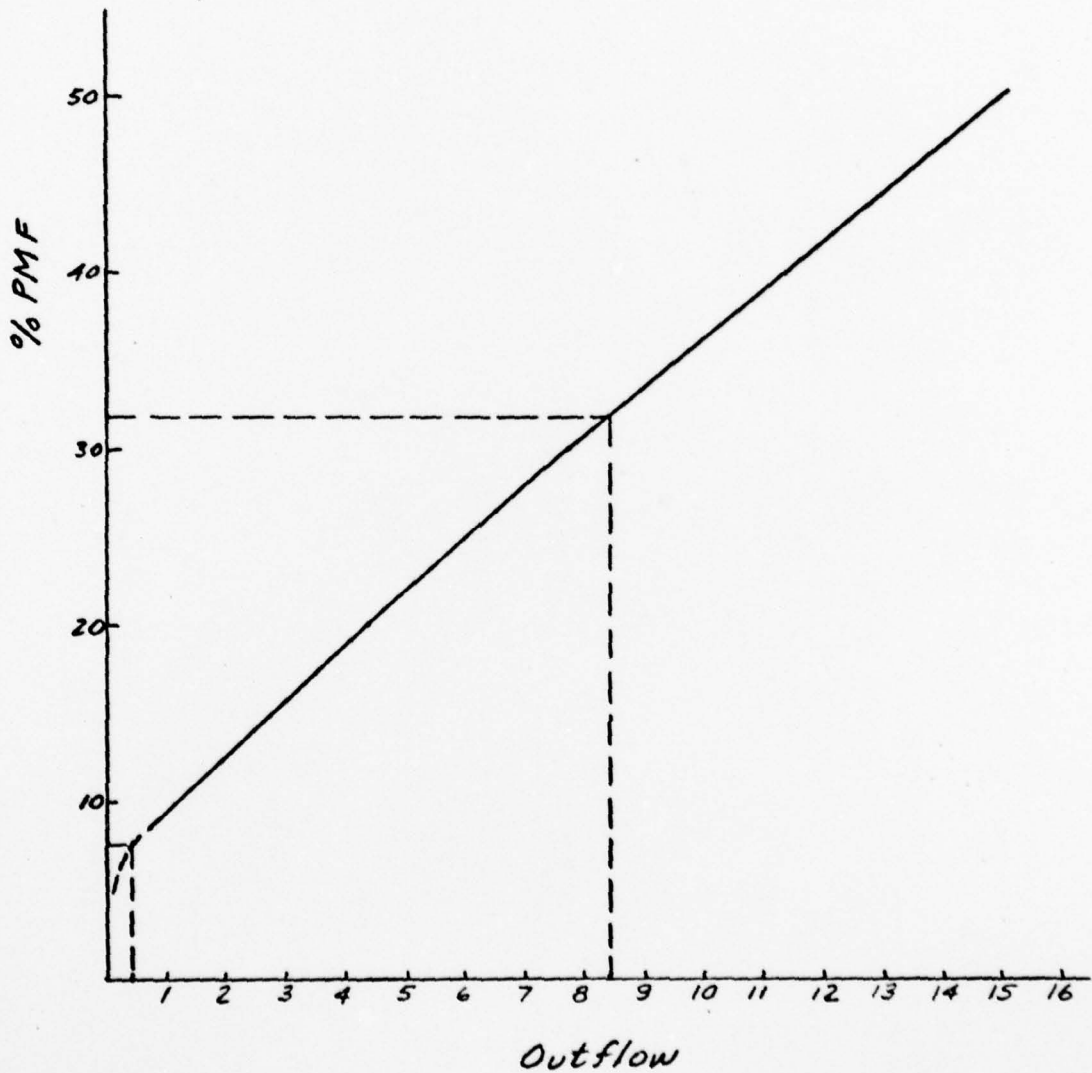
OVERTOPPING POTENTIAL

Overtopping of low area occurs at elev. 71.2
with $Q = 42$ cfs. ($\sim 8\%$ PMF)
Overtopping of dam occurs at elev. 72.4 with
 $Q = 844$ cfs. ($\sim 32\%$ PMF)
