# ORANGE RESERVOIR DAM

## NJ 00361

### PHASE 1 INSPECTION REPORT NATIONAL DAM SAFETY PROGRAM

79 05 14 1979  
February, 1979

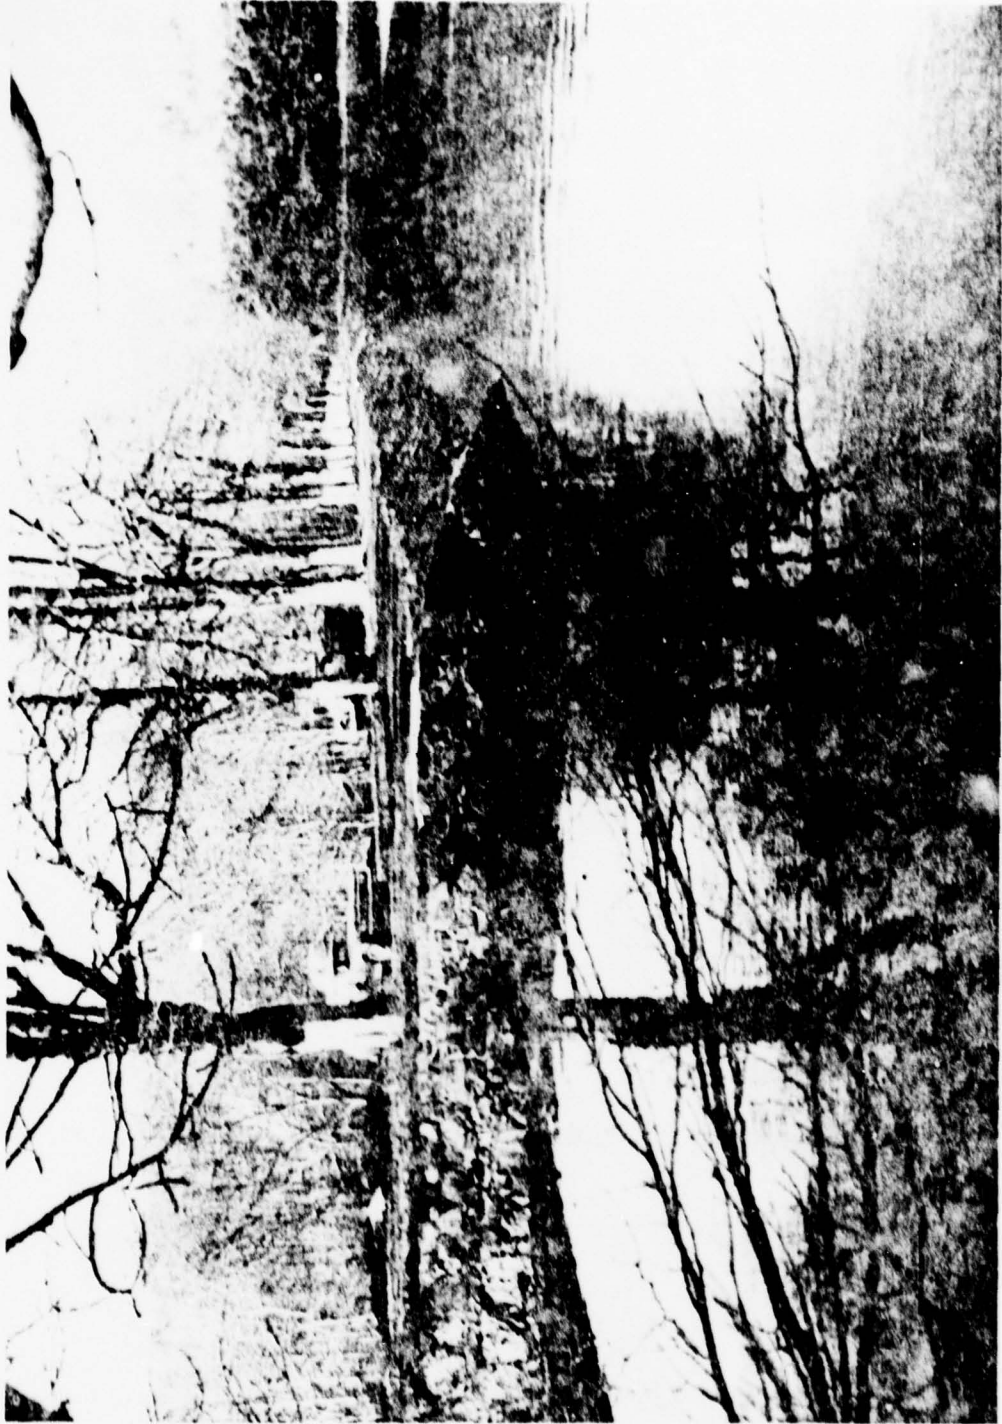
View of dam from left abutment with spillway in foreground. (Dec. 2, 1978)

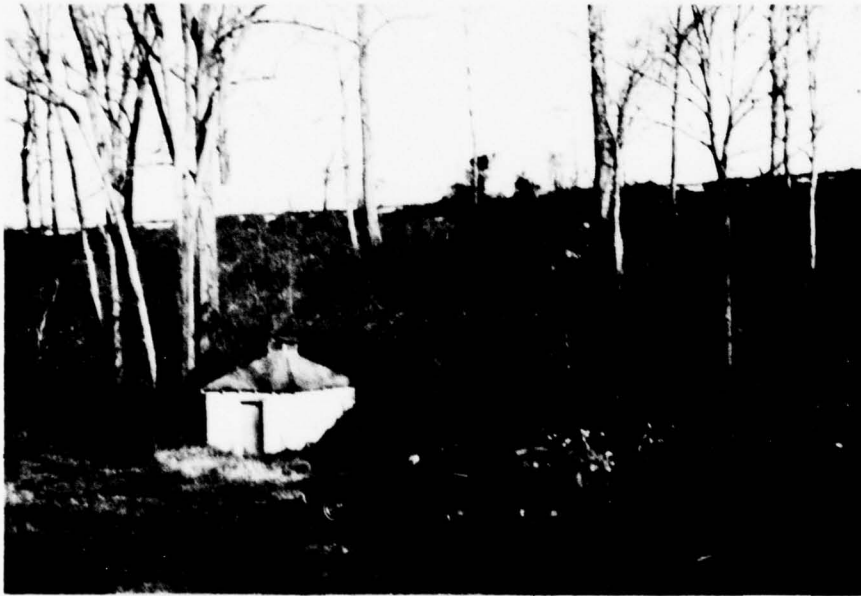
Photo 1 - View showing central section of the downstream face of dam.

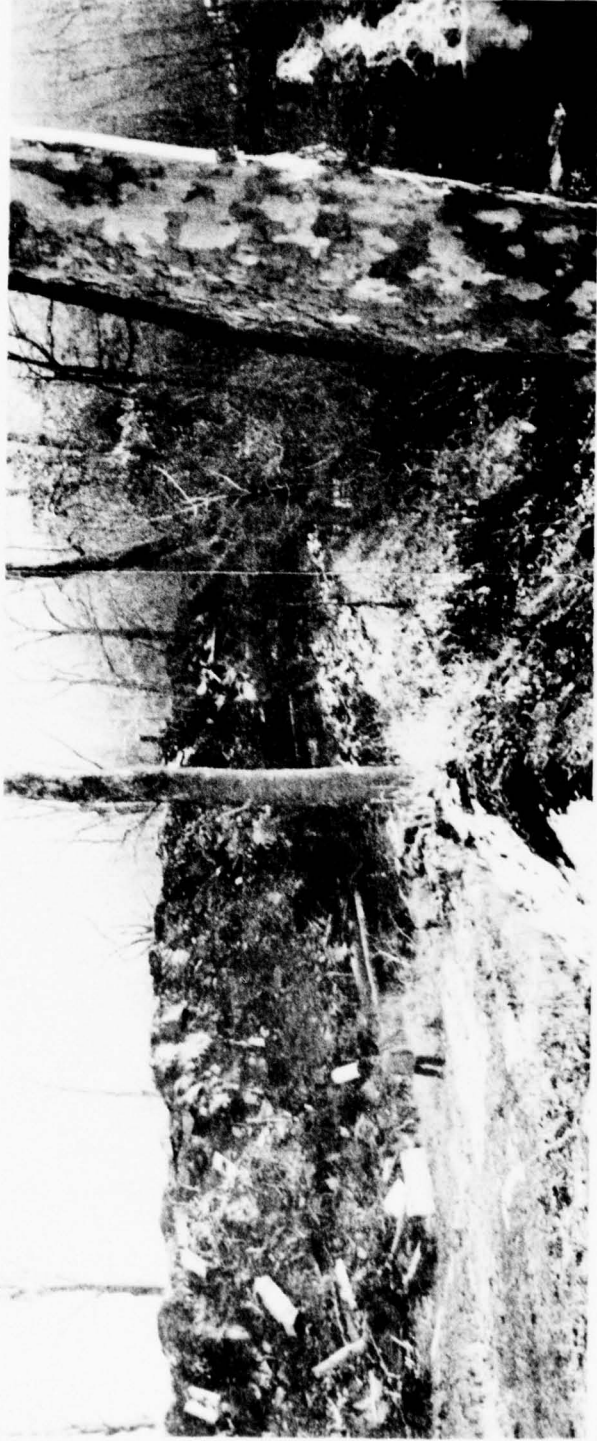
Photo 2 - View looking towards the downstream left abutment of dam showing mixed fill, spillway diversion dike and spillway channel.

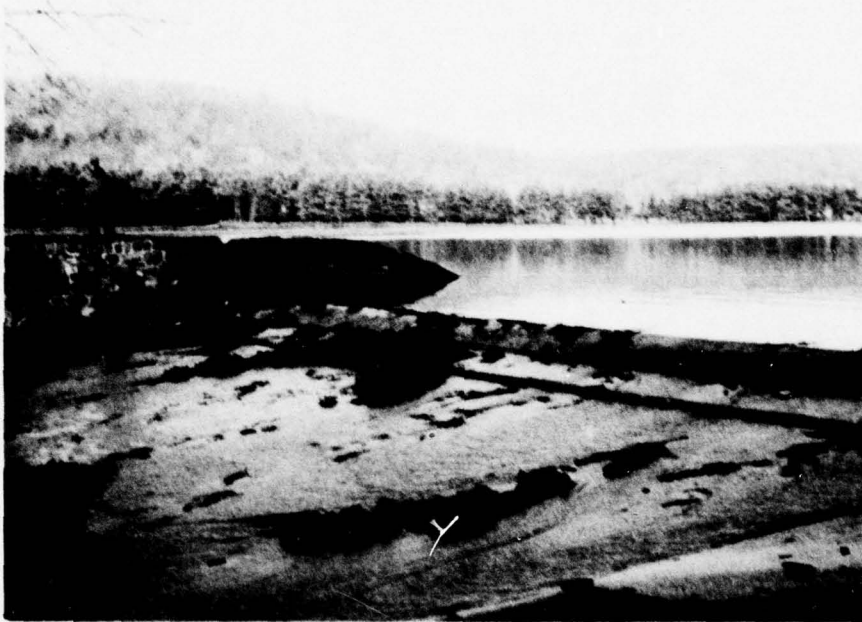
Photo 3 - View of spillway and right wing wall looking northwest.

(3) Stones dislodged from the upstream end of the right spillway wing wall should be replaced.

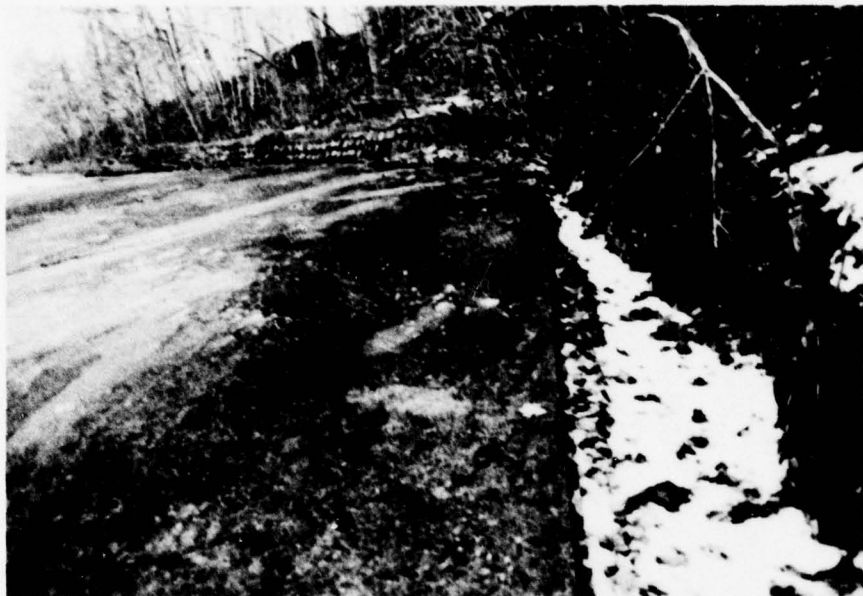
holes are present in the spillway wing walls, but no flow was observed. Minor erosion of the left abutment has occurred adjacent to the concrete apron, downstream of the wing wall (Photo 5).

Photo 5 - View of left abutment from downstream spillway apron.

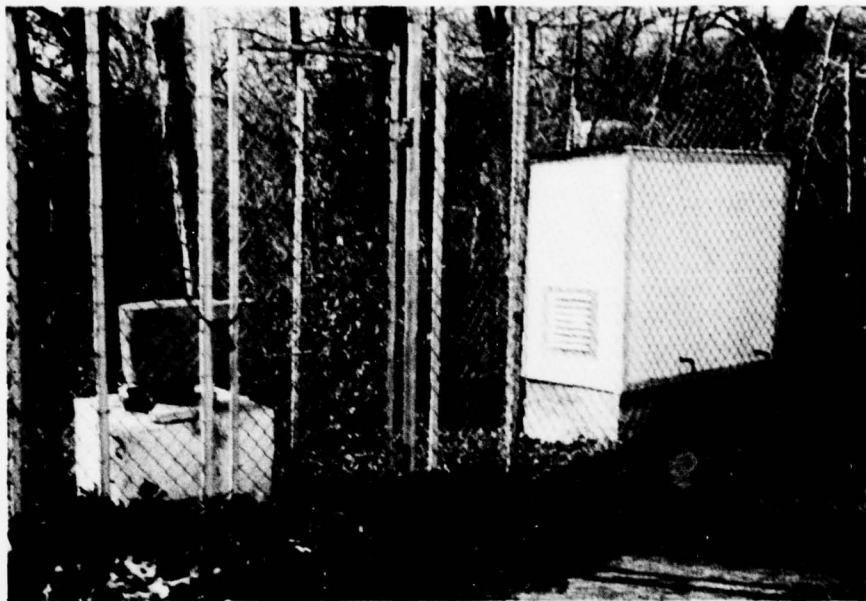
Photo 7 - View showing tunnel vent (left) and aerator compressor (right) at crest of dam.

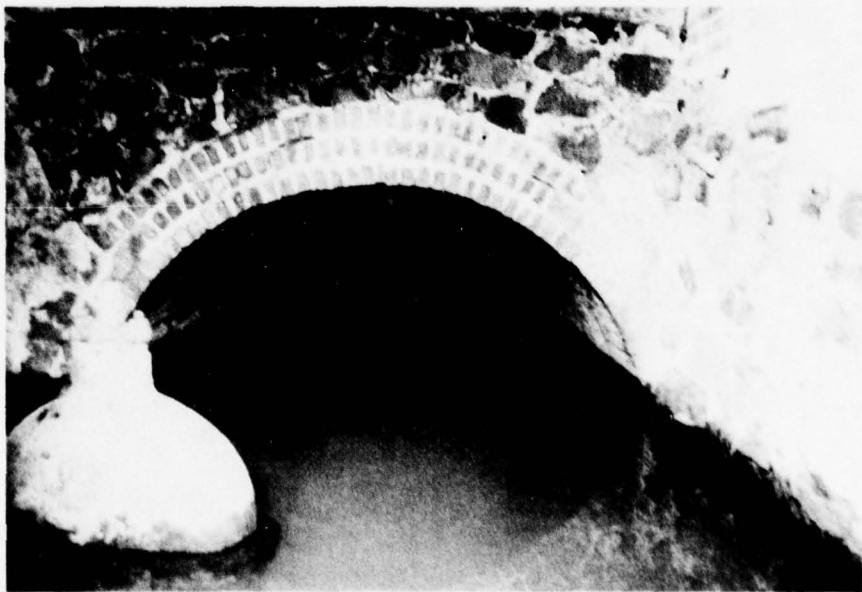
The two outlet pipes were observed inside a 9-foot diameter brick and masonry tunnel, along with associated gate valves (Photo 8). These pipes are submerged in water about 2 feet deep. Water dripping slowly in the tunnel was heard during the inspection; however, the visible section of the tunnel appears to be in good condition. An air vent for the tunnel exits at the crest of the dam (Photo 7).

Photo 8 - View of outlet pipes (submerged).

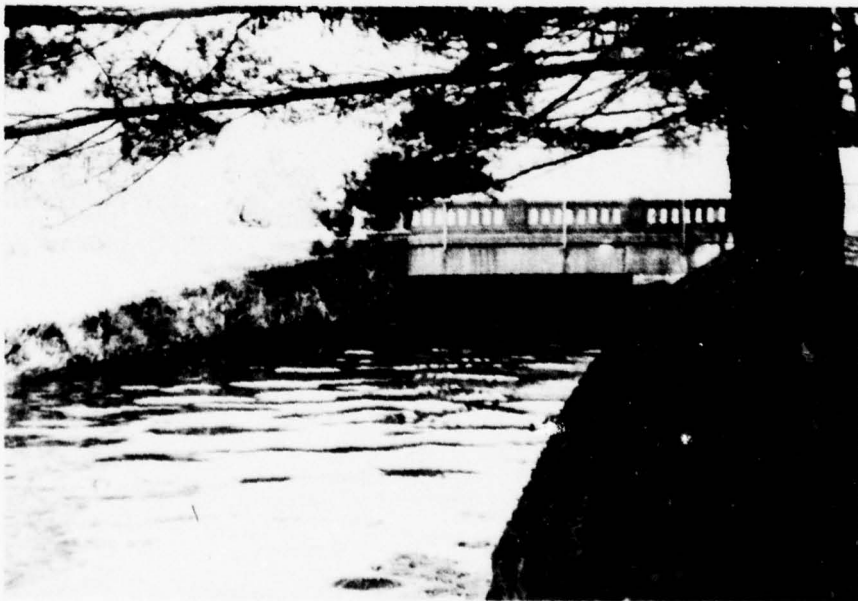
Photo 10 - View of Northfield Road bridge looking upstream.

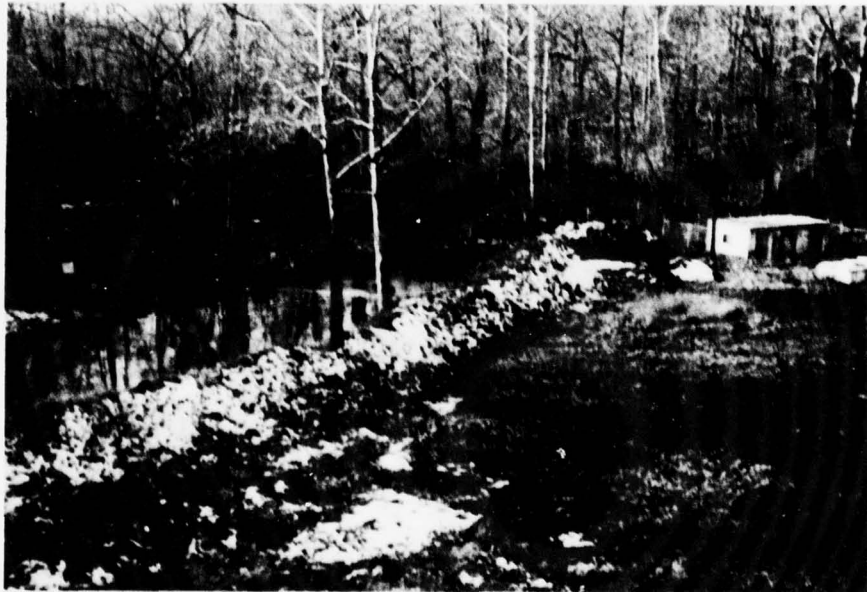
to three feet deep with a levee on the right bank about seven feet high. No dwellings were observed immediately downstream. The flood plane below the dam contains a fairly dense stand of medium and small trees with significant undergrowth (Photo 11).

Photo 11 - View looking downstream from left (east)  
side of dam.
