NATIONAL DAM INSPECTION REPORT. KAERCHER CREEK DAM (PA-00722), --ETC(U)

KAERCHER CREEK DAM  
BERKS COUNTY, PENNSYLVANIA  
NATIONAL I.D. NO. PA 00722

PHASE I INSPECTION REPORT  
NATIONAL DAM INSPECTION PROGRAM

Name of Dam: Kaercher Creek Dam  
County Located: Berks County  
State Located: Pennsylvania  
Stream: Kaercher Creek  
Coordinates: Latitude 40° 33.4' Longitude 75° 58.2'  
Date of Inspection: 18 July 1978

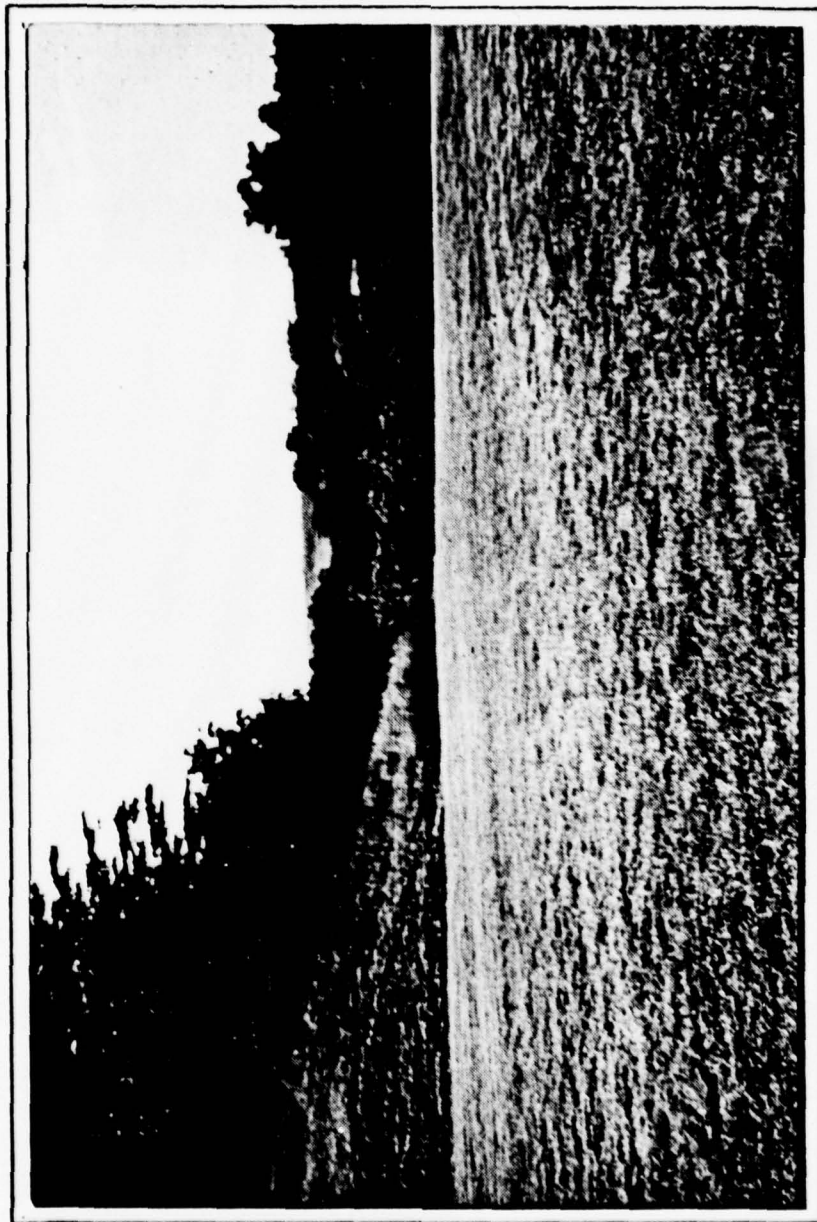
VIEW LOOKING TOWARDS DISCHARGE AREA  
OF EMERGENCY SPILLWAY. THE STREAM CHAN-  
NEL IS IN THE TREE LINED VALLEY.

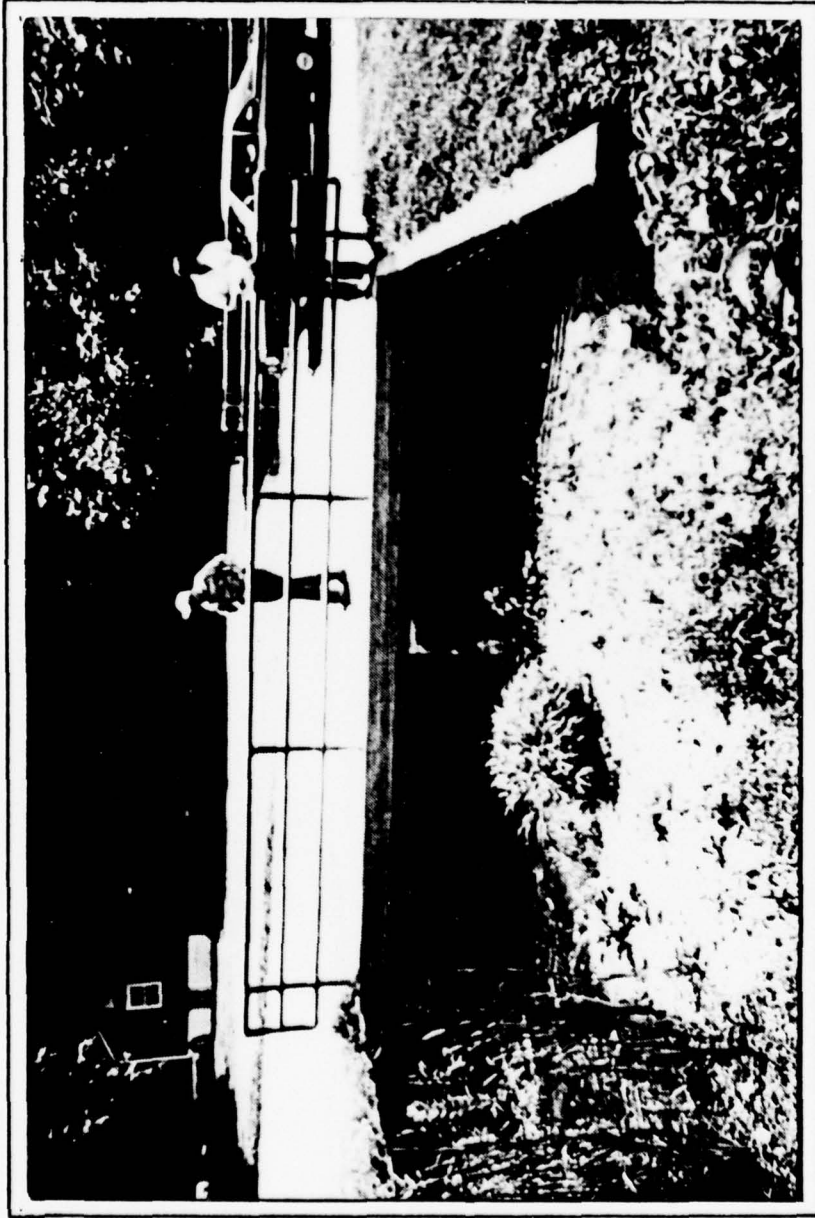
FIRST BRIDGE DOWNSTREAM OF THE DAM.  
HOMES ARE ON THE LEFT AND RIGHT.

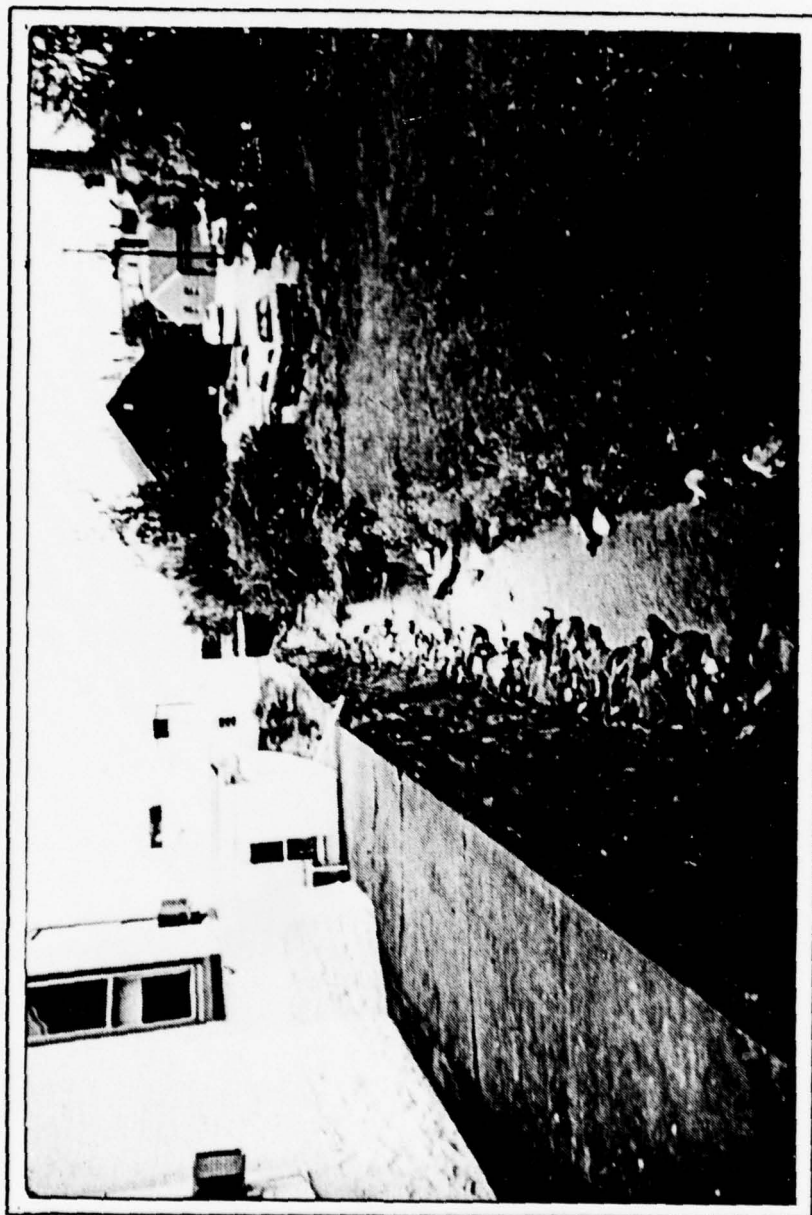
KAERCHER CREEK STREAM CHANNEL THROUGH  
THE TOWN OF HAMBURG, PENNSYLVANIA.
