GAI CONSULTANTS INC MONROEVILLE PA
NATIONAL DAM INSPECTION PROGRAM. HUTCHINSON RESERVOIR DAM NUMBE--ETC(U)
JAN 79

National Dam Inspection Program.
Hutchinson Reservoir Dam Number 1
(NDI-PA-214), Ohio River Basin, Redstone
Creek, Fayette County, Pennsylvania.
Phase I Inspection Report.

The visual inspection, operational history and hydrologic/hydraulic analysis indicate the facility is in poor condition. Apparent rotation of the outlet riser structure, unevenness of the upstream face and a sinkhole in the crest suggest possible internal piping problems which are possibly active under normal or high pool conditions. Records of past performance show numerous problems related to seepage both under and through the embankment during its 91 year life span.

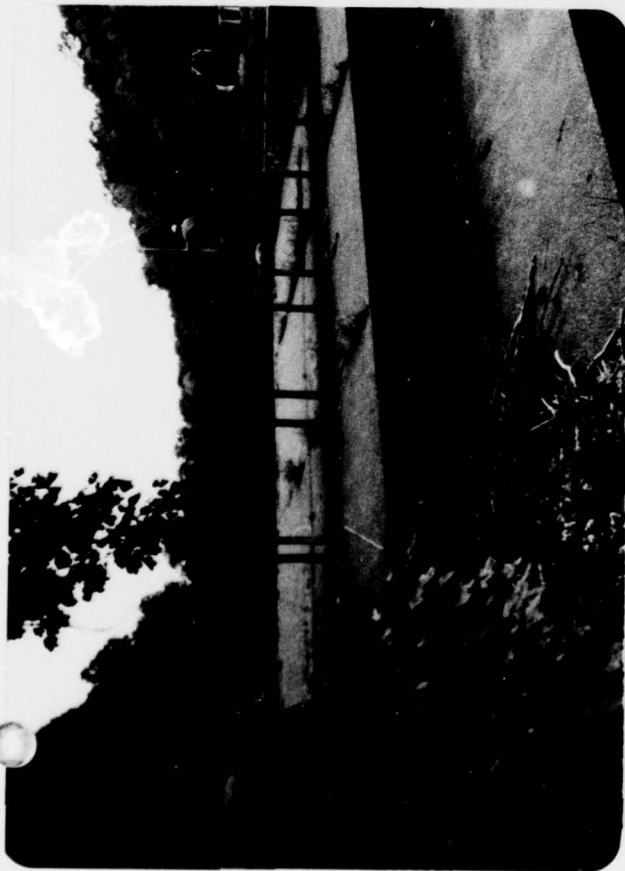
5

2. Spillway. Visual inspection found the spillway to be in fair condition. The flow surface (see Photograph 5) is good throughout, however, the sidewalls are deteriorated, exhibiting many cracks. The sandstone block retaining wall at the bottom left of the spillway channel is in good condition.

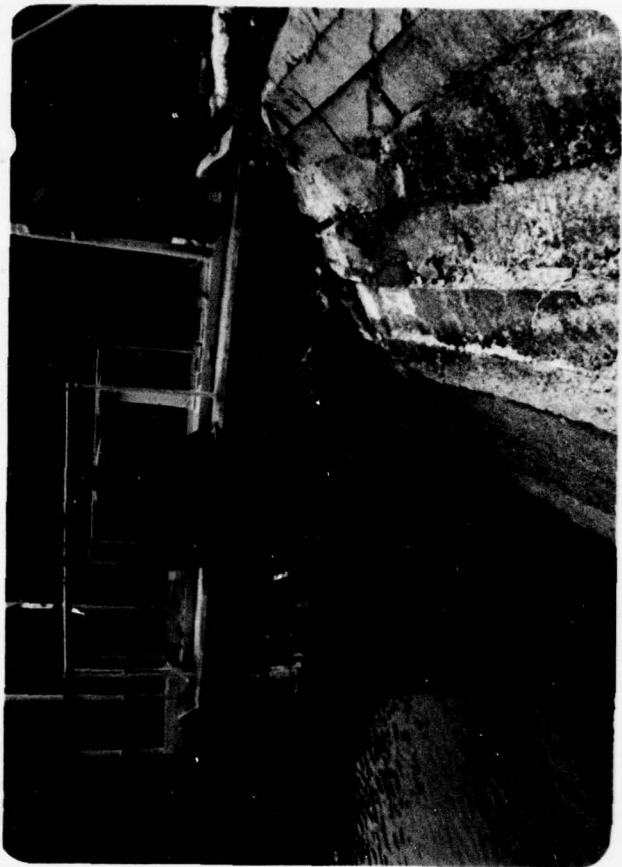
10

b. Embankment. The general appearance of the embankment suggests that it is in poor condition. Poor horizontal alignment, sinkholes on the crest and on the right abutment, visible movement of the upper portion of the vault and a history of chronic seepage problems raise doubts as to the structural integrity of the embankment. A sinkhole on the crest measuring three feet in depth suggests internal erosion of embankment materials (see Figure 1 and Photograph 4) and movement of the upper portion of the vault (Photograph 10) suggests differential movements within the embankment.

1. Outlet Structure and Conduits. As indicated in Photograph 10, the outlet structure has apparently rotated and cracked from differential movements in the upstream slope of the embankment. Valve stems and miscellaneous mechanical devices atop the structure are well

3. Perform a stability and seepage evaluation of the embankment under all possible operating conditions utilizing the results of Item 2 above.
4. Determine the extent of apparent structural distress in the outlet structure.

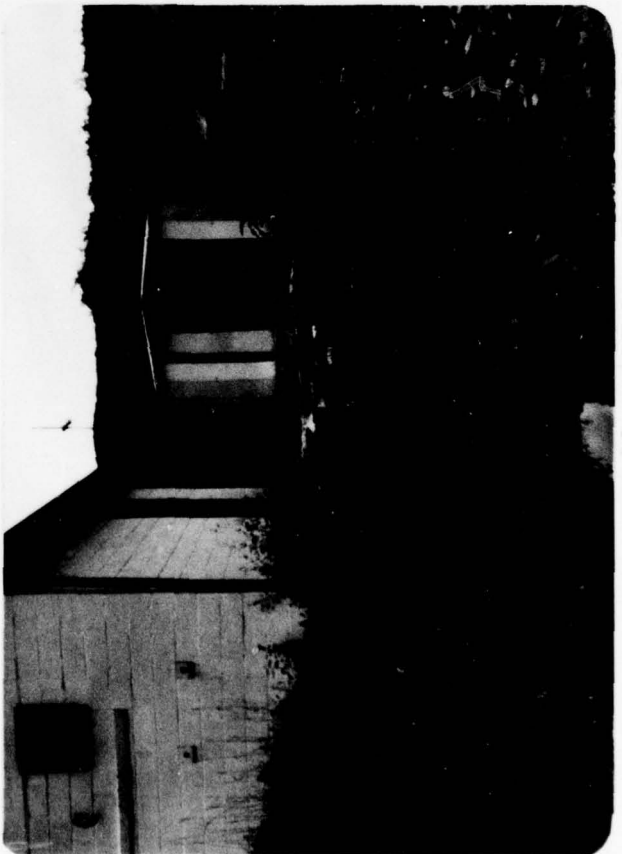
11

Considerable seepage and ponding was observed in the channel adjacent to the treatment building at the downstream toe of the embankment (see Photograph 11). This area of seepage has been observed for many years.

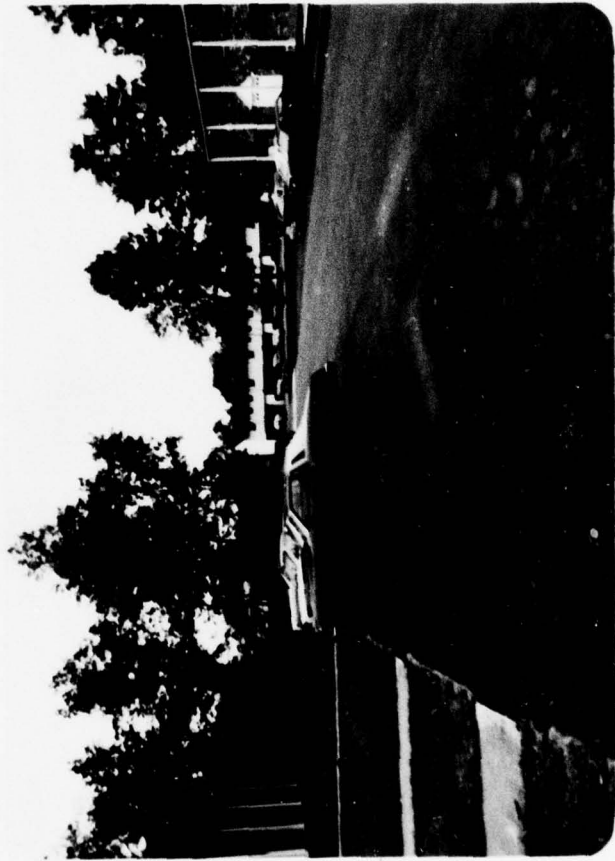
PHOTOGRAPH 13 View of some multiple family dwellings located adjacent to Redstone
Creek approximately one mile downstream of Dam No. 1.
