Thorn Run Dam, NDI Number PA-271.
Ohio River Basin, Thorn Creek, Butler County,
Pennsylvania. Phase I Inspection Report.

PHASE I REPORT
National Dam Inspection Program

Thorn Run Dam

31 August 1978 and 5 September 1978

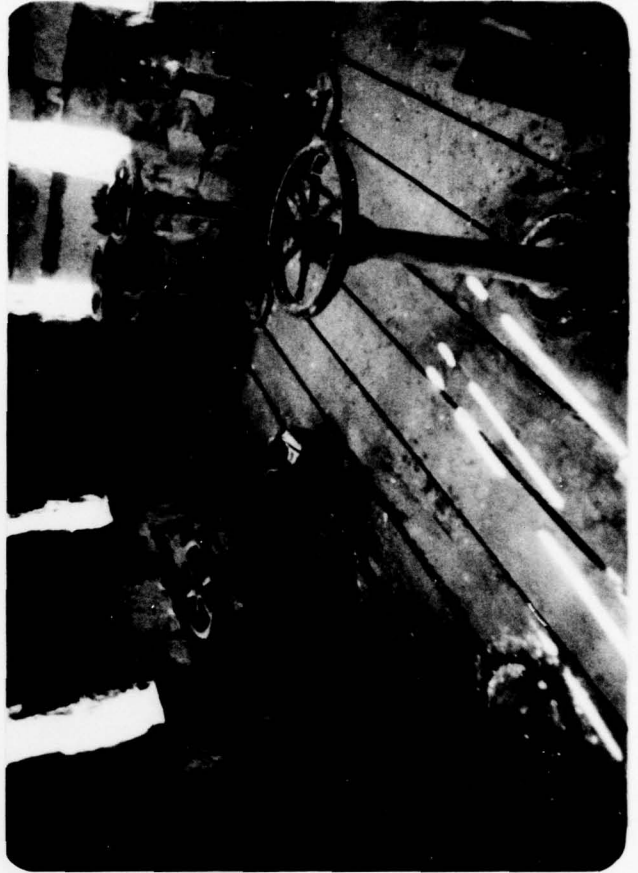
Within the interior of the gate house, six manual controls were observed. As indicated previously only three of the controls are currently utilized in the operation of the outlet system. The condition of the valves associated with the controls is not known. They are reportedly operated several times a year as needed (see Photograph 8).

PHOTOGRAPH 8 View of the interior of the gate house. The three floor stand valves in the background operate the intake gates. The three near valves operate supply and blowoff lines.

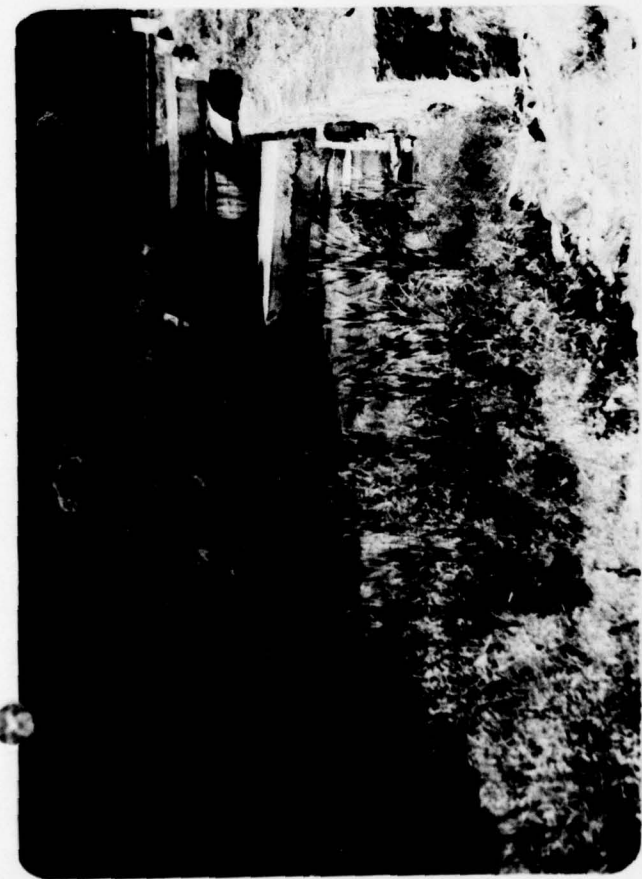
1. Spillway. The visual inspection revealed the spillway to be in poor condition. Severe concrete deterioration is visible throughout the structure. Large areas of spalling and scaling were observed along with extensive cracking. The alignment of the lower left wingwall was visibly off by several inches (see Photographs 9 and 10).

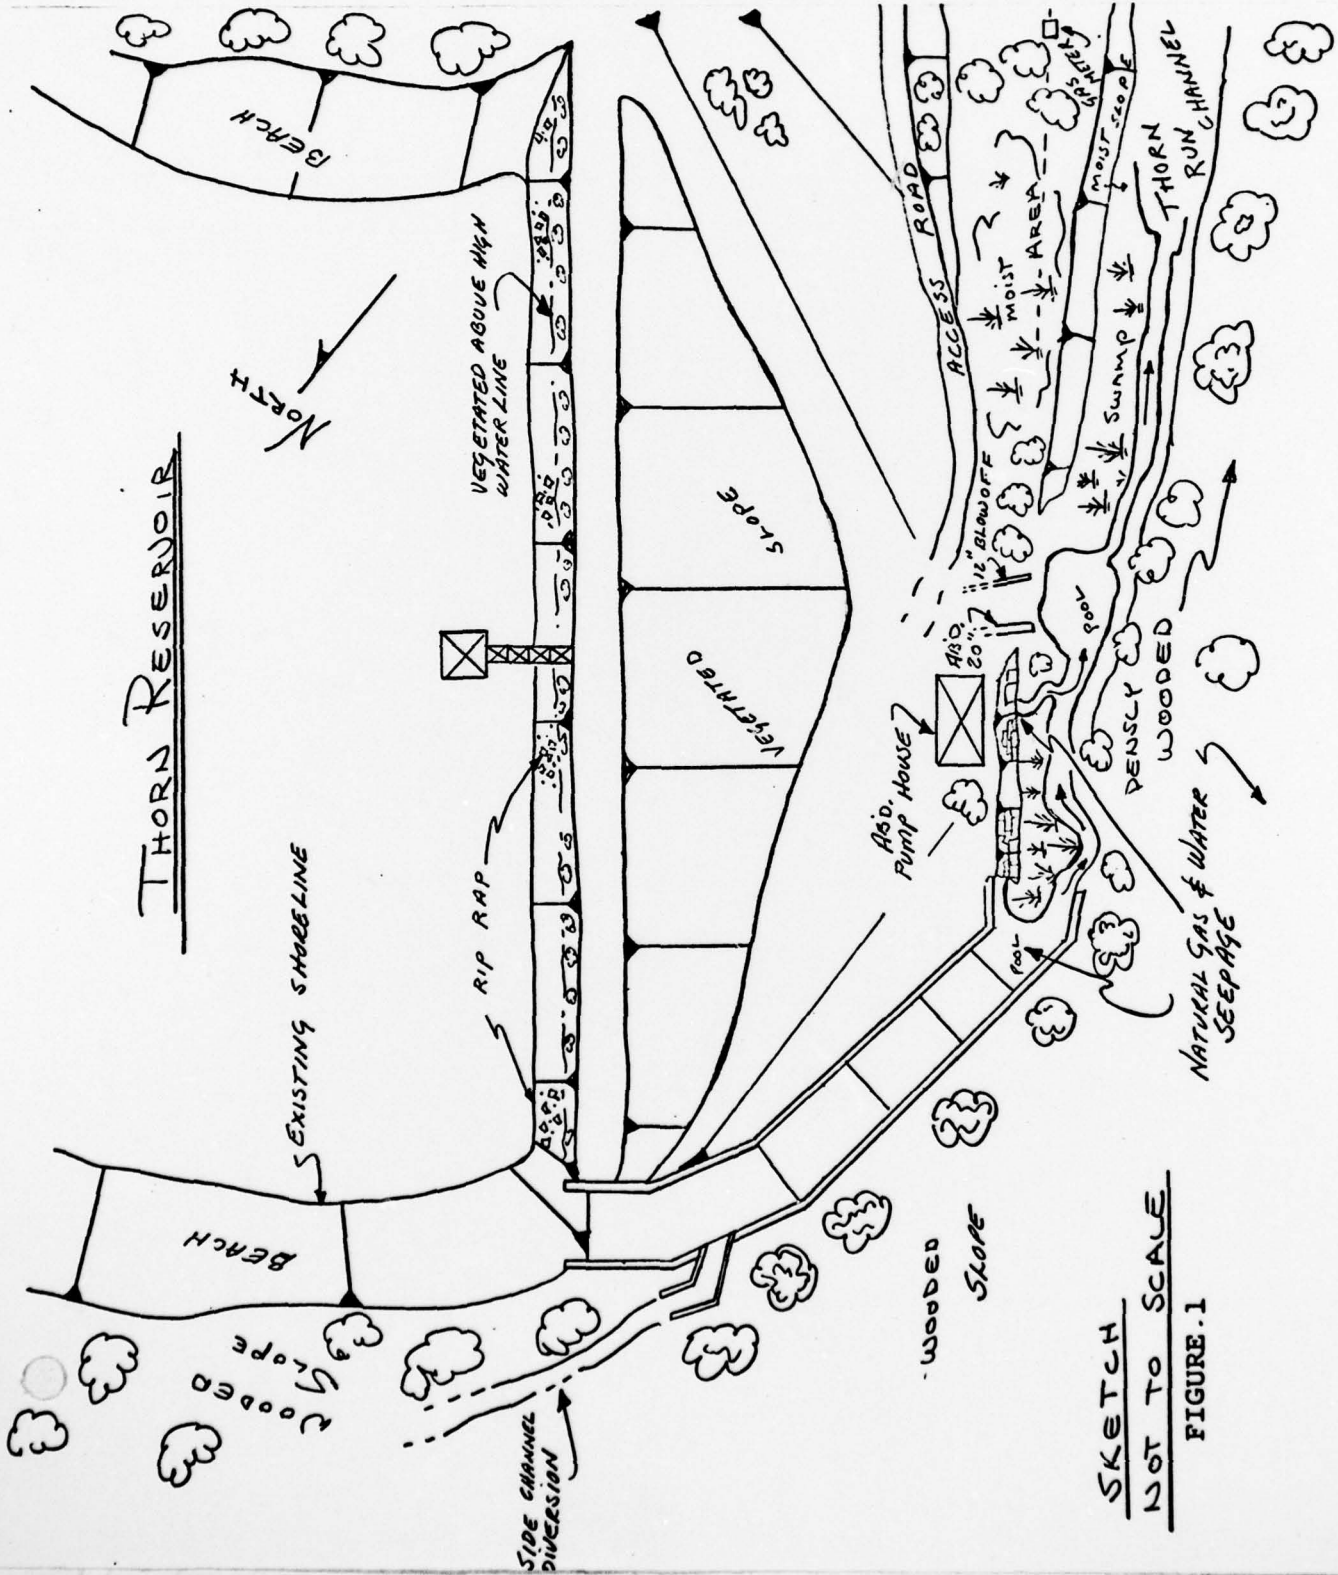
SKETCH
NOT TO SCALE
FIGURE.1

Although the spillway has reportedly not discharged in recent weeks, a significant pool of water is visible at its discharge end. According to the available drawings (see Figure 2), the discharge end of the spillway is designed such that a small pool is normally impounded in this area, apparently to act as a stilling basin. However, the amount of water observed at the time of inspection appeared to be excessive (see Photograph 10). Less than 20 feet beyond the pool a definite flow was observed indicating that some seepage was emanating from the pool area. A small seep (less than 5 GPM) was located directly behind and below the old booster station approximately level with the stream surface. Upon further examination of this seep, gas bubbles were observed issuing from below the water level. Upon re-examining the pool area at the end of the spillway, gas bubbles were also observed from several different areas within this pool (see Figure 1). The nature or origin of the gas could not be readily ascertained.
