² LAKE ONEIDA DAM
NDI No. PA - 272

⁴ PHASE I INSPECTION REPORT

⁶ NATIONAL DAM INSPECTION PROGRAM .

¹¹ SEPTEMBER 1978

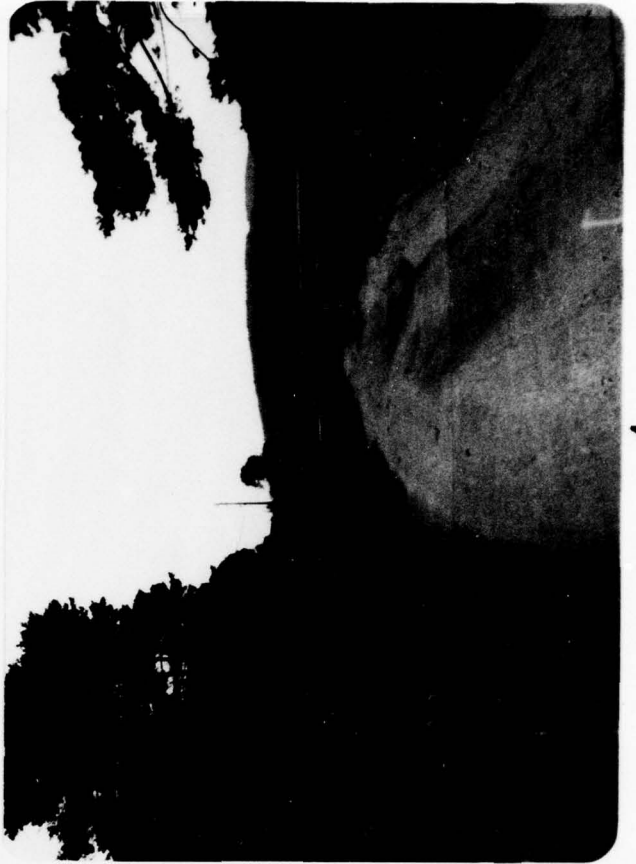
PHOTOGRAPH 4 View of the upper spillway channel and spillway weir. The reservoir is visible in the background.

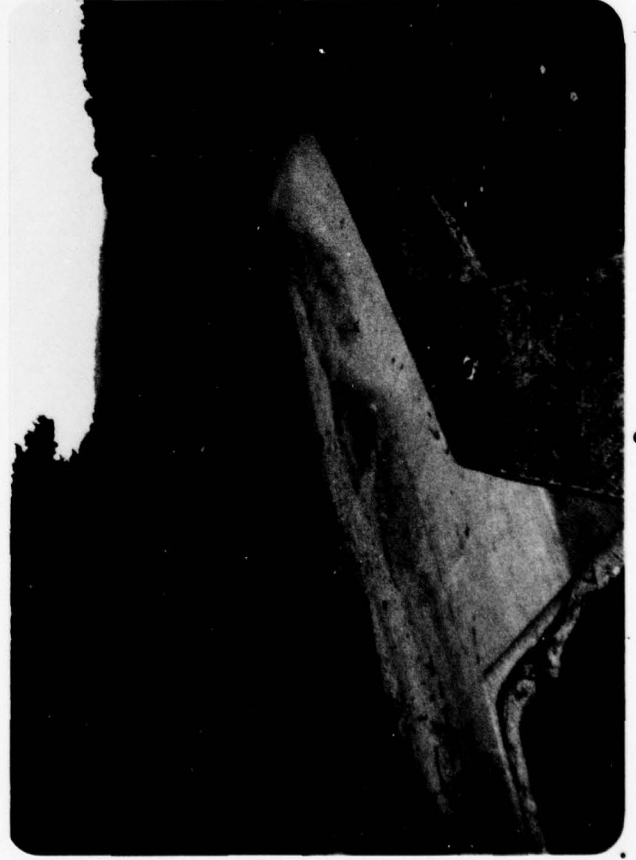
PHOTOGRAPH 3 View downstream of the spillway weir.

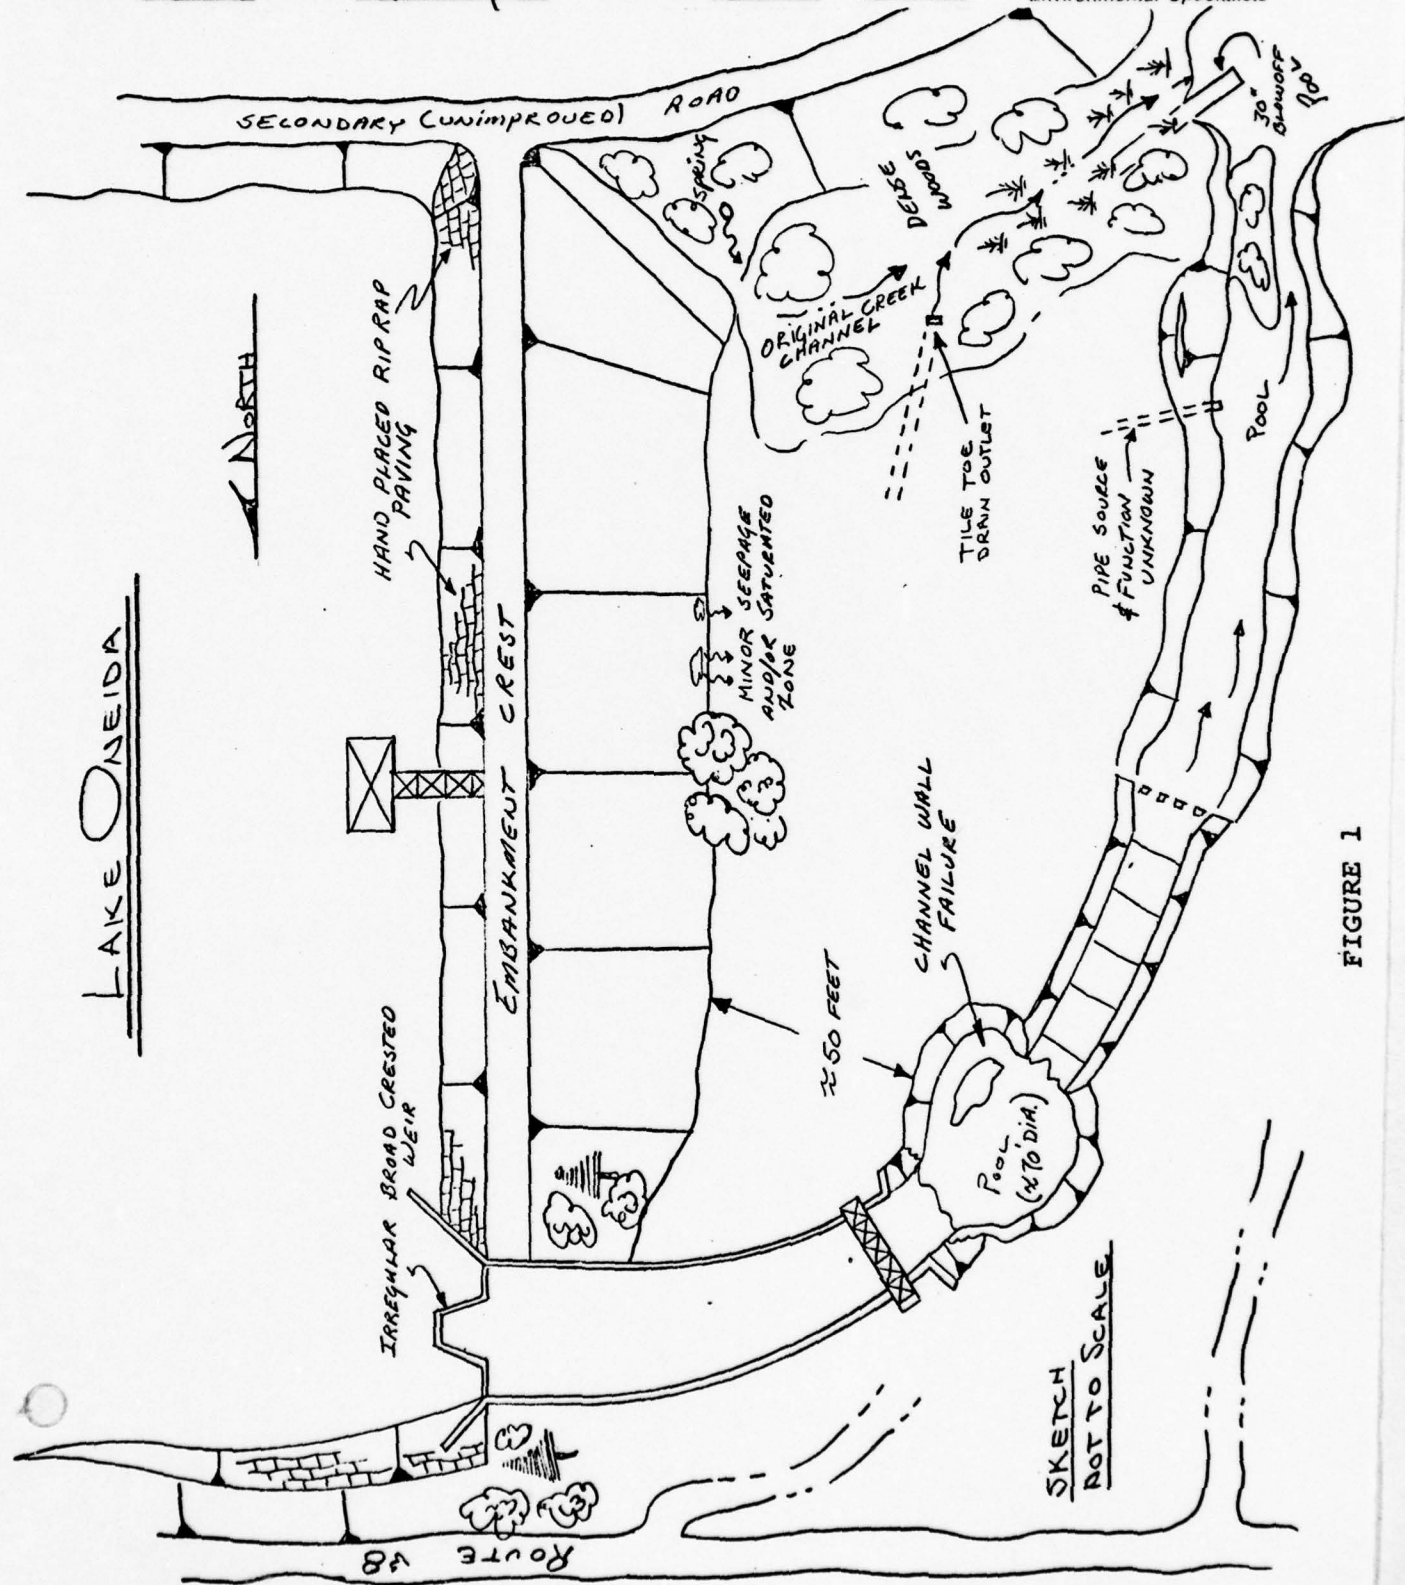
FIGURE 1

Saturated conditions were observed at the toe of the dam in a few areas (see Figure 1). These areas of seepage have been noted in PennDER files since shortly after the embankment was constructed. Flow could not be measured; however, the condition warrants further investigation by a geotechnical engineering experienced in dam design.

ii. To investigate and determine the cause of the seepage observed at the downstream toe of the embankment, its effect on the overall stability of the embankment, as well as the piping potential, and recommend remedial measures if necessary.
