Belmont Lake Dam, NDS ID PA.-00163,
DER ID 64-21. Delaware River Basin,
W. Branch Lackawaxen River, Wayne County,
Pennsylvania. Phase I Inspection Report.

BELMONT LAKE DAM
WAYNE COUNTY, PENNSYLVANIA

NDS I.D. NO. PA 00163
DER I.D. NO. 64-21

PHASE I INSPECTION REPORT
NATIONAL DAM INSPECTION PROGRAM

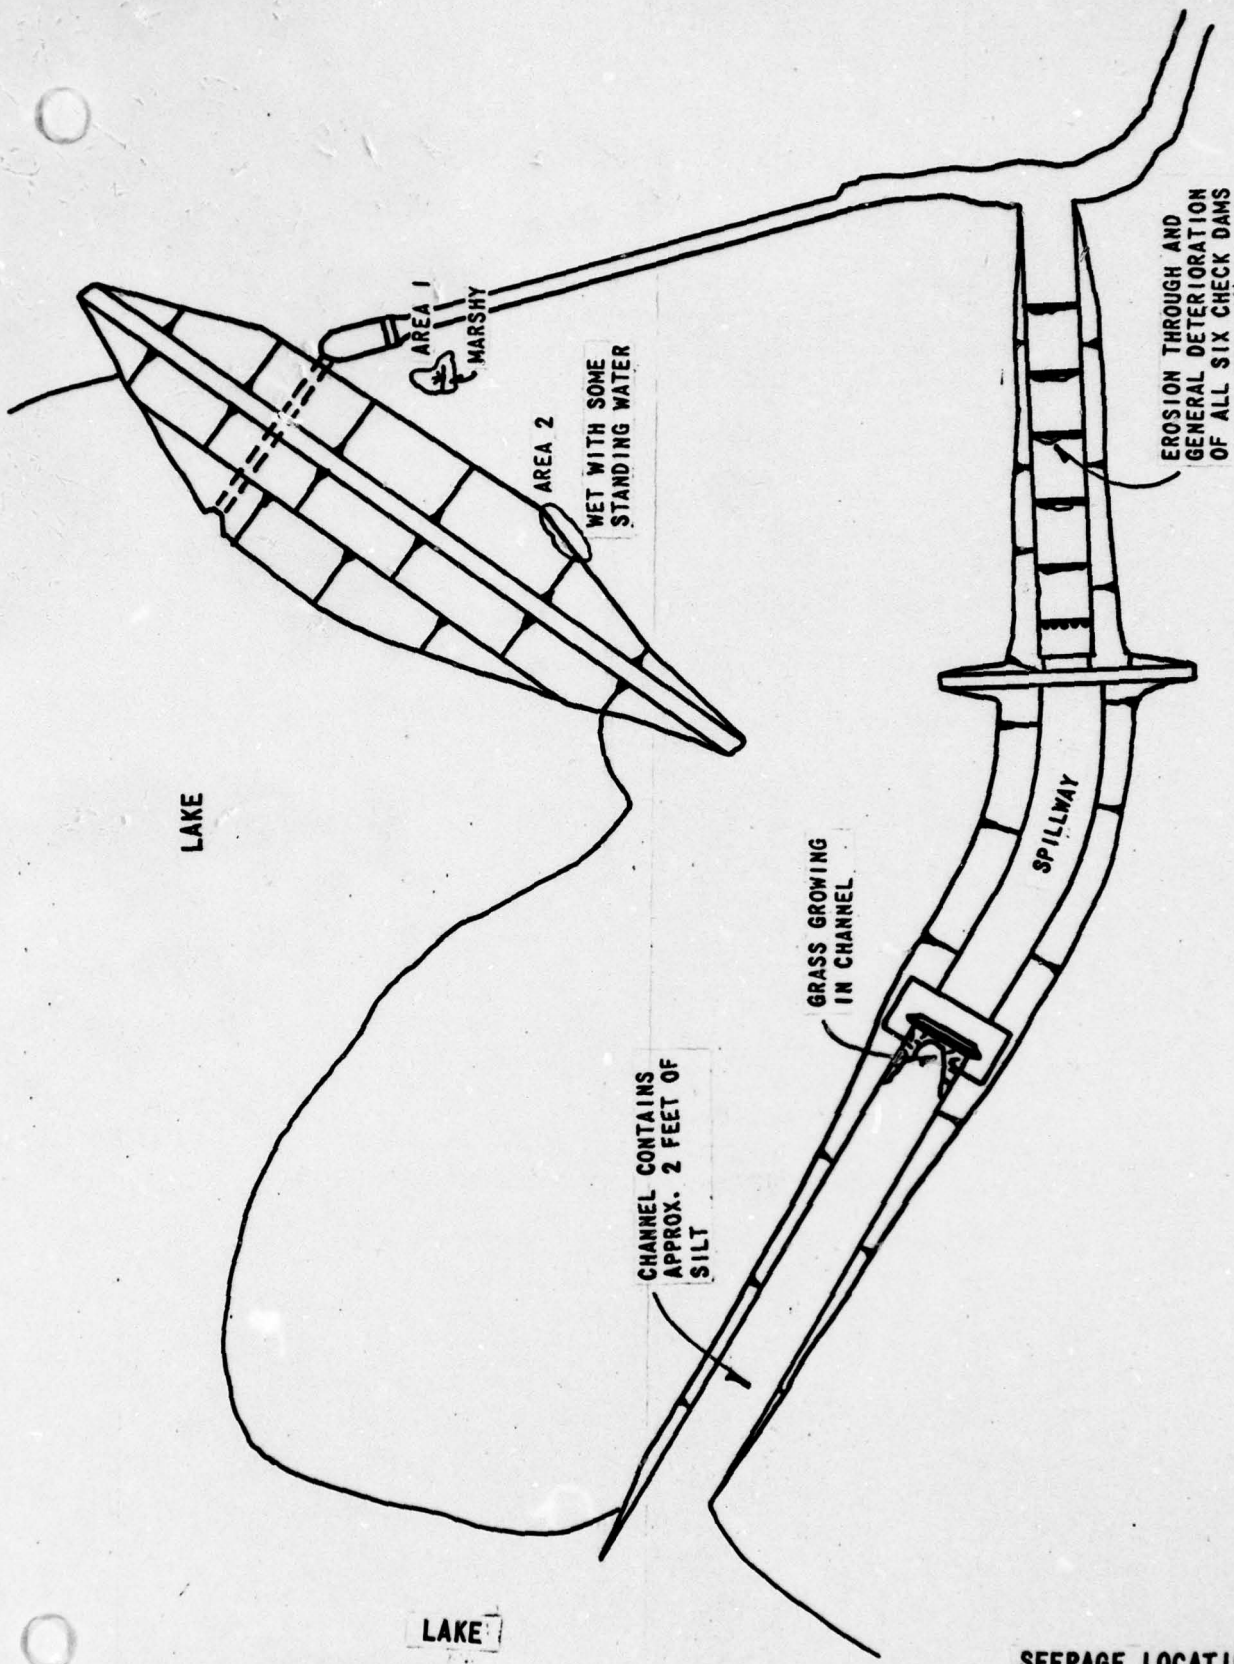
As delineated on Sheet 5a, Appendix B, there were two wet areas noted on the downstream side of the embankment below the toe and to the right of the principal spillway. Area No. 1 is considered to be a topographic low which temporarily retards water after a rainfall. Area No. 2 is considered to be associated with seepage emergence. As a spring house once existed in this area, the possibility of springs cannot be discounted.

The wet areas, noted on Sheet 5a of Appendix B, downstream of the embankment and to the right of the principal spillway discharge channel were assessed to be associated with a topographic low and seepage emergence (perhaps due to a natural spring), respectively. The seepage emergence was clear, and there is evidence that the condition is stable.

1. Seepage Area No. 2 should be drained and stabilized.
2. The flow rate and turbidity from Area 2 should be periodically monitored and recorded. If flow significantly increases, necessary remedial action should be taken.
3. The check dams should be repaired.
4. The silt accumulations in the approach channel to the emergency spillway should be monitored. When the depth of the silt is great enough to impede the discharge capacity, the channel should be dredged.
5. Consideration should also be given to improving the access road over the spillway channel since it is highly susceptible to flooding.

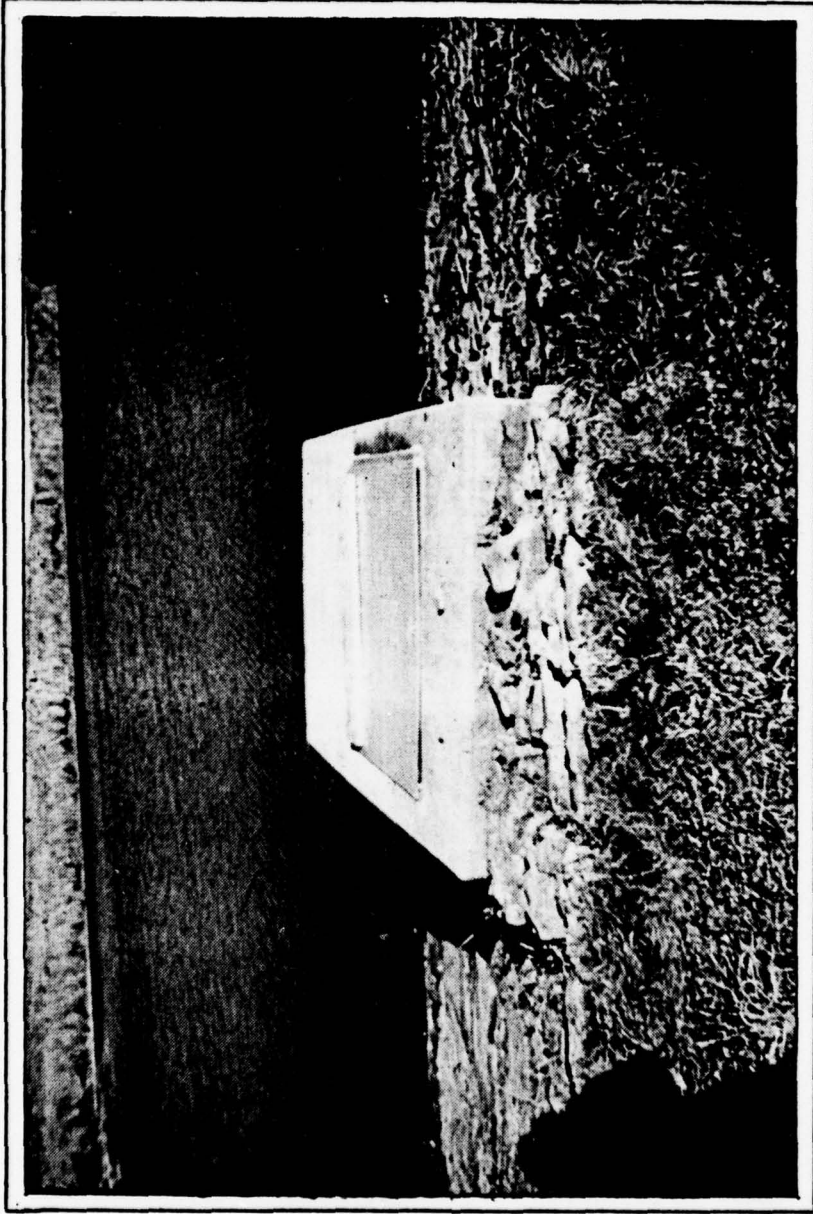
PHOTOGRAPH NO. 1

PRINCIPAL SPILLWAY RISER.

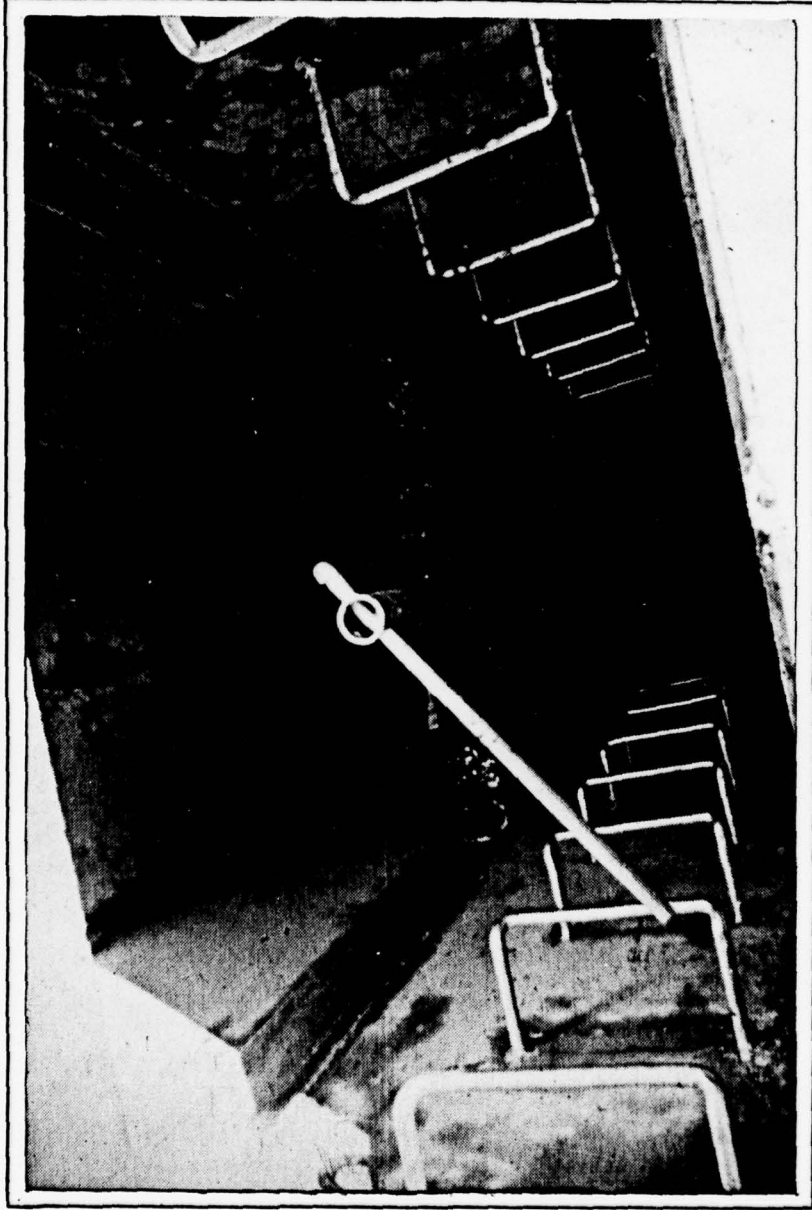
PHOTOGRAPH NO. 2

INTERIOR VIEW OF RISER. NOTE WOOD
STOP LOGS AND VALVE HANDLE FOR POND
DRAIN.

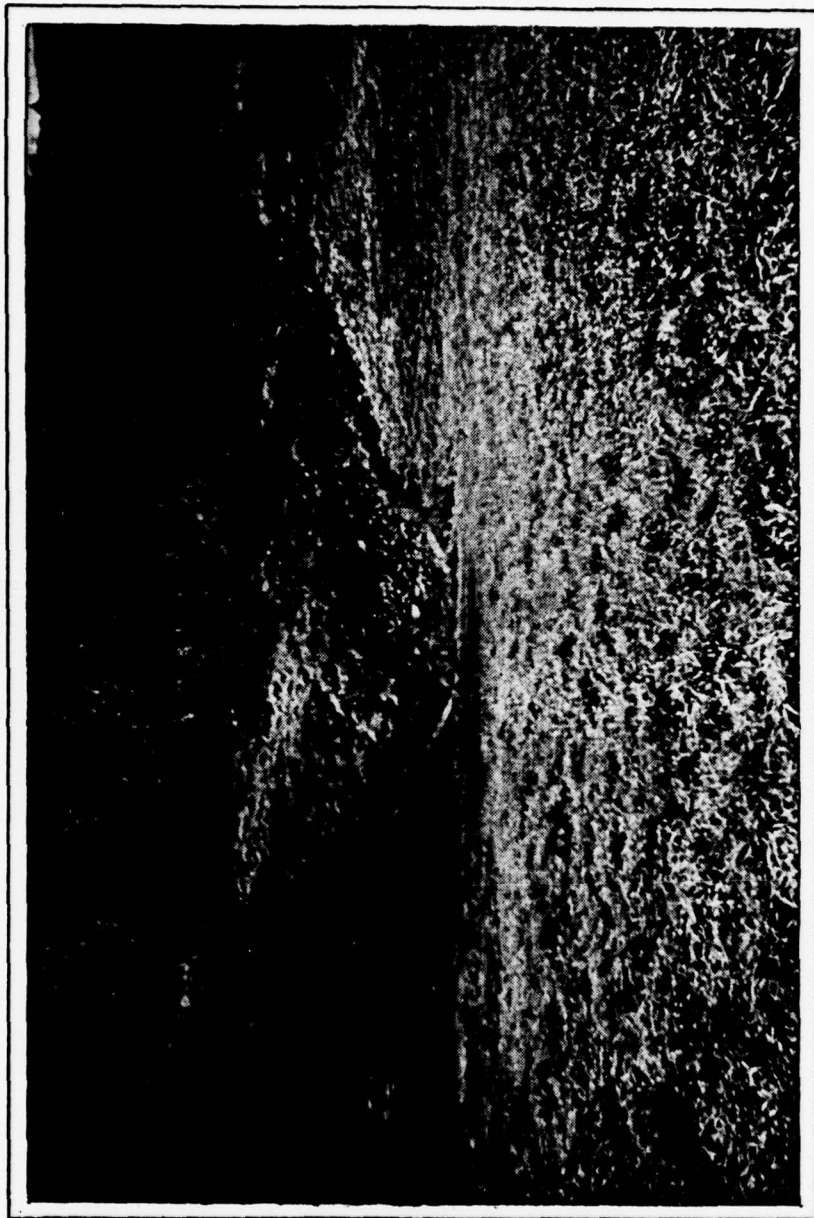
PHOTOGRAPH NO. 4

The outlet channel was inspected and found to be in good condition. The riprap was stable, there was no excessive vegetation growing in the riprap, nor was there significant debris in the channel.

OVERVIEW OF DISCHARGE CHANNEL BELOW
PRINCIPAL SPILLWAY.

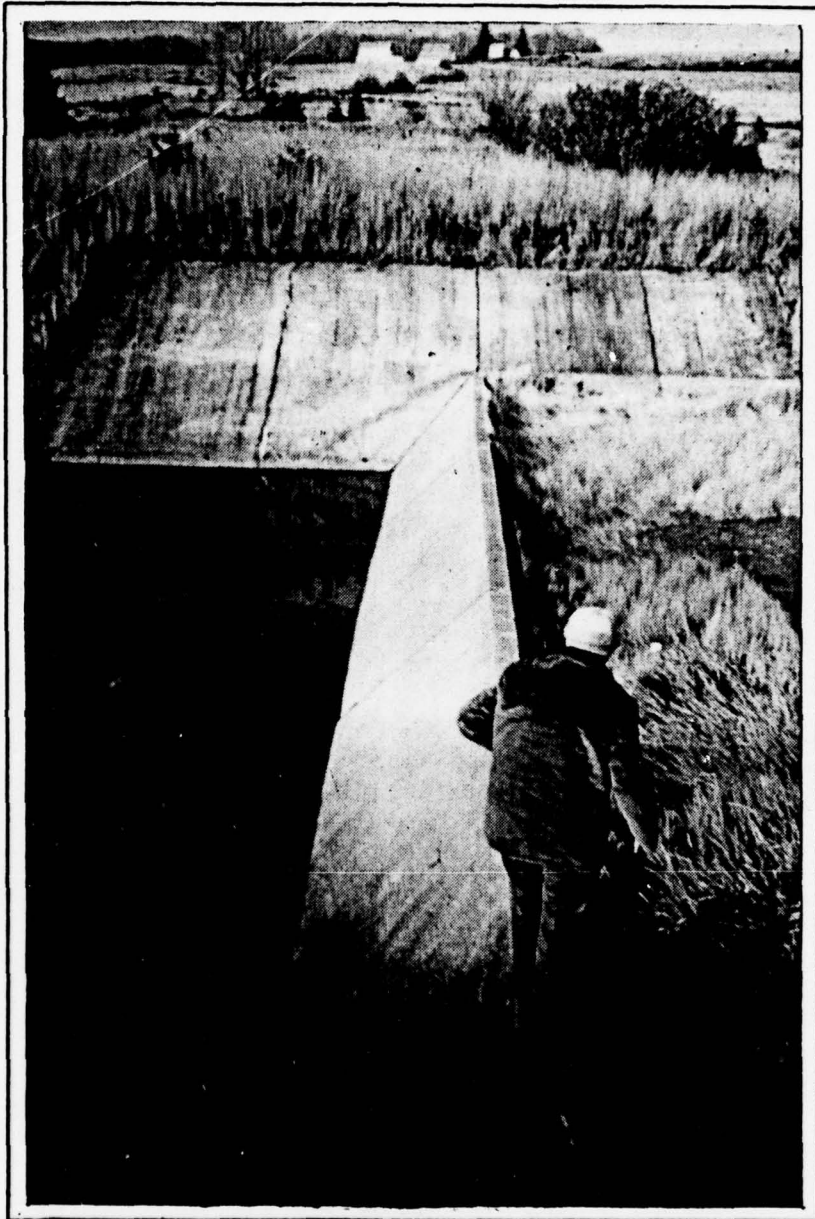
PHOTOGRAPH NO. 5

The trapezoidal weir was inspected and found to be in good condition. Similarly, the slope paving on each side of the weir was found to be in good condition.

OVERVIEW OF TRAPAZOIDAL
WEIR OF EMERGENCY SPILLWAY
LOOKING TOWARDS RIGHT
ABUTMENT.

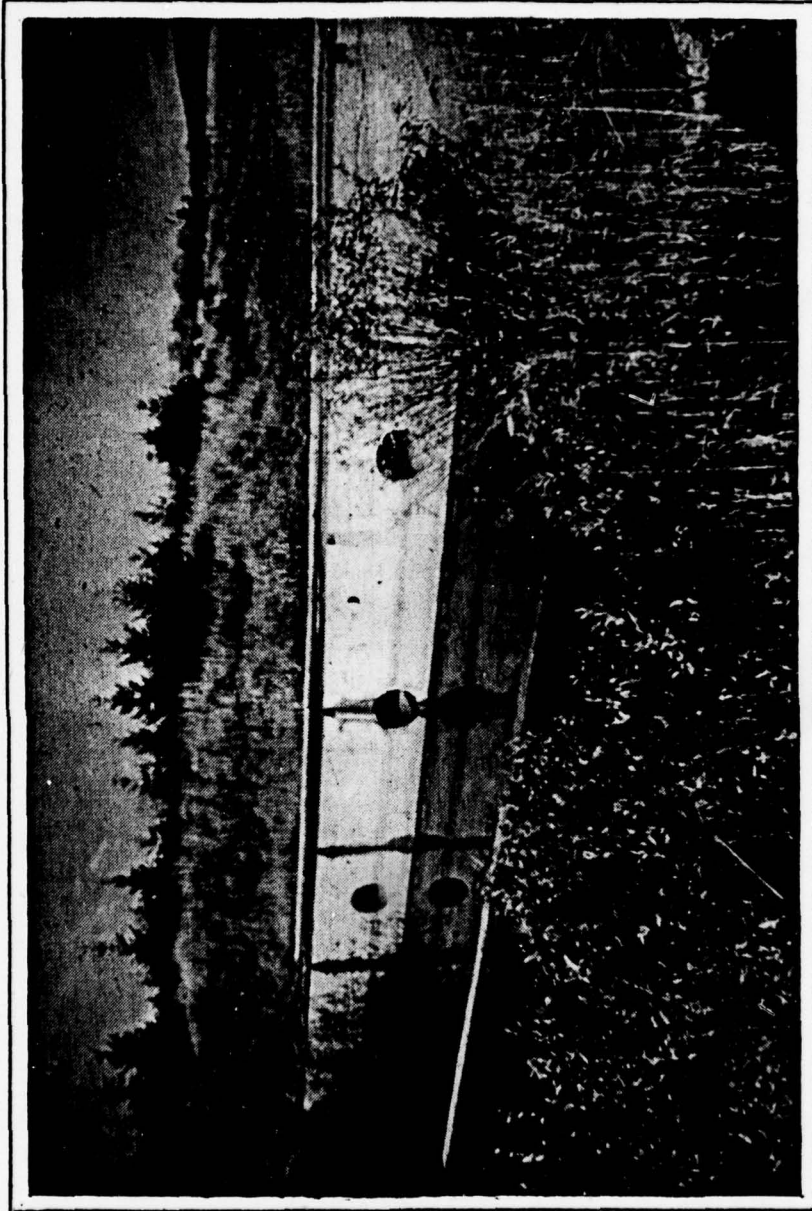
PHOTOGRAPH NO. 7

The discharge channel below the access road contains six rock check dams which were judged to be in poor condition and in a state of disrepair. These can be seen in the photographs presented in Appendix D. These dams were installed to dissipate the energy of the discharging water before it enters the West Branch of the Lackawaxen River. The dams still function to reduce the energy of the water before entering the creek; although, unless repaired, it is only a matter of time before they will cease to function effectively. The access bridge, or ford, containing the three 24-inch diameter culverts was inspected and found to be in good condition. However, due to the fact that there are only three 24-inch diameter pipes, it is expected that water would pond behind the roadway and, during severe storms, inundate this roadway, preventing access to the dam. These culverts are also susceptible to clogging.

DISCHARGE CONDUITS BENEATH ACCESS
ROAD SHOWN IN PHOTOGRAPH 6.

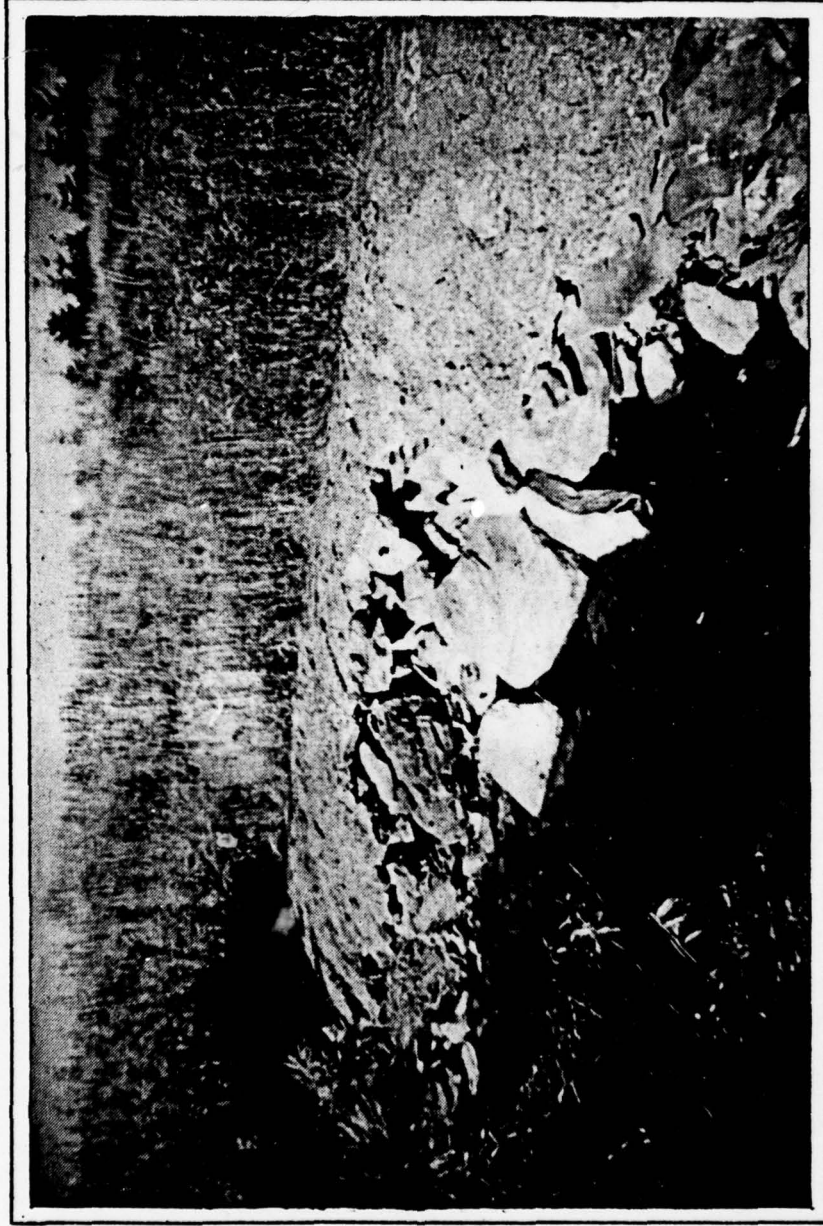
The emergency spillway was also judged to be in good condition. The channel and side slopes of the spillway were stable and apparently well maintained. However, the downstream channel of the emergency spillway contains six check dams which were judged to be in poor condition. Although the check dams are deteriorating, their condition does not affect the ability of the channel to pass high flows. The purpose of these check dams is to dissipate the energy of the water before entering the West Branch of the Lackawaxen River. However, unless repaired in the near future, the dams will cease to function as designed.

The discharge channel was found to be in good condition but the six rock check dams were observed to be in poor condition. See photographs in Appendix D. All were in a state of disrepair. Although it is not considered to be critical, the check dams should be repaired.

VIEW OF TYPICAL CHECK DAM CONSTRUCTION
WITHIN THE EMERGENCY SPILLWAY CHANNEL
BELOW ACCESS ROAD.

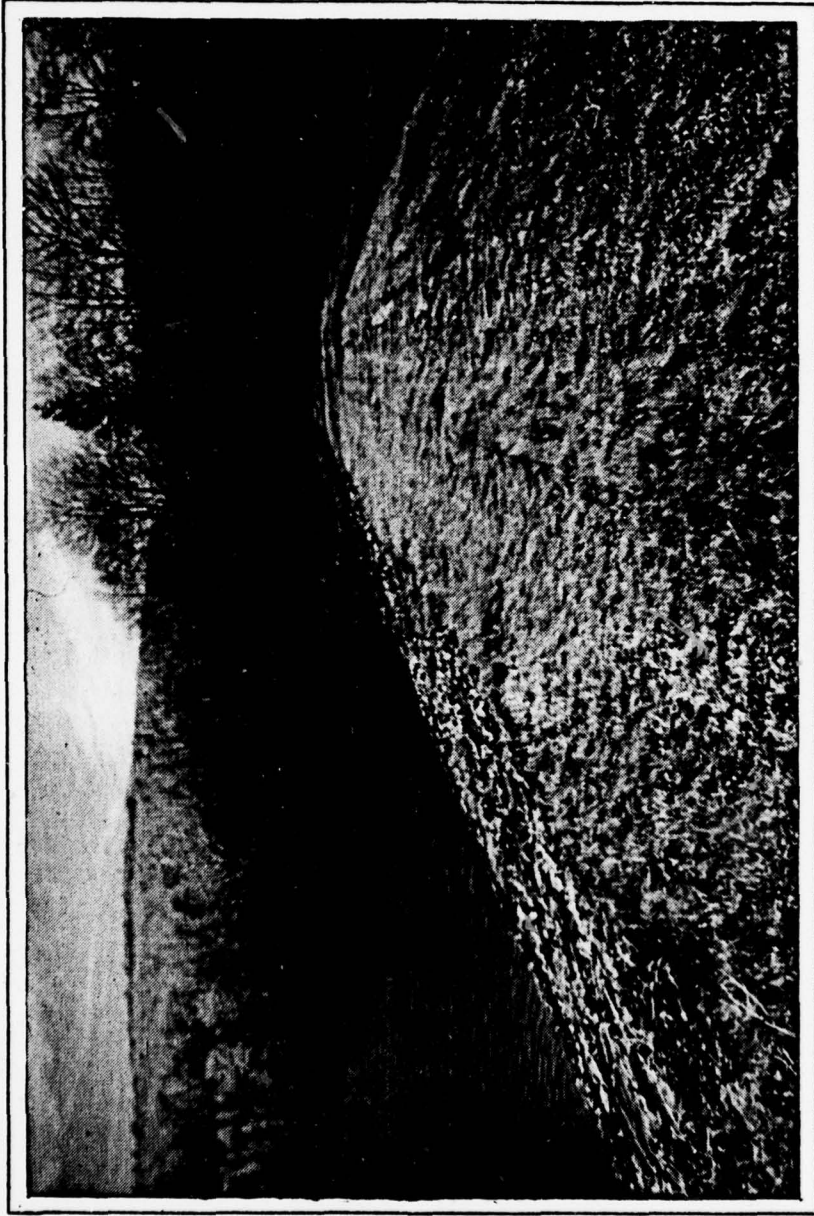
PHOTOGRAPH NO. 9

OVERVIEW OF CREST AND UPSTREAM SLOPE
LOOKING TOWARDS LEFT ABUTMENT.

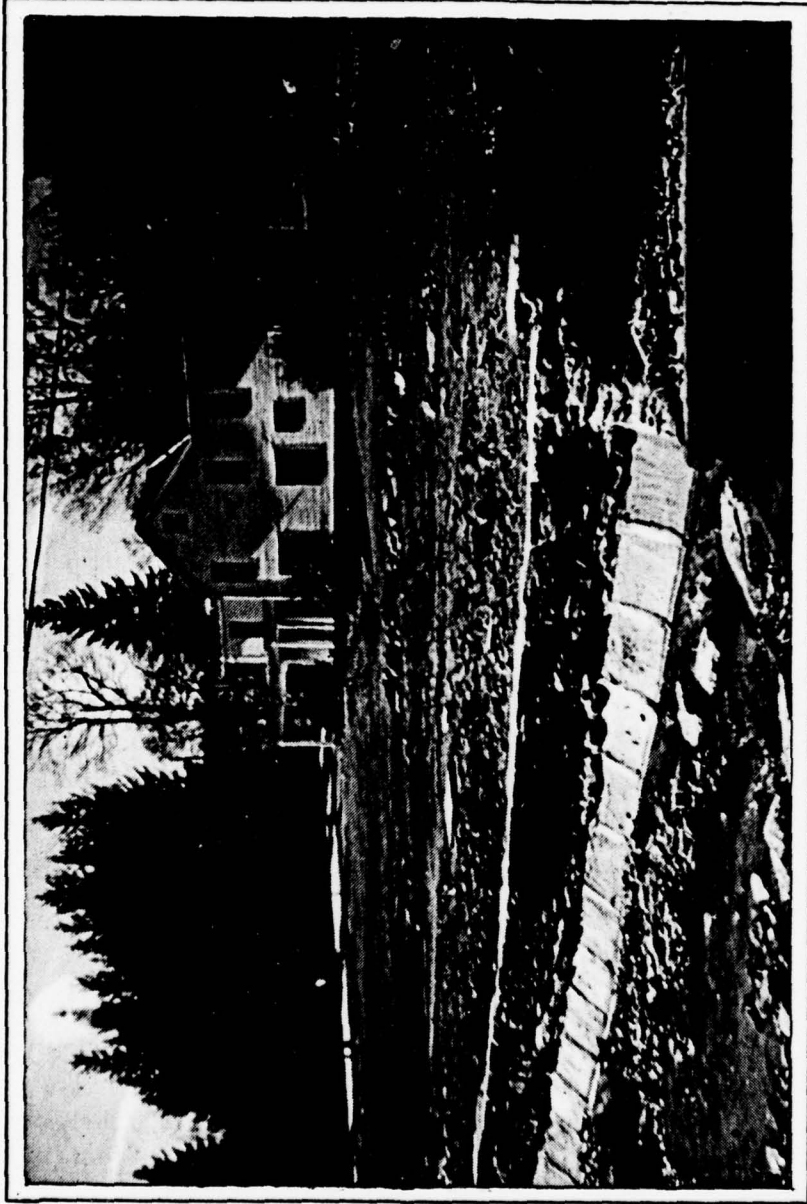
About 1.7 miles below the dam the West Branch of the Lackawanna River enters a Pennsylvania State fish hatchery. Several buildings and the superintendents house would be subject to damage in the event of a dam failure. About 1000 feet below the fish hatchery are two more houses which would be subject to damage.

STREAM AS IT PASSES THROUGH FISH
HATCHERY APPROXIMATELY TWO MILES
DOWNSTREAM.
