Fawn Lake Dam, ID Number PA-00693.  
Schuylkill River Basin, Plum Creek,  
Schuylkill County, Pennsylvania.  
Phase I Inspection Report.

PHASE I INSPECTION REPORT  
NATIONAL DAM INSPECTION PROGRAM

PHASE I INSPECTION REPORT  
NATIONAL DAM INSPECTION PROGRAM  
FAWN LAKE DAM  
NATIONAL ID #PA 00693  
DER ID #54-175

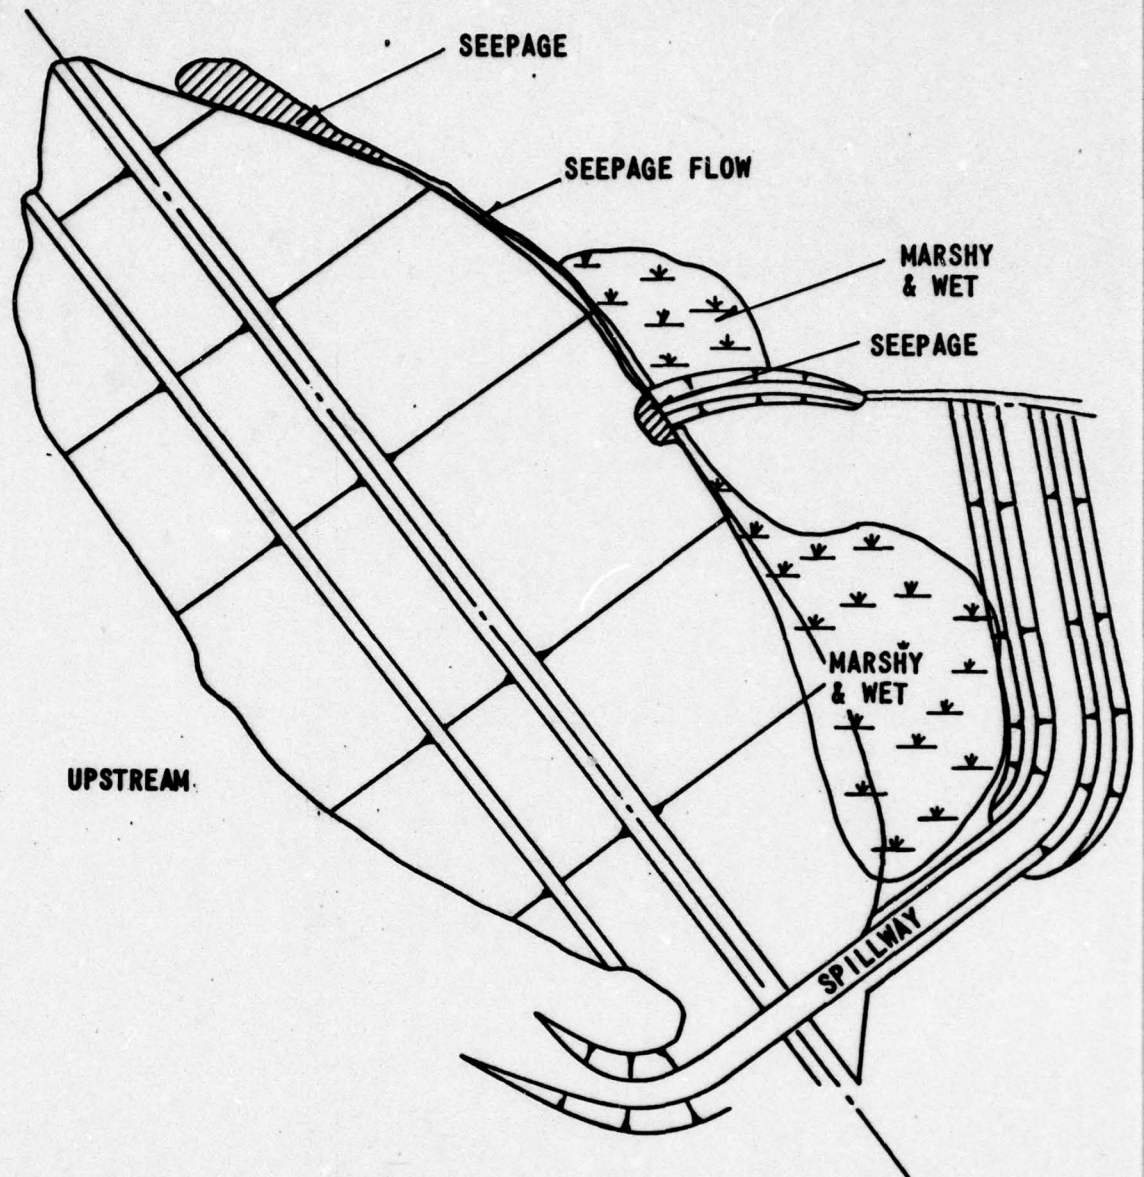
SEEPAGE LOCATION PLAN  
 FAWN LAKE DAM  
 SHEET 5a OF 11

b. Dam. During the visual survey, there were no indications or evidence observed of distortions in alignment or grade that would be indicative of movement of the embankment or foundation. There were no surface cracks or misalignment observed. Some settlement (10 ± inches) of backfill around the concrete spillway chute was noticed. No significant erosion was observed. The riprap was in good condition and stable. Seepage was noted along the downstream toe of the embankment and at the left abutment, which was also reported in a DER inspection report made following filling of the reservoir. Wet, marshy areas were observed downstream of the toe. The seepage locations are shown on Sheet 5(a), Appendix B.

*NOTE: Due to the type of seepage occurring, the rate of seepage could not be estimated.*

As discussed in Appendix B, seepage and wet marshy areas were noted. These areas should be monitored for turbidity, erosion and change in flow rates.

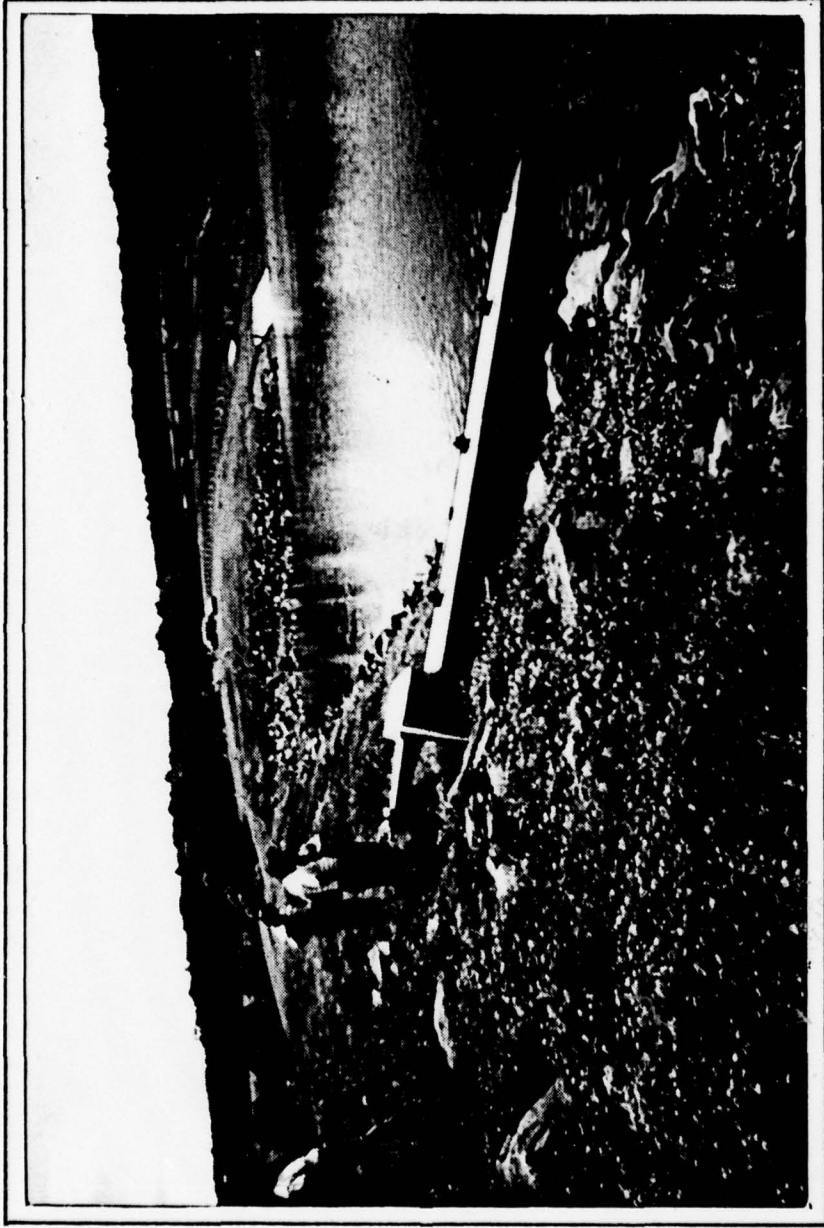
PHOTOGRAPH NO. 1

3. Outlet Works. Water was flowing through the discharge pipe and could not be inspected. The 18-inch sluice gate was not completely seated, and leaked. The gate was exercised and found to be generally in good condition with exception of complete seating and the need for lubrication.

VIEW OF POND DRAIN VALVE MECHANISM

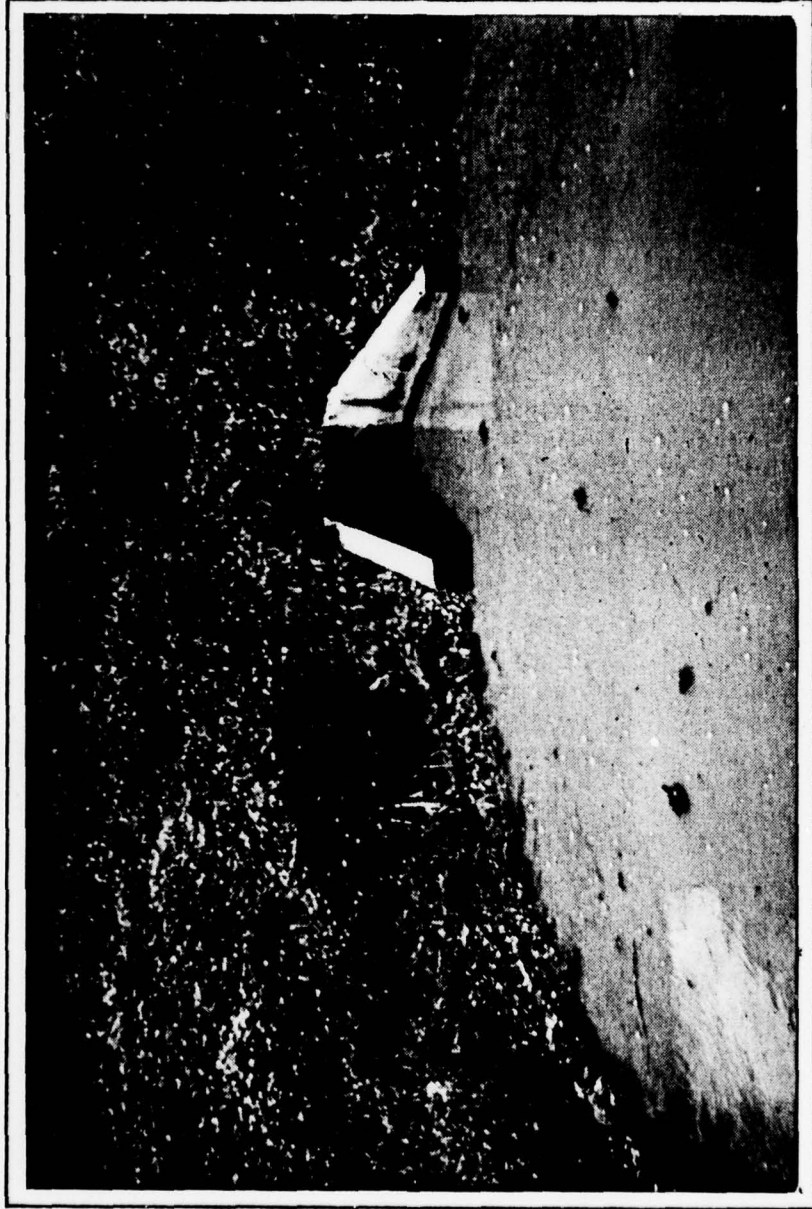
PHOTOGRAPH NO. 2

VIEW OF POND DRAIN OUTLET SYSTEM.  
WATER IS MUDDY BECAUSE DRAIN WAS  
OPENED TO TEST SYSTEM.

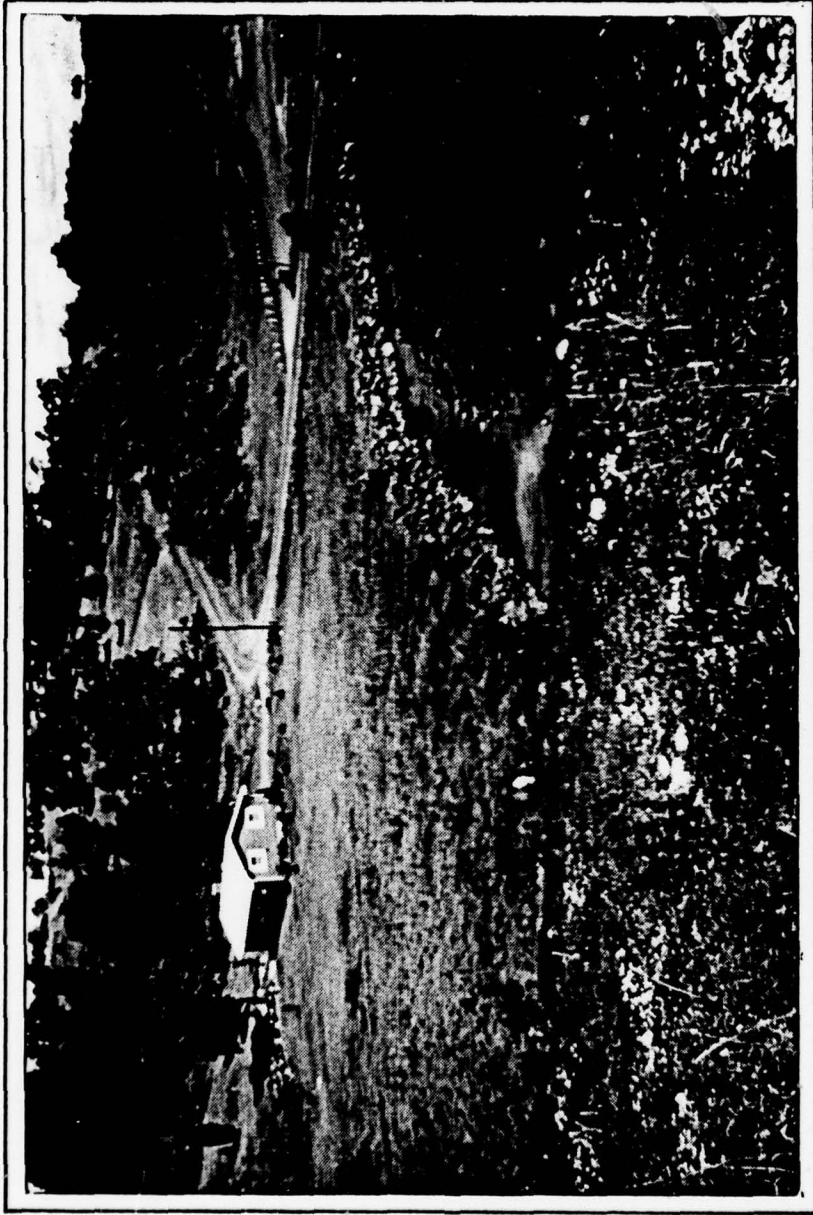
PHOTOGRAPH NO. 3

VIEW OF POND DRAIN OUTLET CHANNEL.  
NOTE DISCHARGE UNDER ROADWAY AND  
HOME ON LEFT, SUBJECT TO FLOODING.

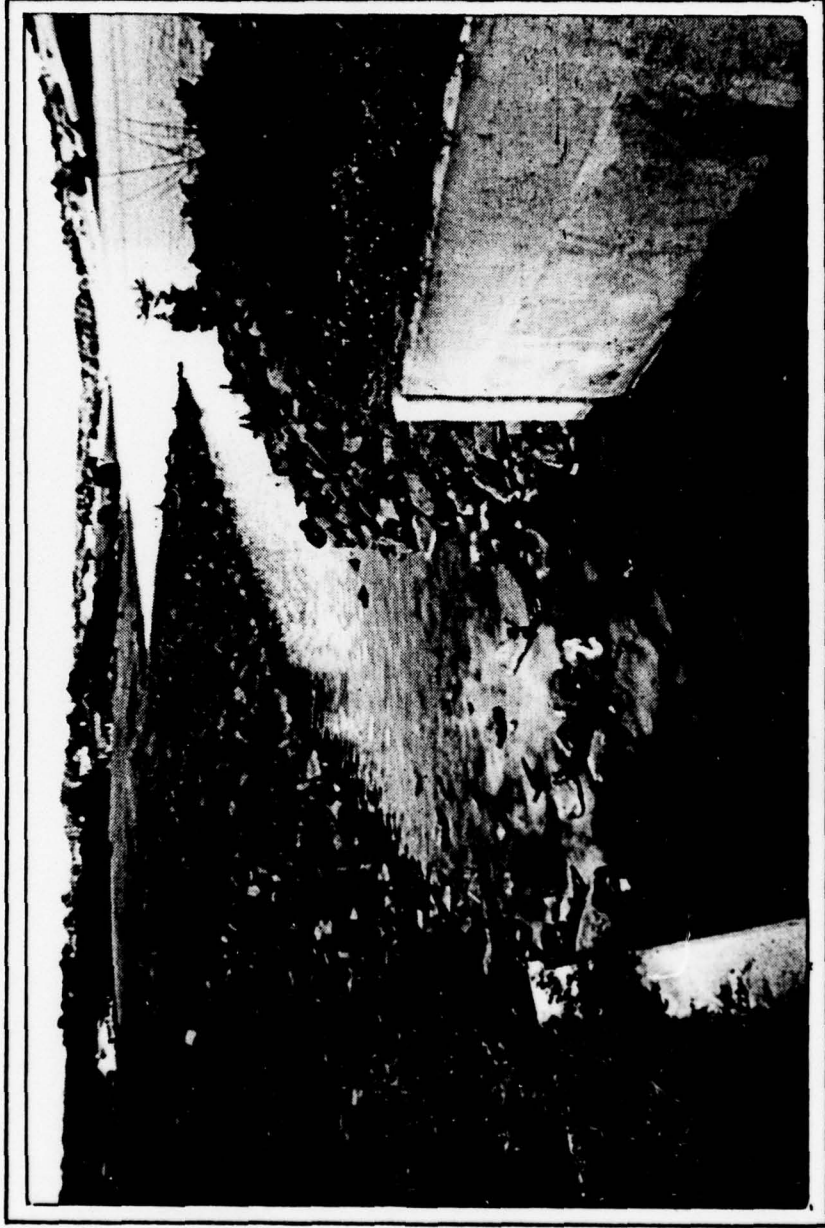
PHOTOGRAPH NO. 4

INTAKE CHANNEL OF PRINCIPAL SPILLWAY.  
NOTE CONTROL WEIR AT CHANNEL ENTRANCE.

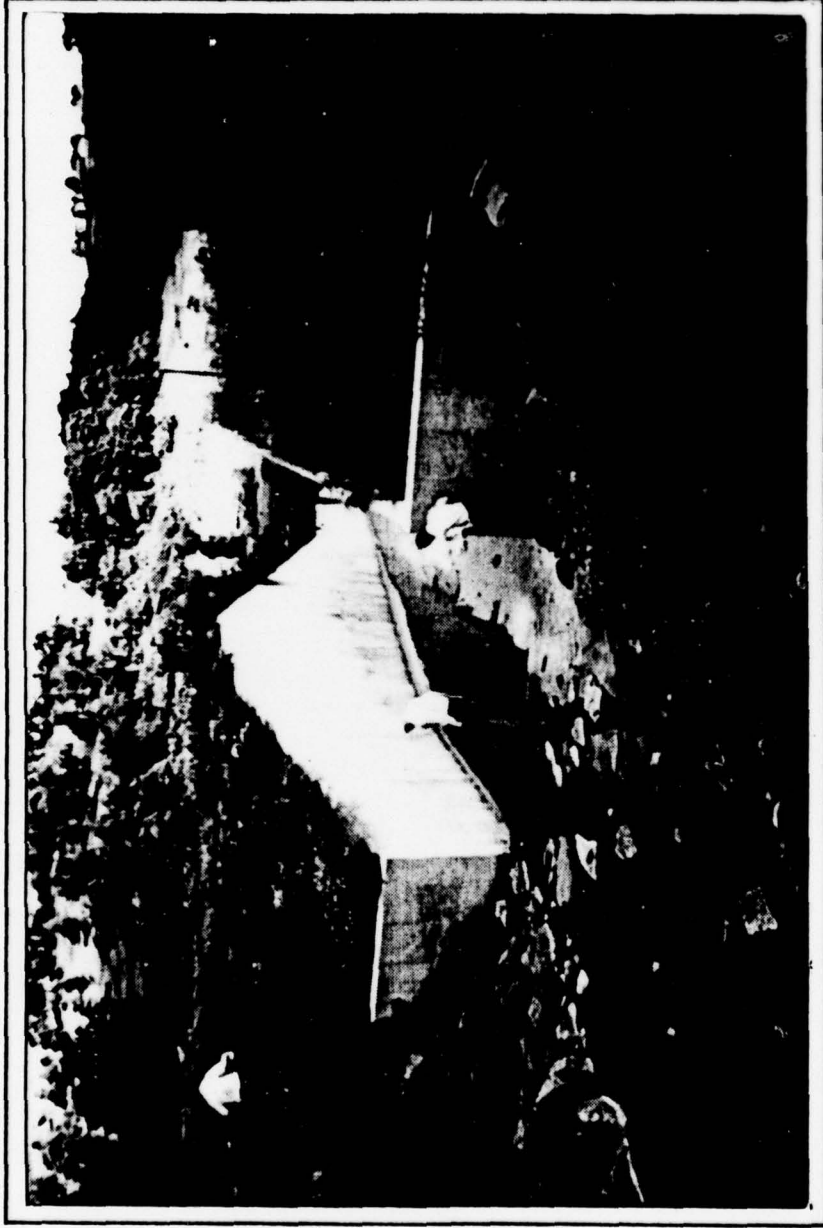
PHOTOGRAPH NO. 5

LOOKING DOWNSTREAM THROUGH  
PRINCIPAL SPILLWAY.

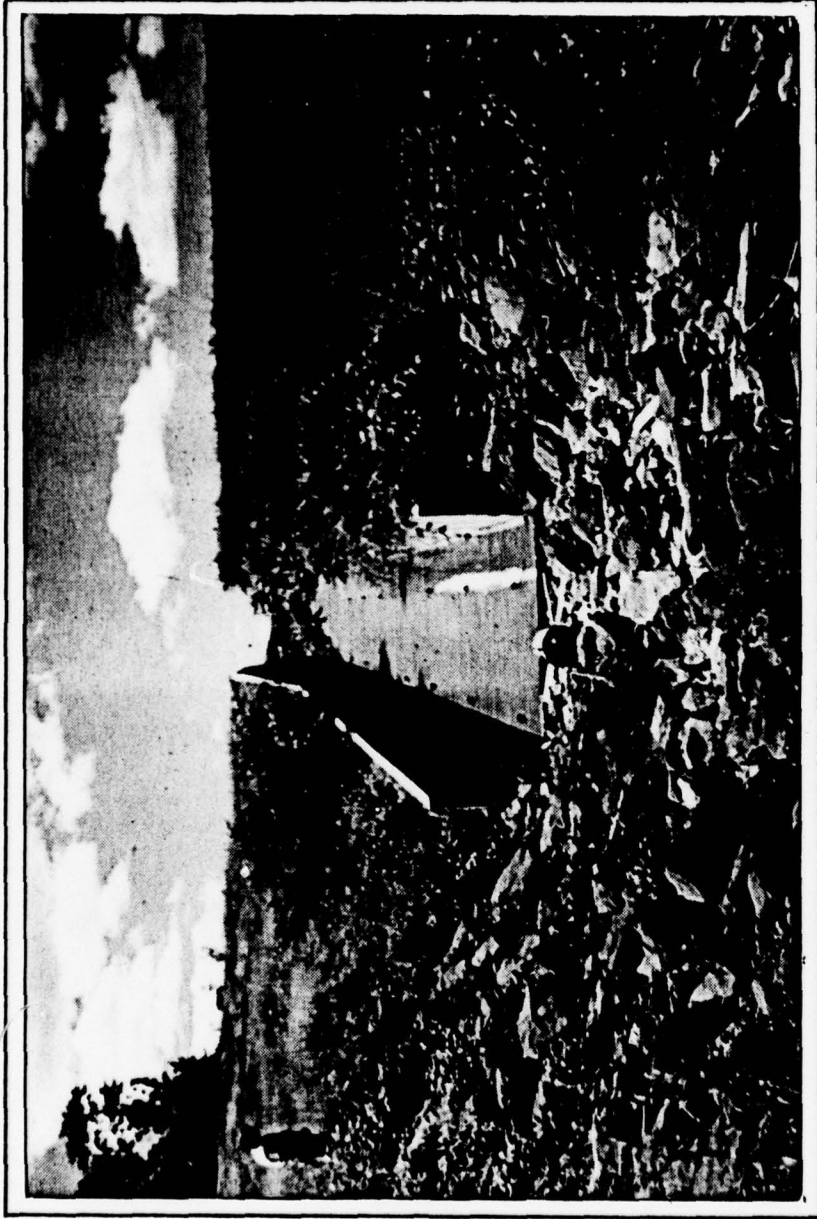
PHOTOGRAPH NO. 6

LOOKING UPSTREAM THROUGH PRINCIPAL  
SPILLWAY. NOTE DENSE GROWTH ADJA-  
CENT TO WINGWAY WHERE SOIL IS WET.

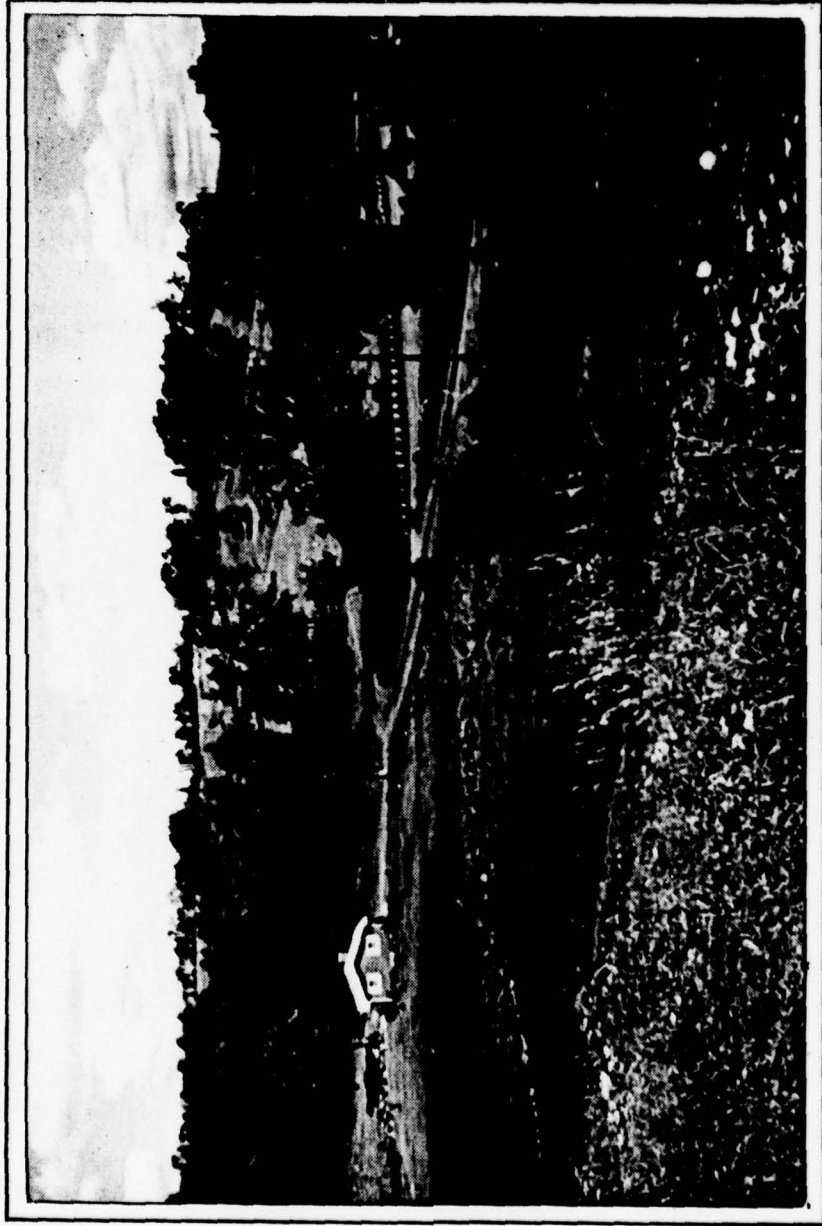
PHOTOGRAPH NO. 7

VIEW OF DOWNSTREAM AREA BETWEEN TOE  
OF DAM AND HEADWATERS OF LAKE WYNONAH.  
SPILLWAY DISCHARGES FLOW THROUGH CUL-  
VERTS UNDER LONESTAR DRIVE.
