Suydam Dam, NDS ID PA 00085, DER ID 64-169  
Delaware River Basin, Lollipop Creek,  
Wayne County, Pennsylvania. Phase I  
Inspection Report.

SUYDAM DAM  
WAYNE COUNTY, PENNSYLVANIA

NDS. I.D. NO. PA 00085  
DER I.D. NO. 64-169

PHASE I INSPECTION REPORT  
NATIONAL DAM INSPECTION PROGRAM

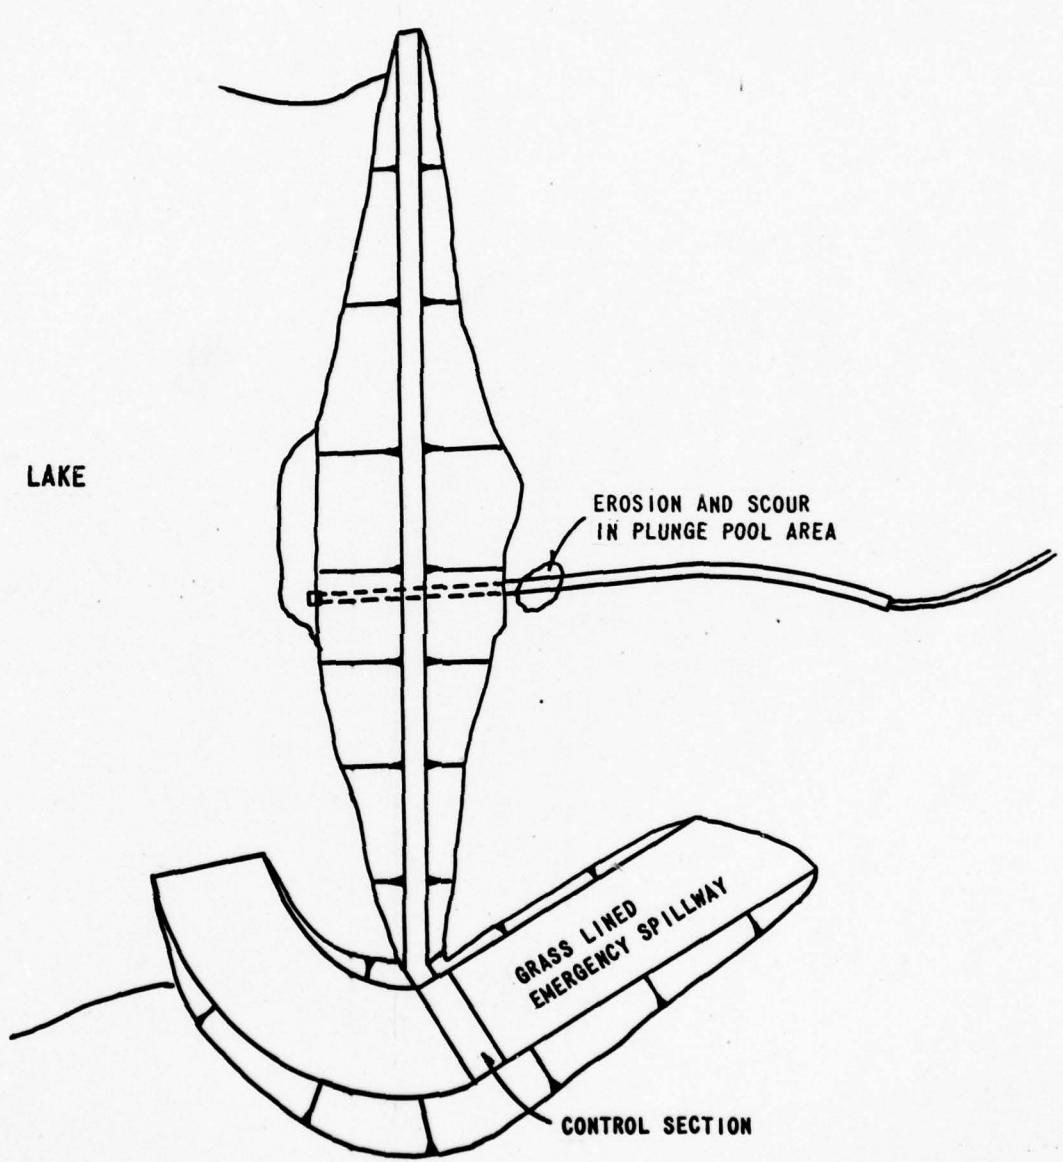
EROSION AND SCOUR  
IN PLUNGE POOL AREA

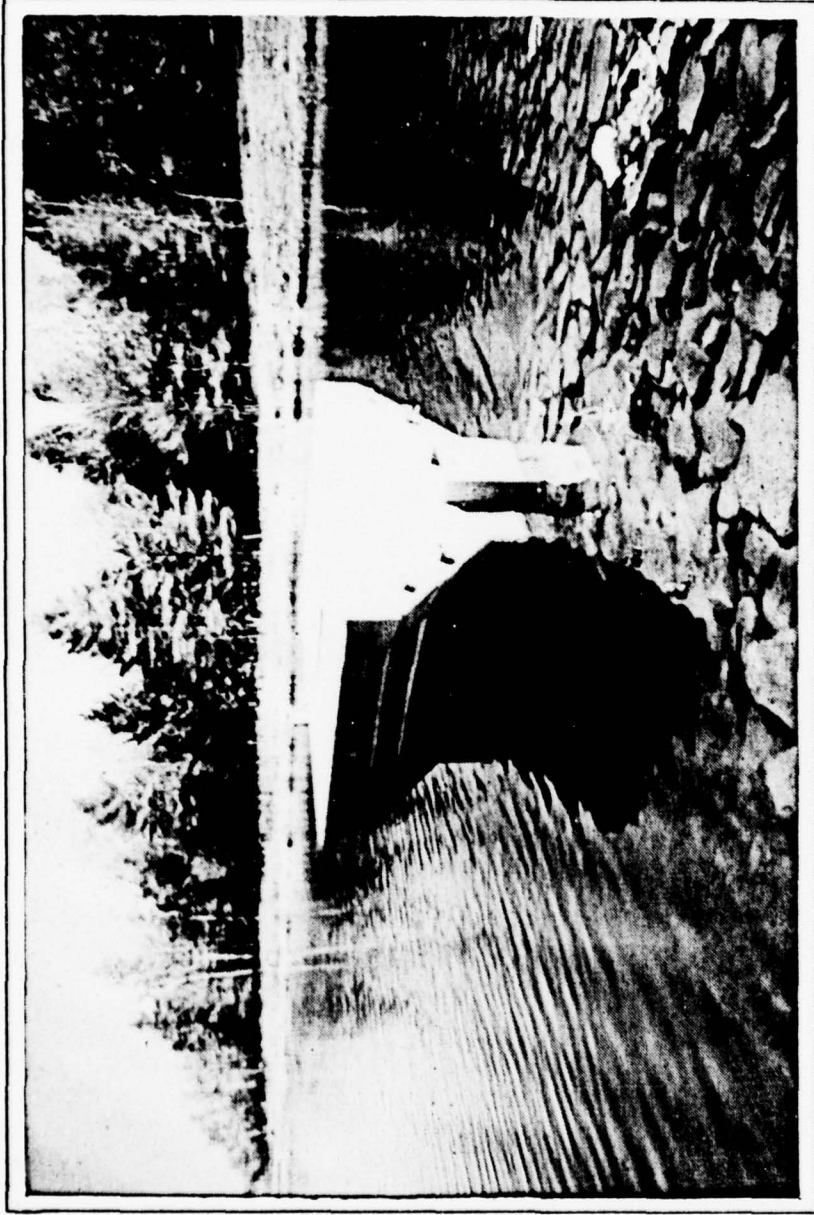
PHOTOGRAPH NO. 1

VIEW OF THE INTAKE RISER, PRINCIPAL  
SPILLWAY.

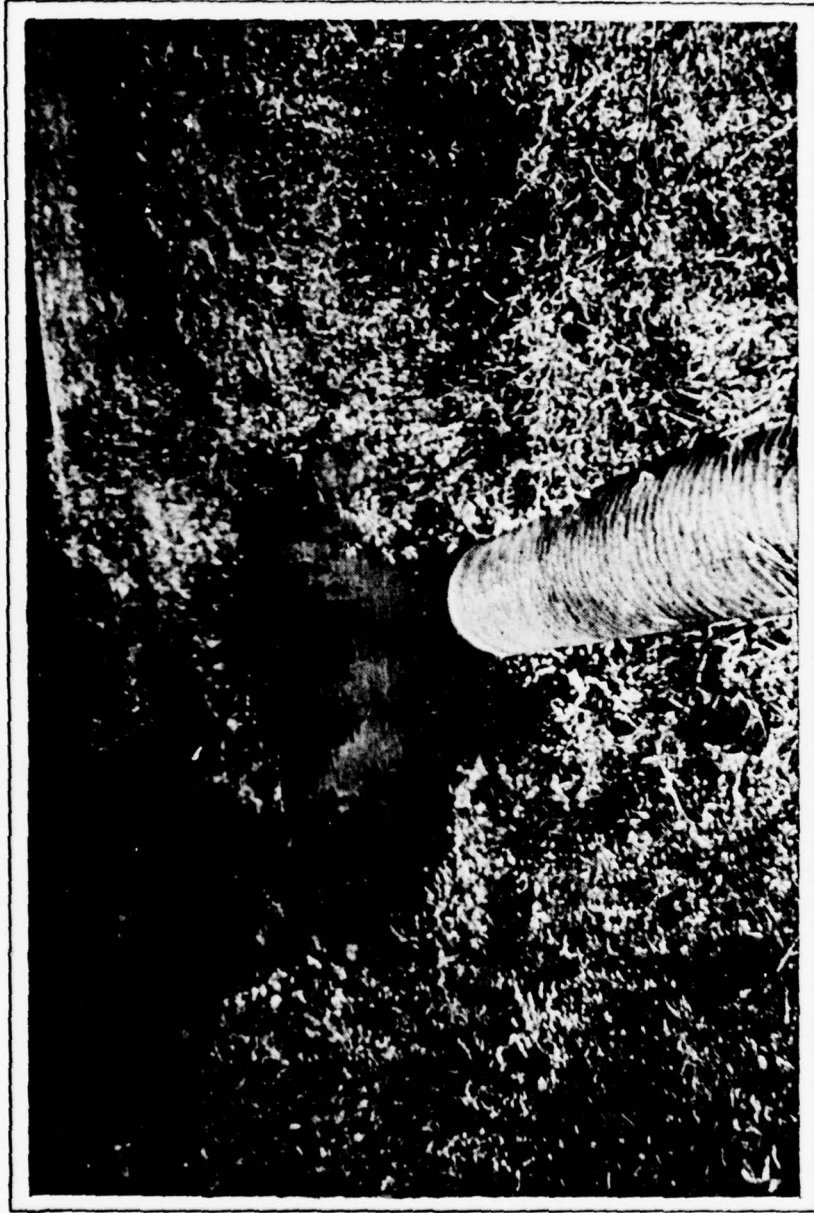
PHOTOGRAPH NO. 2

The length of the discharge pipe could not be inspected primarily because of its size and the fact that water was flowing through the principal spillway pipe. However, the end of the pipe was inspected and observed to be in fairly good condition. The plunge pool at the downstream toe was inspected and observed to be in fair condition. There was some sloughing and erosion of primarily the right slope of the basin, which is continuing to eat away at the right side of the slope. Although this condition of sloughing and erosion of the discharge basin is not considered to be detrimental to the performance of the dam, continued erosion could lead to undermining of the principal spillway bent.

PRINCIPAL SPILLWAY. DISCHARGE PIPE.

1. The plunge pool should be checked after each severe storm for scour and for possible undermining of the spillway bent. Should excessive scour occur, the plunge pool should be rehabilitated.

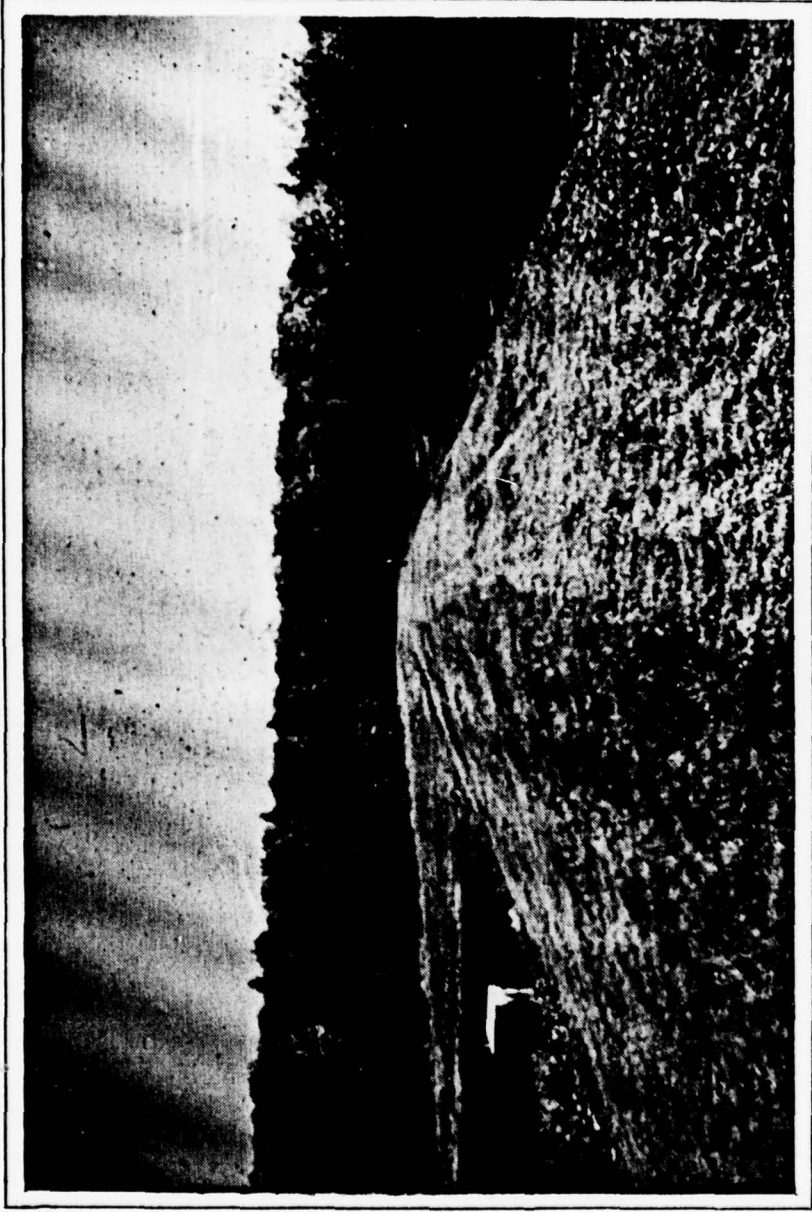
PHOTOGRAPH NO. 3

OVERVIEW OF DAM AND UPSTREAM SLOPE.

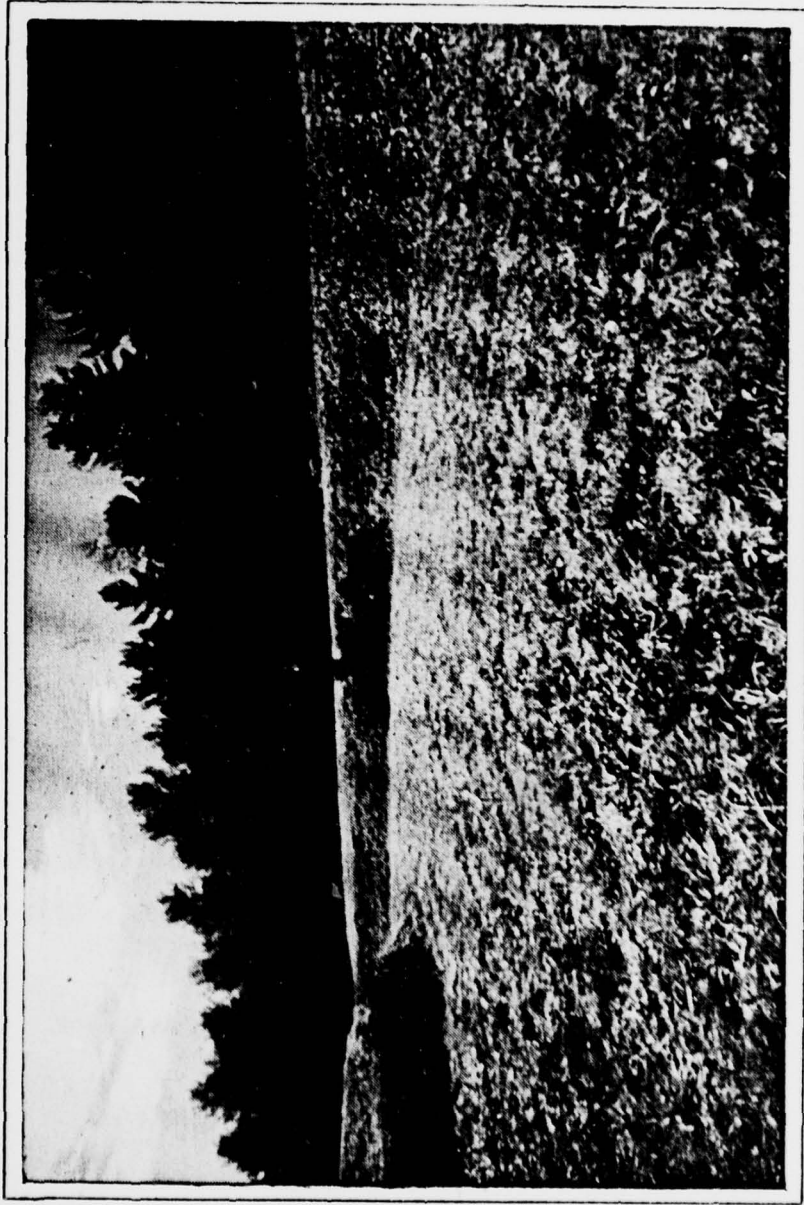
EMERGENCY SPILLWAY LOOKING  
DOWNSTREAM.

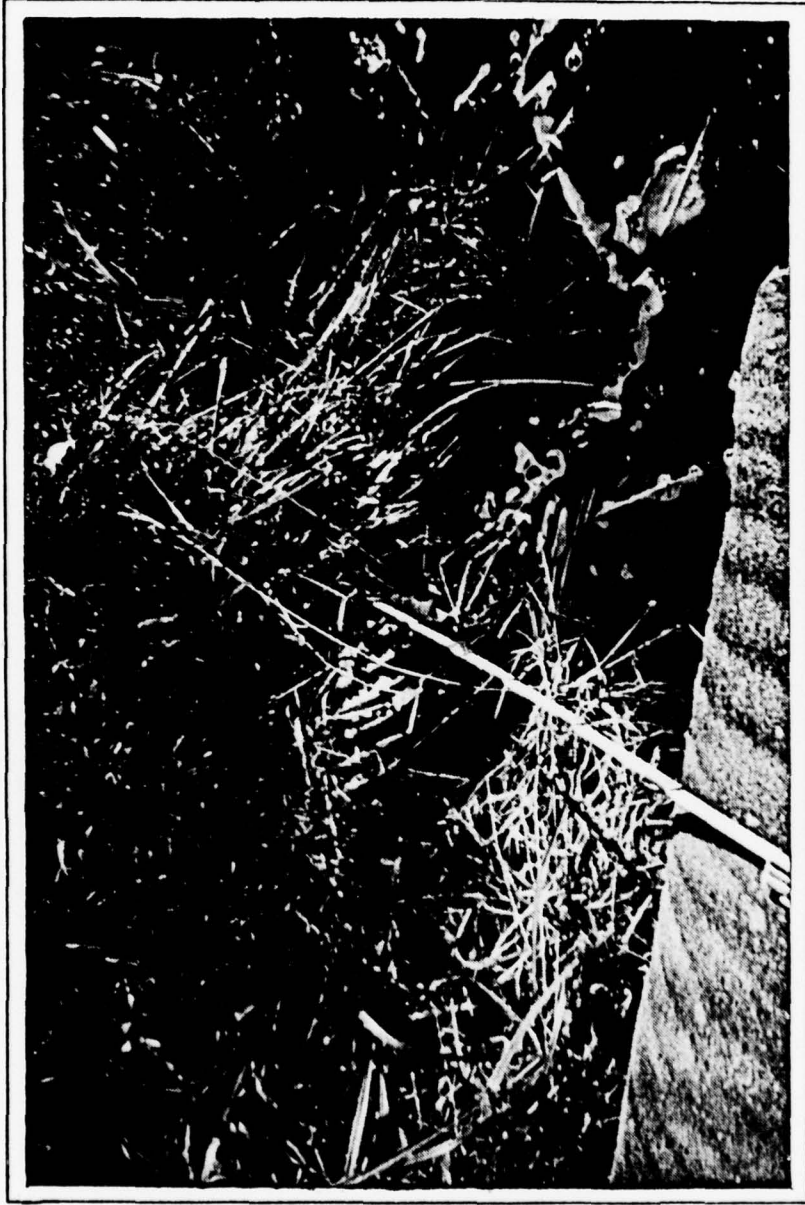
PHOTOGRAPH NO. 7

*Two - 6 inch CMP were observed on each side of the principal spillway outlet pipe. Both were seeping water at rates of less than 0.01 gpm.*

VIEW OF 6 INCH ID EMBANKMENT  
DRAINAGE PIPE LOCATED ON LEFT  
SIDE OF PRINCIPAL SPILLWAY  
DISCHARGE PIPE.

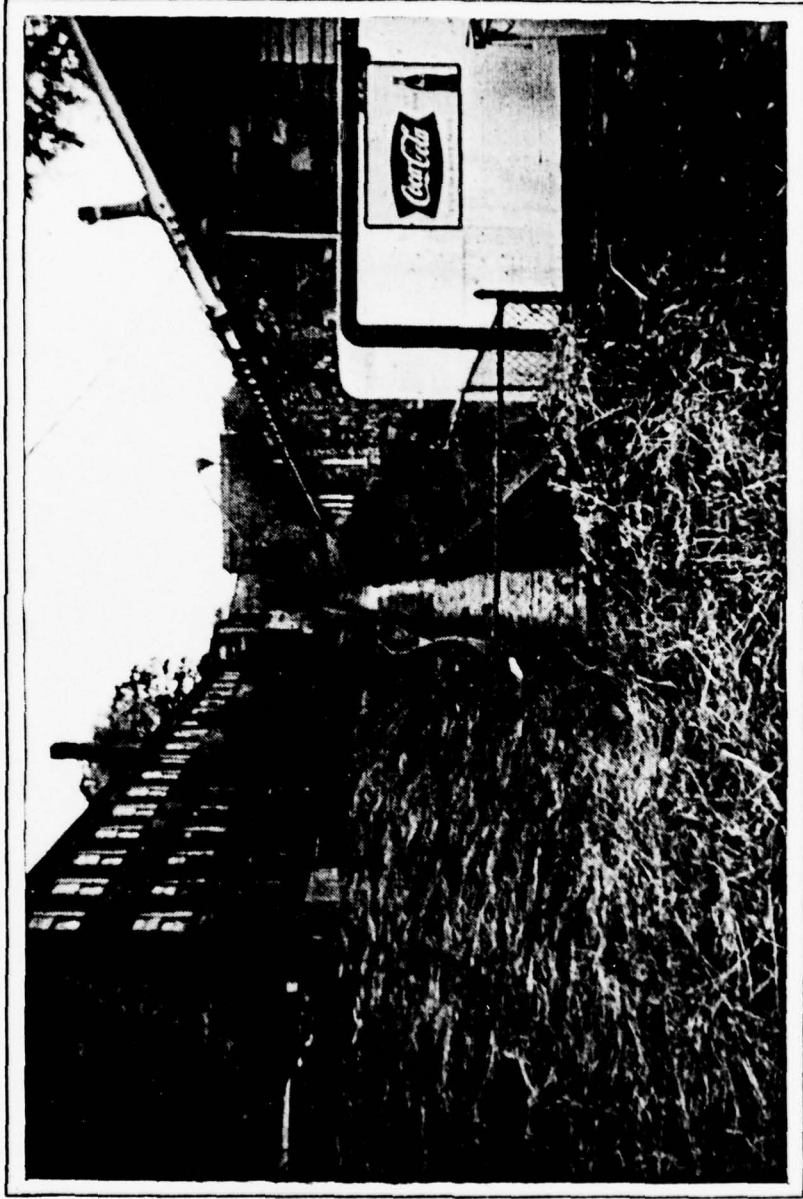
PHOTOGRAPH NO. 12

DISCHARGE CHANNEL THROUGH TOWN.
