Glendale Dam, NDI ID Number 912.
Susquehanna Basin, Beaver Dam Run,

Cambria County, Pennsylvania.
Phase I Inspection Report.

PHASE I REPORT
NATIONAL DAM INSPECTION PROGRAM

GLENDALE DAM
NDI I.D. NO. 912
AUGUST 9, 1978

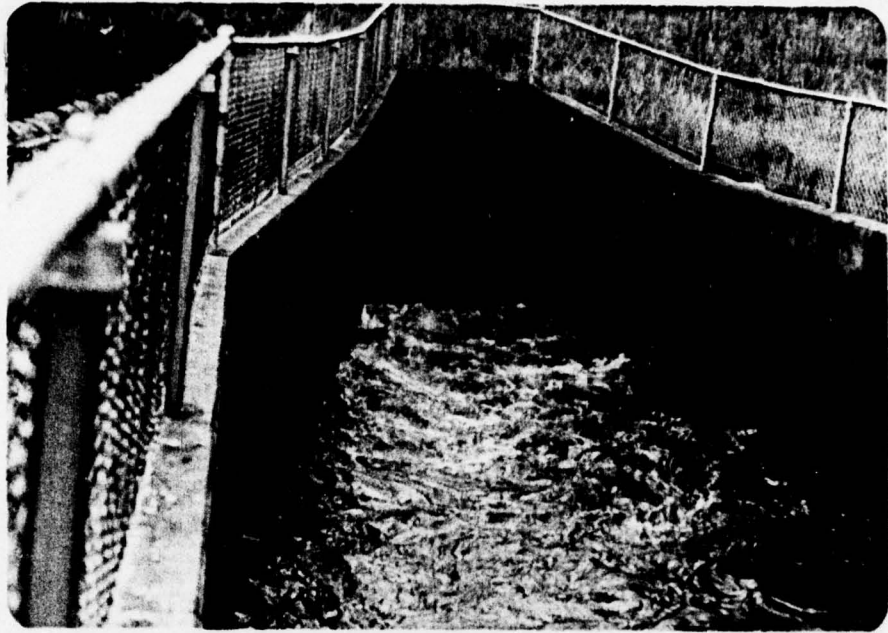
Photograph No. 7
Outlet pipe discharging.
