**CHEMUNG RIVER BASIN
WAVERLY LOWER
RESERVOIR DAM
TIOGA COUNTY, NEW YORK
INVENTORY NUMBER NY 623**

**PHASE 1
INSPECTION REPORT
NATIONAL DAM
SAFETY PROGRAM**

**L. ROBERT KIMBALL and ASSOCIATES
615 W. Highland Ave. Ebensburg, Pa.**

**DEPARTMENT OF THE ARMY
NEW YORK DISTRICT, CORPS OF ENGINEERS
NEW YORK, NEW YORK**

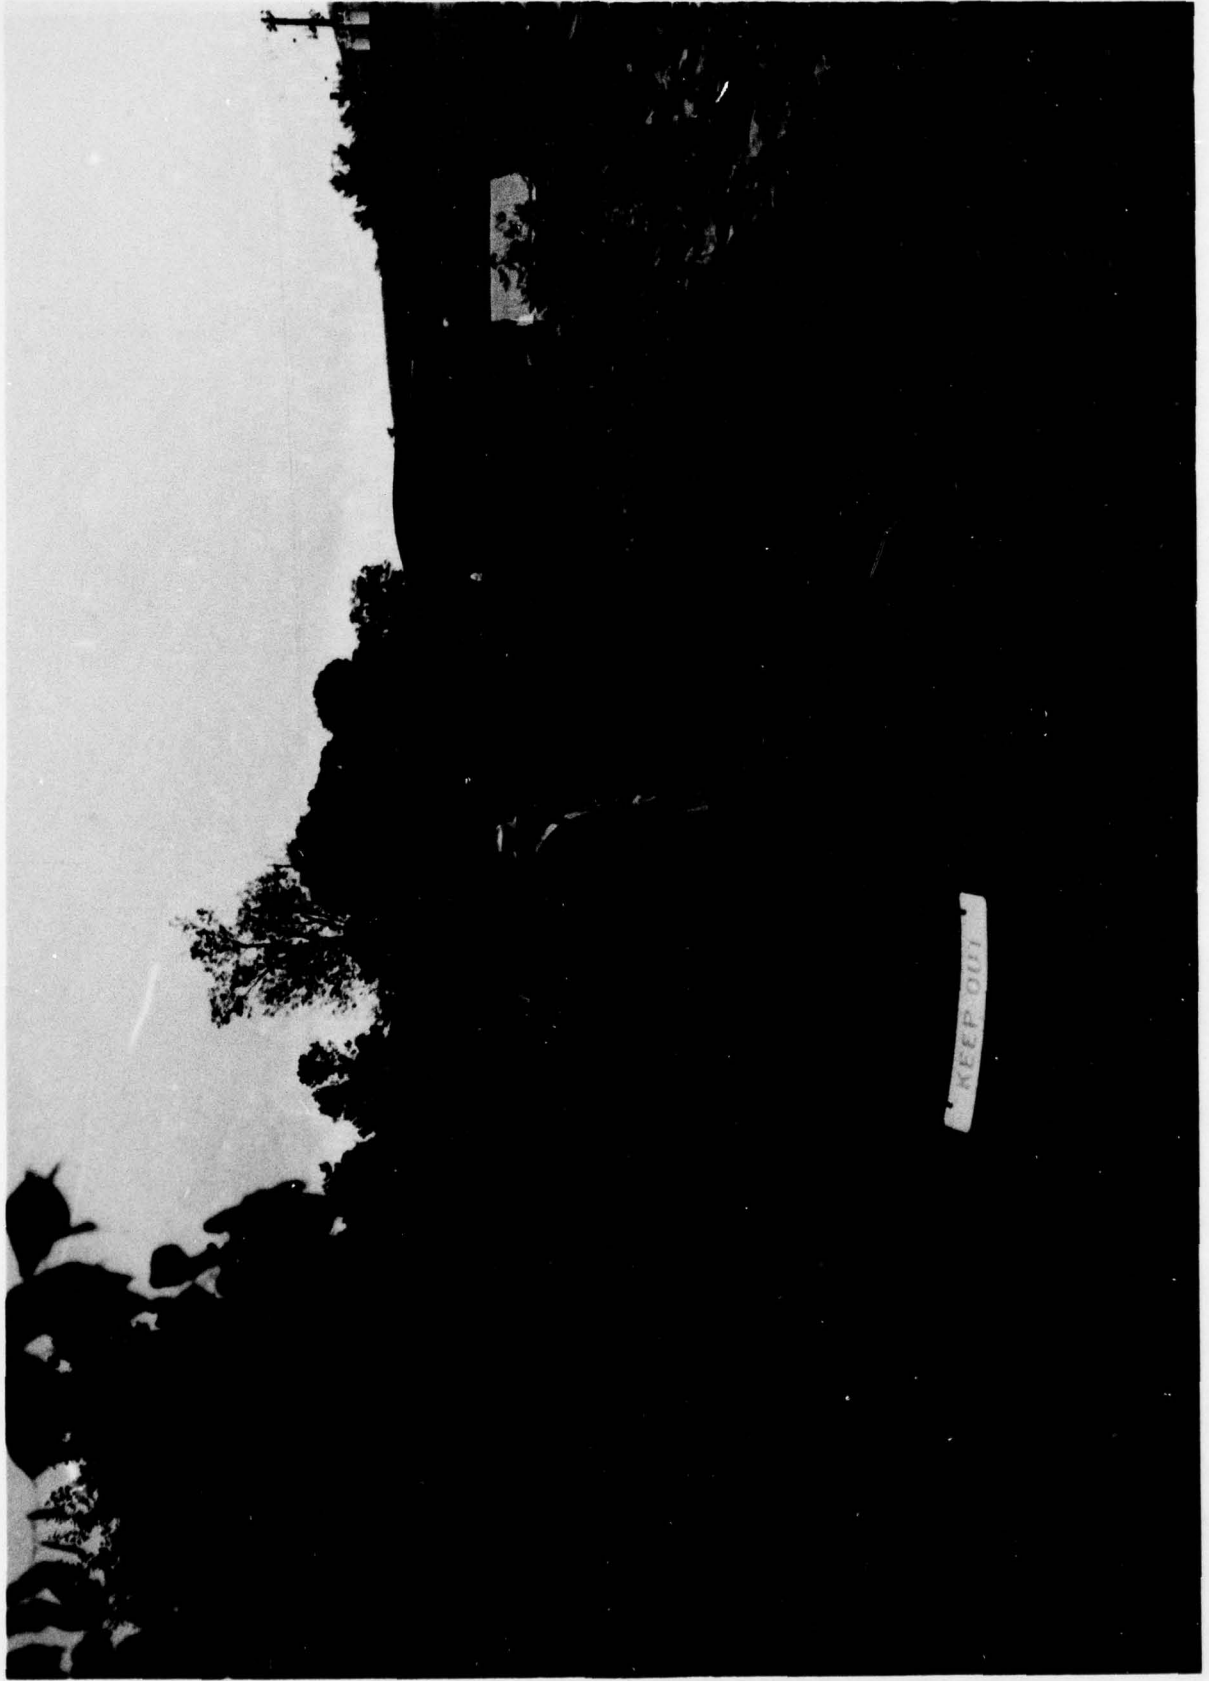
OVERVIEW FROM LEFT ABUTMENT

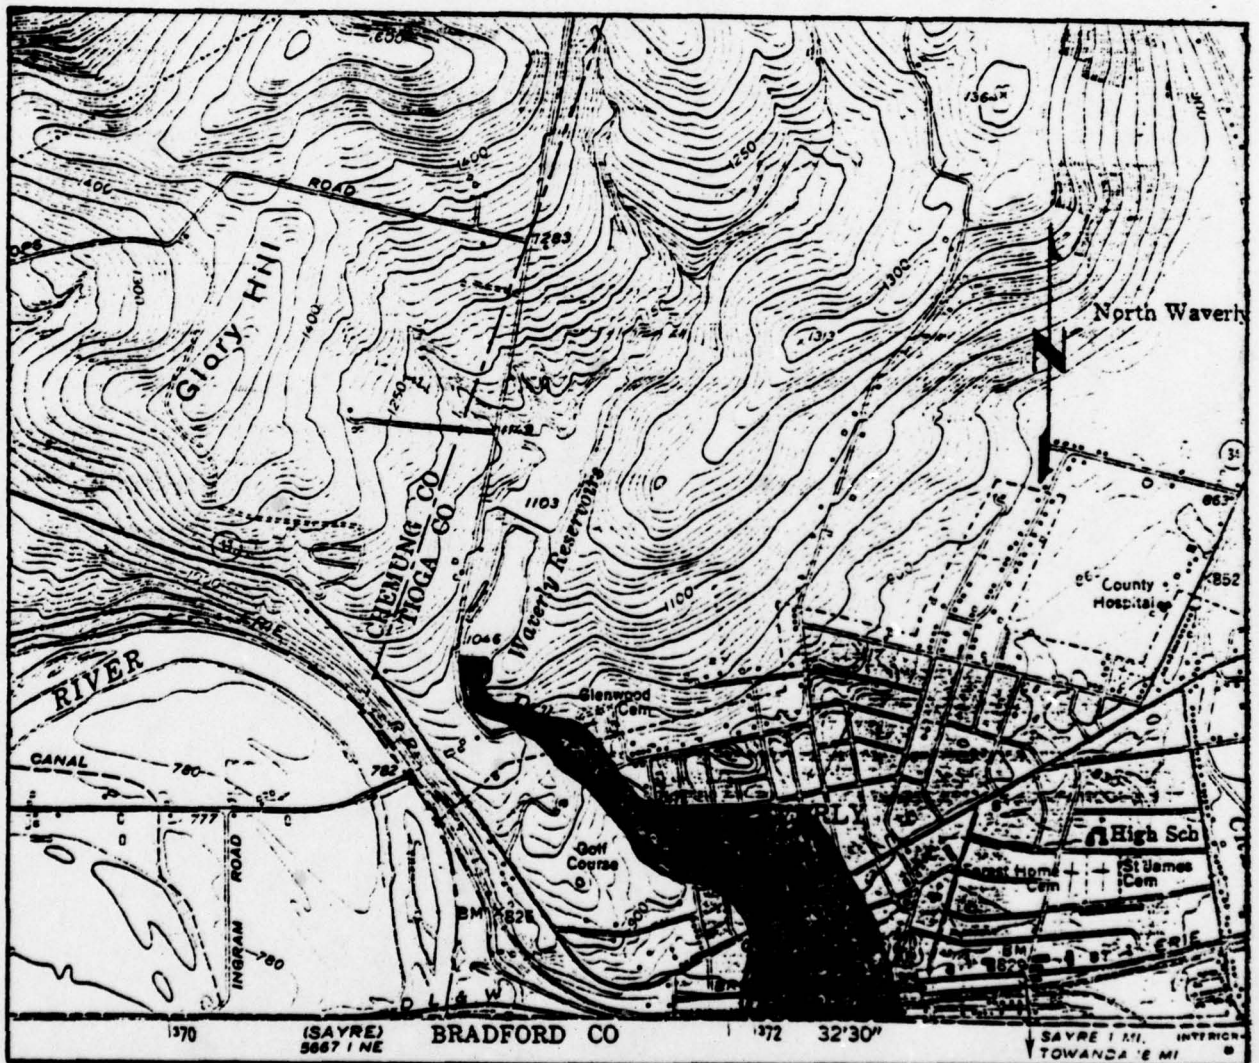
WAVERLY LOWER RESERVOIR DAM FULL BREACH

The town of Waverly Village is located 2,000 feet southwest of the dam. For both total and partial failure, the southwestern portion of the town was inundated by an average of 5 feet of water for total failure and 4 feet for partial failure.
