UPPER KITTANNING DAM

NDI I.D. NO: 530

PHASE I INSPECTION REPORT

Upper Kittanning Dam, NDI ID Number 530,  
Susquehanna River Basin, Burgoon Run,  
Blair County, Pennsylvania. Phase I.  
Inspection Program.

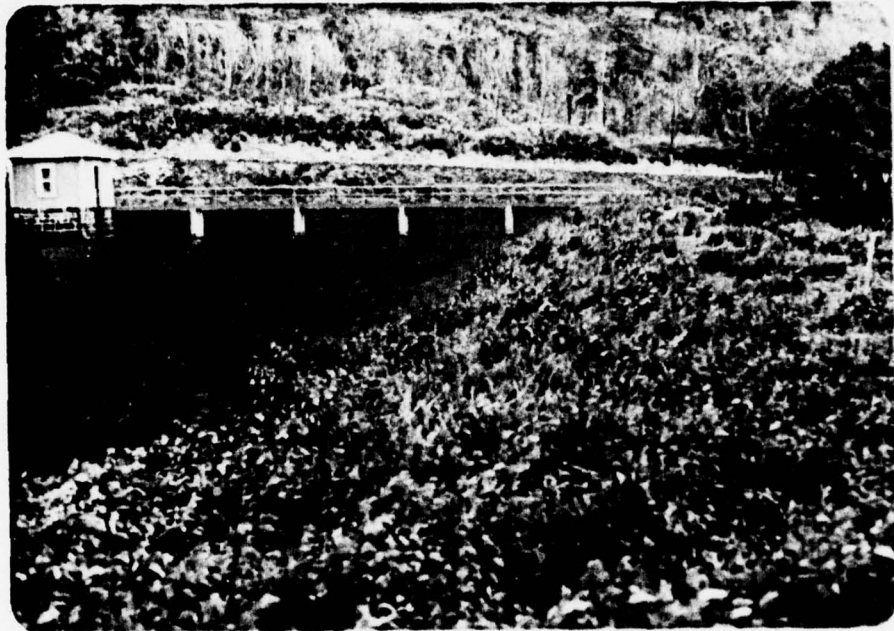
Upstream Face

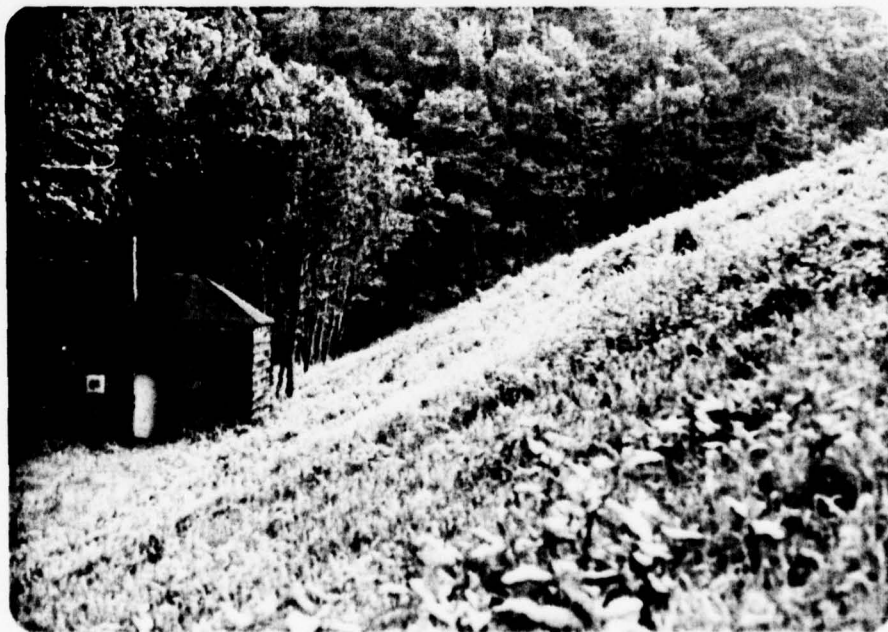
Downstream Face

4.2 Maintenance of the Dam. The overall maintenance condition of the dam is considered to be fair. More frequent removal of brush from the downstream face of the dam is required.

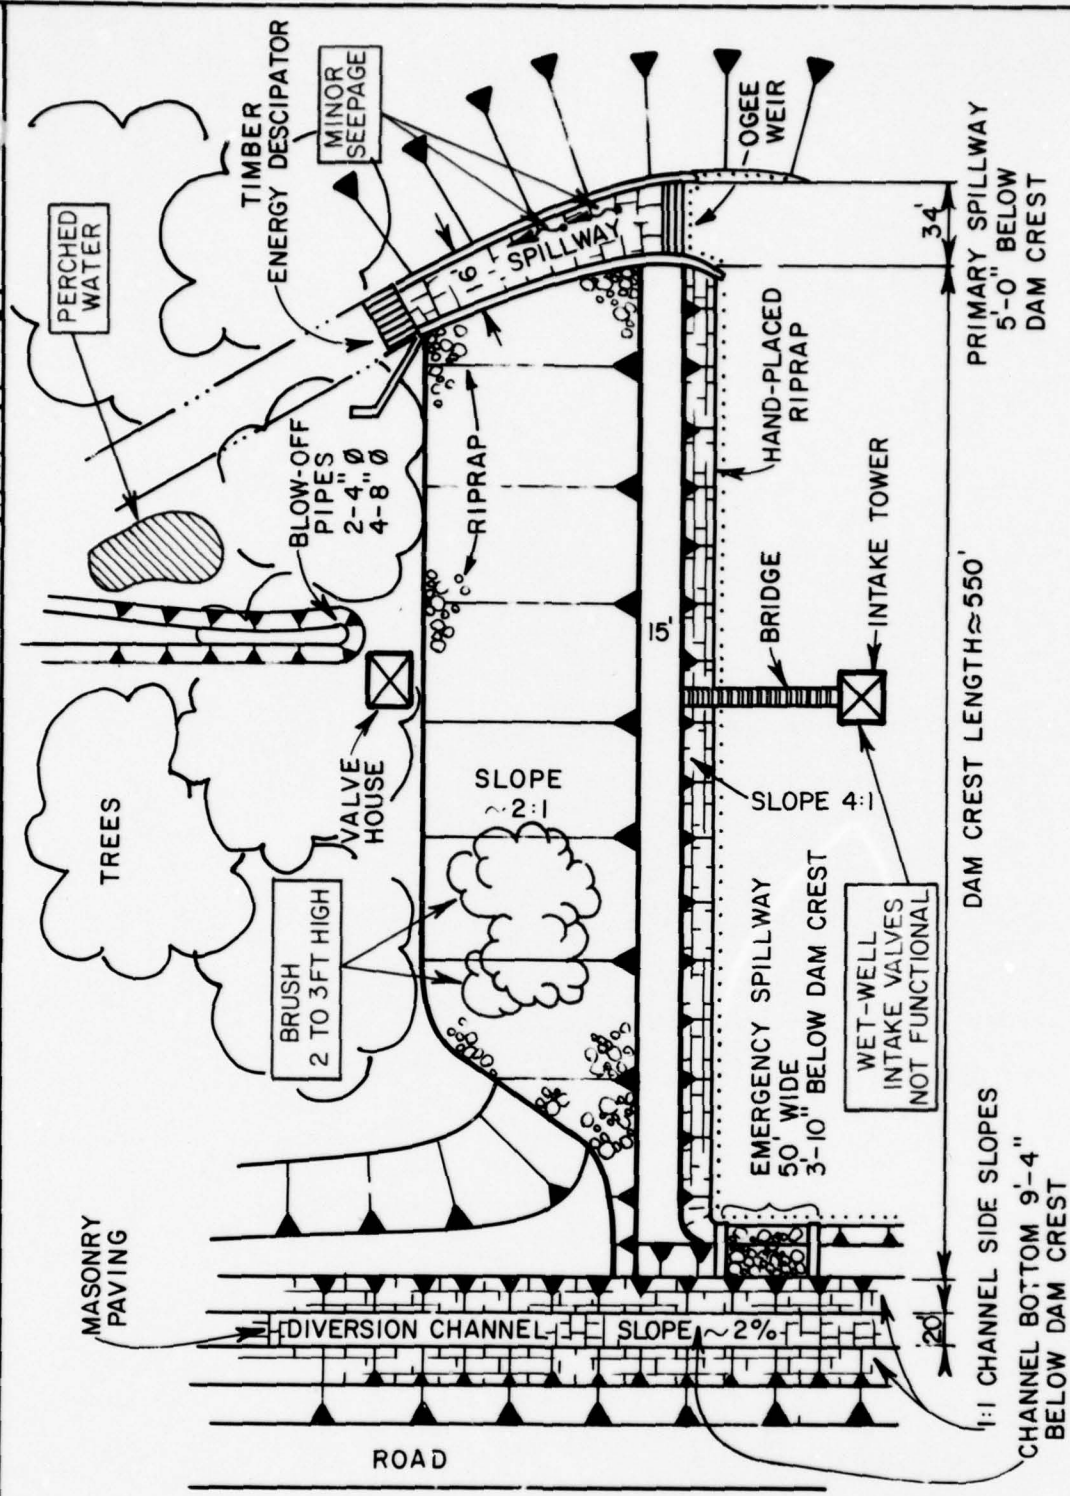
PLATE 7  
 UPPER KITTANNING DAM NDI ID:530  
 GENERAL PLAN  
 FIELD INSPECTION NOTES  
 FIELD INSPECTION DATE : AUGUST 8, 1978

VISUAL EXAMINATION OF	OBSERVATIONS	REMARKS OR RECOMMENDATIONS
JUNCTION OF EMBANKMENT AND ABUTMENT, SPILLWAY AND DAM	NO VISUAL SIGNS OF DISTRESS, NO SEEPAGE.	
ANY NOTICEABLE SEEPAGE	PERCHED WATER ABOUT 100-FT DOWN STREAM OF TOE. NO NOTICABLE SEEPAGE.	SEE PLATE - 7 FOR LOCATION.
STAFF GAGE AND RECORDER	NONE	
DRAINS	NONE

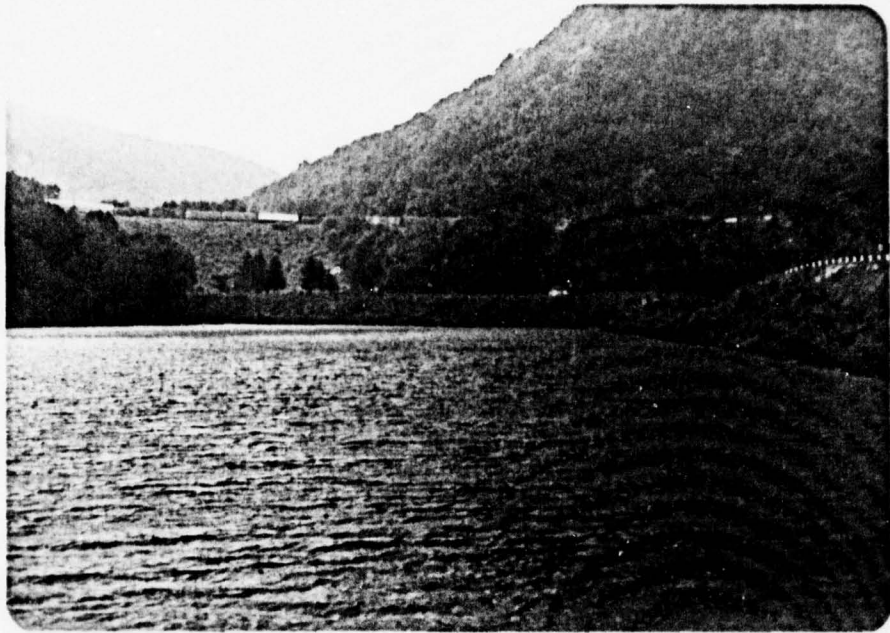
Photograph No. 1  
Reservoir (horseshoe curve in background).

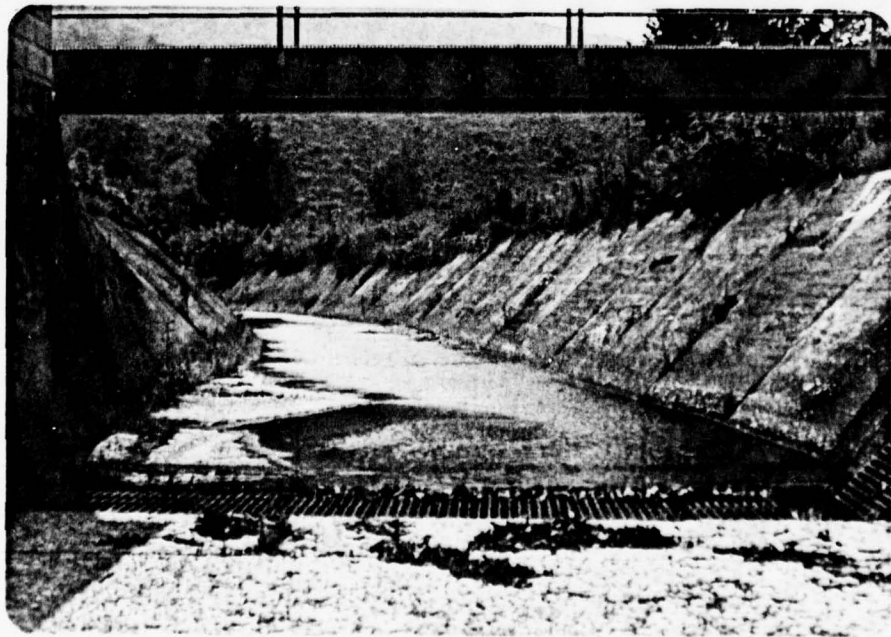
Photograph No. 2  
Diversion channel (looking upstream,  
foreground reservoir intake).

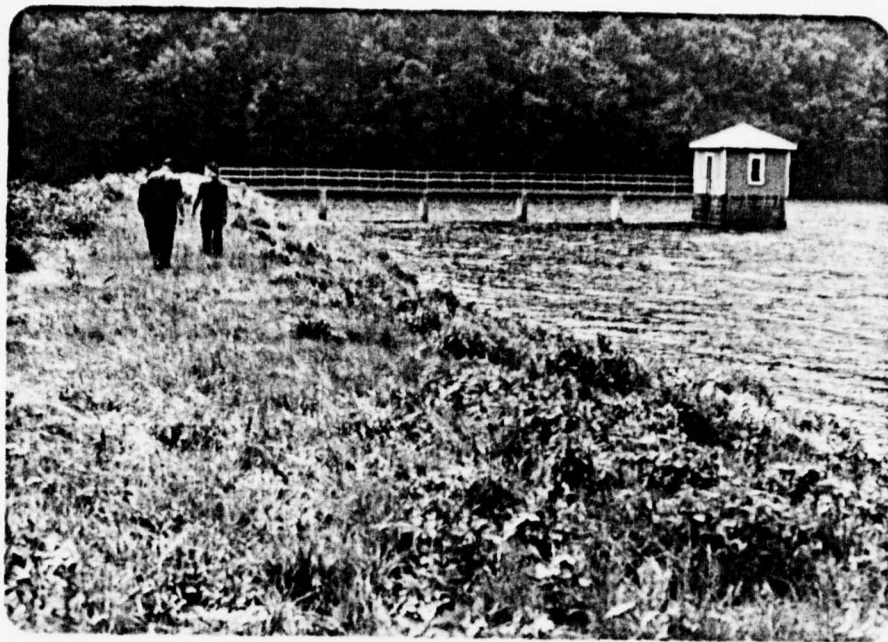
Photograph No. 3  
Crest (looking south).

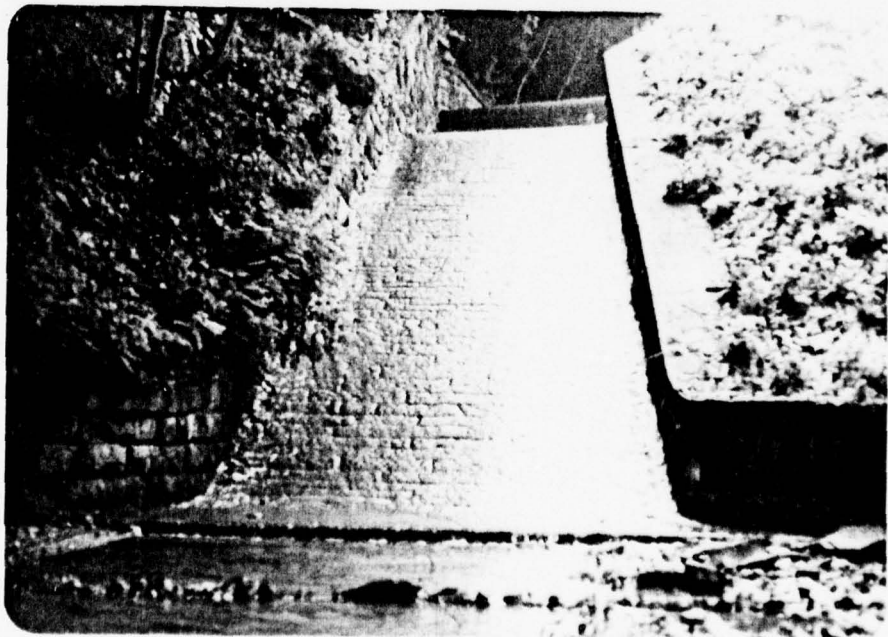
Photograph No. 4  
Primary spillway chute.

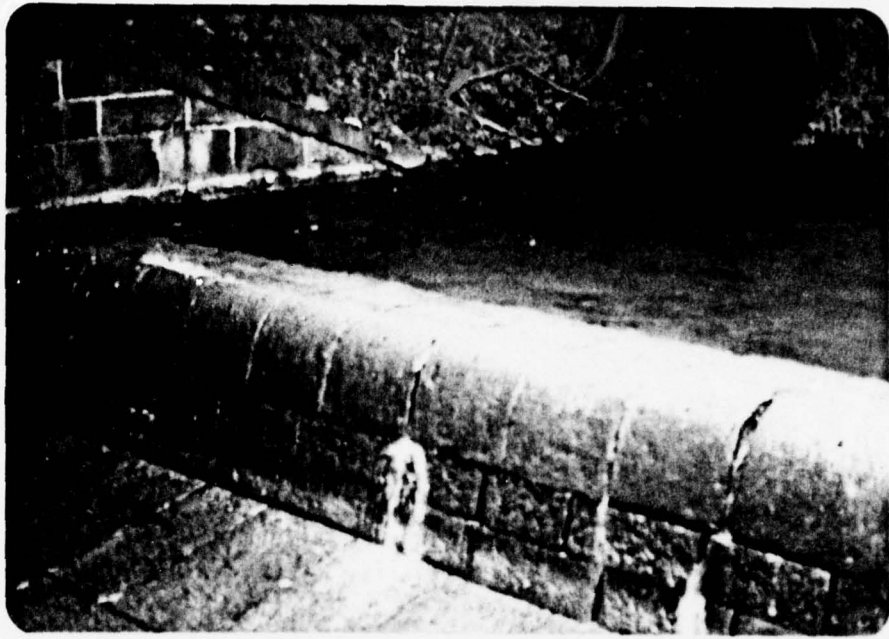
Photograph No. 5  
Crest of primary spillway.

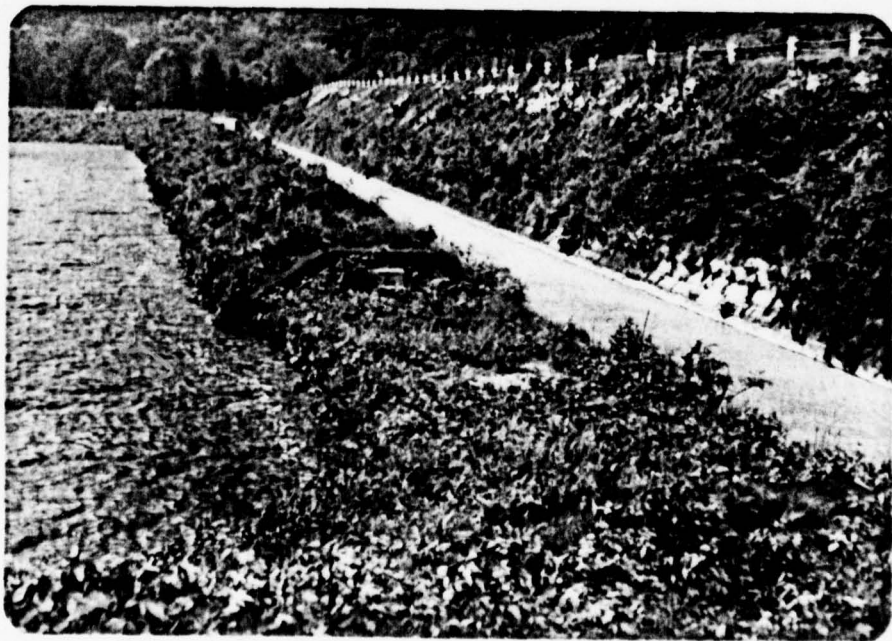
Photograph No. 6  
Emergency spillway and diversion channel.

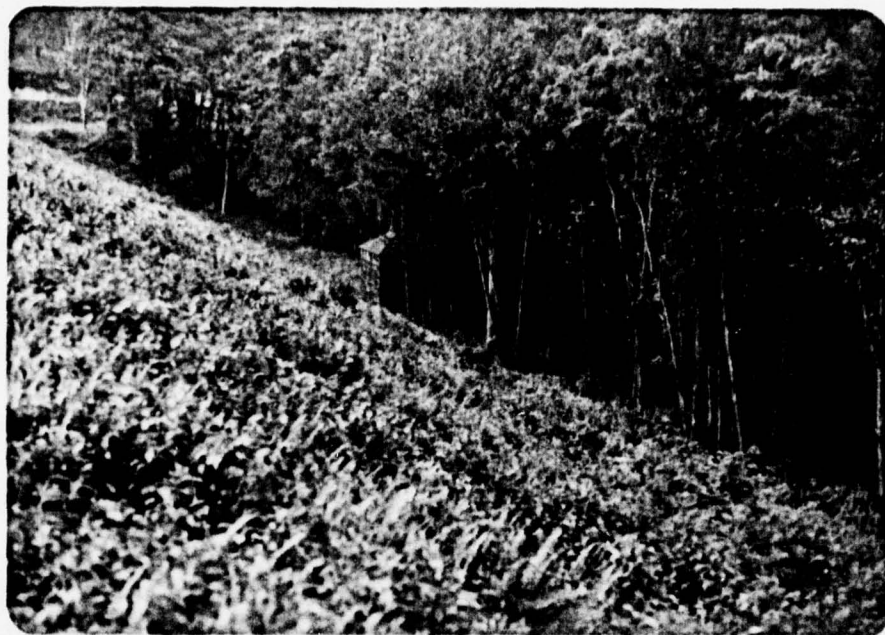
4.5 Evaluation. The operational condition of the dam is considered to be poor. It is reported that the valves located at the intake tower to control flow through the blow-off and supply lines are not operational. Flow from these pipes is presently controlled by valves located at a valve house at the toe of the dam.

Photograph No. 7  
Valve house.

3. It is recommended that the owner immediately evaluate the operational condition of the upstream valves, perform necessary maintenance, and adequately maintain the equipment. It is also recommended that necessary steps be taken to evaluate the structural integrity of the pipes through the embankment.
4. Brush and trees should be removed from the downstream face of the dam and for a distance of at least 50 feet below the toe of the dam to permit adequate inspection of these areas in future inspections.
5. It is recommended that the owner be advised that the dam and appurtenant structures be inspected regularly and necessary maintenance should be performed.

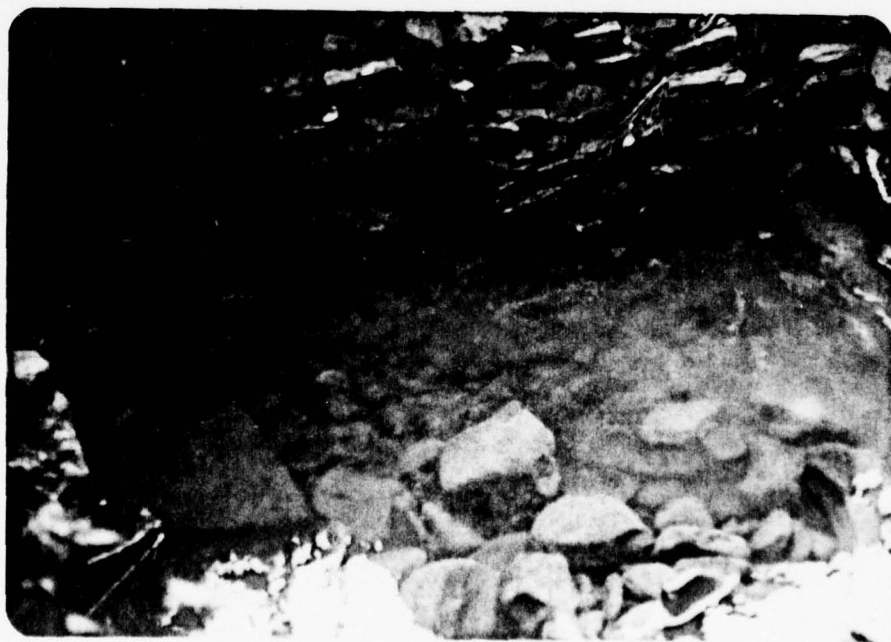
Photograph No. 8  
Blow-off pipe (four 4-inch-diameter  
and two 8-inch-diameter pipes).

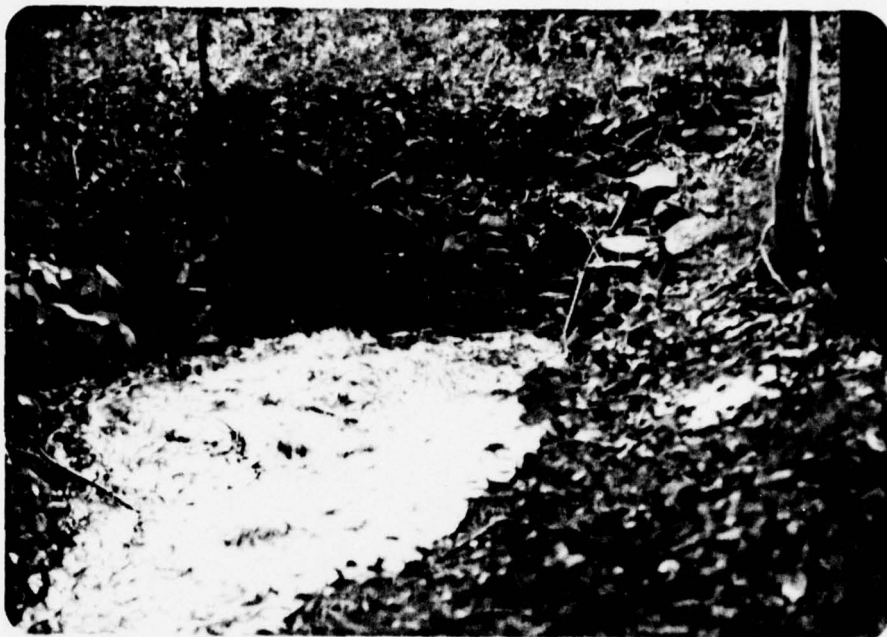
Photograph No. 9  
Blow-off pipes discharging.

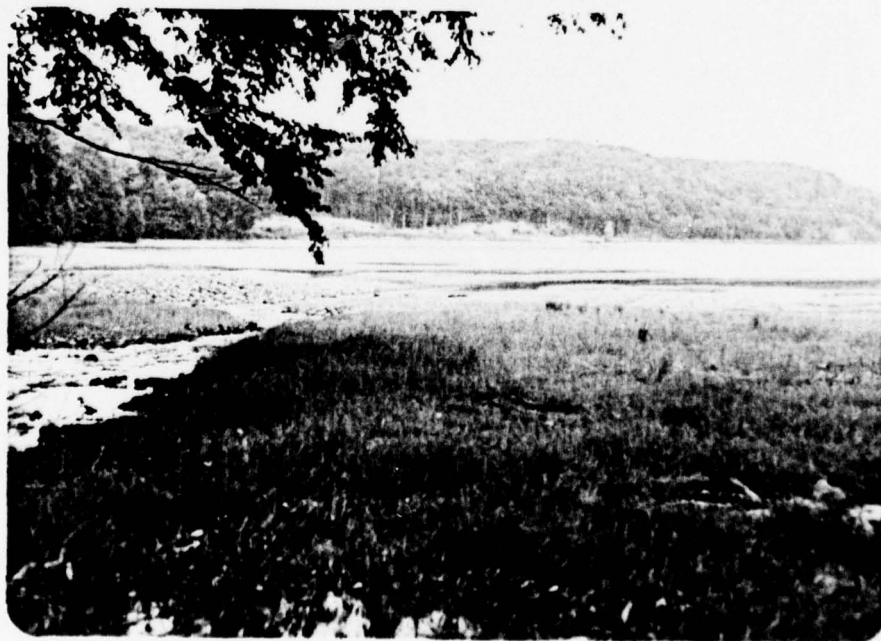
Photograph No. 10  
Downstream: Lower Dam.
