LAKE ALTOONA DAM

NDI I.D. NO: 532

PHASE I INSPECTION REPORT

LAKE ALTOONA DAM
NDI I.D. NO. 532
AUGUST 9, 1978

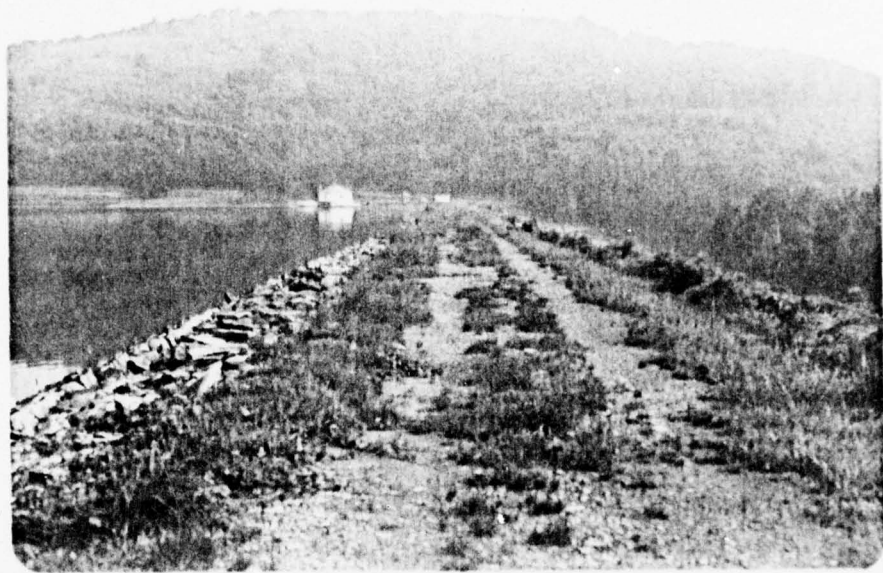
Photograph No. 1
Crest (looking north).

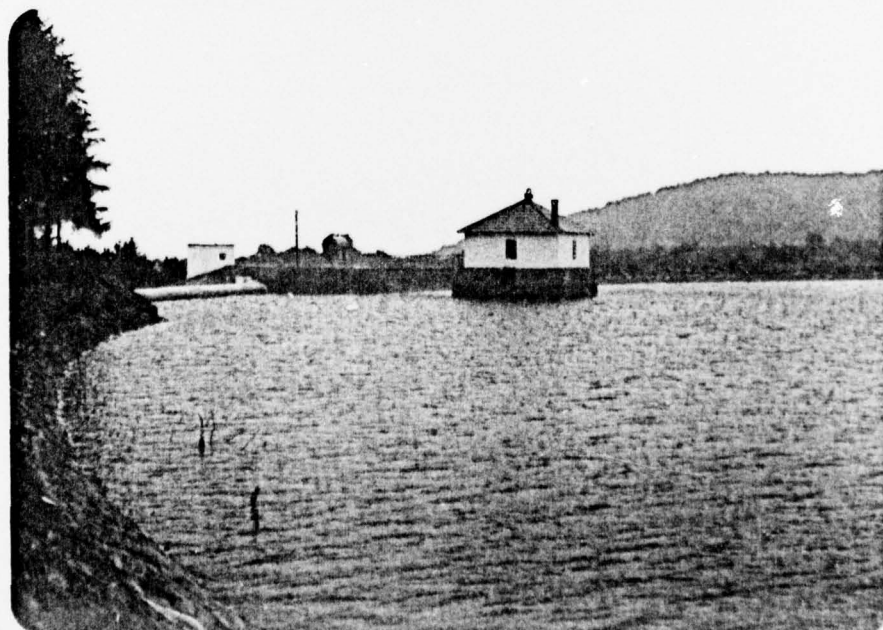
Photograph No. 2
Intake tower and spillway entrance.

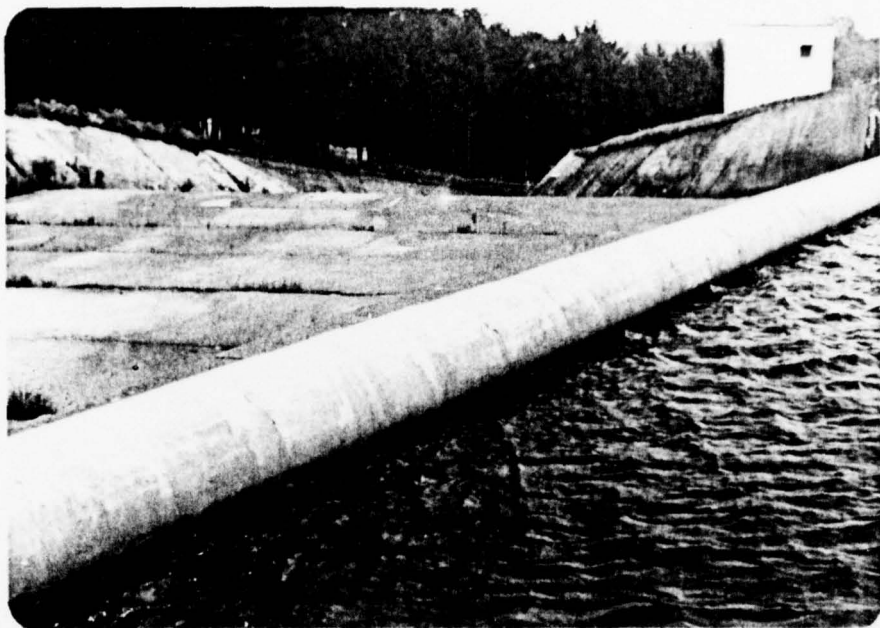
Photograph No. 3
Fabridam spillway gates.

5. Due to the unique nature of the Fabridam spillway gates and since a sudden release of water in the event of their failure may cause property damage downstream by overflowing the channel in a residential area of Altoona, this appurtenance should be frequently inspected by personnel experienced in design, construction, maintenance, and operation of such equipment.

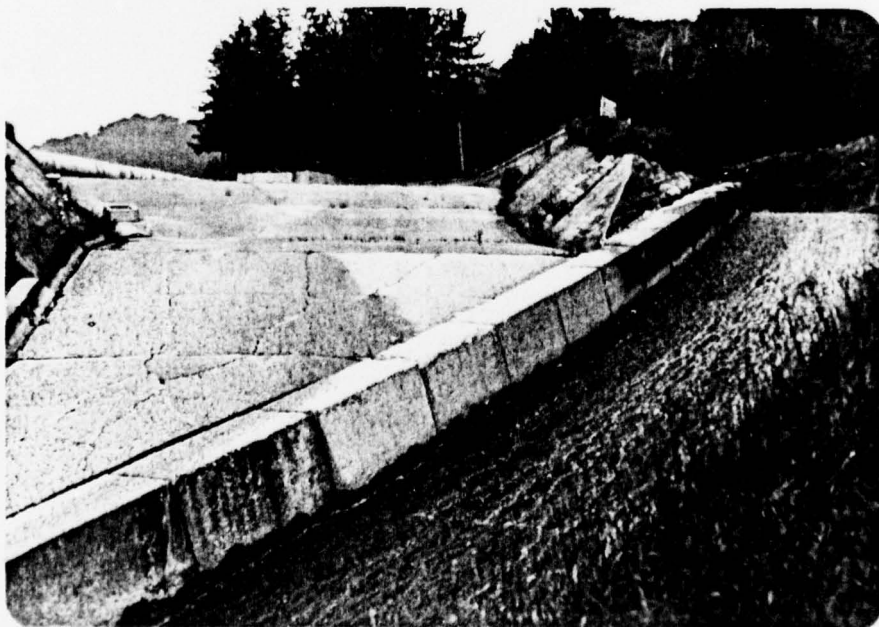
Photograph No. 4
Spillway chute.

4. The portion of the spillway wall that was reported as removed during the construction of the Fabridam gates should be replaced to eliminate the potential threat of high flows from the spillway discharging over the embankment and causing erosion of the downstream face of the dam.

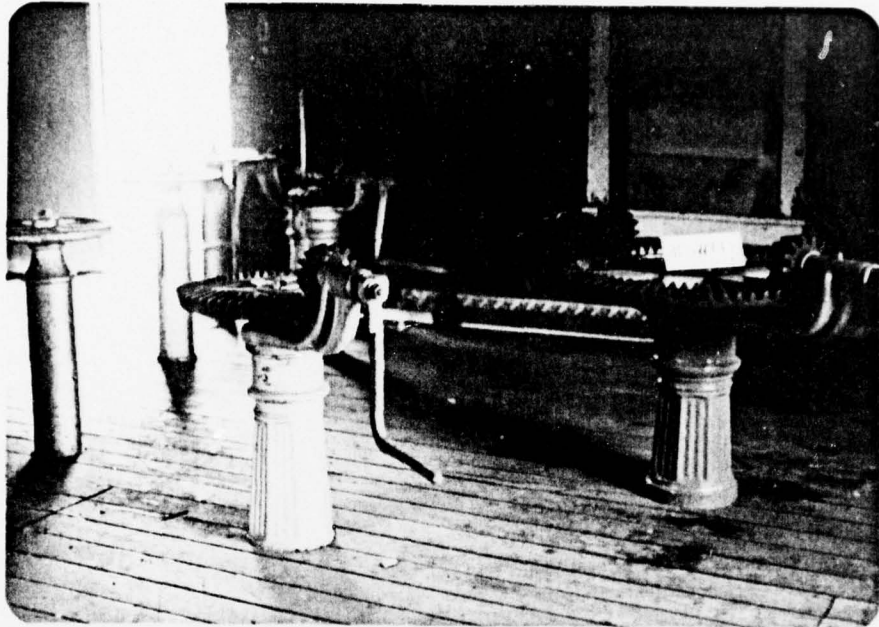
4.3 Maintenance of Operating Facilities. City maintenance personnel reported that the blow-off valve has not been functional. Visual observations indicate that the operating equipment is in poor condition.

Photograph No. 5
Valve controls at intake tower.

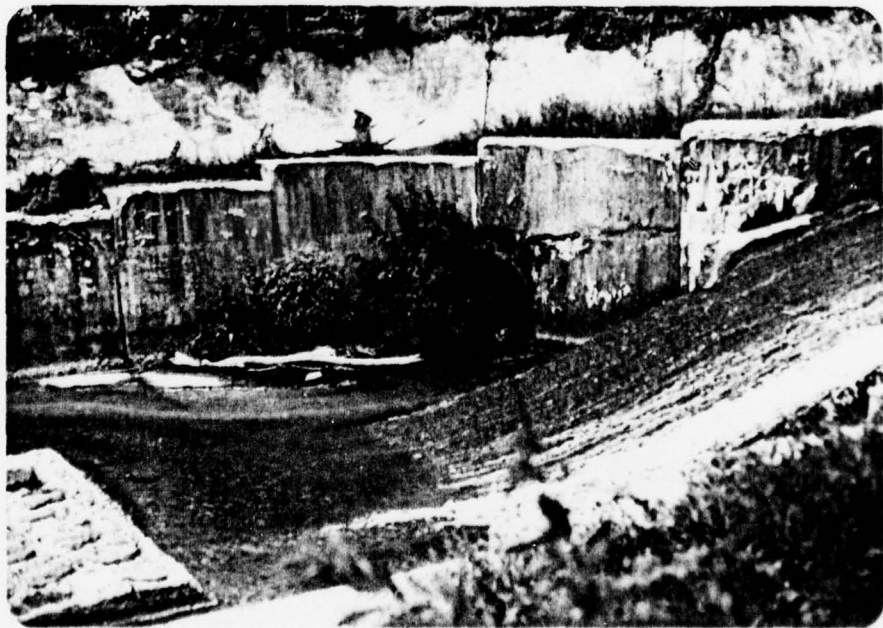
The condition of the operational facilities is considered to be poor. It was reported that the blow-off valve is not functional.

Photograph No. 6
Blow-off pipe.

1. The owner should initiate additional hydrology and hydraulic studies to more accurately ascertain the spillway capacity and to determine the nature and extent of remedial measures required to increase the spillway capacity.
2. It is recommended that the owner immediately evaluate the operational condition of the blow-off pipe valve and perform necessary maintenance and adequately maintain the equipment.

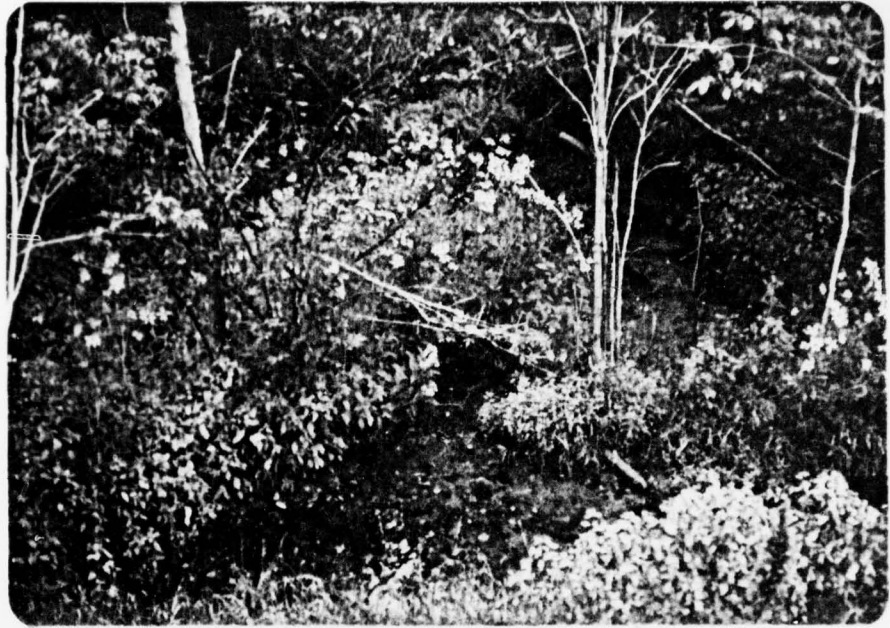
Photograph No. 7
Perched water along the toe.

3. Brush and trees below the toe of the dam should be cleared to the limit of the ponded area and this area regraded to drain the ponded water. The quantity of flow from this area should be measured and recorded, and the turbidity of the flow should be noted. If flow increases, a detailed study and necessary remedial action should be undertaken.

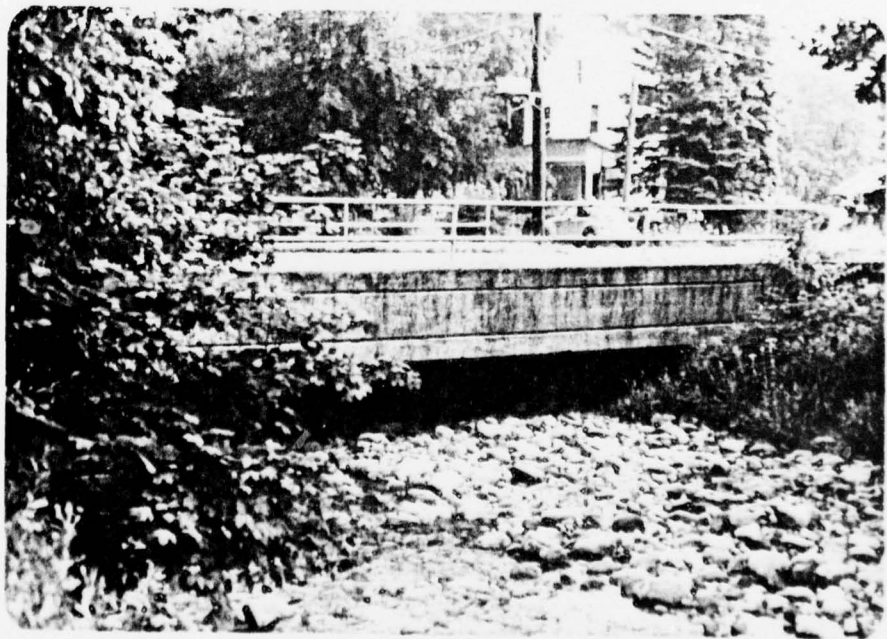
Photograph No. 8
Typical downstream channel (through Altoona).
