SILVER CREEK DAM

NDS ID NO. PA-00665
DER ID NO. 54-23

PHASE I INSPECTION REPORT

Prepared by
GANNETT FLEMING CORDDRY AND CARPENTER, INC.
Consulting Engineers
Harrisburg, Pennsylvania 17105

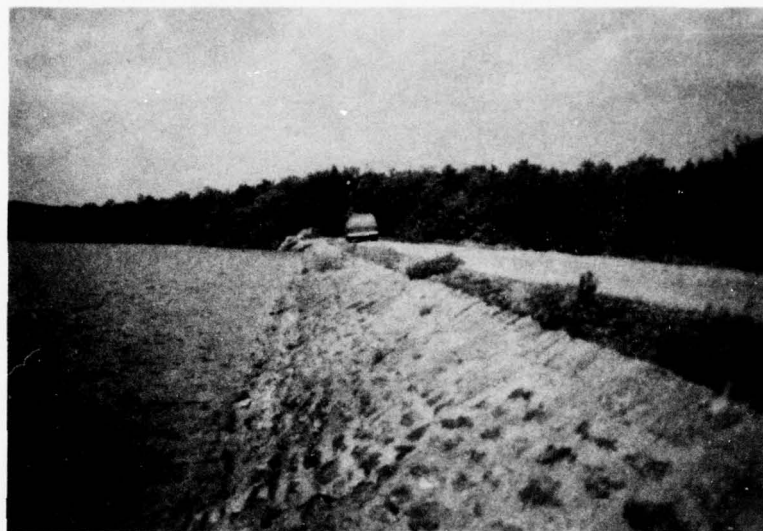
(2) The mortar between the riprap on the upstream slope was cracked along the water line (Photograph A). Near the left abutment, the cracking was accompanied by differential movement of up to 3 inches and by displacement of some of the stones (Photograph D). At other areas, the riprap was intact and in good condition (Photograph A). The slush-grouted riprap ends about 100 feet from the right abutment. The riprap beyond the grouted riprap is intact, but it is overgrown with ferns and light brush (Photograph C). The Owner said that the cause of the damage to the riprap on the upstream slope is ice.

(2) The cracking of the mortar between the riprap along the water line is a condition that will cause progressive deterioration of the slope protection. At the areas where the differential movement and stone displacement has occurred, the deterioration has already progressed to the extent of being unsatisfactory. At the right end of the dam where the riprap is not grouted, there were no signs of unsatisfactory performance. However, the growth of brush among the riprap is undesirable.

A. Upstream Slope of Embankment.
View Toward Left Abutment.

(1) Repair damaged riprap on upstream slope.

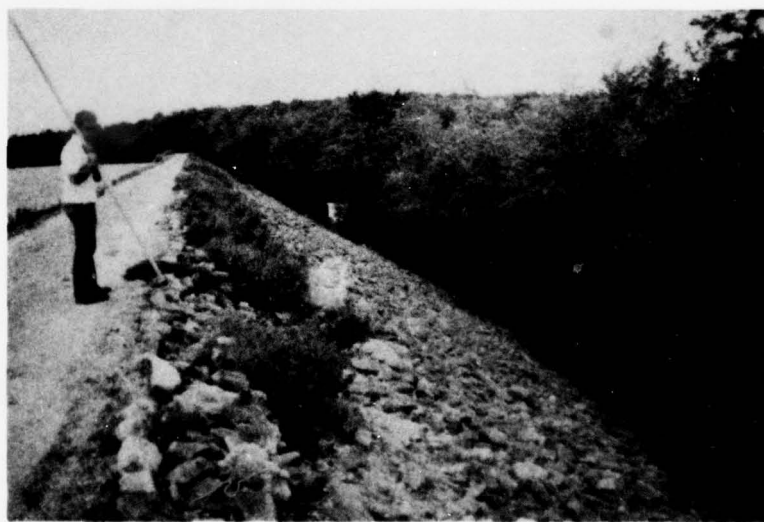
(3) The riprap on the downstream slope of the embankment was generally in good condition except that light brush was growing in some areas (Photograph B).

B. Downstream Slope of Embankment.
View Toward Left Abutment.

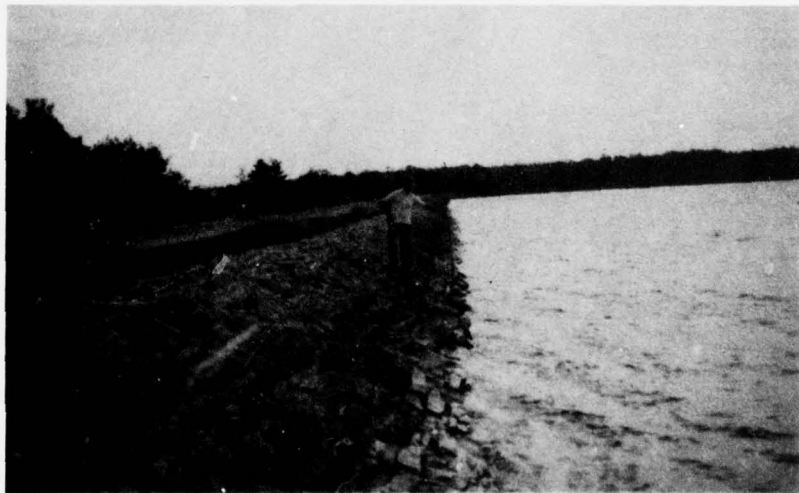
D. Damaged Riprap Near Left Abutment.

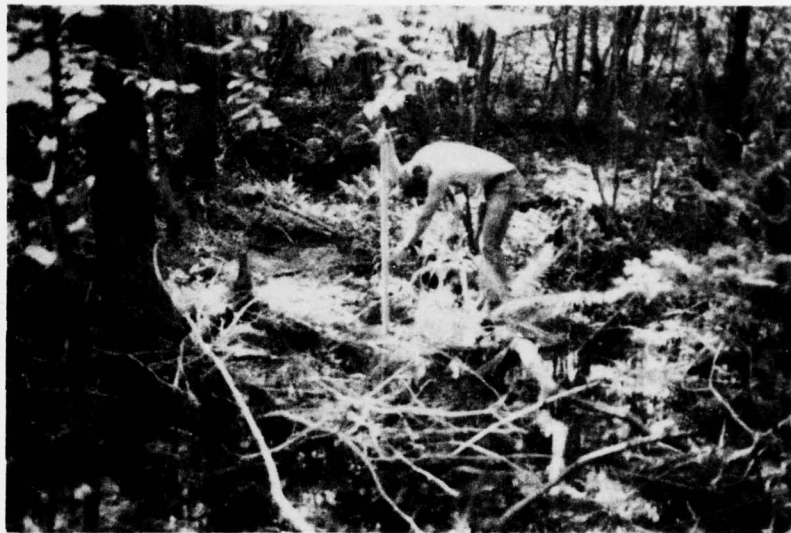
(4) The eight wet areas that were observed during this inspection are of concern. Research of records of previous inspections indicates that the first seepage developed about 1927, at which time the dam was 77 years old. The first seepage that developed was along the toe of the embankment to the right of the gatehouse. Apparently, seepage was first observed to the left of the gatehouse about 1933. Because detailed descriptions of the character and quantity of seepage are not available, it is not possible to determine to what extent the problem has increased. Inspections performed after 1933 indicate that the seepage continued, but the descriptions are somewhat sketchy. It appears that the conditions observed in this inspection are essentially similar to those observed in previous years. However, almost nothing is known about the design or construction of the dam. Consequently, the possible effects of the seepage are difficult to evaluate. During this inspection, three of the eight wet areas appeared to have accumulations of fine soil at their outlets. Although all the flow was clear at the time of the inspection, there might have been some migration of embankment materials in the recent past. The age of the dam, which is 128 years, the lack of information concerning its design and construction, and the extent and character of the seepage combine to create a situation that is of special concern.

E. Wet Area No. 2.

(2) Clear the area along the downstream toe of the embankment and identify all seepage outlets. Construct a system of channels and weirs so that flow measurements can be made for all seepage points and so that any accumulation of soils that might be coming from the embankment can be recognized. Monitor and record data so that any change in conditions is readily apparent.

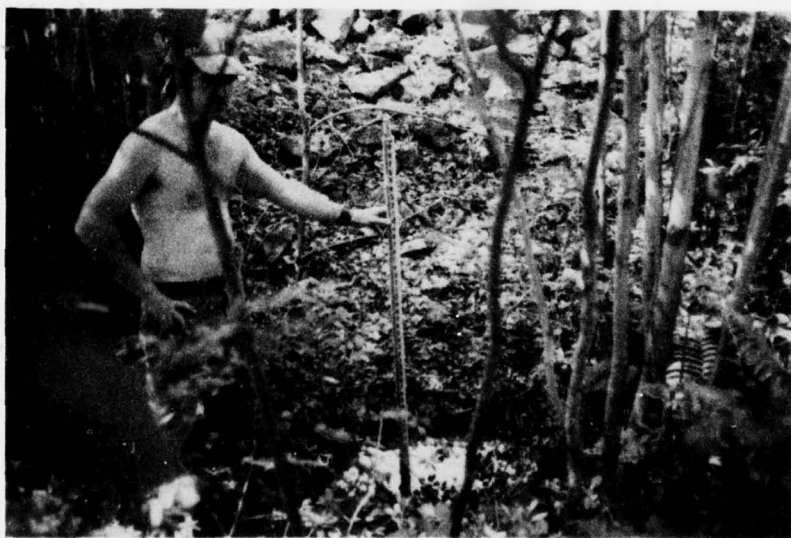
F. Wet Area No. 4.

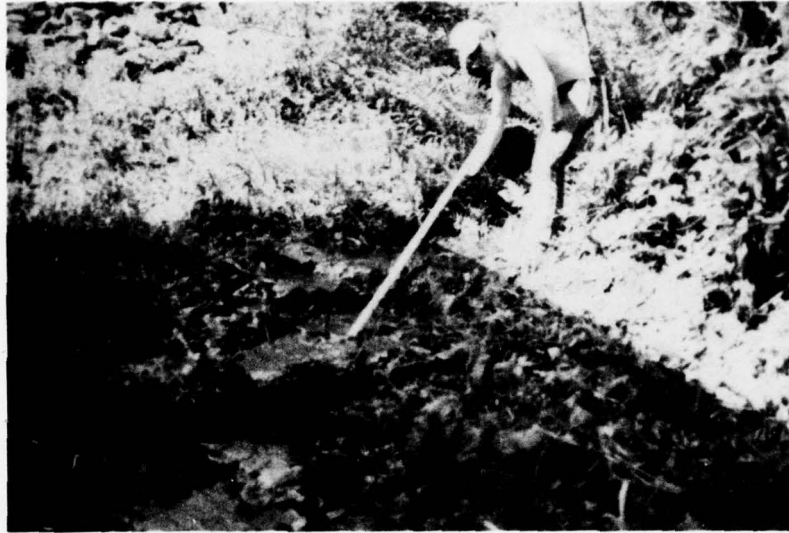
G. Wet Area No. 6.

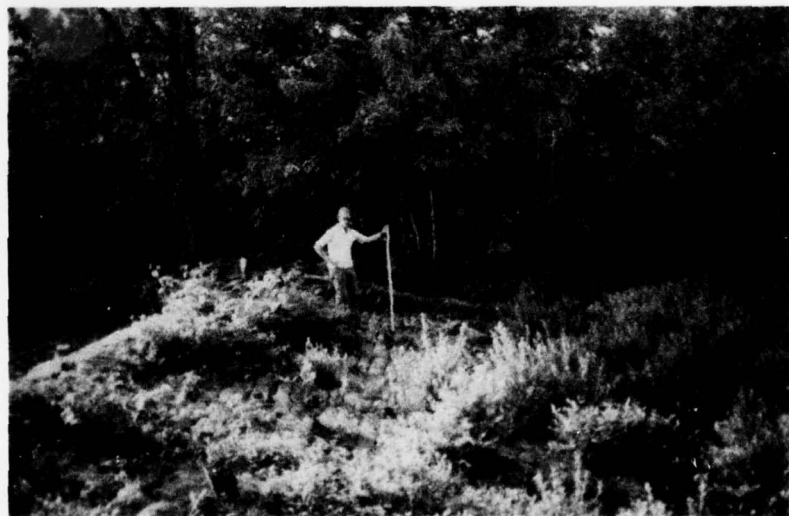
(1) Spillway. The concrete spillway weir was in poor condition. The concrete was cracked at intervals of 3 to 4 feet, and a 3-foot long section was missing near the left end. Light brush was growing in portions of the stone-lined channel, and all of the unlined channel was overgrown with 3-foot high brush (Photograph H). It was also observed that significant flow across the overbanks would occur on both sides of the spillway before the dam would be overtopped.

H. Spillway.

(3) Repair concrete on spillway weir.
