² CRYSTAL DAM

NDS ID NO. PA-00677

³ MUNICIPAL AUTHORITY OF THE TOWNSHIP OF BLYTHE

⁵ PHASE I INSPECTION REPORT
NATIONAL DAM INSPECTION PROGRAM

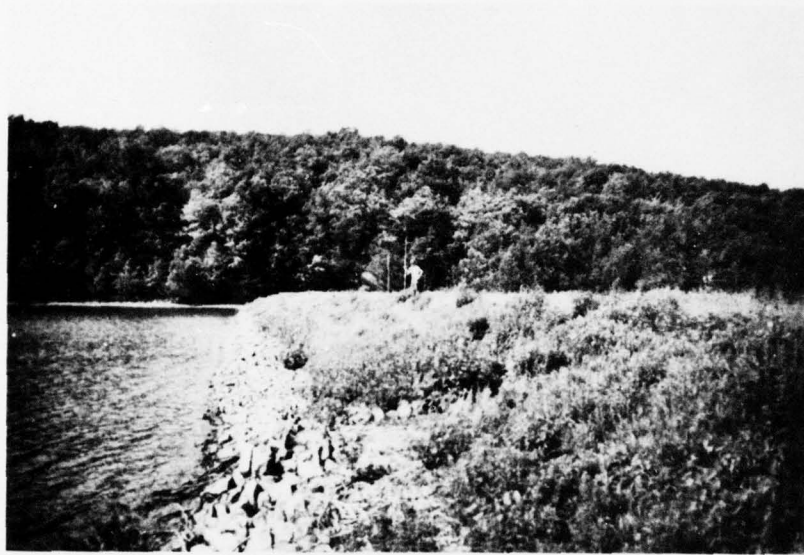
(2) The hand-placed riprap on the upstream slope of the embankment was intact to the top of the dam. The riprap was in good condition except for a growth of ferns and light brush that extended from normal pool level to the top of the dam (Photograph A). Larger brush had apparently been cut earlier this year.

A. Upstream Slope of Embankment.

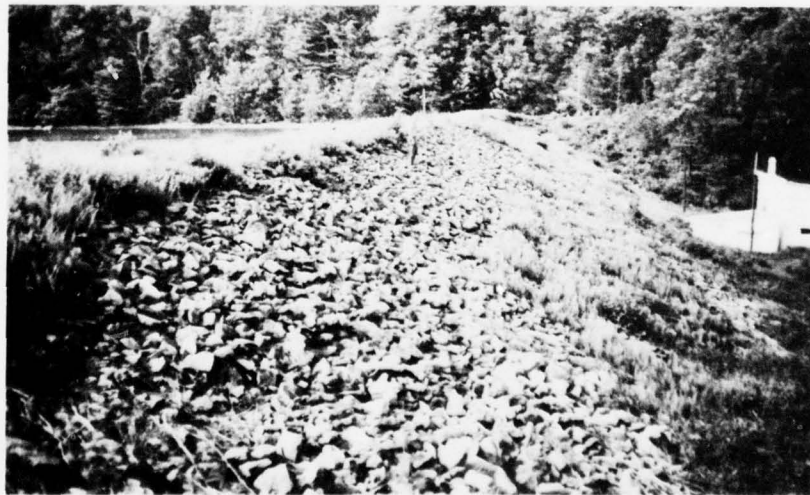
B. Downstream Slope of Embankment.

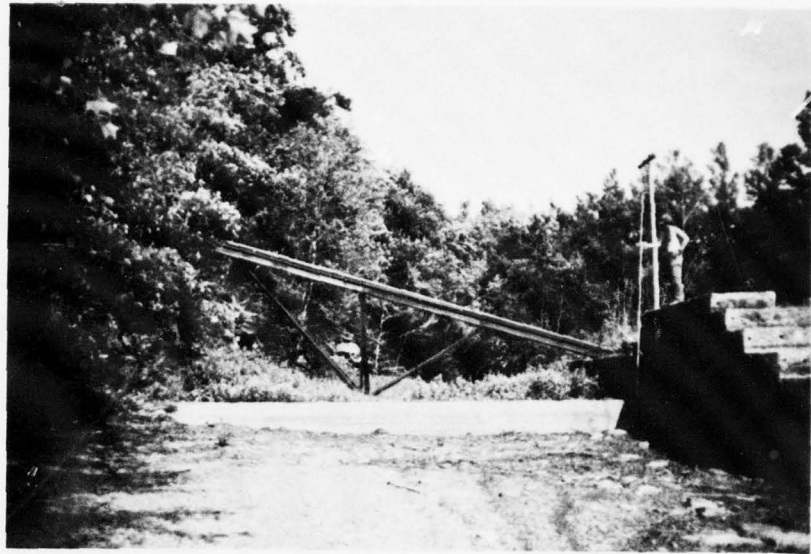
(1) Left Spillway. The approach channel to the left spillway was clear and had no apparent deficiencies. The concrete weir appeared to be in good condition, and no deficiencies were observed for the stone masonry wall at the left end of the embankment (Photograph C). Immediately downstream from the spillway weir is a support for a pipe bridge that carries an 8-inch diameter pressure line across the left spillway (Photograph C). The discharge channel in this area also had substantial amounts of debris, and considerable brush was growing in the stone lining that covers this portion of the channel. Beyond the stone-lined portion of the discharge channel, the discharge channel is excavated into rock. The right side of the channel is bounded by a dry masonry wall and the left side is bounded by the left hillside. Some trees up to 4 inches in diameter were growing in the fractures in the rock (Photograph G). A small bridge is located across the downstream end of the left spillway discharge channel.

C. Left Spillway — View from Upstream.

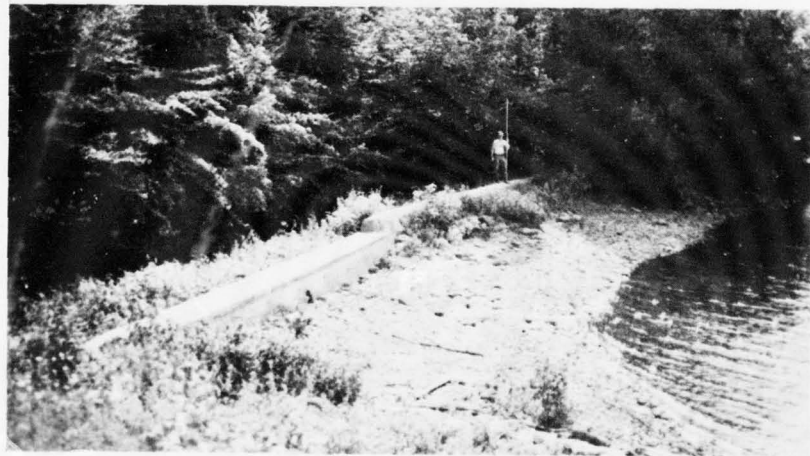
(2) Right Spillway. The approach area for the right spillway had a small amount of light brush growth (Photograph D). The concrete on both the main and auxiliary weir sections was in good condition except for one small area of disintegration about 6 inches in diameter. The right spillway discharges into the diversion channel that was excavated around the right side of the reservoir. Between the spillway weir and the discharge channel, a distance of about 20 feet, there was a considerable growth of brush (Photograph D). Farther downstream, the right spillway discharge channel is similar to the left one in that it is excavated into rock and bounded by a dry masonry wall on one side and by the hillside on the other. A number of small trees were growing in the fractures in the rock (Photograph H).

(2) Right Spillway. The light brush growing in the approach area of the right spillway is undesirable. The small area of disintegration of the concrete on the weir has not yet progressed to the extent that repairs are warranted. The growth of brush between the weir and the diversion channel is undesirable. The trees in the discharge channel could cause debris collection and a reduction in channel capacity during floods.

D. Right Spillway — View from Downstream.

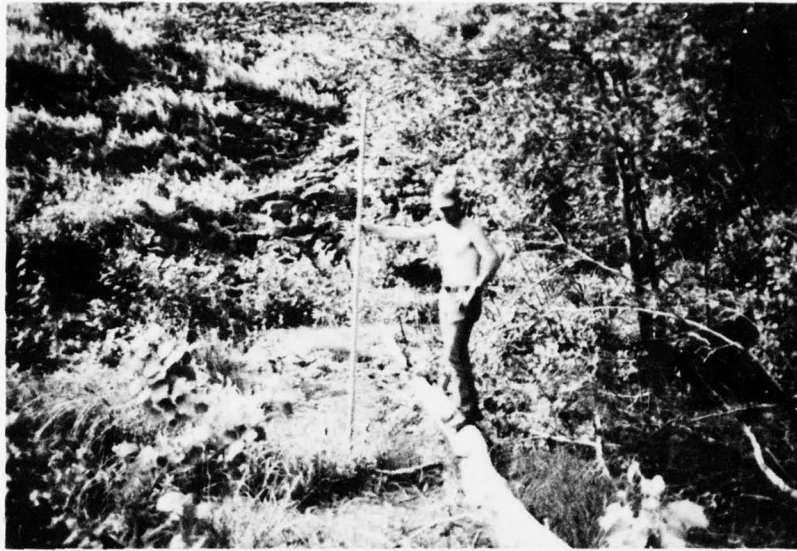
inspections since at least 1927. However, examination of available information suggests that this flow has existed since the dam was built and that the source of flow to this area is outflow from a spring located at the left abutment. Although the spring outlet could not be found in this inspection, the available information indicates that the spring was boxed in and piped through the embankment to this area. The existence of the small channel with low masonry walls that drains this area supports the conclusion. The condition of that channel, which is overgrown with weeds, shrubs, and small trees, is such that it does not drain the wet area effectively. The lack of adequate drainage causes the large wet area. This could mask the development of any uncontrolled seepage through the embankment.

E. Wet Area at Toe Near Left Abutment.

- (1) Clear spillway discharge channels of brush and trees.
- (2) Clean out the small channel that drains the wet area along the toe of the dam near the left abutment so the wet area is properly drained. Install a weir to measure outflow, monitor the area visually, and maintain records.
- (3) Make provisions, such as drains or ditches, to drain the wet area along the toe 50 feet right of the gatehouse. Measure outflow and maintain records. If conditions worsen they should be thoroughly studied and, if necessary, remedial action should be taken.
- (4) Visually monitor wet area along toe 30 feet left of gatehouse.

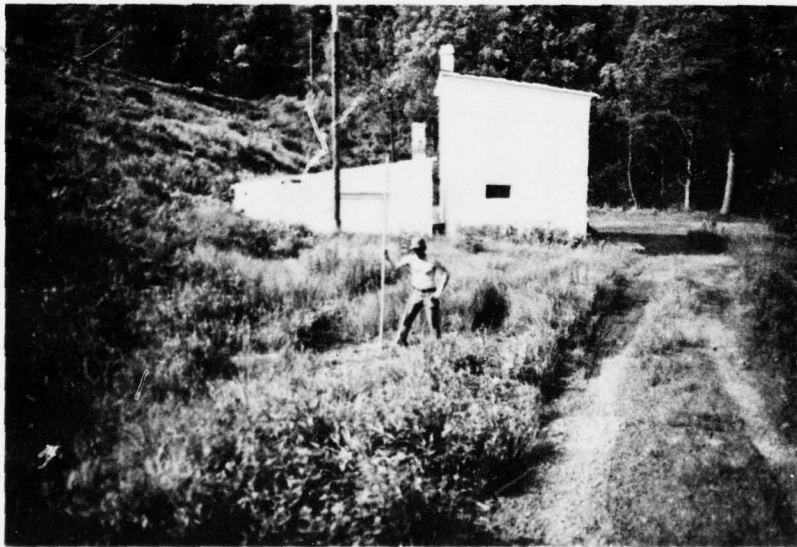
(5) The wet area along the toe 50 feet right of the gatehouse has been reported in previous inspections at least since 1934. Information in the 1914 report by the Pennsylvania Water Supply Commission indicates that the source of the water is a french drain that was constructed to convey water from a spring in the cutoff trench near the right abutment to the toe of the dam. Assuming that this is the case, the only real hazard of the wet area is that it might mask the development of any uncontrolled seepage.

F. Wet Area at Toe
50 Feet Right of Gatehouse.

(3) Make provisions, such as drains or ditches, to drain the wet area along the toe 50 feet right of the gatehouse. Measure outflow and maintain records. If conditions worsen they should be thoroughly studied and, if necessary, remedial action should be taken.

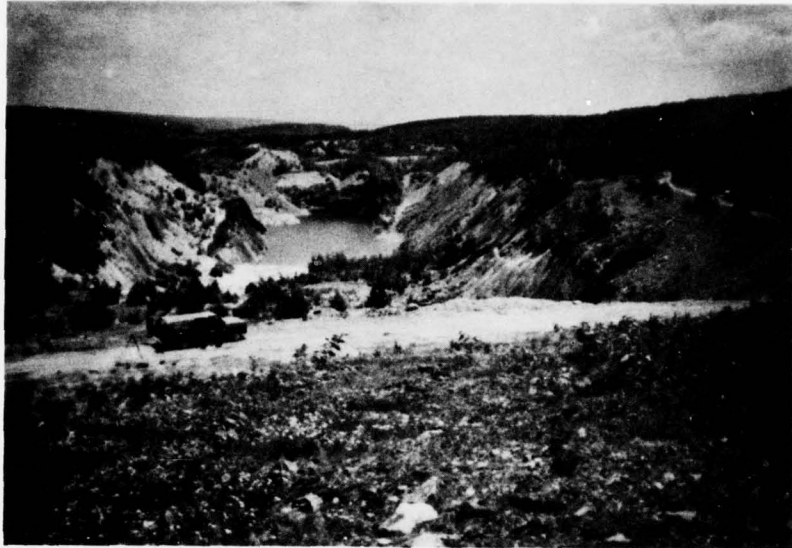
J. Strip-Mined Area of Watershed.

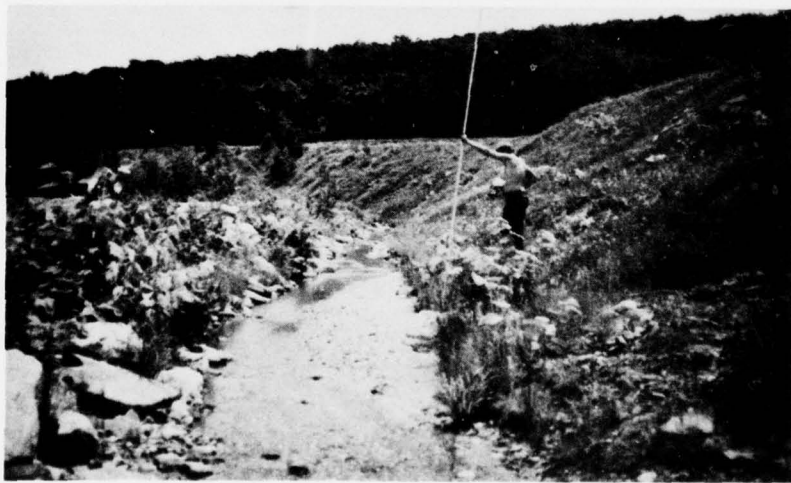
K. Flume Around Strip-Mined Area.

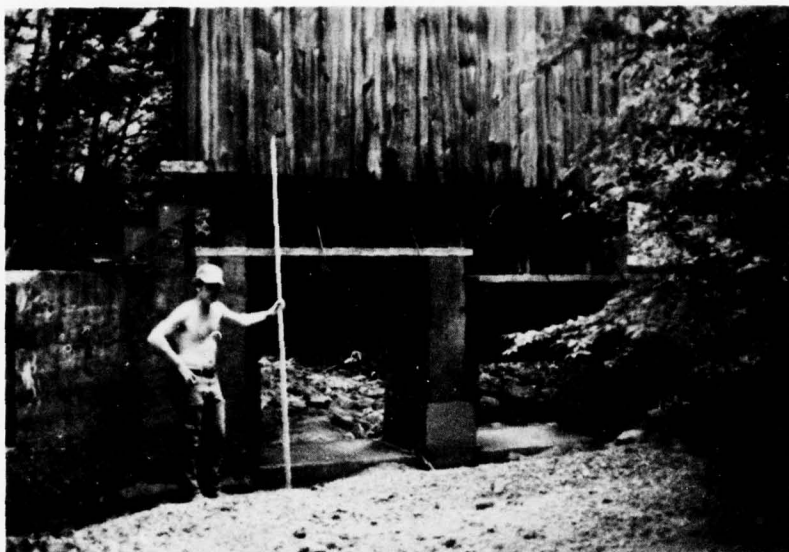
L. Right Side of Diversion Structure —
View from Upstream.
Diversion Channel in Background.

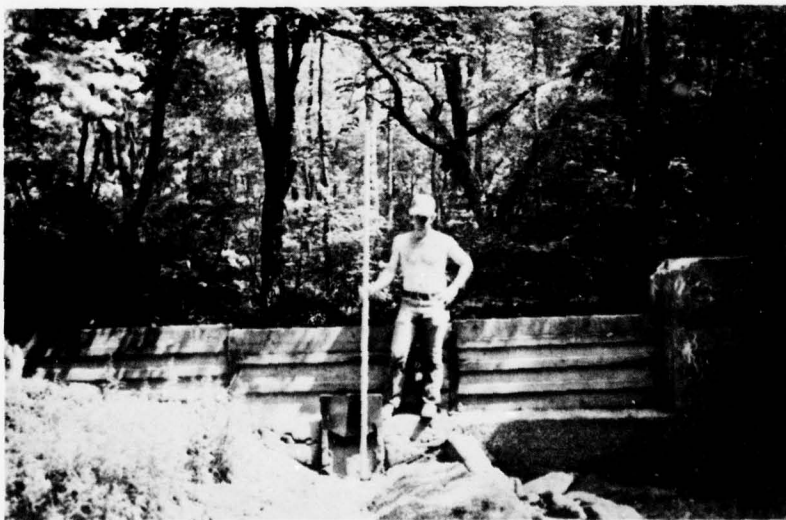
M. Left Side of Diversion Structure —
View from Upstream.
Original Channel of West West Branch Schuylkill River
in Background.

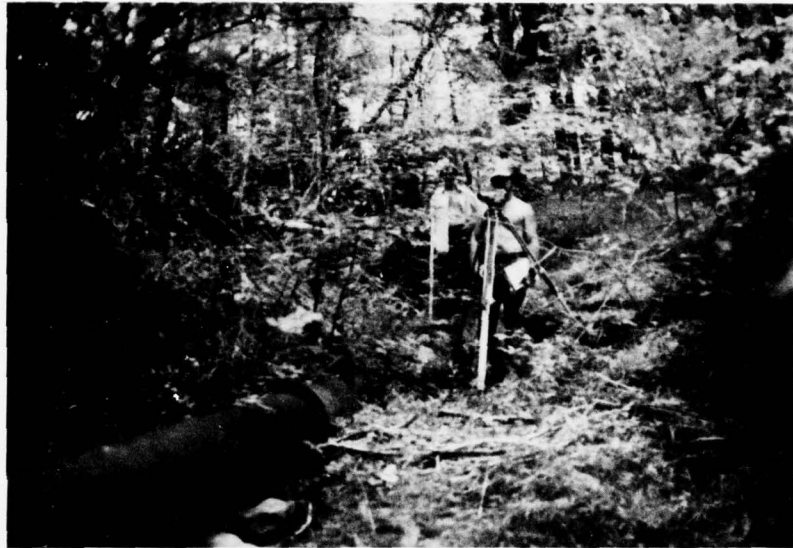
O. Excavated Area Between Diversion Channel and Original Channel of West West Branch Schuylkill River. View from Diversion Channel.
