② LAKE SUSQUEHANNA DAM

NDS ID NO. PA-00818

5 PHASE I INSPECTION REPORT
NATIONAL DAM INSPECTION PROGRAM

AUGUST 1978

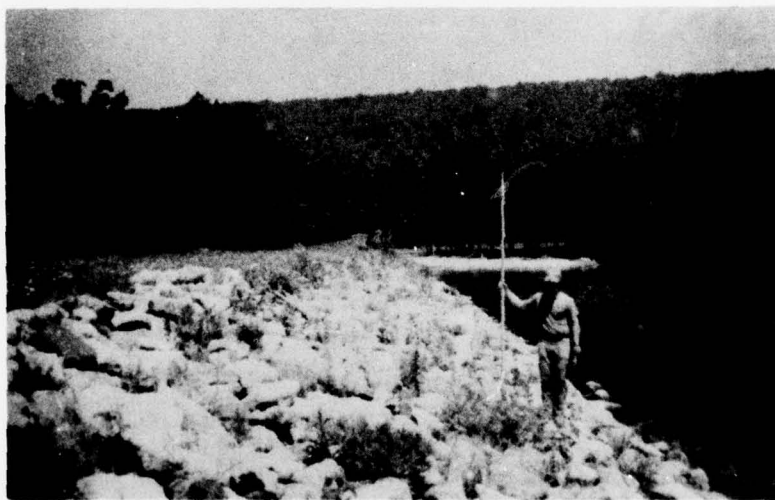
B. Riprap on Upstream Slope
Near Center of Embankment.

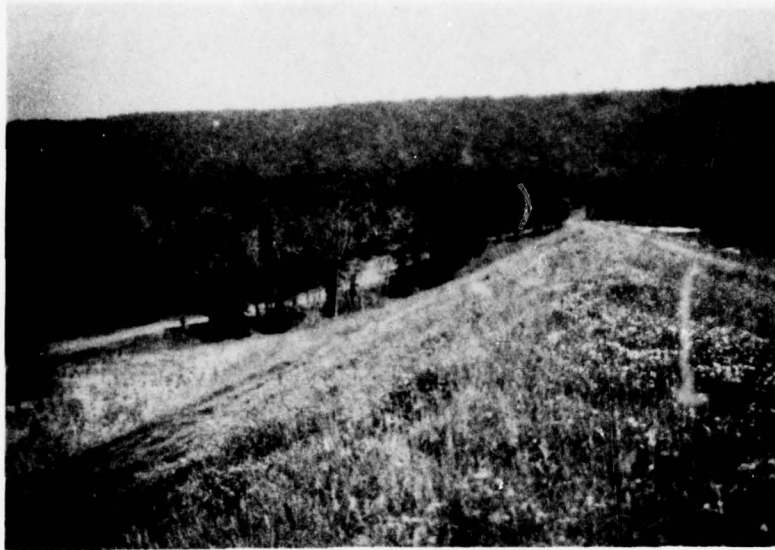
(4) Except for a few small areas, the downstream slope of the embankment was covered with crownvetch, grass, and clover ranging from 12 inches to 30 inches high (Photograph C). Those areas not yet covered with vegetation will soon be covered. Some minor sloughing and gullying were observed, but it appeared that it had occurred before vegetation had become fully established. A typical sloughed area is shown on Photograph D. Anti-erosion boards that were installed about mid-height on the downstream slope in conjunction with repair of erosion gullies in 1976 are still in place (Photograph D).

C. Downstream Slope of Embankment —
View from Left Abutment.

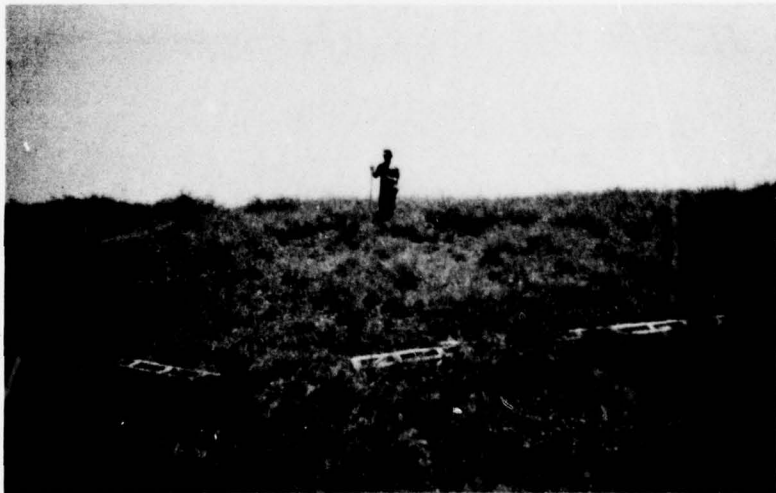
(4) The sloughing and erosion that was observed is minor and repairs to the embankment are not warranted. The downstream slope of the embankment appears to have been stabilized by the vegetal cover that was established in 1976, and it is unlikely that erosion and sloughing will occur in the future.

D. Sloughed Area on Downstream Slope
Near Spillway.

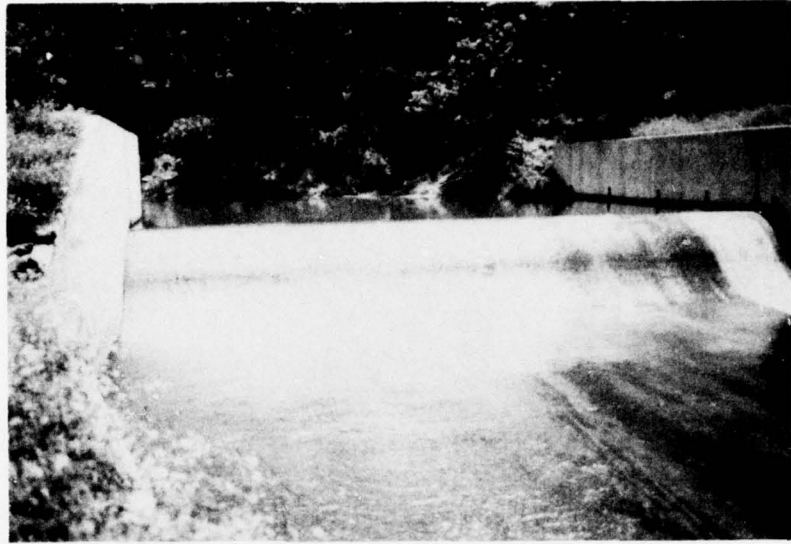
(1) Spillway. No deficiencies were noted for the concrete chute spillway. The concrete was in excellent condition and all joints were sealed (Photographs E and F). However, the spillway discharge channel was apparently not constructed in accordance with the plans. The riprap in the discharge channel extends about 80 feet downstream on a 1V an 4H slope (Photograph H), whereas the plans show riprap for a distance of 125 feet. In addition, the riprap was not grouted in place as shown on the plans. The placement of the riprap was not uniform and occasional gaps were visible. The size of the stone ranges from about 12-inch stone to derrick size stone. It did not appear that a specific gradation had been used. At the end of the riprap, the channel makes a sharp bend to the right. This unlined outlet channel then runs approximately parallel to the toe of the dam until it reaches the center of the valley, where it then curves to the left and follows the natural stream channel. A profile along the outlet channel showed that the

E. Spillway Approach Channel and Spillway Crest.

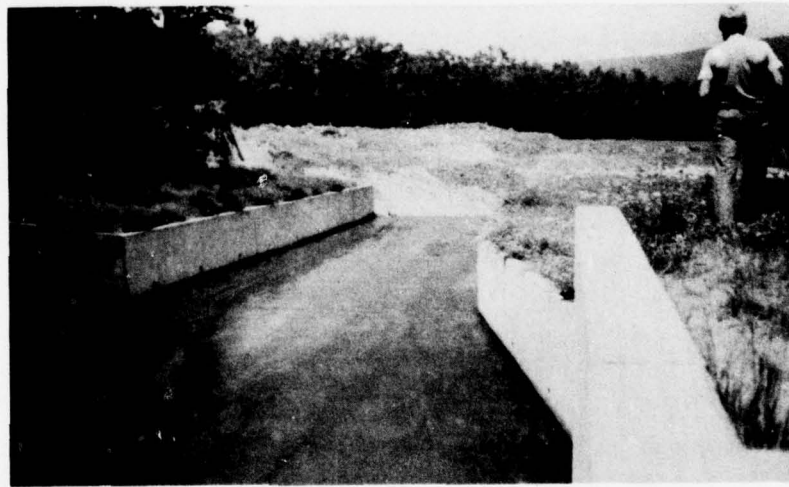
F. Concrete Spillway Chute.

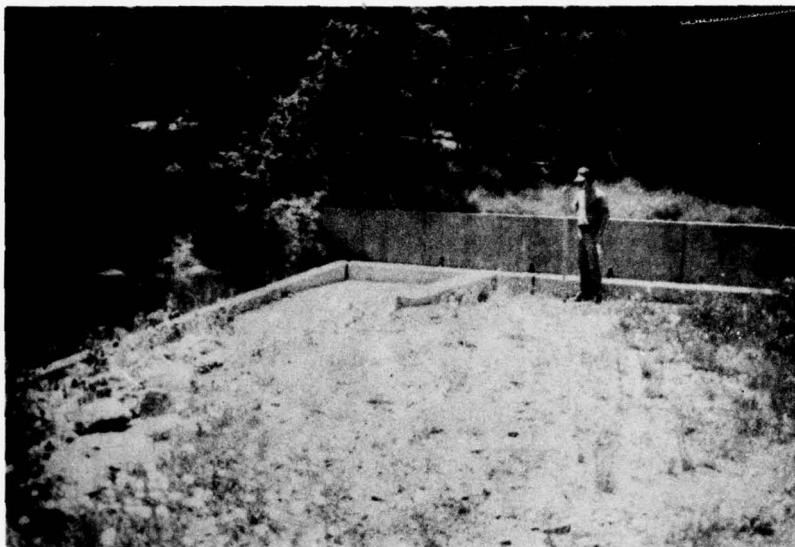
(5) If the low area of the top of embankment were brought up to grade, which would be a relatively minor maintenance task, the spillway capacity would be increased to 2,740 cfs. This would permit the accommodation of a flood with a peak inflow of 3,330 cfs, or 66 percent of the Lake Susquehanna PMF peak flow. The spillway capacity of Lake Susquehanna Dam would still be rated as inadequate.

G. Low Area on Embankment at Spillway.

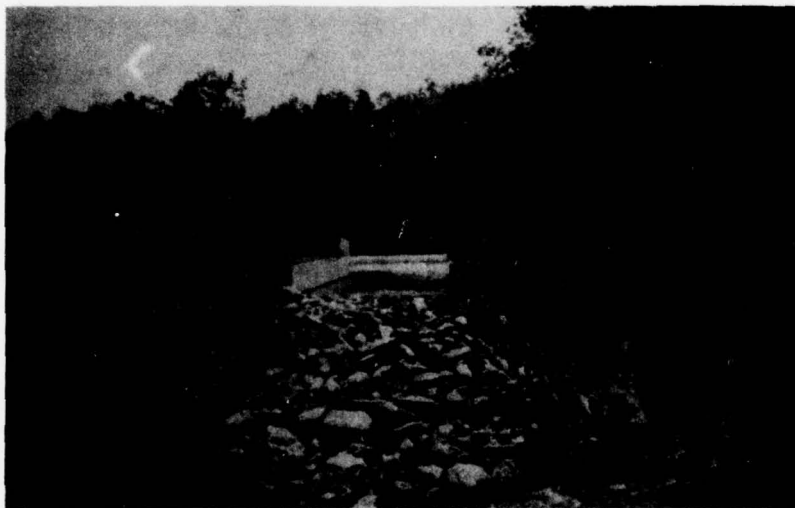
(1) Spillway. The reasons for the departures from design for the riprapped portion of the spillway discharge channel are not known. The nature of the departures are such that progressive erosion of the steep slope might occur during large spillway discharges. However, the area is located 120 feet downstream from the dam, and it is more likely that damage to the spillway chute would occur than damage to the embankment. With the exception of obvious deficiencies such as gaps and some stone that is too small, the overall adequacy of the extent and gradation of the riprap cannot be determined without additional study. As shown on Plate 5, the grade of the unlined portion of the outlet channel is lower than the design grade. This change was apparently made to accommodate the grade requirements imposed by the outlet works. However, this change has resulted in a deeper and steeper channel. Consequently, additional study is also necessary to determine if the existing channel is stable under high discharges.

(3) Spillway. The riprap in the spillway discharge channel does not appear to have been placed in accordance with the plans. The detailed description and evaluation of the condition are in Paragraphs 3.1c.(1) and 3.2b.(1), respectively.

H. Concrete Chute Spillway and
Spillway Discharge Channel.

(2) Fill gaps in riprap in spillway discharge channel with derrick stone. Perform additional study to determine the adequacy of the gradation and extent of riprap in the spillway discharge channel and outlet channel, and make any improvements that are found to be necessary.

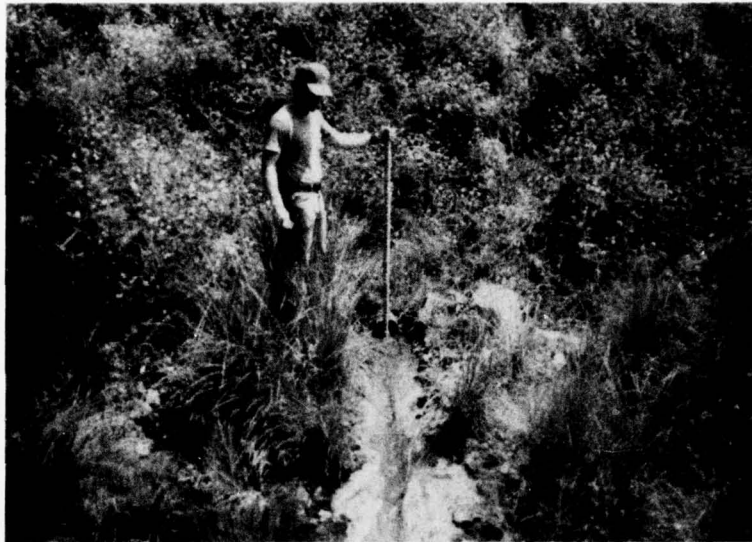
(6) The flow from the toe drain outlet that is located about 400 feet from the right abutment is expected because of the geologic conditions described above. The flow was clear, and the outflow appears to be satisfactorily controlled. The lack of significant flow from the outlets located in the outlet works outlet structure is also expected because the foundation is primarily a sandy clay. However, the accumulation of sandy clay along the length of the right outlet and the accumulation of sand and fine gravels in front of both outlets is of interest. Two explanations are possible. Either some migration of fine materials and filter materials has occurred, or the material has been sucked from the reservoir bottom during the course of operation of the slide gate. During the gate operation for this inspection, it was observed that the water level in the outlet structure rose to such an extent that some flow occurred from the outlet structure into the toe drain outlets. It was also observed that the water from the conduit was muddy. In either case, no great concern is warranted at the present time.

J. 6-Inch Toe Drain Outlet
400 Feet from Right Abutment.

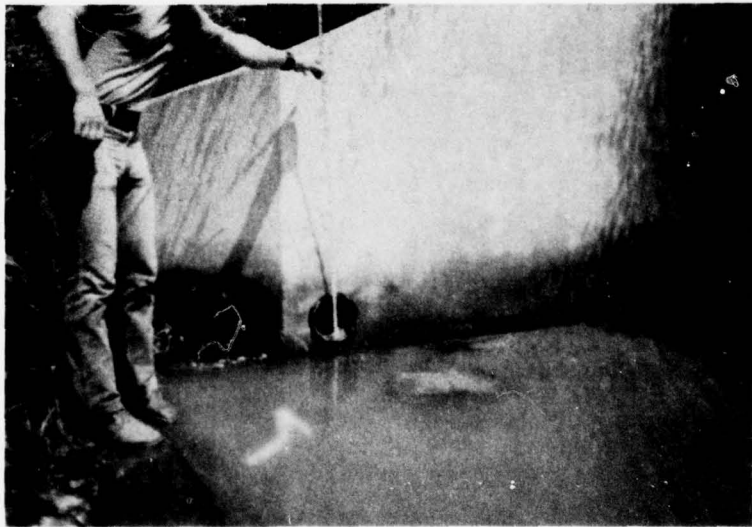
K. 8-Inch Toe Drain Outlet at
Outlet Works Outlet Structure.

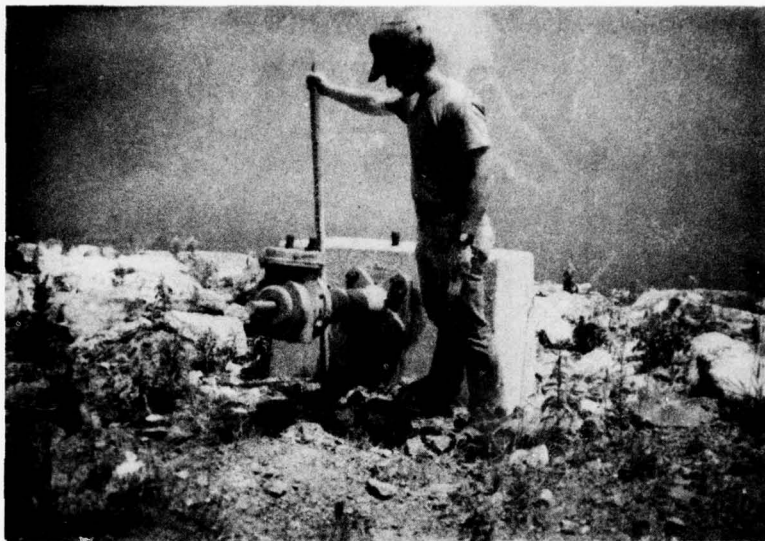
(2) Outlet Works. The gate stand at the top of the embankment was in good condition (Photograph L). The 36-inch RCP outlet conduit and the outlet structure were in good condition except for some fine cracking that extended outward from an expansion joint where the conduit enters the outlet structure. About 3 cubic yards of mud, sand, and fine gravel were in the outlet structure. The intake structure and the slide gate were submerged and could not be inspected. However, the gate was opened easily to about 1/3 full opening (Photograph M). The Owner said that the gate is partially opened every six months, and, at the same time, the oil level in the stem casing is checked to ensure that it is full. After operating the gate, it sealed tightly with no significant leakage. The discharge channel from the outlet works is riprapped with 12-inch stone from the outlet structure to where it joins the spillway outlet channel. No evidence of erosion was visible.

L. Gate Stand on Top of Dam.

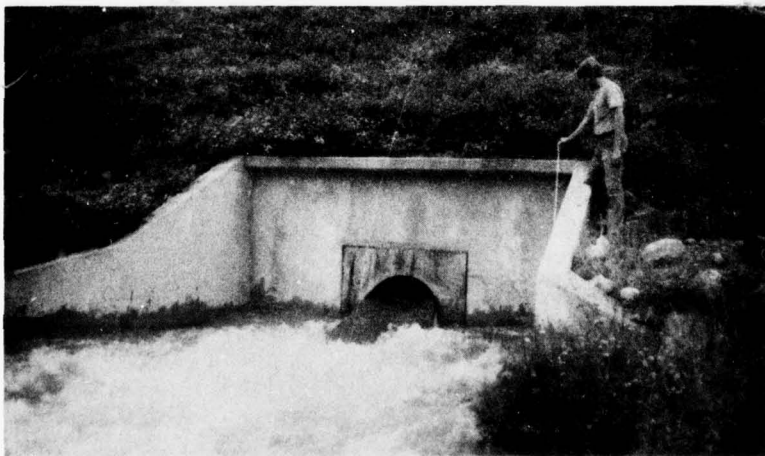
(2) Nothing was observed in the outlet works that caused concern. However, removal of the present accumulation of mud, silt and gravel from the outlet structure and some testing would allow the determination of the source of the material.

M. Outlet Works During Operation of Slide Gate.

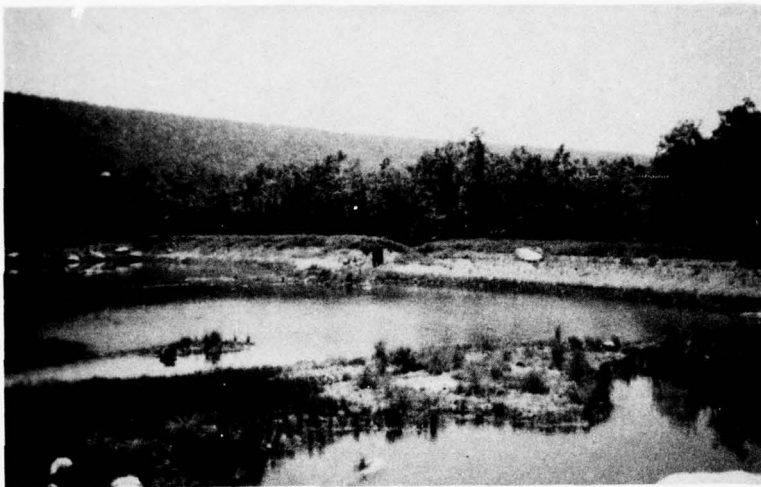
N. Lake Calumet Dam Located Upstream from
Lake Susquehanna Dam. Breached Area of
Embankment is at Center.
