**BEAVER RUN DAM  
NDI No. Pa. - 484**

**PHASE I INSPECTION REPORT  
NATIONAL DAM INSPECTION PROGRAM**

PHASE I INSPECTION REPORT  
NATIONAL DAM INSPECTION PROGRAM  
BEAVER RUN DAM  
ID NDI# PA-484, PENNDER# 65-114

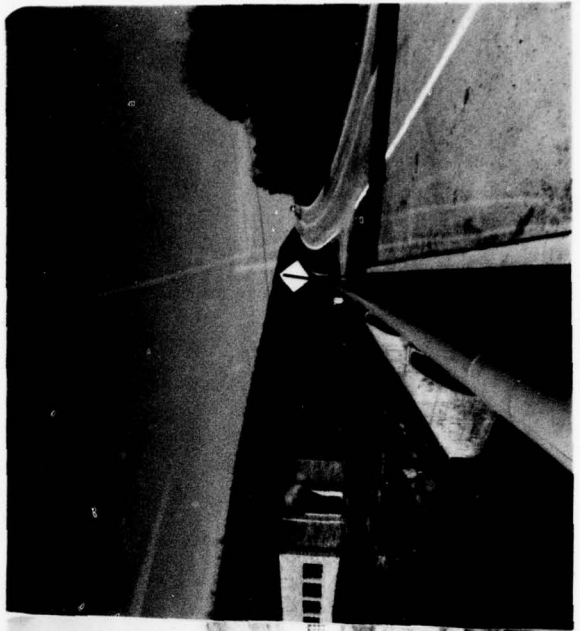
PHOTOGRAPH 1 View looking across the top of the Beaver Run embankment. The spillway and gate house are shown on the right. The pump house is at the toe of the embankment in the left-central portion of the photograph.

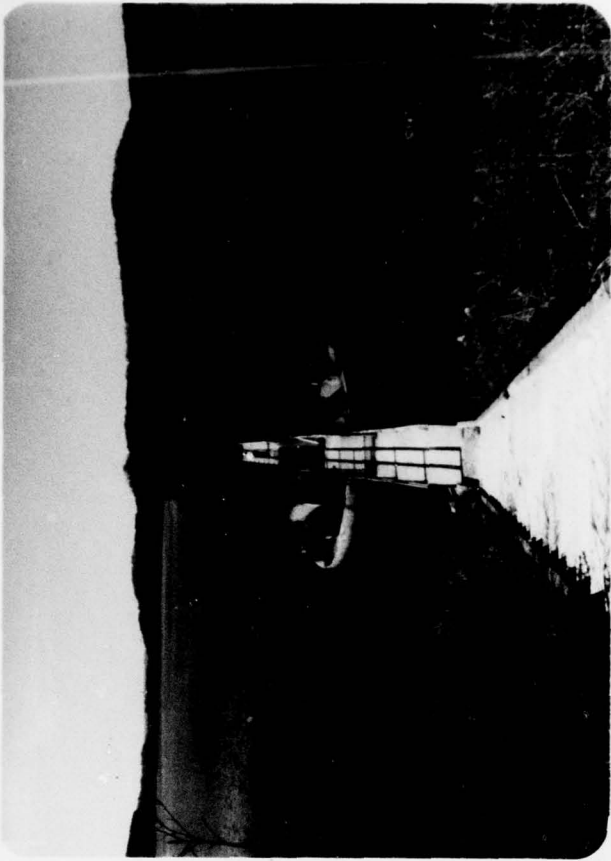
1. Spillway. The "Morning Glory" spillway appeared to be in satisfactory condition. Efflorescence was observed along the cold joint resulting from raising the spillway in 1962. Reportedly some repair work was performed on the impact block in the spillway, however, access to this portion of the outlet structure could not be attained hence we were not able to observe this remedial work during our investigation.

PHOTOGRAPH 4 View of the Morning Glory spillway which is the primary outlet works at the facility. The gate house is shown in the background.

a. It is recommended that the owner retain the services of a registered professional engineer, experienced in hydraulic and hydrologic design, to evaluate the condition of the spillway outlet and to make any modifications deemed necessary to provide for safe and unattended flow through the outlet system.

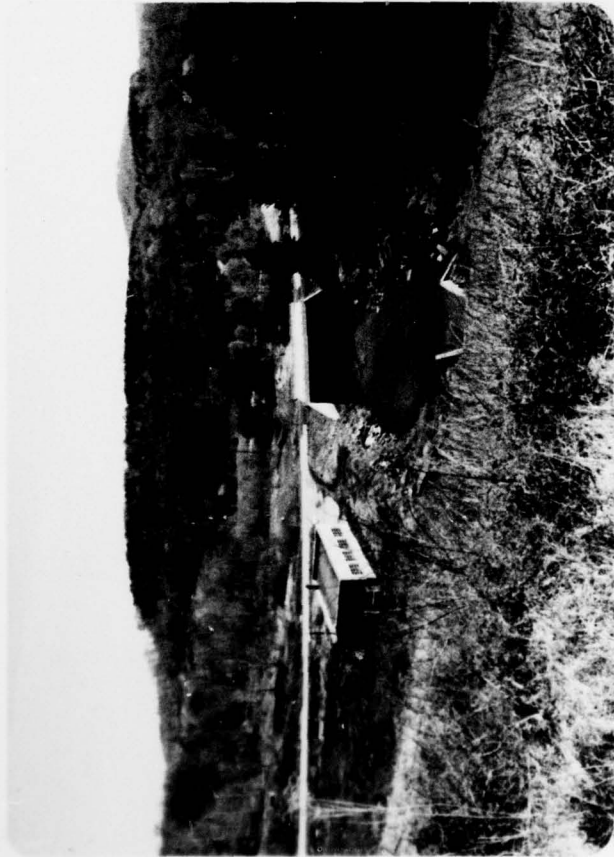
PHOTOGRAPH 3 View looking downstream from the crest of Beaver Run embankment showing a bridge on Route 380 which is located  $\approx$ 400 feet downstream of the dam. Note the valley downstream of the dam.

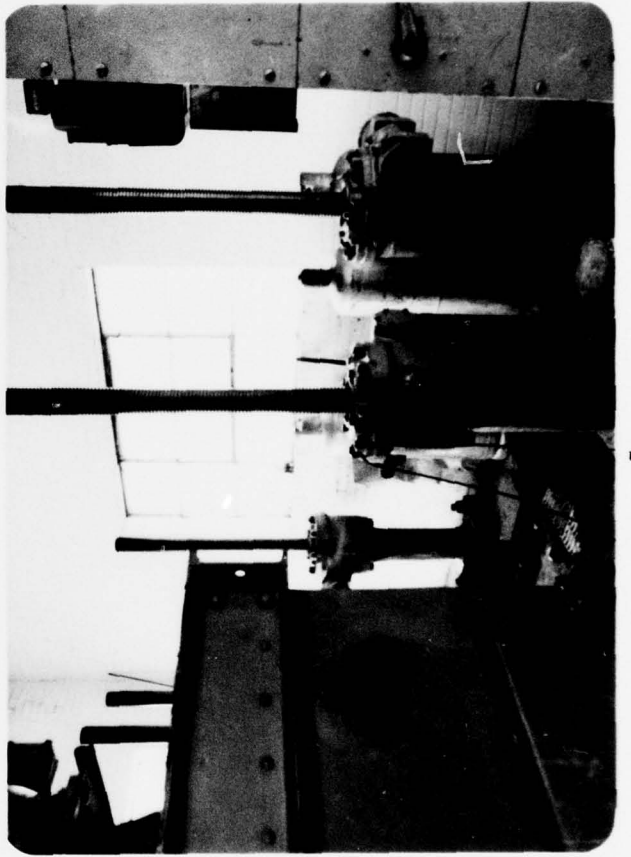
2. Gate House. The general condition of the gate house, access bridge, and valves appeared satisfactory. According to a representative of the Water Authority, the valves are in good working order and are periodically maintained. Three valves located within the gate house allow for the removal of water from different elevations within the reservoir. This water discharges into two 42-inch cast iron pipes which pass through the dam beneath the 10-foot diameter extension to the spillway (see Figure 6).

PHOTOGRAPH 5 View of the three main valves in the gate house at the Beaver Run Facility. Numbers on each of the gate screws depict the elevation at which each of the particular gates can be opened to obtain water from different levels.
