**NDI No. Pa. - 231
HIGH POINT LAKE**

**PHASE I INSPECTION REPORT
NATIONAL DAM INSPECTION PROGRAM**

High Point Lake, NDI Number PA-231.
Ohio River Basin, Negro Glade Run, Somerset
County, Pennsylvania. Phase I Inspection
Report.

**PREPARED BY
GAI CONSULTANTS, INC.
570 BEATTY ROAD
MONROEVILLE, PENNSYLVANIA 15146**

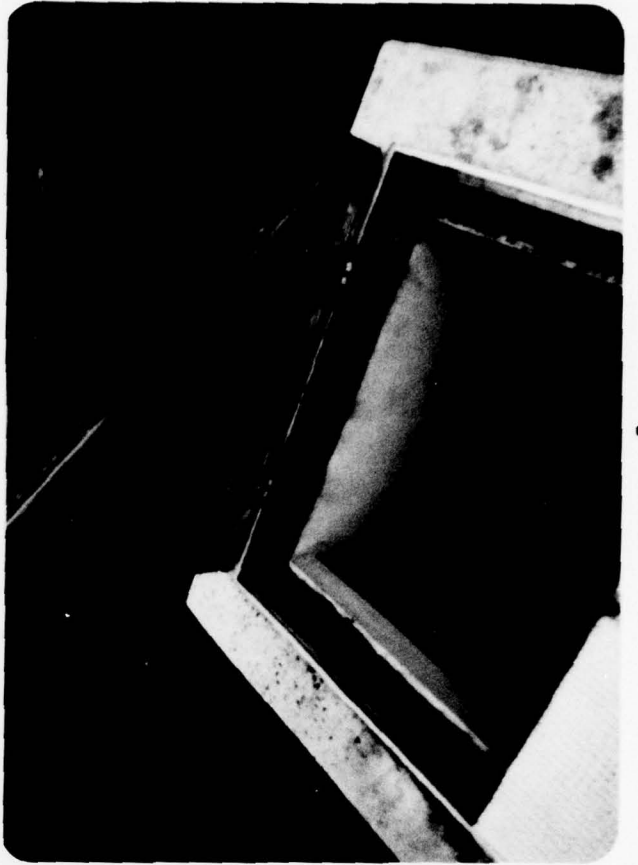
PHOTOGRAPH 8 Close-up view of the gate control located within the concrete riser on the upstream portion of High Point Lake Dam.

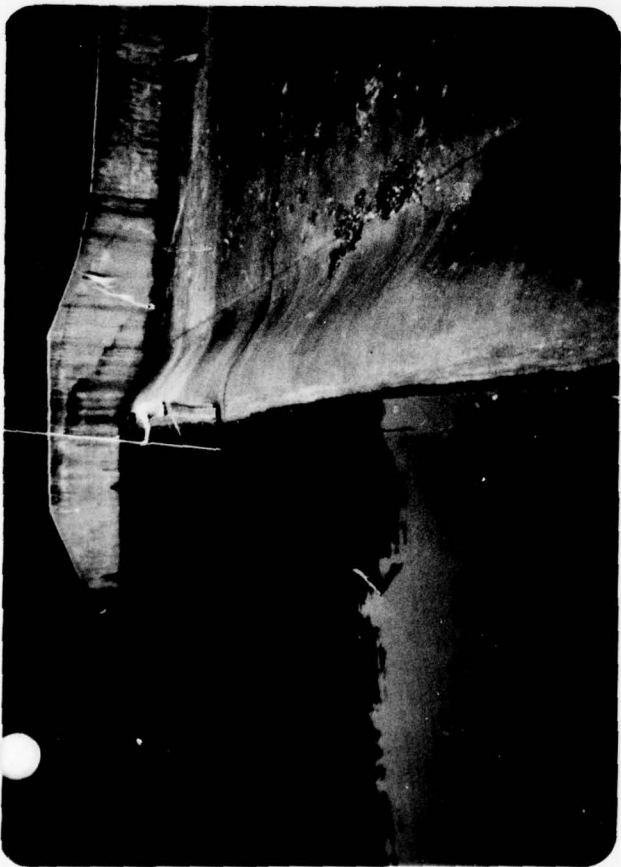
1. Spillway. The spillway, spillway abutments, discharge channel, and stilling basin all appeared in excellent condition except for some minor spalling of the weir crest and minor efflorescence.

PHOTOGRAPH 5 View of the ogee-shaped spillway crest. Note the efflorescence in the spillway wingwall.

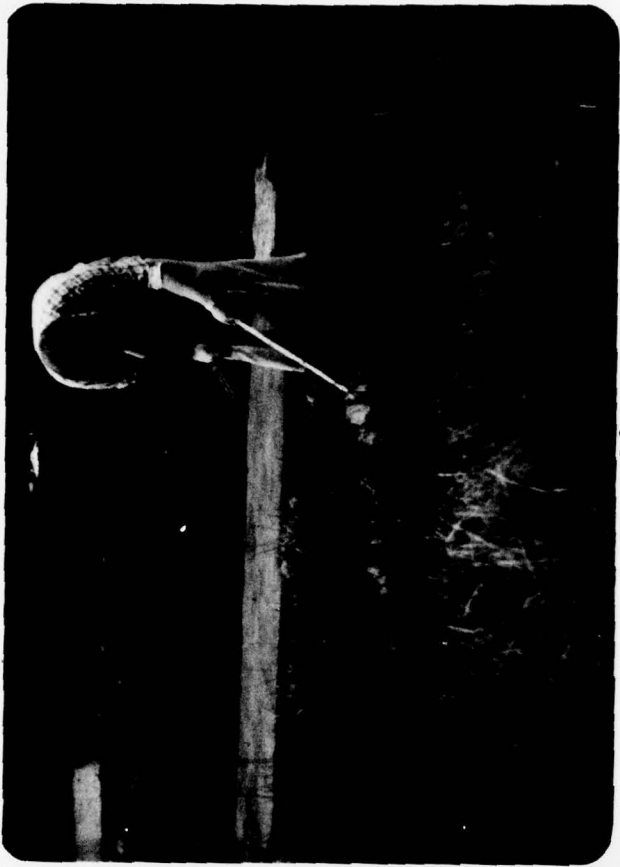
The discharge end of the outlet, including the asphalt-lined fish catch basin were in good condition. Some minor cracking has developed in the asphalt but the basin continues to function as designed. Seepage was noted along the right side of the fish catch basin (see Photographs 9 and 10 and Geology) and is probably related to natural ground water conditions.

PHOTOGRAPH 10 View of a small water filled cavity on the right side of fish catch basin. The area to the right of the basin was very swampy. The cavity may be one of many auger holes drilled during construction to delineate a gravel pocket encountered in the core trench excavation.

During the current inspection, an artesian flow was observed to be issuing from a 2-foot-deep hole adjacent the bituminous paving of the fish catch basin (see Photograph 10

and Figure 3). The observed discharge may be coincidental with auger hole number 23. This flow is most likely originating in the aforementioned pocket of permeable silty sand and gravel.
