National Dam Inspection Program. Oneida
Mining Co. Dam (NDI PA-830), Ohio River
Basin, Unnamed Tributary to Brush Creek,
Indiana County, Pennsylvania. Phase I
Inspection Report.

PHASE I REPORT
NATIONAL DAM INSPECTION PROGRAM

Oneida Mining Company Dam

PHASE I INSPECTION REPORT
NATIONAL DAM INSPECTION PROGRAM
ONEIDA MINING COMPANY DAM
NDI# PA-830, PENNDER# 32-79

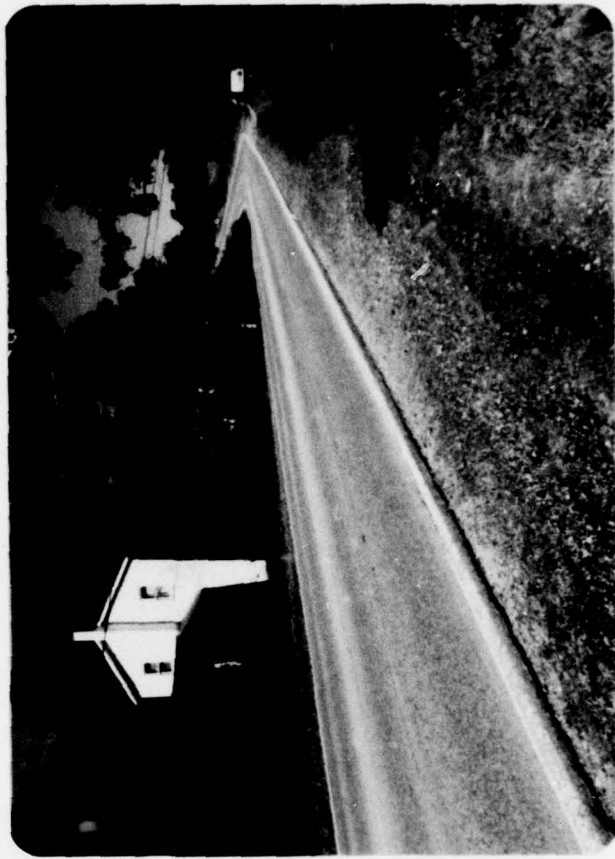
12

This view shows two dwellings located on the floodplain approximately 3 miles downstream of the embankment. Brush Creek passes beneath State Route 56 through a box culvert just right of center.

- c. A warning system be developed to provide for the notification of downstream inhabitants should the need arise. The program should include round-the-clock surveillance during periods of intense or prolonged rainfall.
