National Dam Inspection Program. Eberle
Dam (NDI PA 036, PA-456), Susquehanna
River Basin, Closes Creek, Tioga County,
Pennsylvania. Phase I Inspection Report.

PHASE I REPORT
National Dam Inspection Program

PA-456 Dam (Eberle Dam): NDS I.D. No. PA-00036

Owner: Tioga County Commissioners
State Located: Pennsylvania (PennDER I.D. No. 59-63)
County Located: Tioga County
Stream: Closes Creek
Inspection Date(s): 6 November 1978
Inspection Team: GAI Consultants, Inc.
570 Beatty Road
Monroeville, Pennsylvania 15146

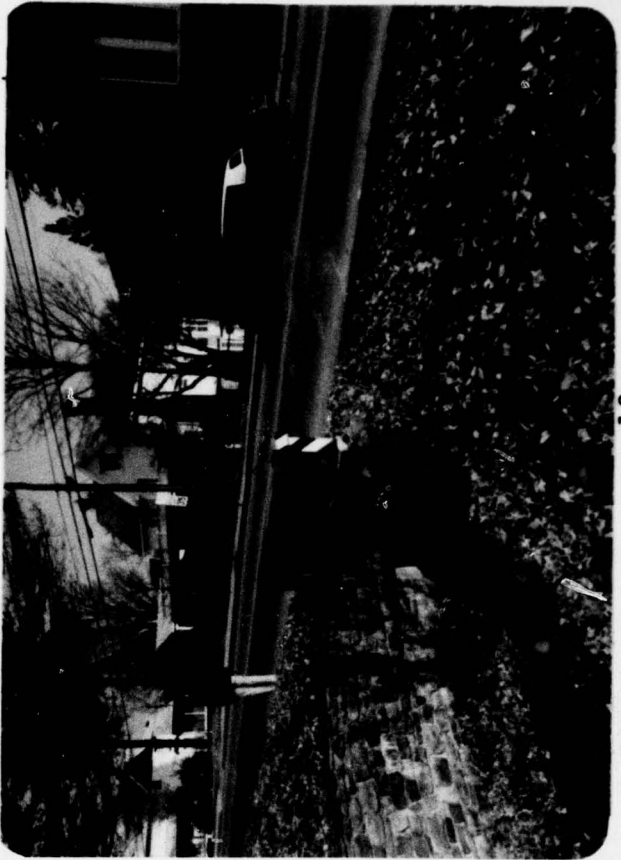
10

View 2,000 feet downstream of the embankment showing the culvert which passes the flow beneath Pennsylvania Route 349 at the southern boundary of the Borough of Westfield. The leather tanning factory is located across the road on the right side of the photograph.
