**GRAVEL LICK DAM
NDI No. Pa - 807**

**PHASE I INSPECTION REPORT
NATIONAL DAM INSPECTION PROGRAM**

27 June 1978 (visual inspection)

Inspection Team - GAI Consultants, Inc.
570 Beatty Road
Monroeville, Pennsylvania 15146

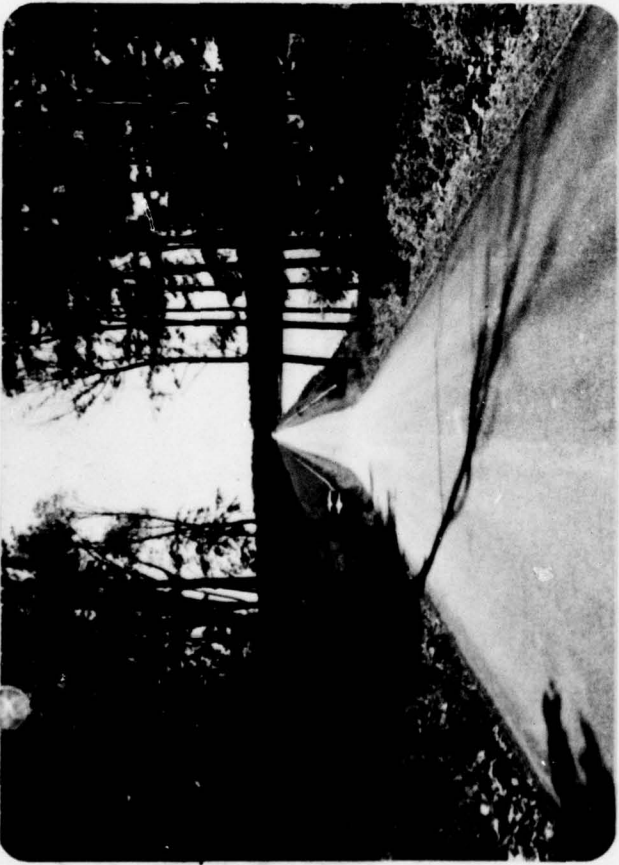
a. Embankment. Two problem areas of concern were noted relative to the embankment. One involves the erosion gullies visible across the downstream face which were apparently formed by surface runoff during and immediately after construction. These have since been seeded and the majority are protected by a vegetative cover. The condition is presently considered a minor problem which can be remedied by backfilling and reseeded and does not pose an immediate threat to the stability of the structure.

PHOTOGRAPH 3 View of erosion channels below the berm on the downstream slope of Gravel Lick Dam.
