National Dam Inspection Program.
Tyrone Reservoir 2 (NDI 535)
Susquehanna River Basin, Sink Run,
Blair County, Pennsylvania. Phase I
Inspection Report.

PHASE I REPORT
NATIONAL DAM INSPECTION PROGRAM

NAME OF DAM: Tyrone Reservoir No. 2
STATE LOCATED: Pennsylvania
COUNTY LOCATED: Blair
STREAM: Sink Run, secondary tributary of the Little Juniata River
DATE OF INSPECTION: July 12 and 18, 1978

TYRONE RESERVOIR NO. 2
NDI I.D. NO. 535
JULY 12, 1978

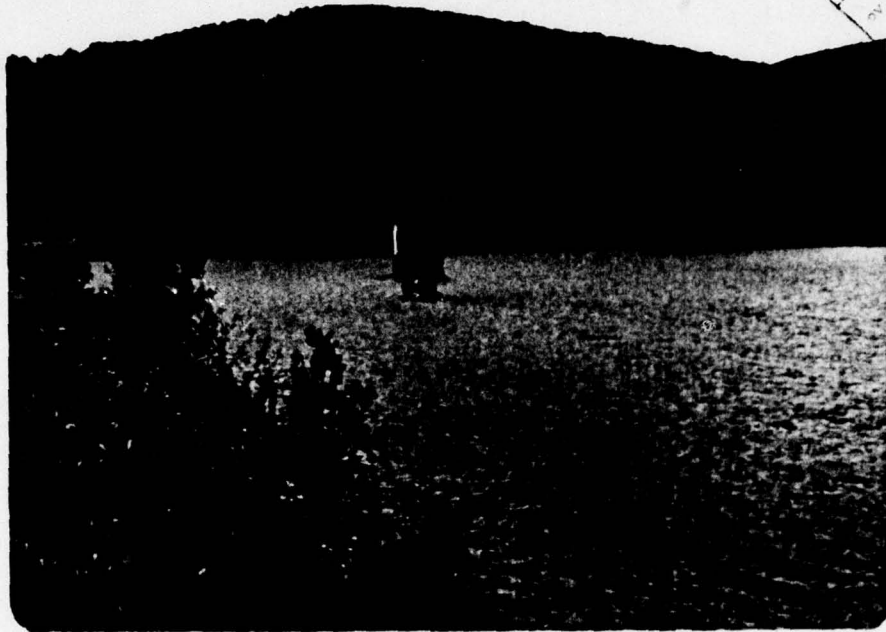
Upstream Face

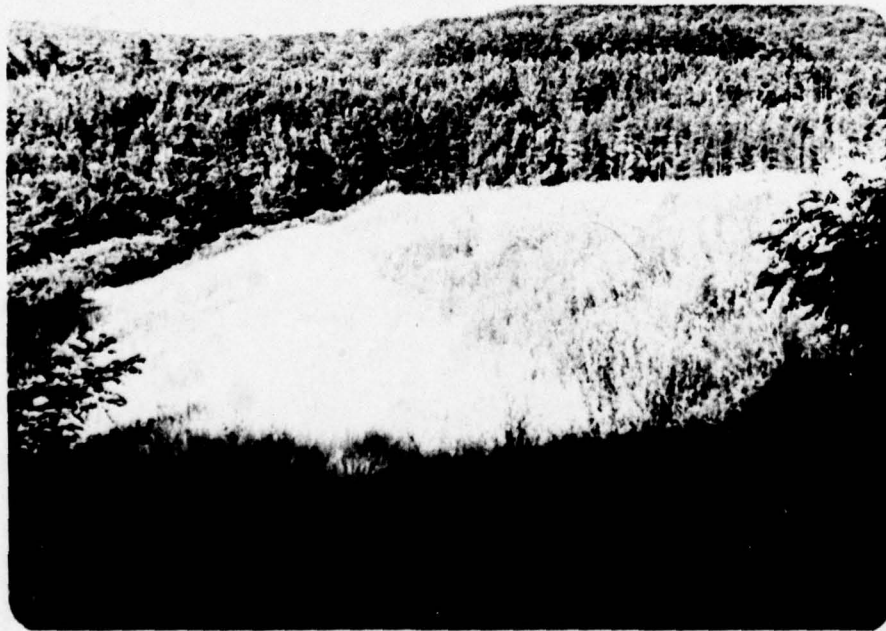
Downstream Face

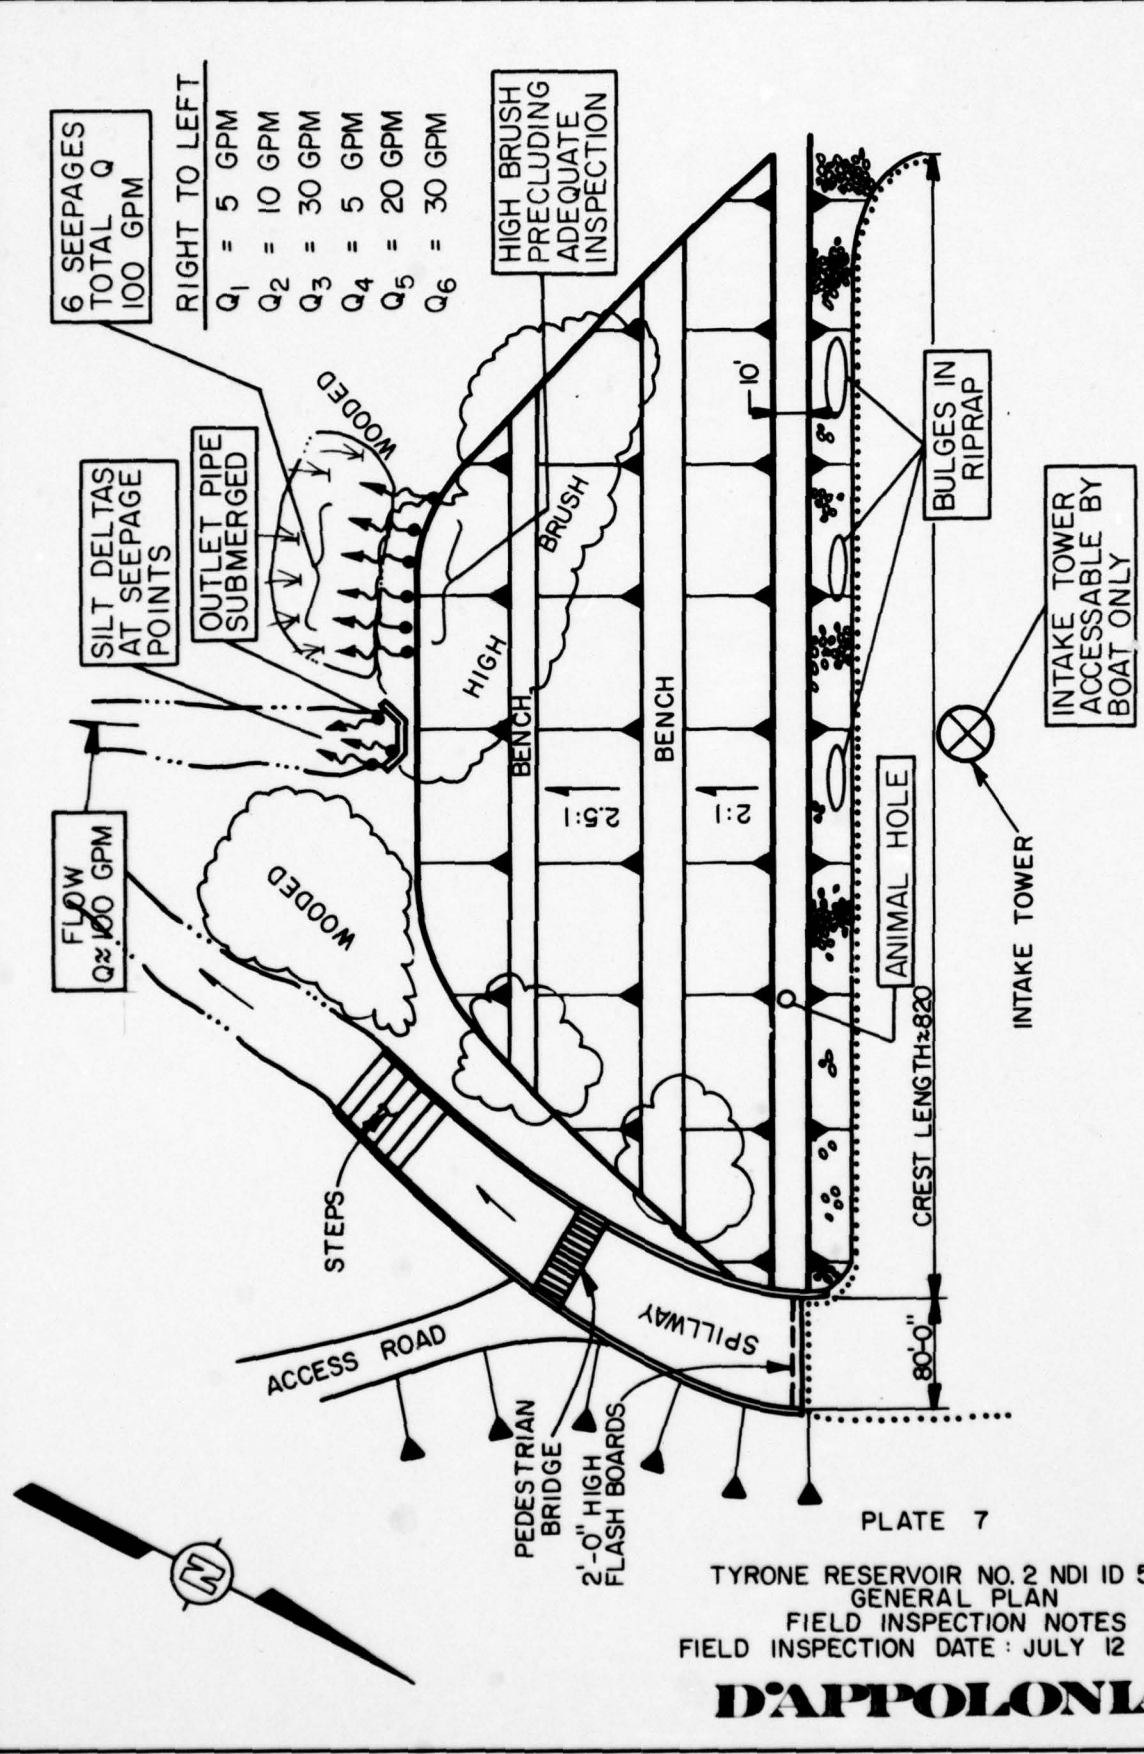
PLATE 7

The most significant problem at the site is the presence of numerous seeps along the toe of the dam, located on the right side of the blow-off pipe. At least six seepage points were observed. Estimated seepage flows ranged from 5 to 30 gallons per minute (Plate 7).

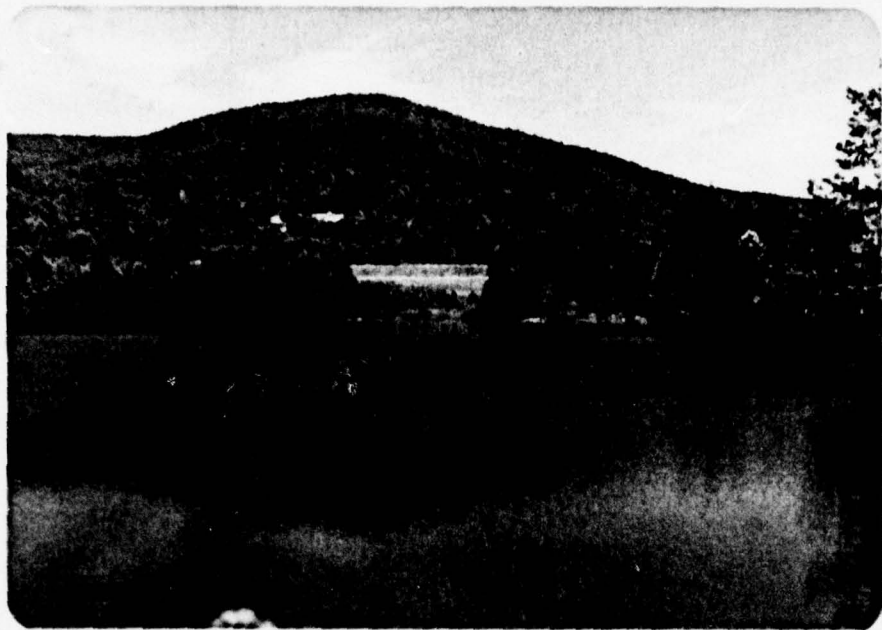
Photograph No. 1

Tyrone Reservoir No. 2 (background).
Tyrone Reservoir No. 1 (foreground).

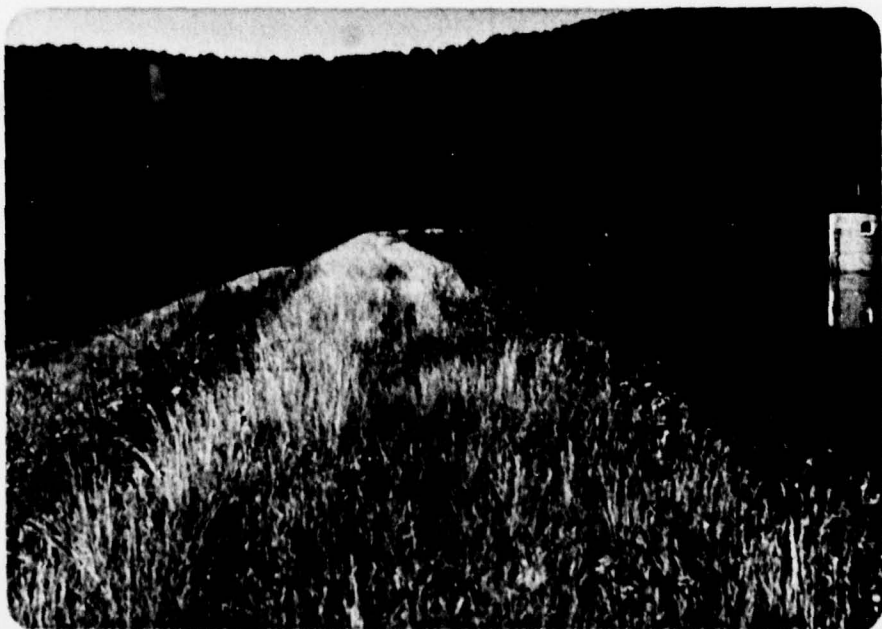
Photograph No. 2

Crest.

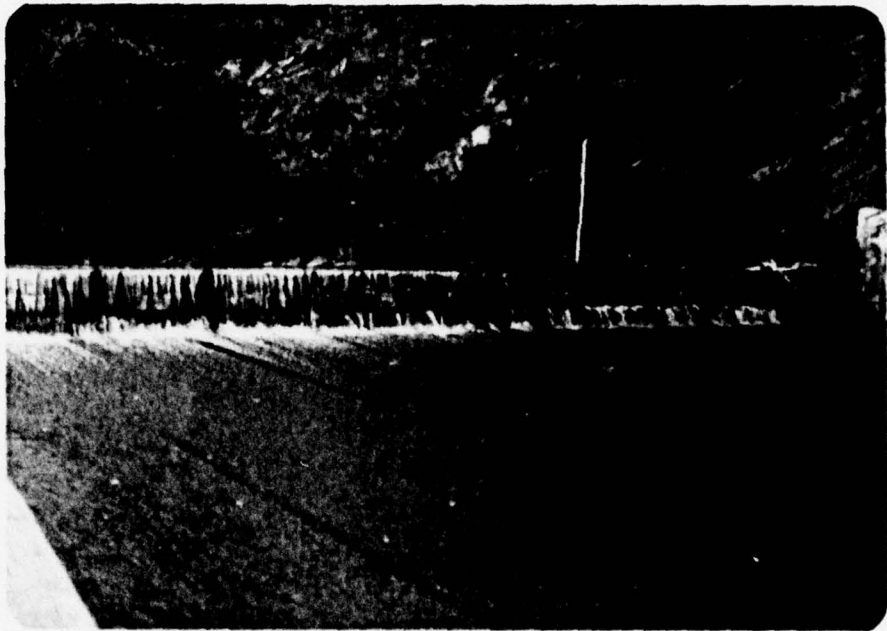
Photograph No. 3
Spillway crest (note flash boards).

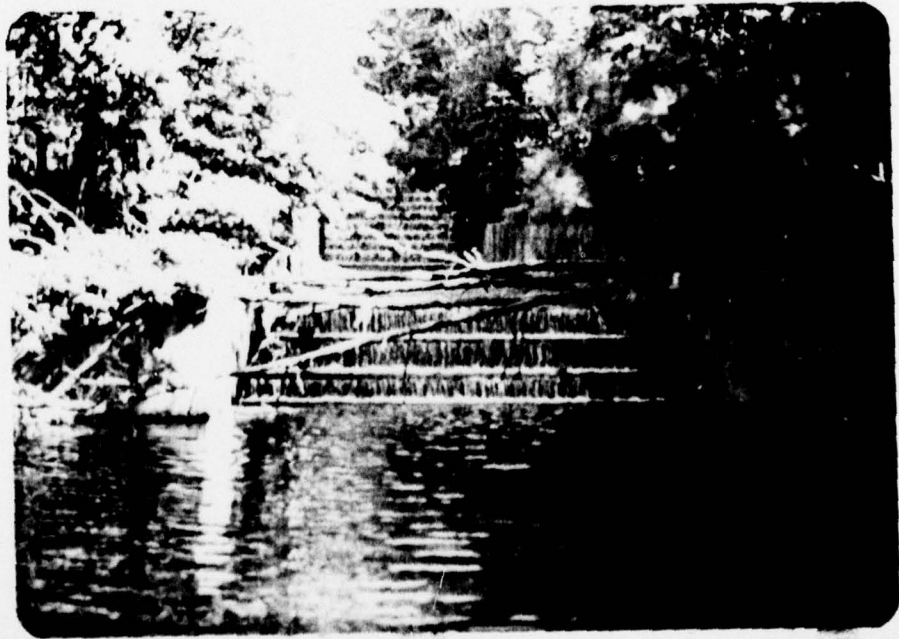
Photograph No. 4
Spillway discharge channel.

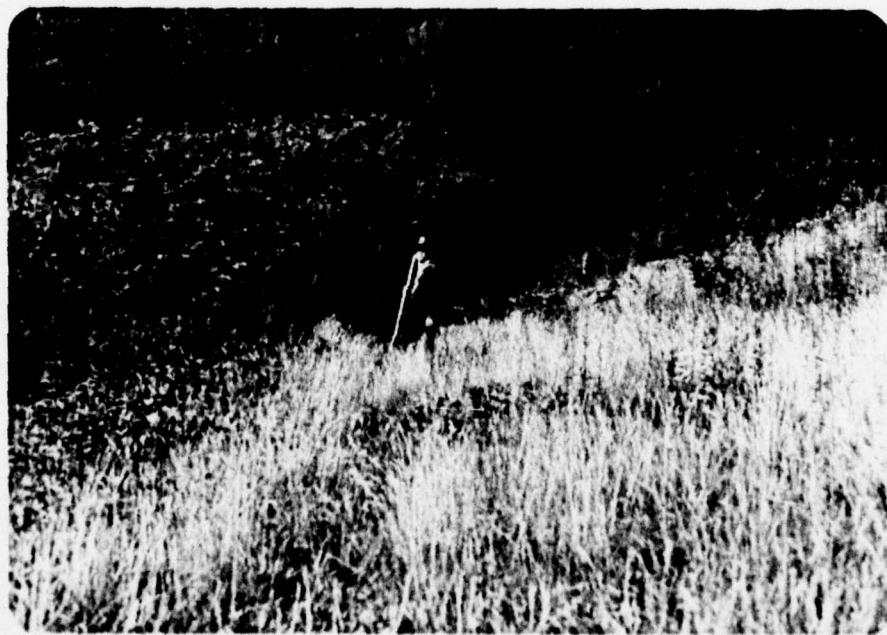
Photograph No. 6
High brush on downstream slope.

3. Brush and trees should be removed from the downstream face of the dam and for a distance of at least 50 feet below the toe of the dam to permit adequate inspection of these areas in future inspections.
4. It is recommended that the owner should provide around-the-clock surveillance during unusually heavy runoff and develop a formal warning system to alert the downstream residents in the event of an emergency.
5. It is recommended that the owner be advised that the dam and appurtenant structures should be inspected regularly and necessary maintenance should be performed.

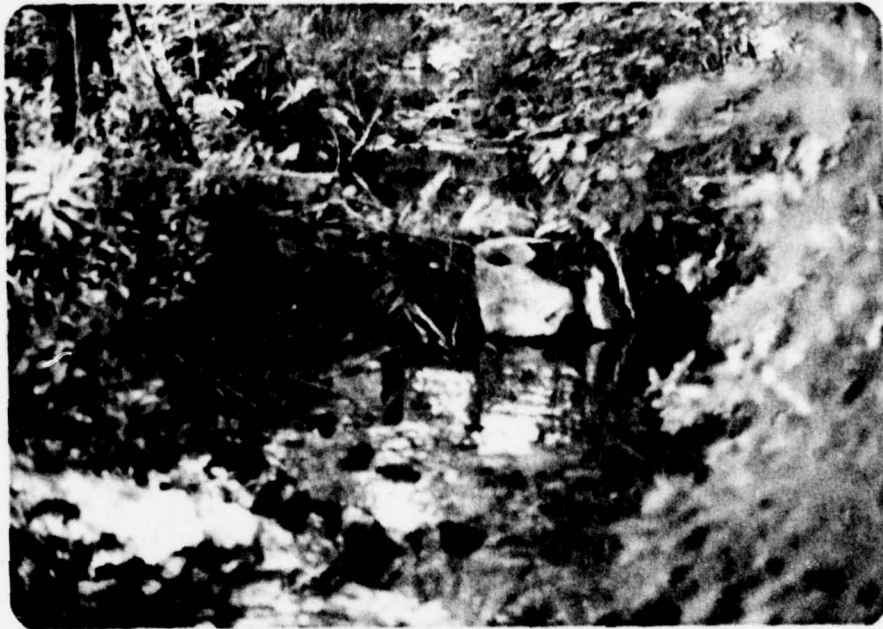
Photograph No. 7

The most significant condition at the dam appears to be the seepage exiting around the headwall of the blow-off pipe and numerous other seepages along the toe on the right side of the blow-off pipe. Accumulation of silt at seepage locations around the headwall of the pipe suggest internal erosion of the embankment.

Seepage in blow-off pipe discharge channel
(note abandoned weir).

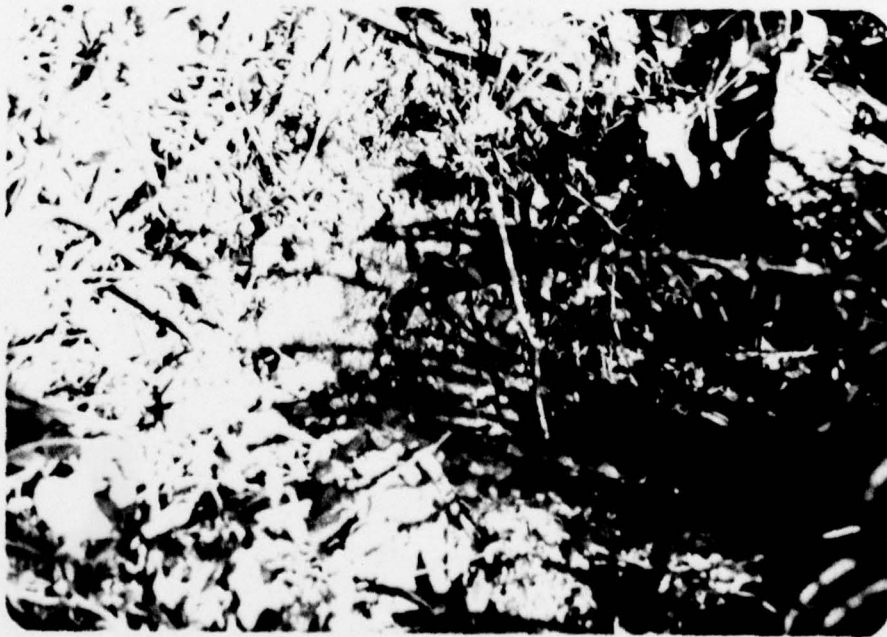
Photograph No. 8

Seepage from toe (typical).
