ELMHURST DAM
PENNSYLVANIA GAS AND WATER COMPANY
(NDS ID No. 296)

PHASE I INSPECTION REPORT
NATIONAL DAM INSPECTION PROGRAM

11/ MAY 1978

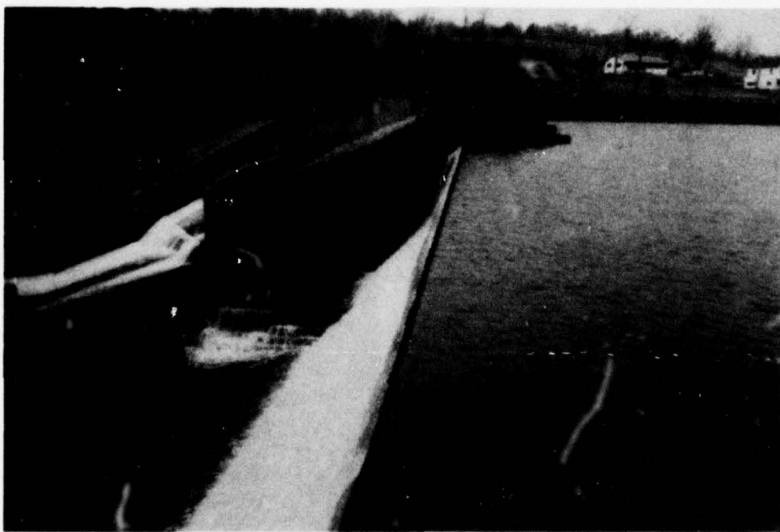
B. Masonry Gravity Spillway and
Concrete Chute Spillway

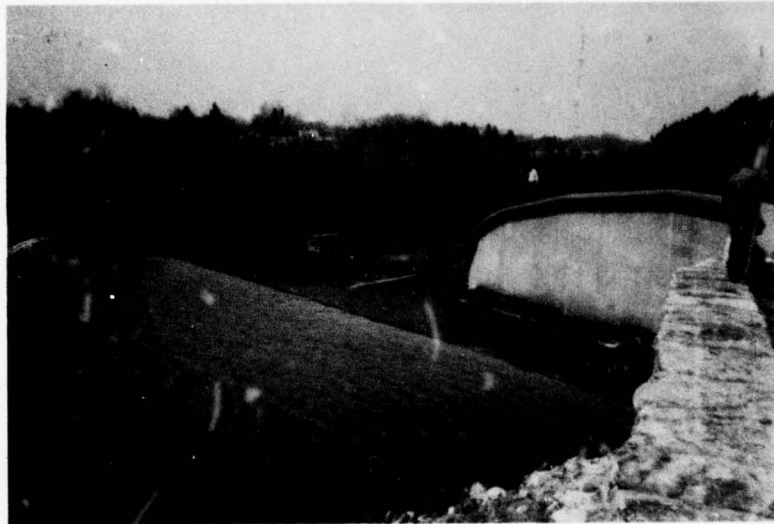
C. Concrete Chute Spillway

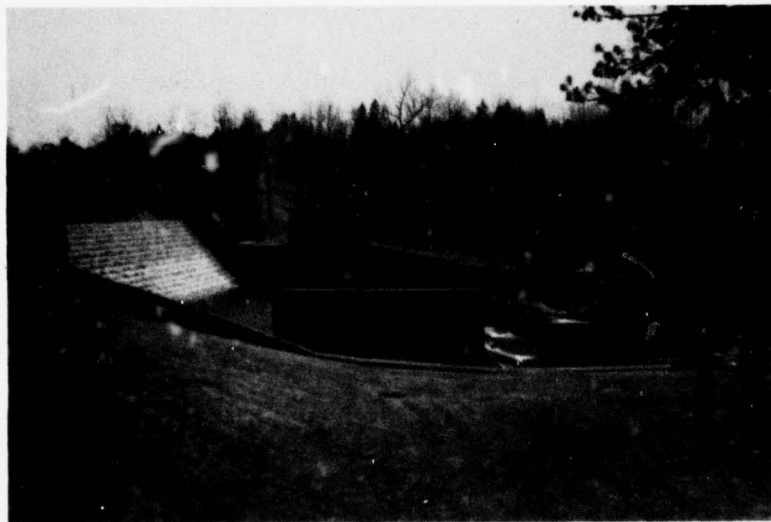
D. View from Downstream Right Abutment
Showing Screen Chamber Building and
Three Gatehouses

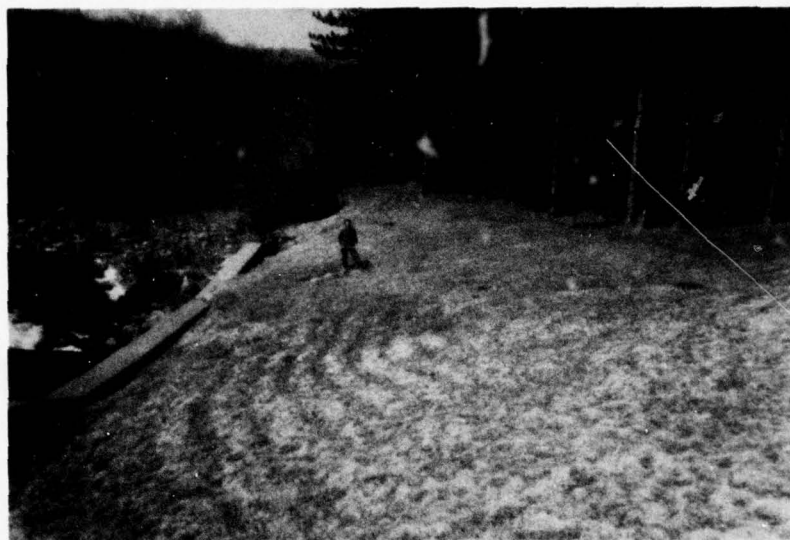
b. Dam. The dam embankment was maintained adequately. The sod on the downstream surface was intact and well maintained. The only noticeable problems were with the surface runoff control system at the right abutment. A 40-foot long, 36-inch diameter BCCMP, which is designed to receive flow from a ditch, had flow under it. A defective pipe junction near the midpoint of the pipe has resulted in the formation of an 18-inch diameter sinkhole. There were also signs of inadequate capacity of the system. Uncontrolled overland flow has apparently produced an eroded area just beyond the toe of the embankment. This area was filled with some large stones (Photograph E). The uncontrolled flow apparently exits over the most downstream monolith of the concrete chute spillway right wall and along the ground surface parallel to the back face of the wall. There was some erosion behind the end of the wall to a maximum depth of 4 feet (Photograph E). A manhole that is located at the toe of the embankment has two pipes entering and one leaving it. A 4-inch diameter pipe, identified by the Owner as a spillway wall drain, had an accumulation of clayey soil at its outlet. The soil was cleared away and a small, clear flow was observed. Probing the pipe indicated additional accumulation of soil along its length. The second pipe entering the manhole, an 8-inch diameter pipe entering on the uphill side from the general direction of the right abutment, had an estimated discharge of 5 to 10 gpm of clear water. Its source was not determined. Outflow from the manhole entered the midpoint of the aforementioned 36-inch BCCMP.

E. Area Adjacent to Embankment
Damaged by Surface Runoff

- (6) Perform repairs on surface runoff control system, outlet channel left wall, concrete apron joint below masonry gravity spillway, and hole at base of concrete chute spillway right wall.

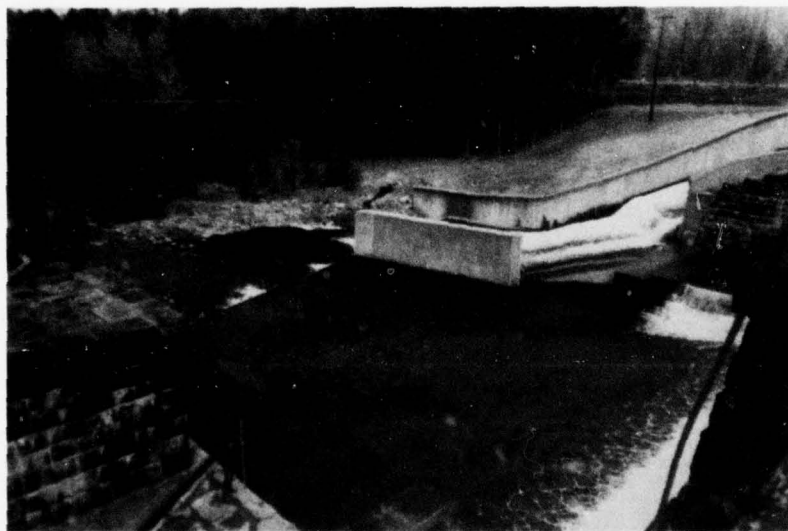
but no differential movement was noted. The concrete apron at the bottom of the masonry gravity spillway (Photograph F) was in excellent condition, except that joint filler was missing between two slabs near the right side. Two leakage areas were on the downstream face of the short, masonry gravity section of the dam that is adjacent to the left side of the masonry gravity spillway (Photograph K). The leakage ran onto the roof of the gatehouse and then into the earthfill along the left side of the gatehouse.

F. Concrete Apron of Masonry Gravity Spillway
and Downstream Channel

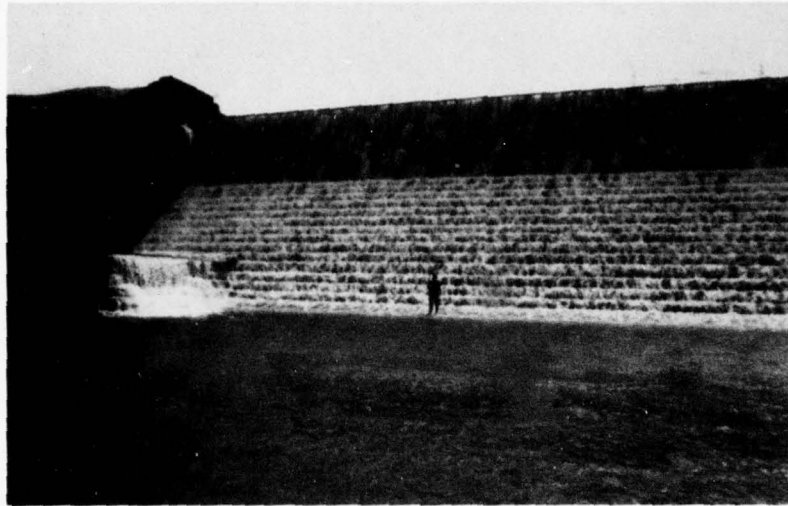
(1) The downstream face of the masonry gravity spillway (Photograph G) had too much flow over it to be examined in detail. However, no blocks of stone were missing. The upstream face has earthfill against it and cannot be inspected. The stone masonry and mortar joints of the spillway walls adjacent to the spillway were apparently sound. The outlet channel left wall, which is along the spillway apron, had two leaks, both near the base. Clear water was being discharged from the leakage points. An 18-inch diameter sinkhole was in the wall backfill above one of the leakage points. Near the downstream end of the wall, a portion that had been repaired with concrete had two vertical cracks and some spalling of the concrete. The cracks extend through the wall

G. Masonry Gravity Spillway and
Concrete Apron

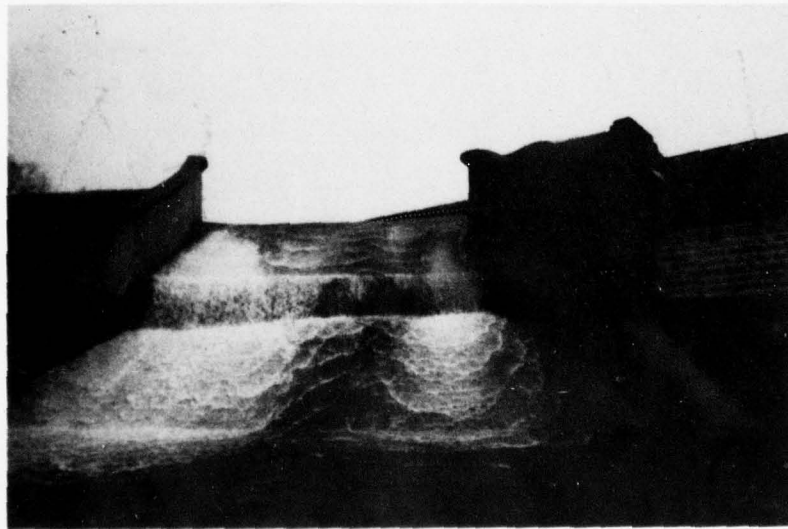
H. Concrete Chute Spillway and Apron

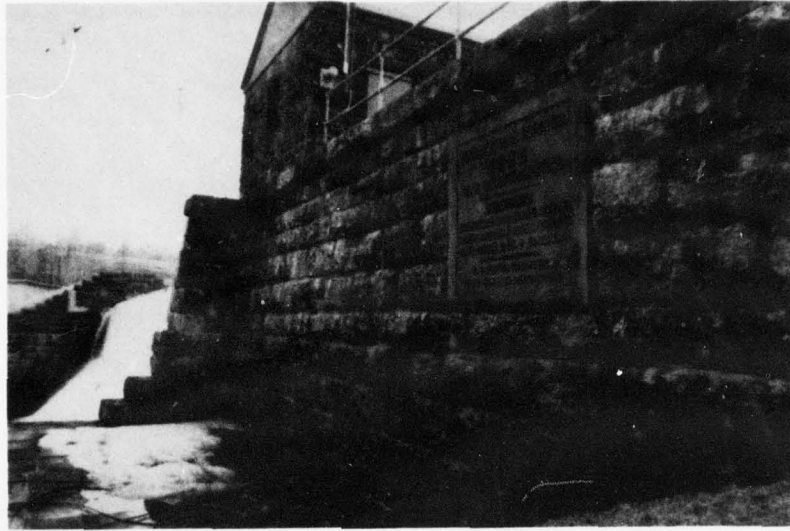
K. Downstream Face of Masonry Gravity Section
and Screen Chamber Building

- (1) Repair stone masonry to eliminate leakage through downstream face of gravity section of dam, gatehouse walls, and left abutment wall. Repair deteriorated stone masonry along top 3 feet of left abutment wall.

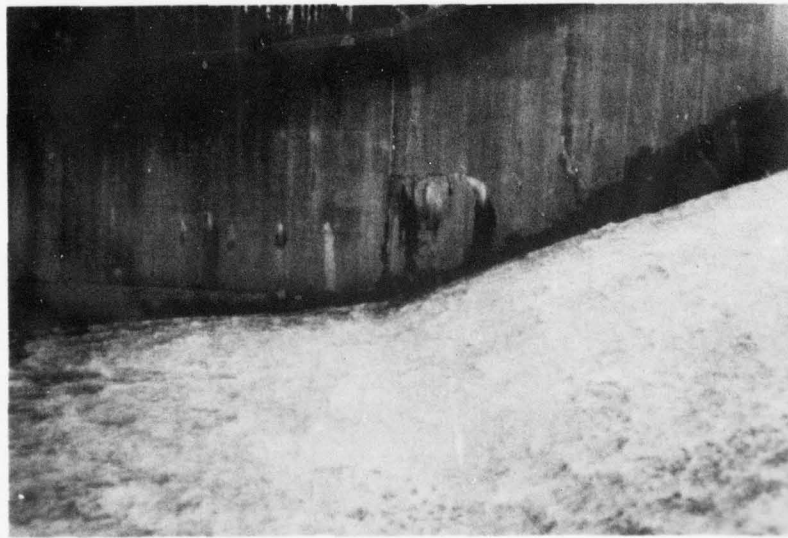
(2) The concrete chute spillway (Photograph H) was in excellent condition, and it exhibited only normal, uniform wear. All monolith joints were properly sealed. However, the following observations were made in the vicinity of the second and third right wall monoliths from the downstream end: three fine diagonal cracks, wider monolith joint separation than at other monoliths, spalling at joint on back face, a 5-inch diameter hole at joint on front face at apron level that extended 2 feet back under the wall, possible differential movement indicated by 1/2-inch monolith misalignment at top of wall, and a 5-foot diameter area on the backfill 6 inches lower than adjacent areas located about 5 feet back of the middle of the second monolith. Apparently, however, none of these deficiencies has affected the satisfactory performance of the wall. Photograph L shows the location of problem area.

(2) The performance of the right spillway wall has not been affected by the problems that were observed, but it should be noted that the wall is a key feature of the project. If the situation is stable, no hazard exists. However, if the observed conditions are part of an active situation, unsatisfactory performance could result.

L. Right Wall of Concrete Chute Spillway
at Apron

- (3) Repair concrete extensions on right abutment wall and left abutment wall.
- (4) Monitor right wall of concrete chute spillway for movement.
- (5) Evaluate effect of possible improper functioning of concrete chute spillway wall drain with respect to design function. If drain must be functional, install several observation wells in the drain to determine the extent of hydrostatic pressure on the wall and to determine if repairs to the drain are necessary. If installed, monitor wells to see if condition worsens.
