**PENNSYLVANIA
ID NO. PA.00787**

**LEASER LAKE DAM
(JACKSONVILLE LAKE)**

**PHASE I INSPECTION REPORT
NATIONAL DAM INSPECTION PROGRAM**

JULY 1978

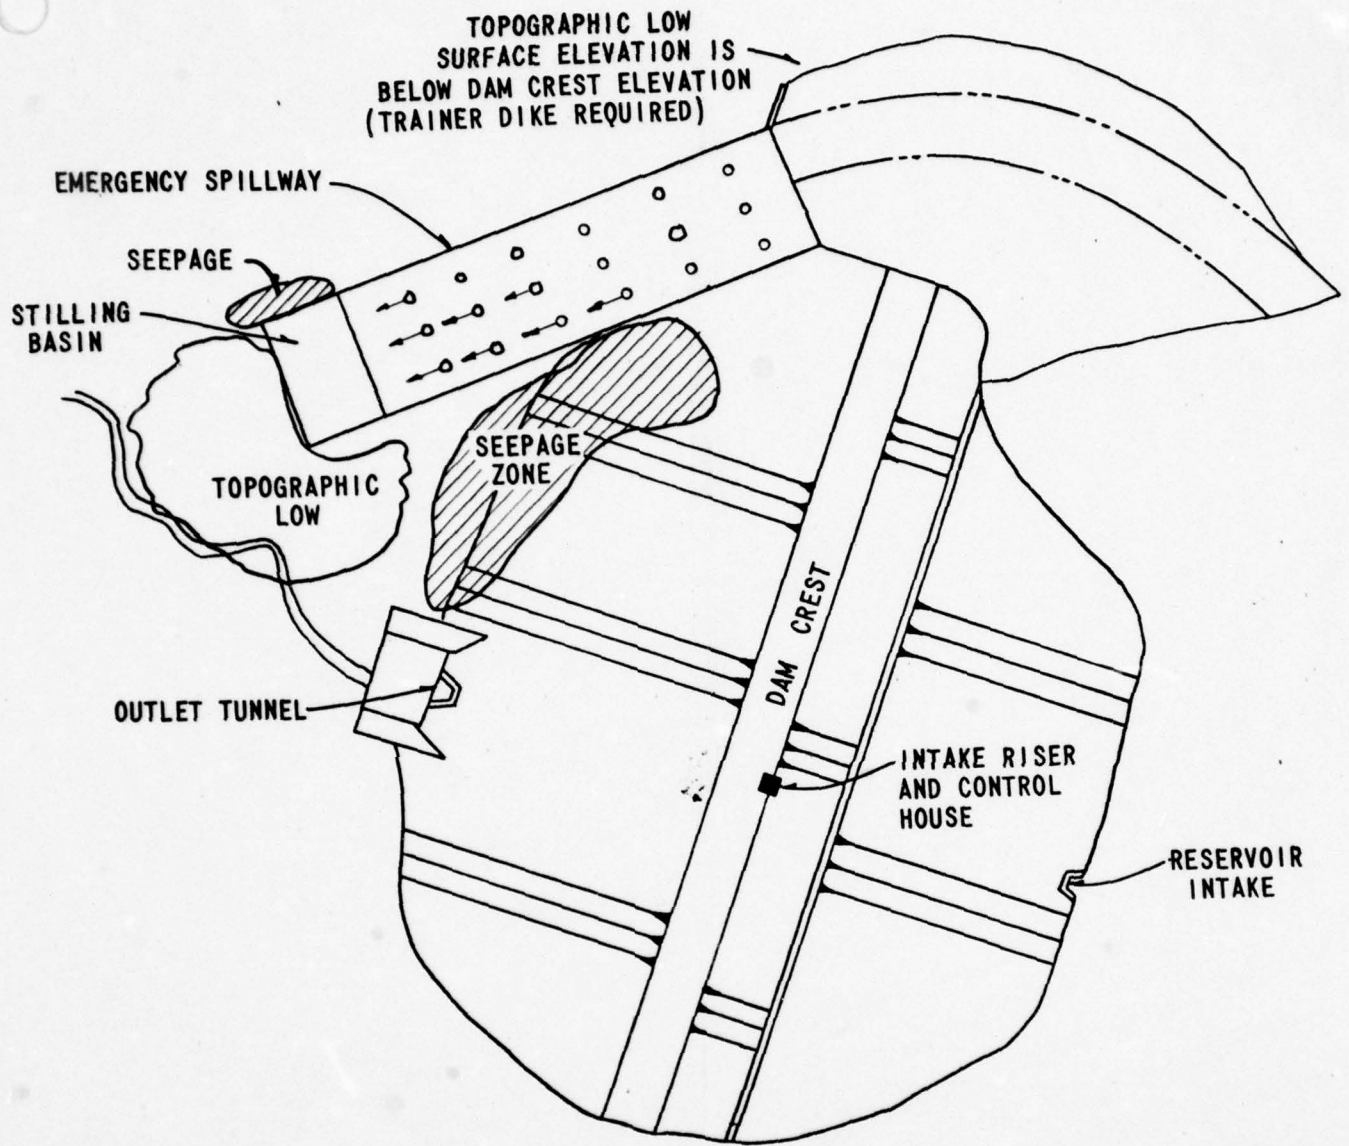
SEEPAGE LOCATION PLAN
LEASER LAKE DAM
SHEET 5a OF 11

As delineated on Sheet 5a, Appendix B, a moderate seepage volume was noticed emanating from the downstream slope near the right abutment. Initially, seepage was noted to exit the embankment as sheet flow, subsequently concentrating into several small channels as shown in Photo 8. Weep holes in the adjacent spillway were noted to be discharging clear water at approximately the same elevation as the seepage noted on the embankment slope. There was no significant distortion, misalignment or bulging of the slope observed. However, the heavy growth on the slope could be masking slight bulging of the embankment. In summary, with the exception of the embankment seepage, the embankment is functioning as designed.

As shown on Sheet 5a of Appendix B, the seepage zone extends well above the toe and covers a fairly significant area. Previous inspections by the State also reported this seepage. The first State inspection to note this was performed on 6 October 1972, by the DER, but the quantity of flow was not determined. Any changes in flow since that time were not determined. This flow was observed to be clear. The cause and future risk potential can not be properly assessed without more detailed study.

Note: Due to the type of seepage occurring (sheet flow), the quantity of flow could not be accurately estimated.

3. Further evaluation of the downstream slope seepage should be performed as soon as possible. This evaluation should include cutting the vegetation on the slope and delineating the exact extent of the seepage zone. In addition, the phreatic line should be delineated and the embankment materials investigated with regard to the causal features of the seepage emergence. Pending the results of this investigation, corrective measures should be provided to control the seepage.
4. The spalled concrete on the channels should be repaired and packed with an epoxy grout or similar material to protect the reinforcing steel.

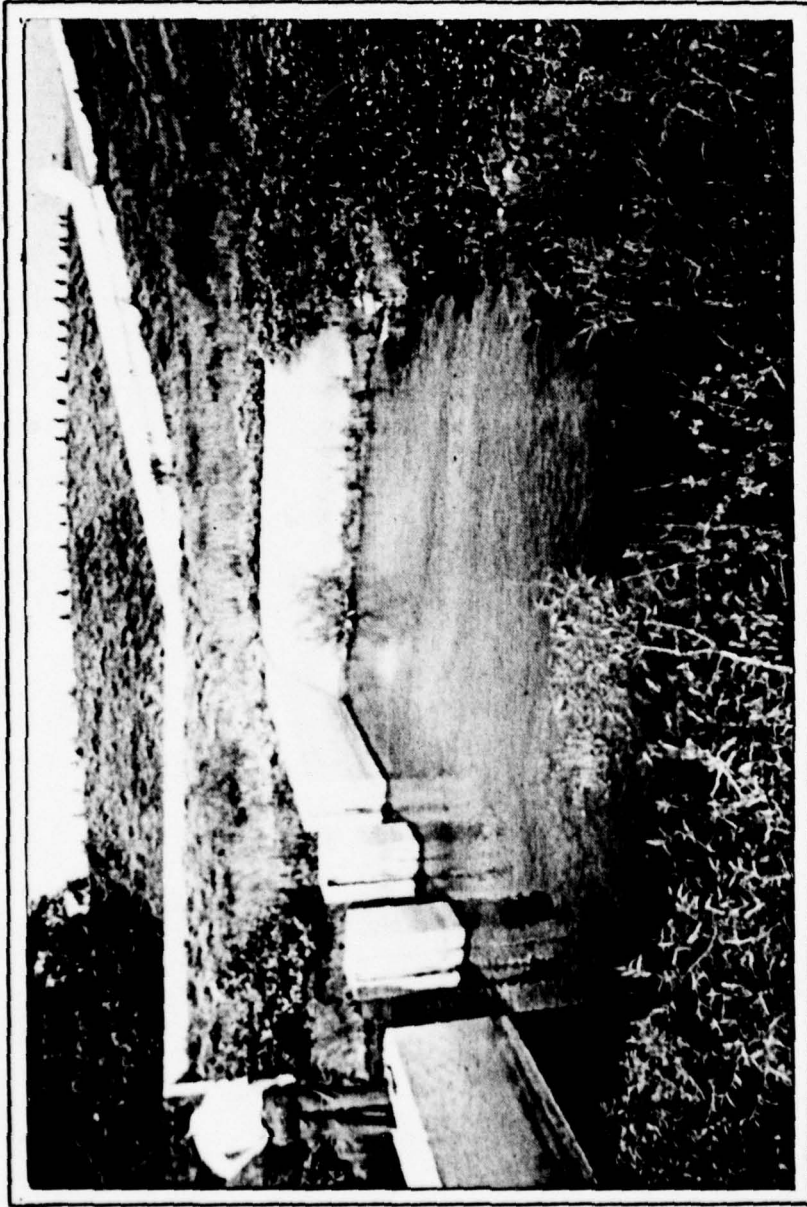
VIEW OF STILLING BASIN AT POND DRAIN OUTFALL.
NOTE COLUMNS TO HOUSE STOP LOGS FOR STILLING
BASIN.

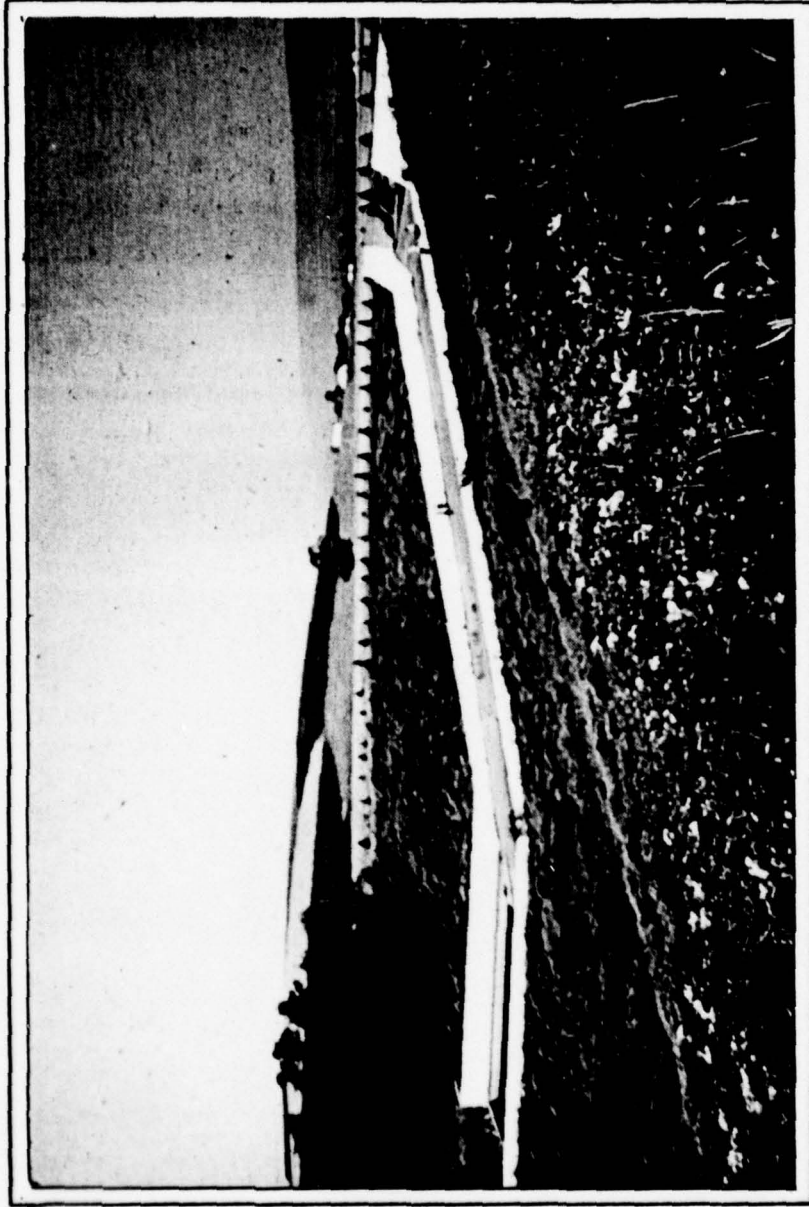
PHOTOGRAPH NO. 4

OVERVIEW OF EMERGENCY SPILLWAY

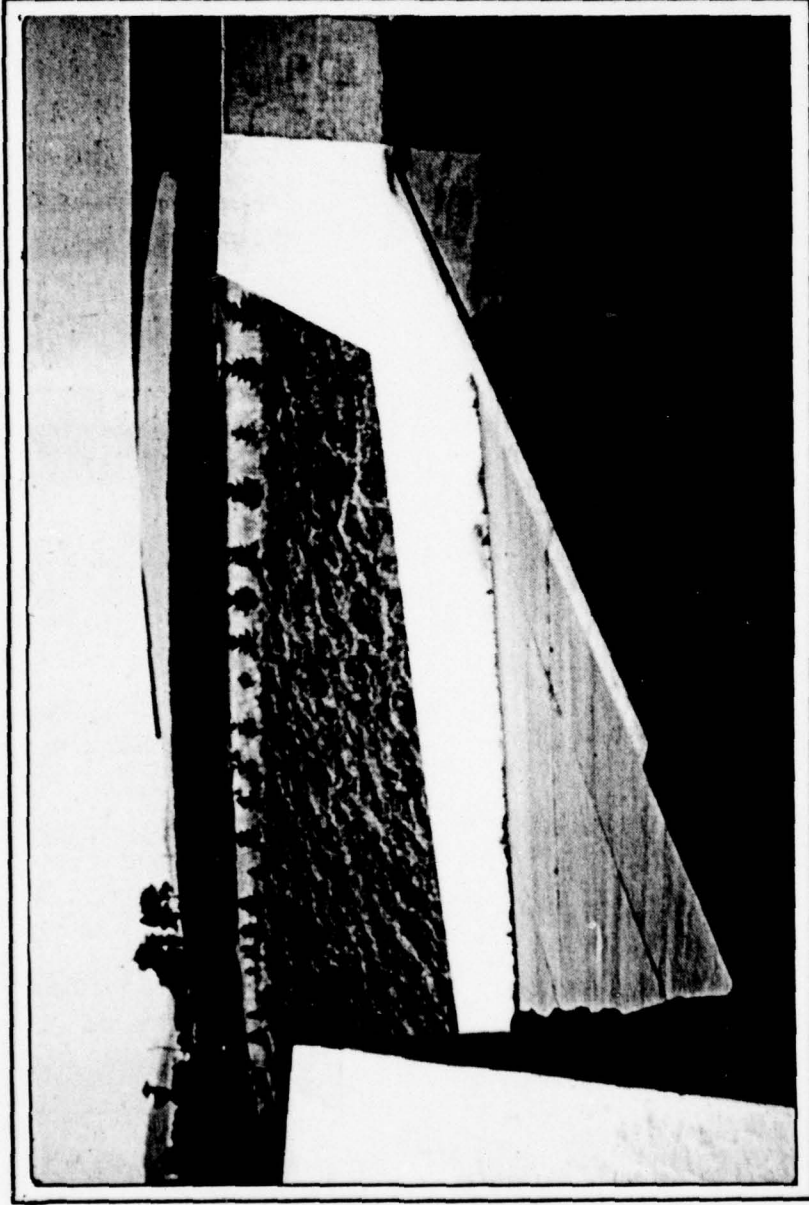
VIEW OF EMERGENCY SPILLWAY WEIR LOOKING
FROM LEFT ABUTMENT OF STRUCTURE

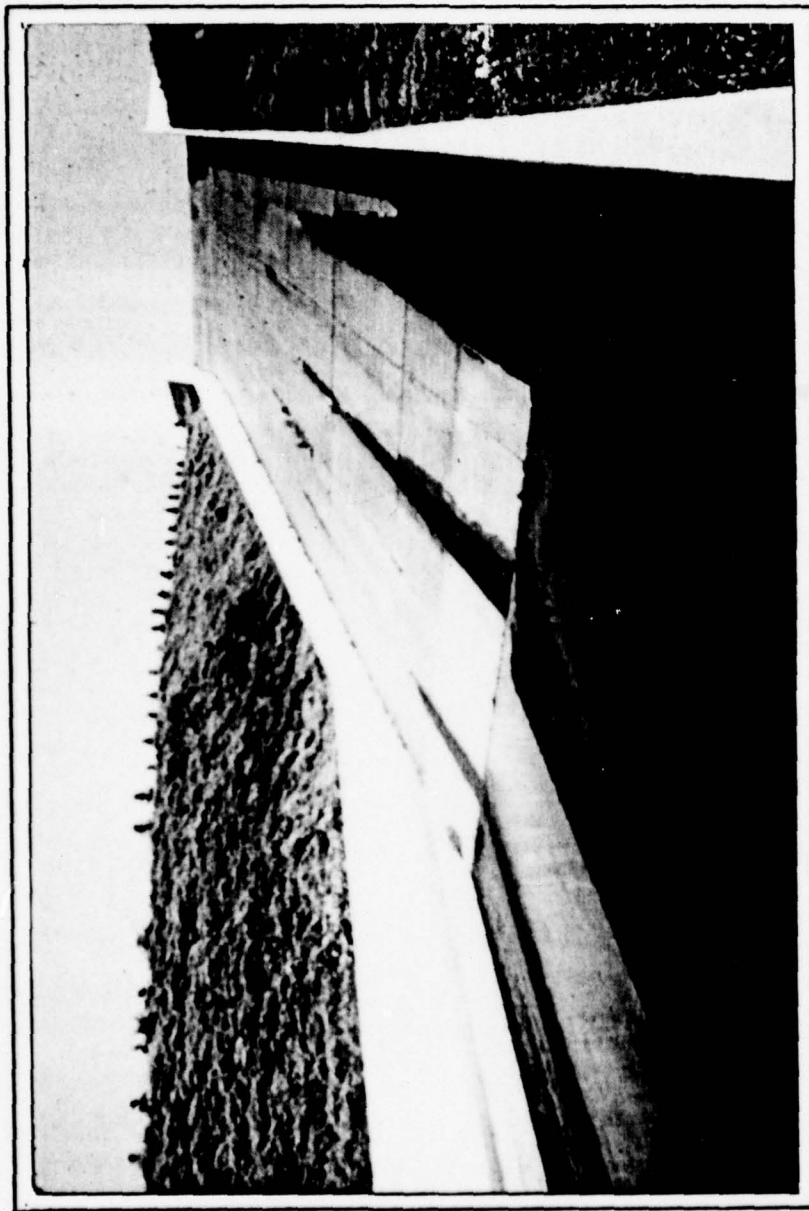
LOOKING UP THE SPILLWAY CHUTE. NOTE SEEPAGE
THROUGH DRAIN HOLES AND HIGH WATER MARK ON
WING WALLS.

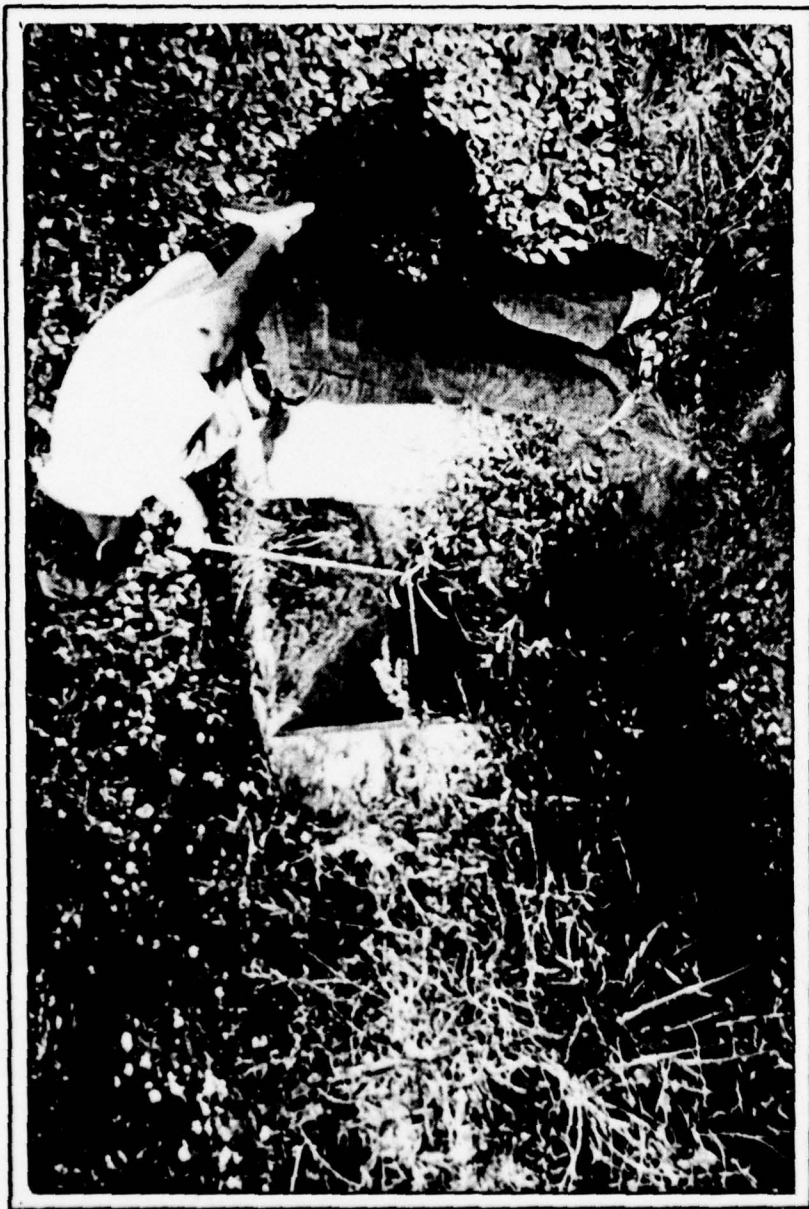
VIEW OF DRAINAGE OUTFALL PIPE DISCHARGING
FROM DRAINAGE BLANKET.

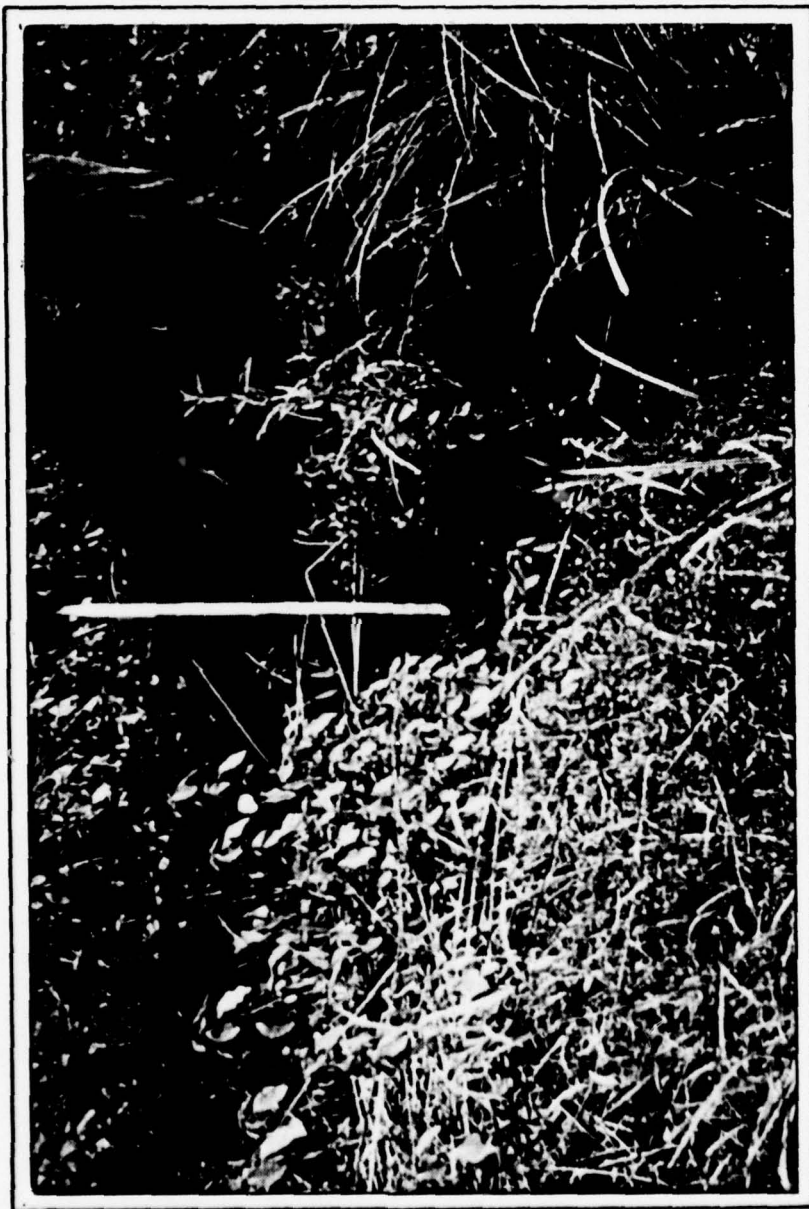
As previously described in Section 3, settlement was noted on the right portion of the embankment crest next to the emergency spillway. Immediately downstream of this area, seepage was observed emanating from the slope, causing some minor gullying.

TYPICAL STREAM OF EMBANKMENT SEEPAGE FLOWING
DOWN THE LEFT SIDE OF THE EMBANKMENT RIGHT
OF THE EMERGENCY SPILLWAY.

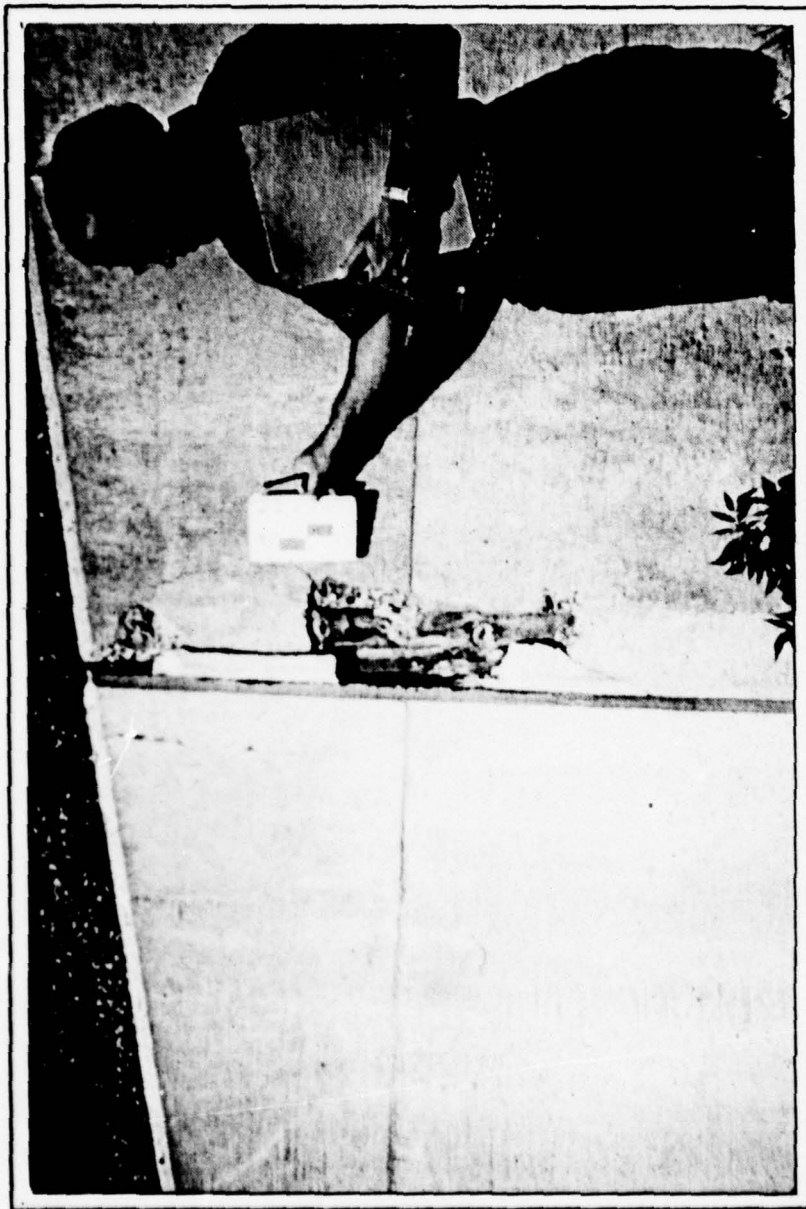
SPALLING NOTED AT SEVERAL LOCATIONS
ALONG THE INSIDE CHANNEL OF THE EMER-
GENCY SPILLWAY. SPALLING WAS CONCENTRATED
NEAR CONSTRUCTION JOINTS.

The emergency spillway was also inspected and found to be in good condition. The few spalled areas on the walls and spillway chute should be patched.

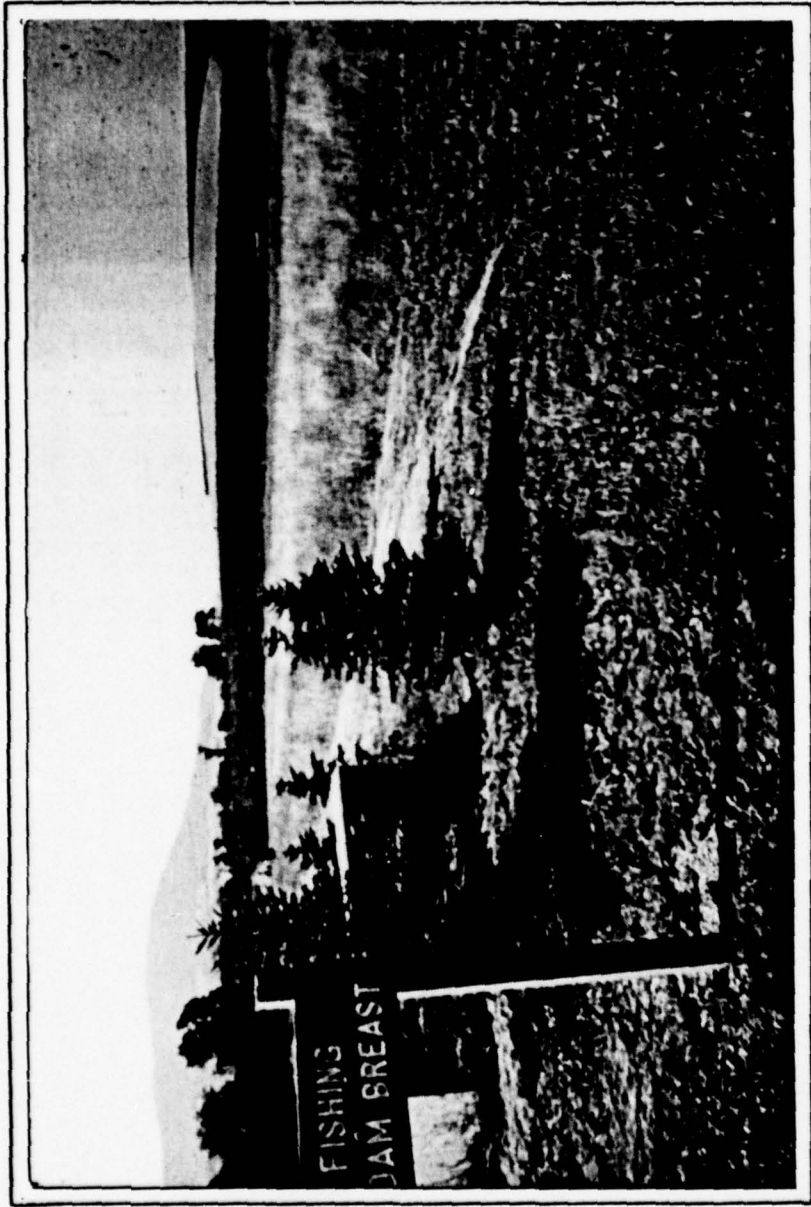
c. Visual Observations. On the date of the inspection, the only condition observed that would indicate that the outlet capacity could be reduced during a flood occurrence is that the ground surface on the right side of the spillway is about 0.8 feet below the embankment crest, thus reducing the minimum distance between the spillway crest and the minimum crest elevation. Observations regarding the condition of the downstream channel, spillway conditions, and reservoir are located in Appendix B.

The channel bottom was judged to be in good condition as well as the left side. On the right side, some bank erosion was noted which can be repaired with riprap. It is noted that the training wall on the right side is tied into the natural ground which is slightly below the dam crest. Therefore, overtopping (21 feet) would occur prior to dam overtopping. This would erode the wall on the right side. A training dike should be constructed to prevent this.

LOW AREA RIGHT OF EMERGENCY SPILLWAY
WHERE WATER WOULD PASS BEFORE OVER-
TOPPING THE DAM. FLOW WOULD TURN LEFT
BEHIND THE WALL.

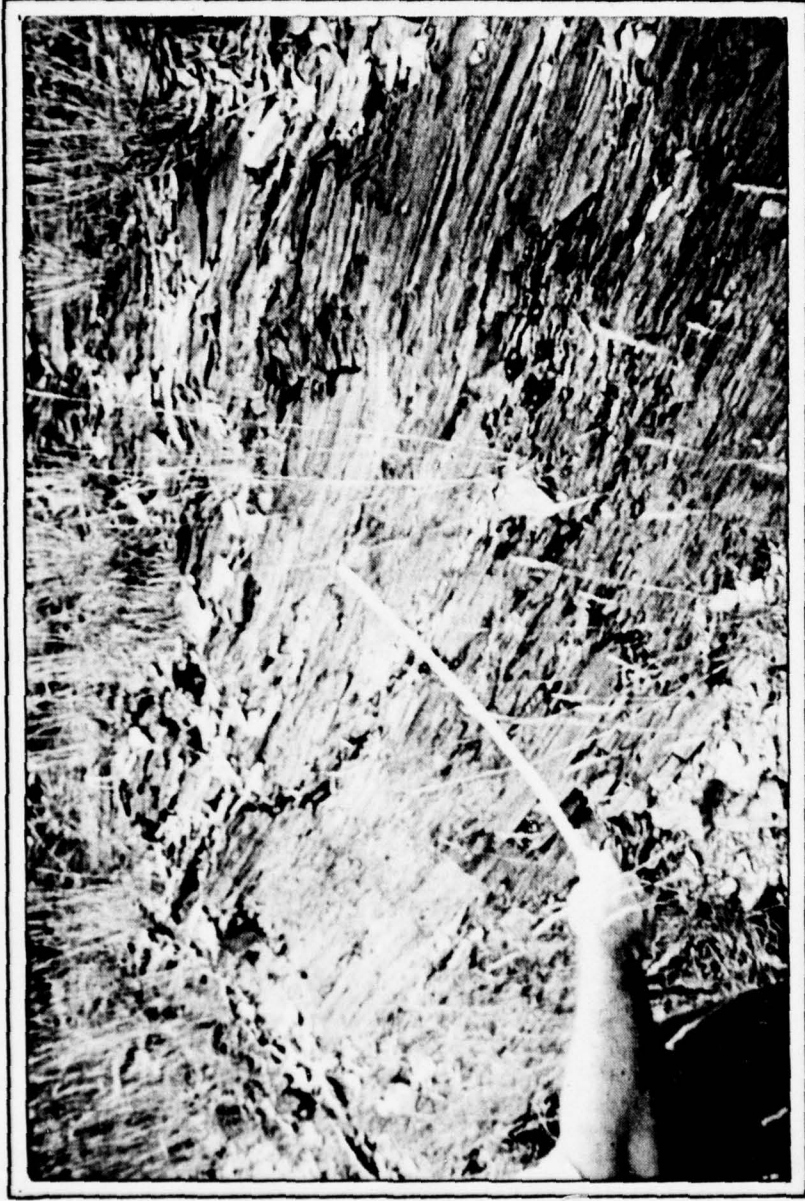
VIEW OF TYPICAL ROCK OUTCROP ON LEFT ABUTMENT. RESERVOIR IS TO THE LEFT OF THE PHOTOGRAPH.
