# LEVEL THE PERFORMANCE OF SELECTED MARINE COATINGS EXPOSED TO HIGH VELOCITY SEAWATER

By G. A. GEHRING, JR.

Prepared for OFFICE of NAVAL RESEARCH

March 1979

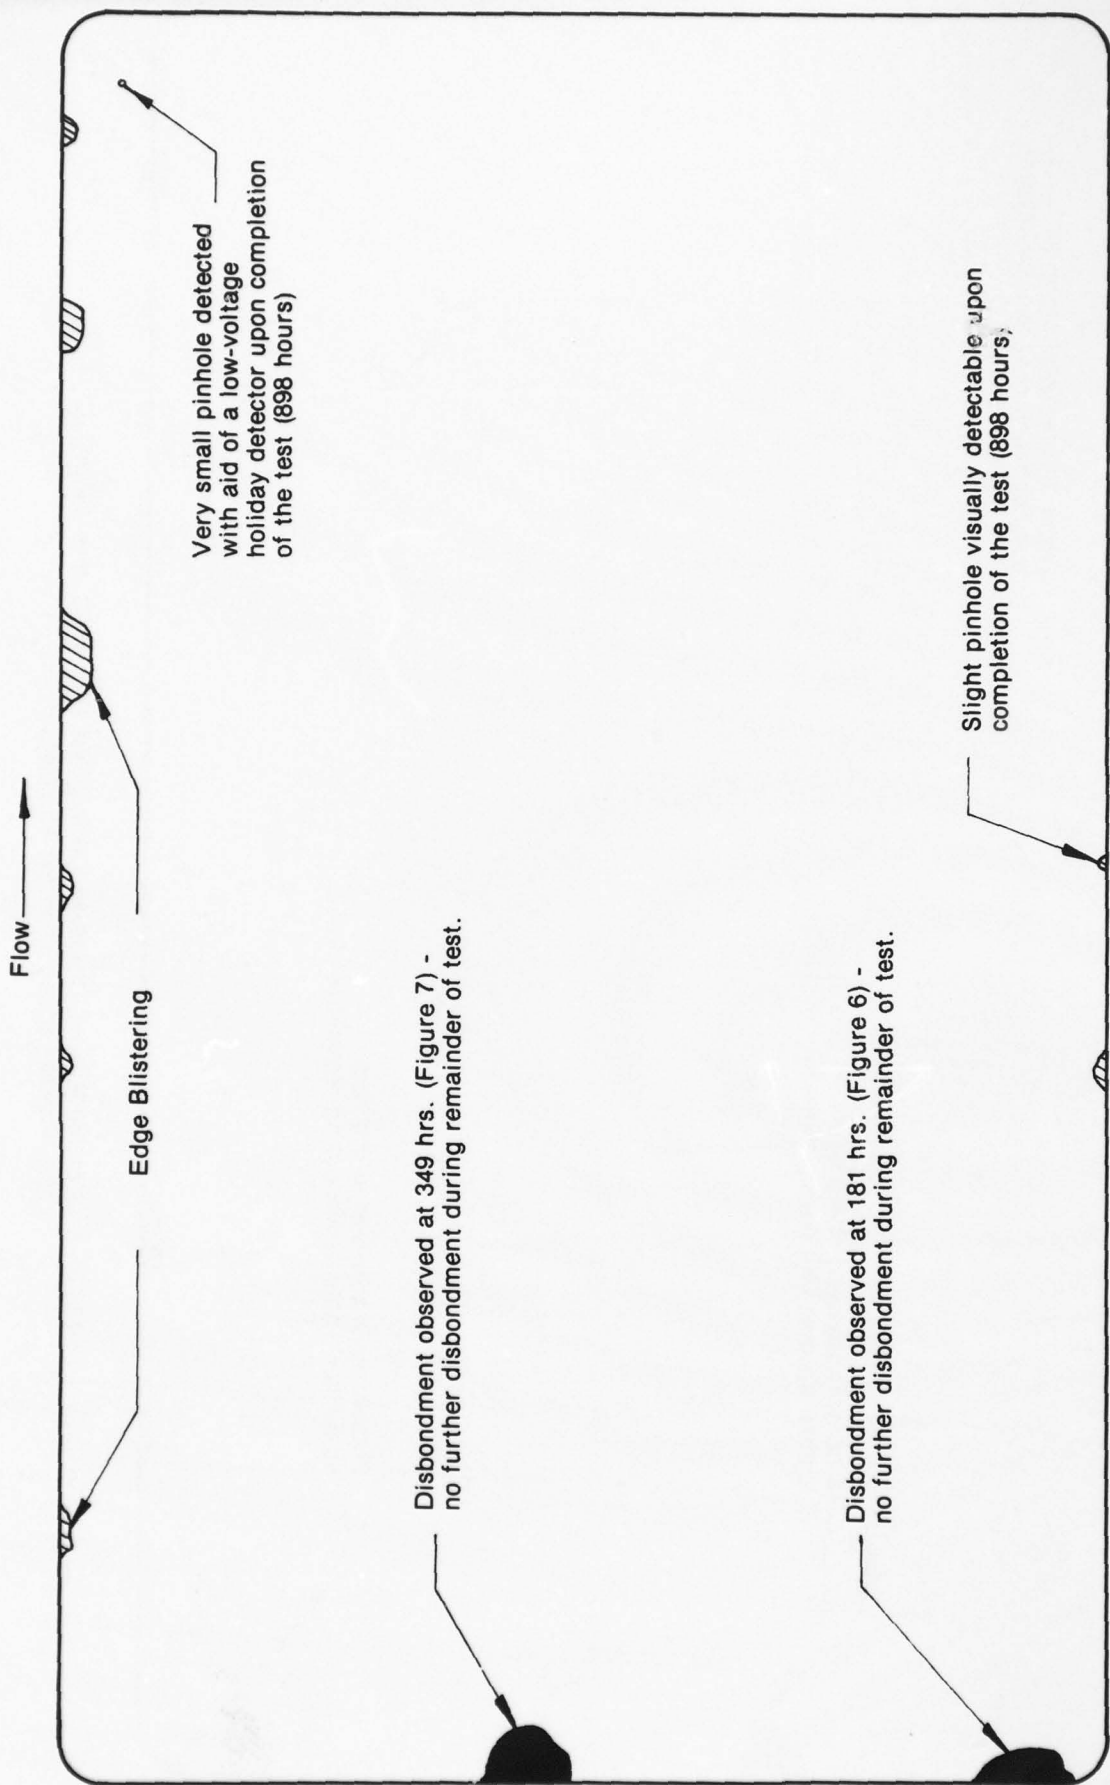
The first sign of coating deterioration was observed on Panel #1 (upstream panel) at 181 hours into test (Figure 6). Coating disbonded over about a 2 cm<sup>2</sup> area on the leading edge. This coating holiday remained approximately the same size over the remainder of the exposure. Corrosion of the exposed steel substrate occurred quite rapidly and at the end of the exposure a pit of .300 mm was measured (Figure 6a). The apparent stability of the coating about the initial holiday was surprising. It had been anticipated that, in the event of such a failure at this velocity, coating disbondment would proceed rapidly from this point.

Figure 4 - Coating Failure Observed During Test Run at 30 m/s - Panel #1; MIL-P-24441 Epoxy (Approx. to Scale)

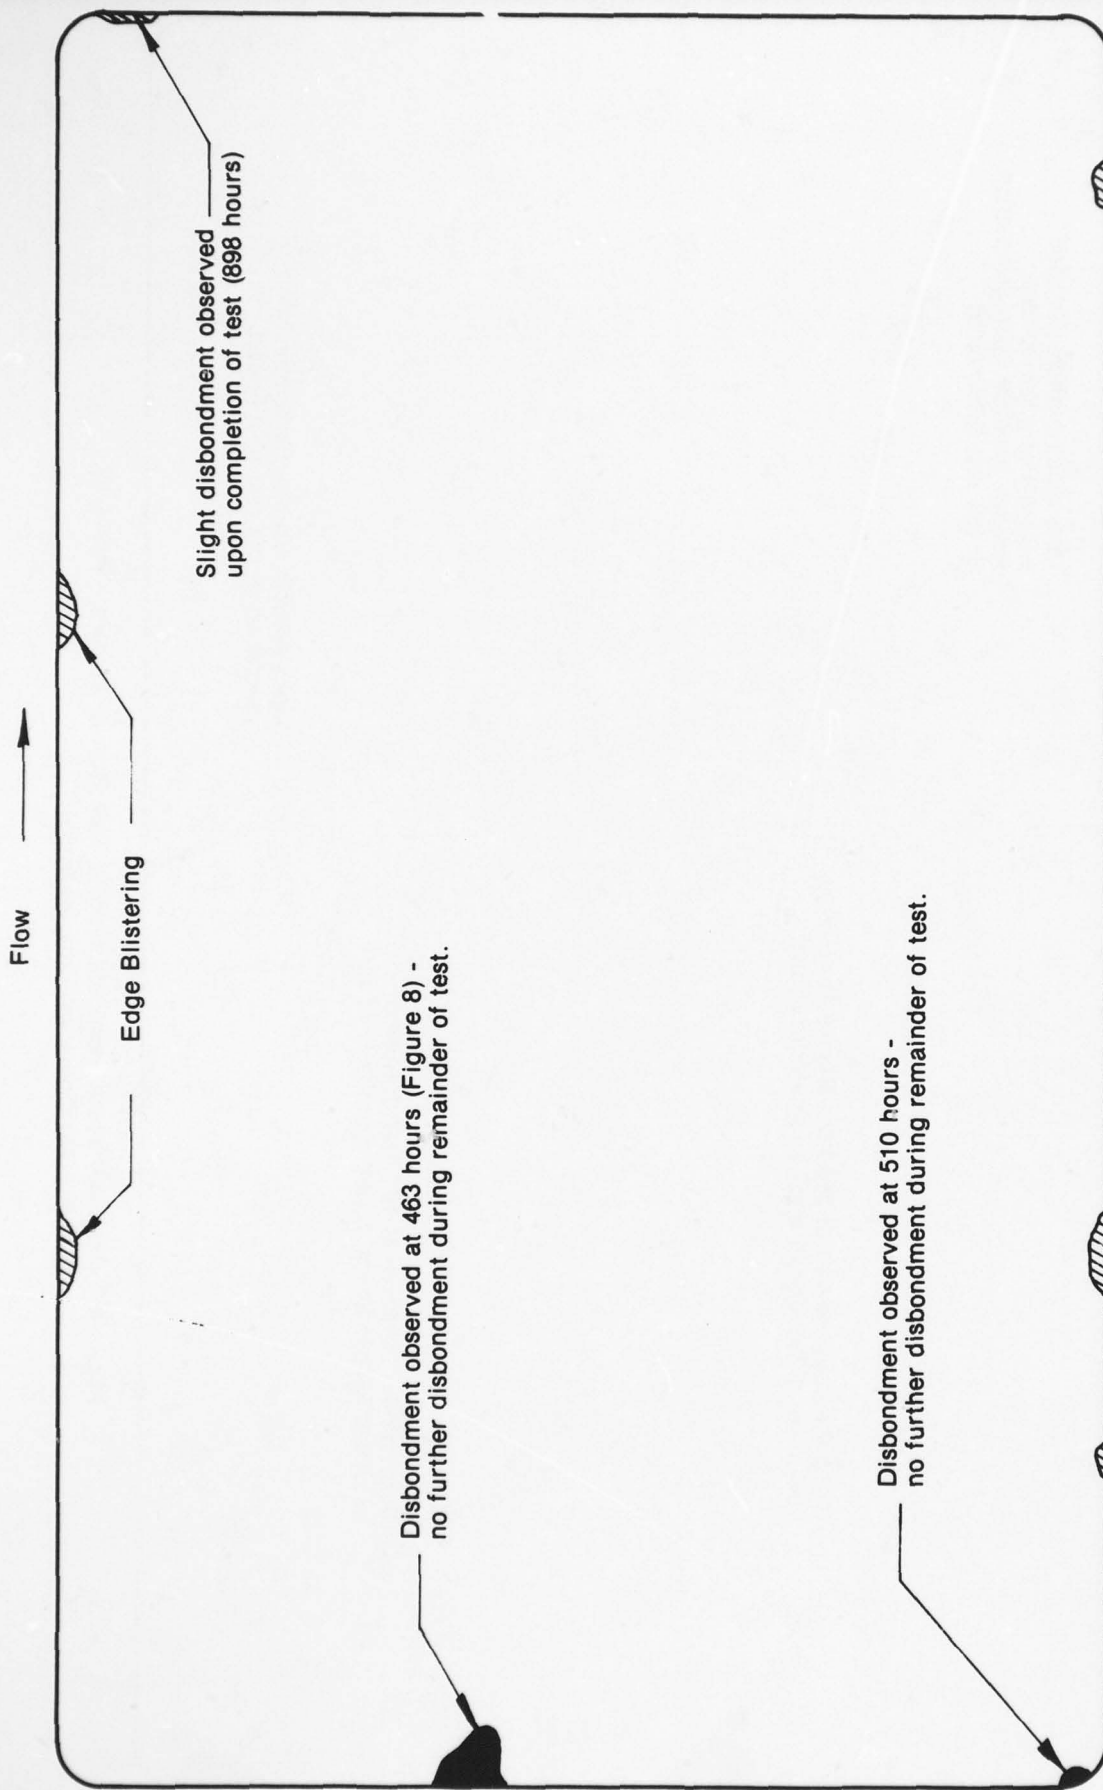
Similar coating failure occurred on panel #2 (downstream panel) at 463 and 510 hours into test as shown in Figure 8. These holidays also were stable over the remainder of the exposure period. Figures 9 and 10 are photographs of each test panel upon completion of the 898-hour exposure test.

Figure 5 - Coating Failure Observed During Test Run at 30 m/s - Panel #2; MIL-P-24441 Epoxy (Approx. To Scale)

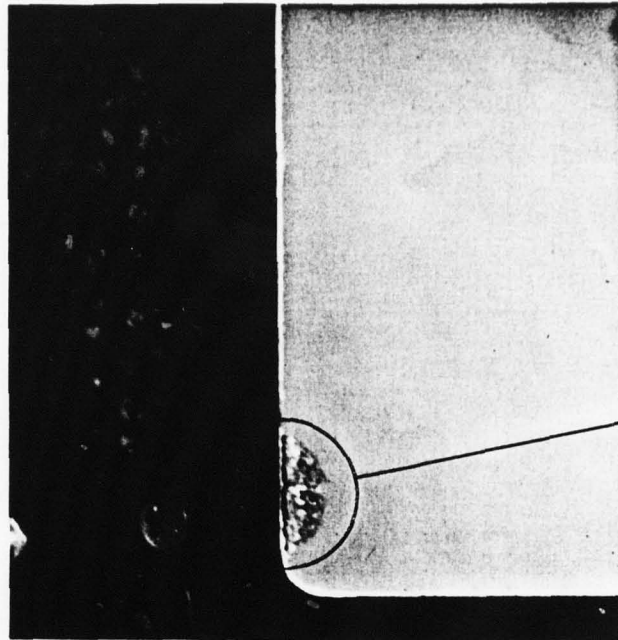
Figure 6a

Figure 6 - Coating Disbondment Observed at 181 Hours at 30 m/s - Panel #1;  
MIL-P-24441 Epoxy.

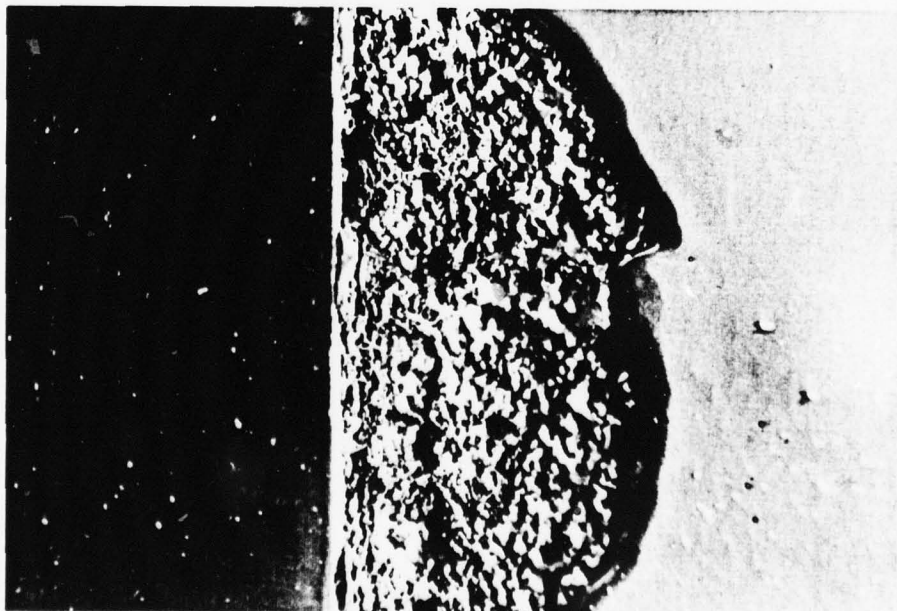
Figure 6a - Close-Up of Coating Holiday After 898 Hours - Panel #1.

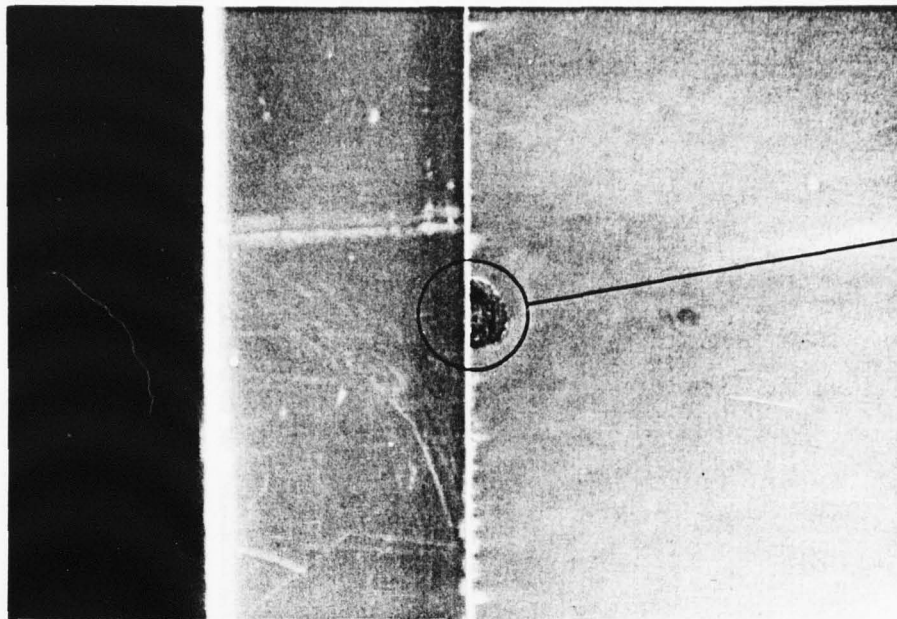
The next observed failure occurred on the same panel at  $\approx$  349 hours into test. Again, the failure was in the form of disbondment initiating at the leading edge (Figure 7). The holiday remained stable in size over the remainder of the test period.

**Figure 7 - Coating Disbondment Observed At 349 Hours at 30 m/s - Panel #1;  
MIL-P-24441 Epoxy**

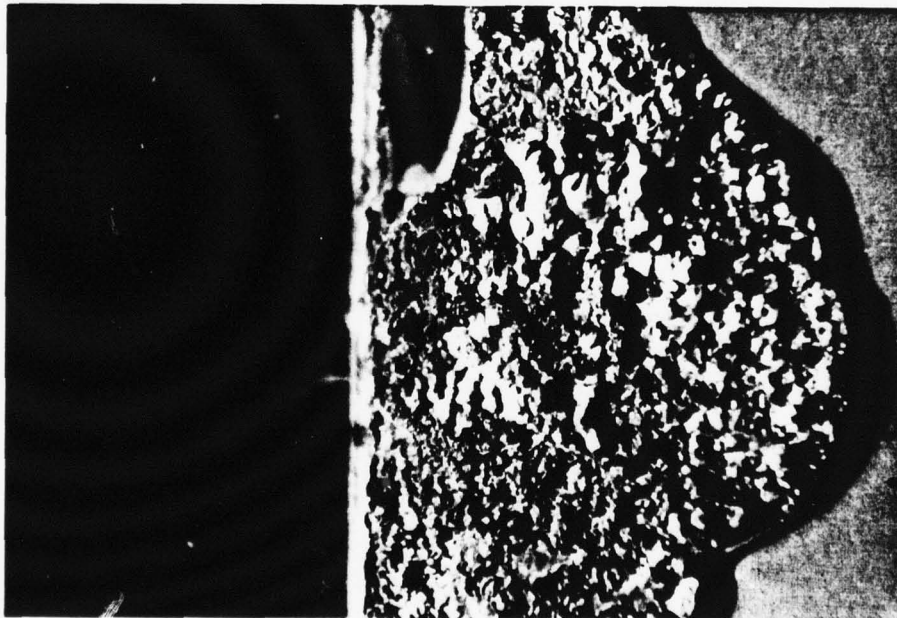
**Figure 7a - Close-Up of Coating Holiday After 898 Hours - Panel #1**

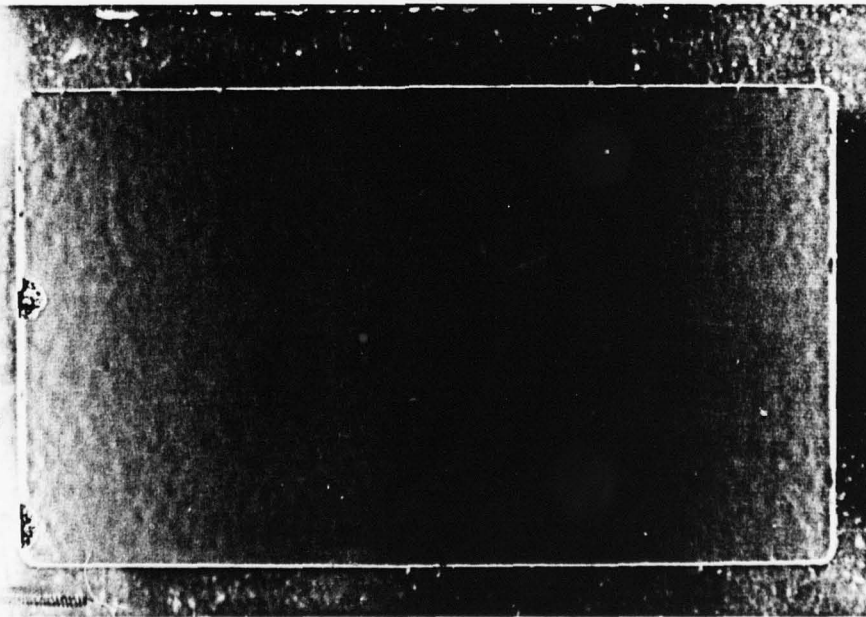
**Figure 9 - MIL-P-24441 Epoxy After 898 Hours Exposure to Seawater Flowing At  
30 m/s (Panel #1)**

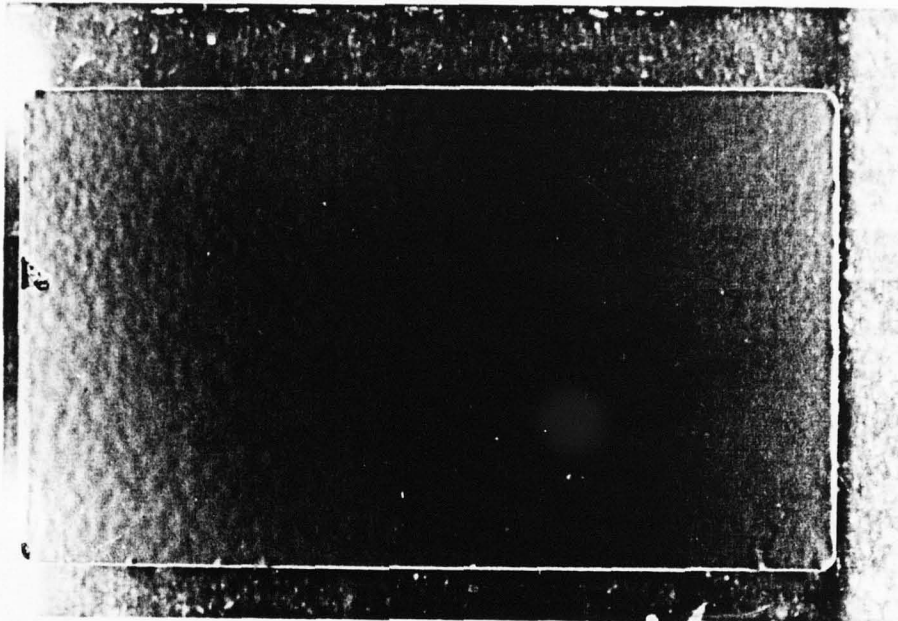
**Figure 10 - MIL-P-24441 Epoxy After 898 Hour Exposure to Seawater Flowing At 30 m/s (Panel #2)**

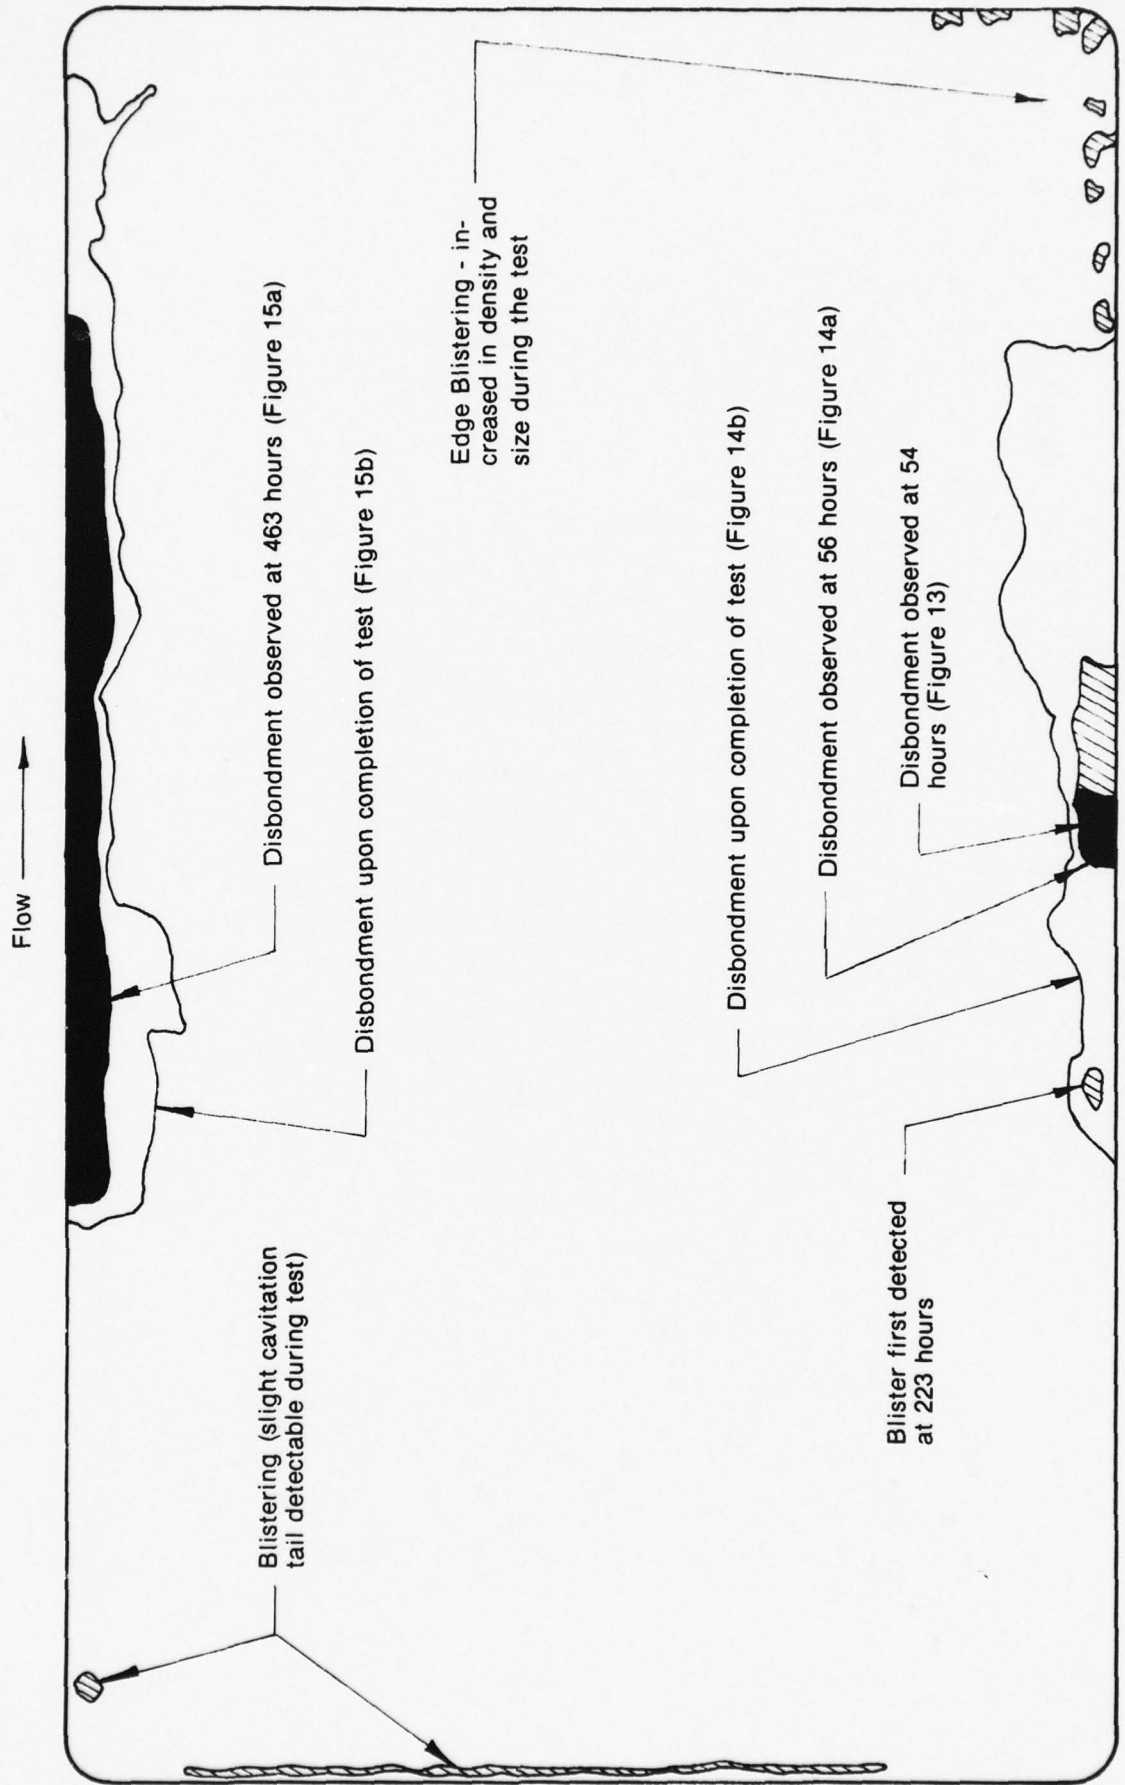
Figure 11 characterizes the deterioration observed on this coating over the test run. Figure 12 shows the test panel after 898 hours exposure. Failure of this coating system first occurred at 54 hours. The failure was in the form of disbondment along the bottom edge (Figure 13). The holiday did not remain stable over the test period, but continued to increase in size (Figure 14). Significant corrosion occurred on the exposed steel substrate. The maximum pit depth was .517 mm after 898 hours.

Figure 11 - Coating Failure Observed During Test Run at 30 m/s - Panel #3; DEVRAN Epoxy (Approx. To Scale)

cavitation  
occurring at  
blister in  
coating

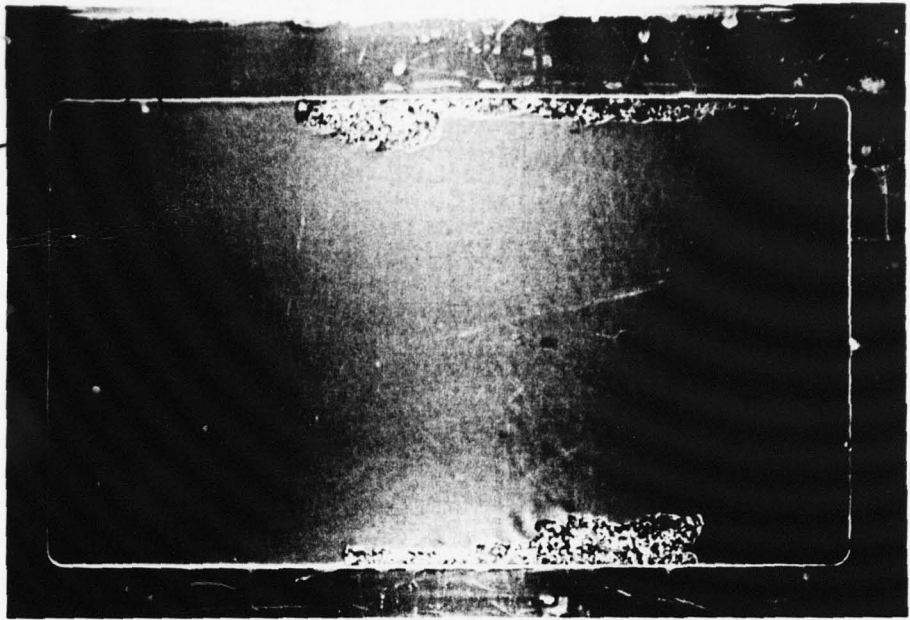
**Figure 12 - DEVRAN Epoxy At 898 Hours Exposure to Seawater Flowing At 30 m/s**

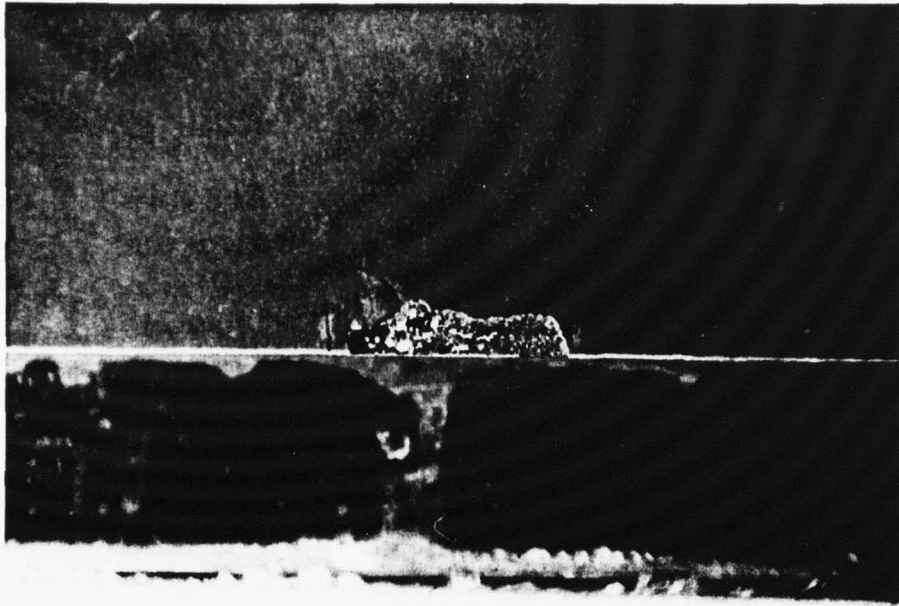
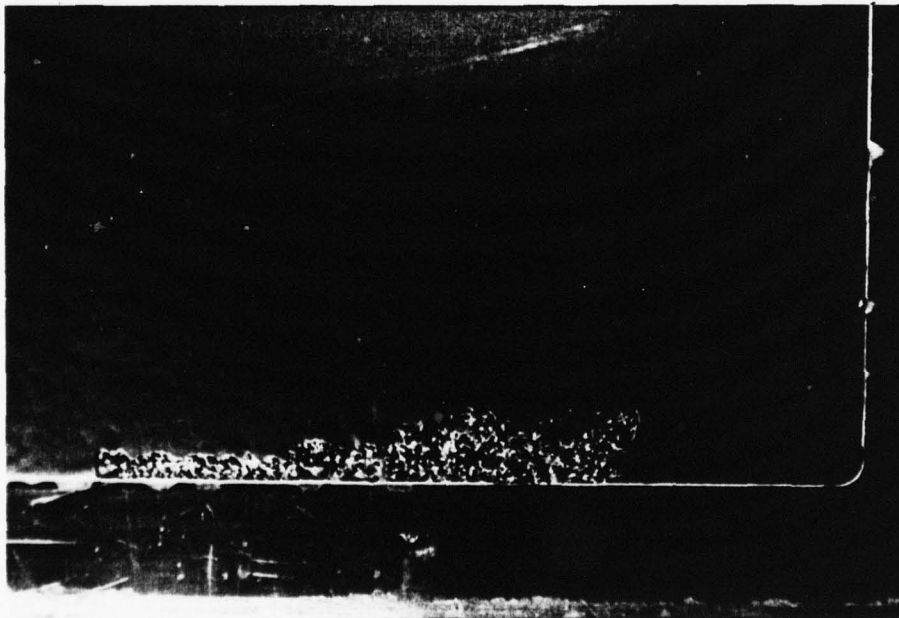
**Figure 14 - Development of Coating Holiday With Time - Panel #3; DEVRAN Epoxy at 30 m/s (Lower Edge of Panel)**

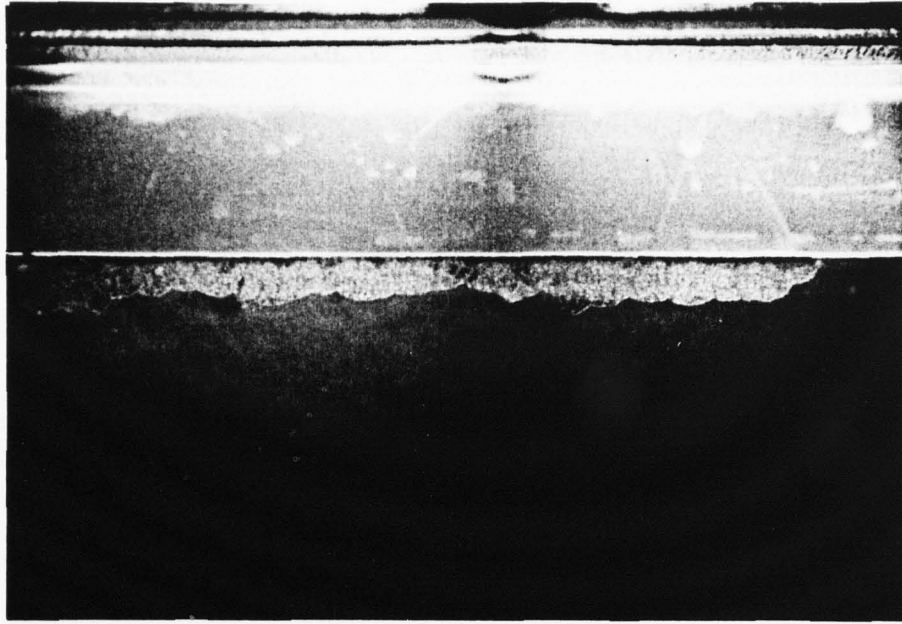
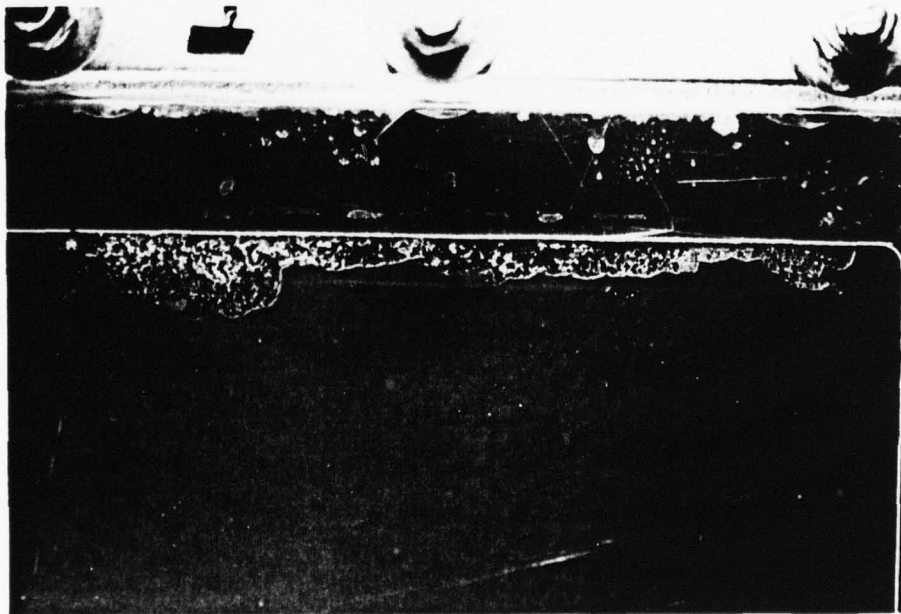
At about 460 hours into test, disbondment of the coating was observed on the upper edge of the test panel. This holiday also continued to increase in size over the rest of the test period (Figure 15). Final inspection of the test panel showed random blistering along the edges of the test panel. The DEVTRAN coating system suffered significantly more damage than the other coatings at 30 m/s.

Figure 15 - Development of Coating Holiday With Time - Panel #3; DEVRAN Epoxy at 30 m/s (Upper Edge of Panel)

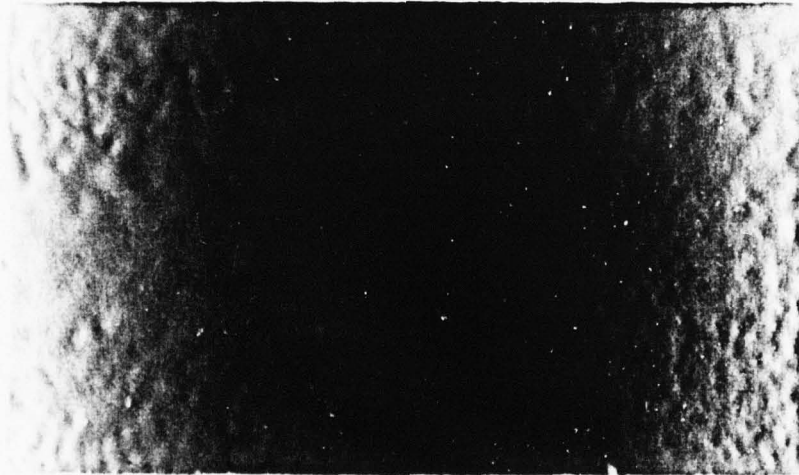
The one panel coated with coal tar-epoxy did not exhibit detectable deterioration over the 898 hour velocity test (Figure 16). Final inspection revealed slight blistering at a few isolated spots along the bottom edge. The coated panel showed no significant weight loss or measurable reduction in thickness.

**Figure 16 - Panel #4 TARSET Epoxy After 898 Hours Exposure to Seawater  
Flowing At 30 m/s**

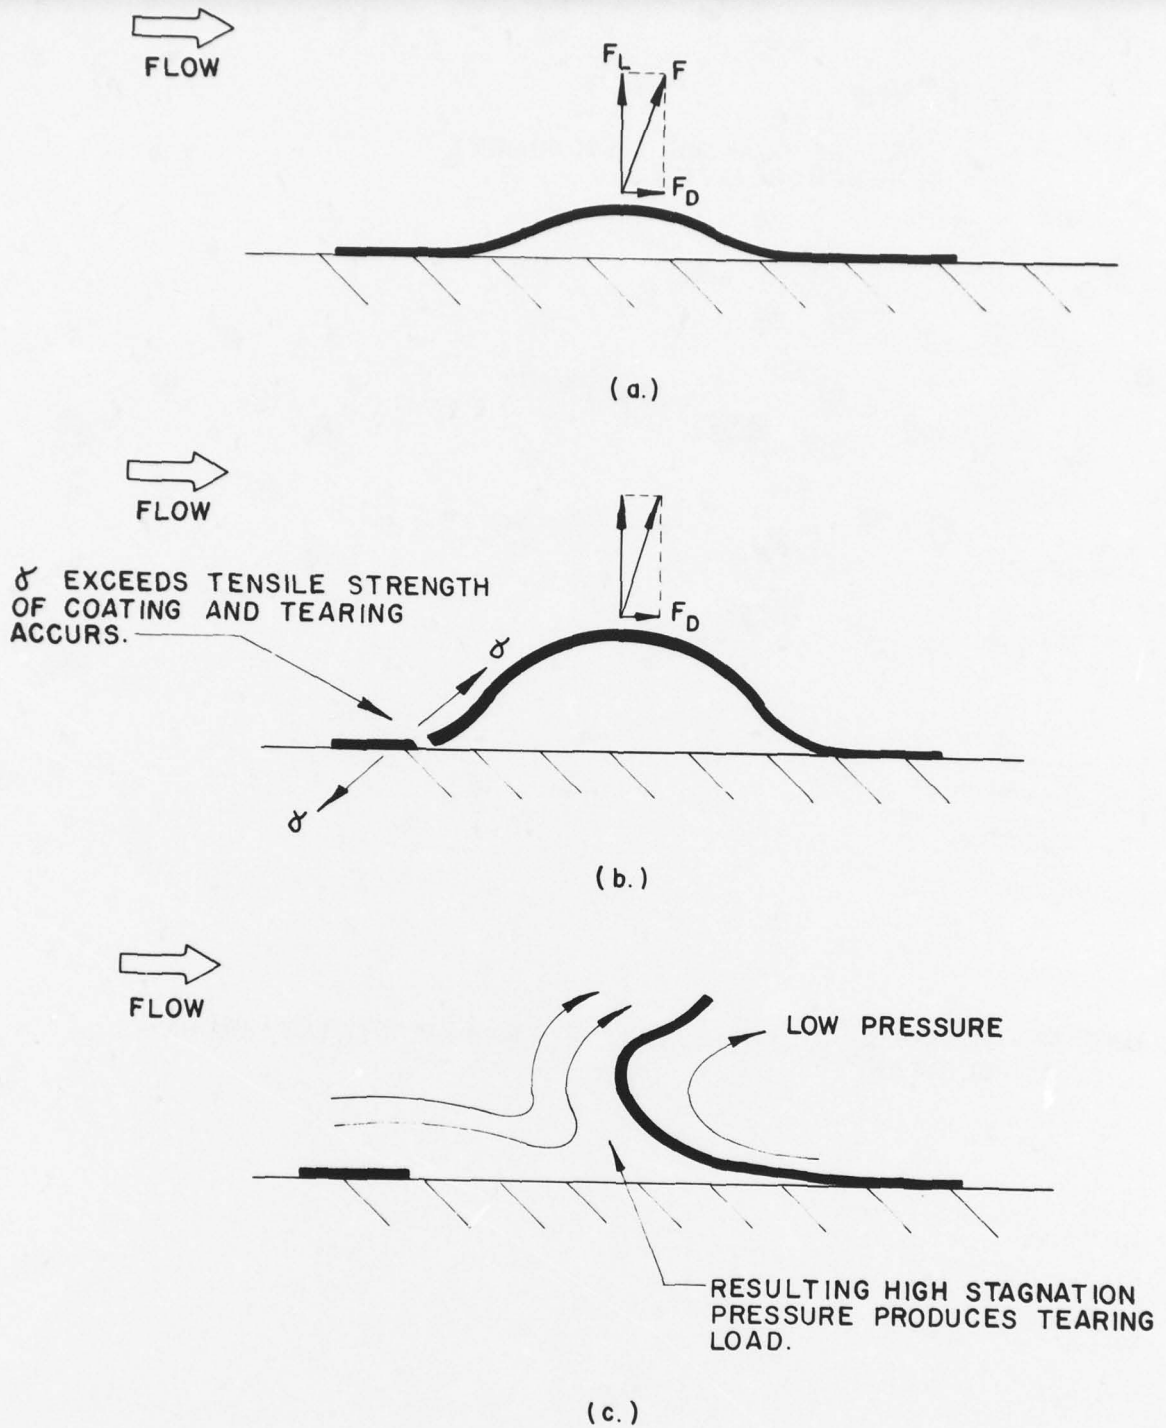
In general conformance with Hackworth's proposed failure mode, Figure 31 presents a simplified picture of the forces that might arise about a blister and how the coating might ultimately respond to such forces. As shown, two mutually perpendicular forces — lift and pressure drag — are distributed over the surface of the blister. The pertinent equations from airfoil theory describing these forces are as follows:

A lifting force would create a differential pressure across the coating at the point of the blister. The situation would be somewhat analogous to the action of a plumber's helper (suction-type plunger). As the coating is lifted from the substrate, it would tend to create a vacuum in the area between the coating and substrate. The resulting differential pressure would accelerate seawater transport through the coating at the blister. The additional volume of seawater entering the blister would increase corrosion of the substrate leading to further breakdown of the adhesive bond and increase expansion stresses from corrosion product formation. Under the combined action of these forces, the blister would continue to grow. Ultimately, the blister reaches a critical size such that the hydrodynamic forces are resolved causing a tensile stress in the coating that exceeds its inherent tensile strength and gross rupture occurs.

FIGURE 31 - POSSIBLE COATING FAILURE MECHANISM AT HIGH VELOCITY.

LIMIT OF COATING DISBONDMENT  
BENEATH BLISTER.

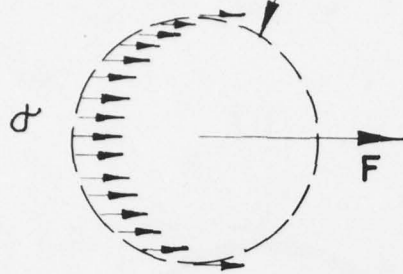
FIGURE 32 - POSSIBLE DISTRIBUTION OF TENSILE STRESS AROUND  
BLISTER.
