# SWARTSWOOD LAKE DAM

**NJ 00171**

**PHASE 1 INSPECTION REPORT  
NATIONAL DAM SAFETY PROGRAM**

May, 1979

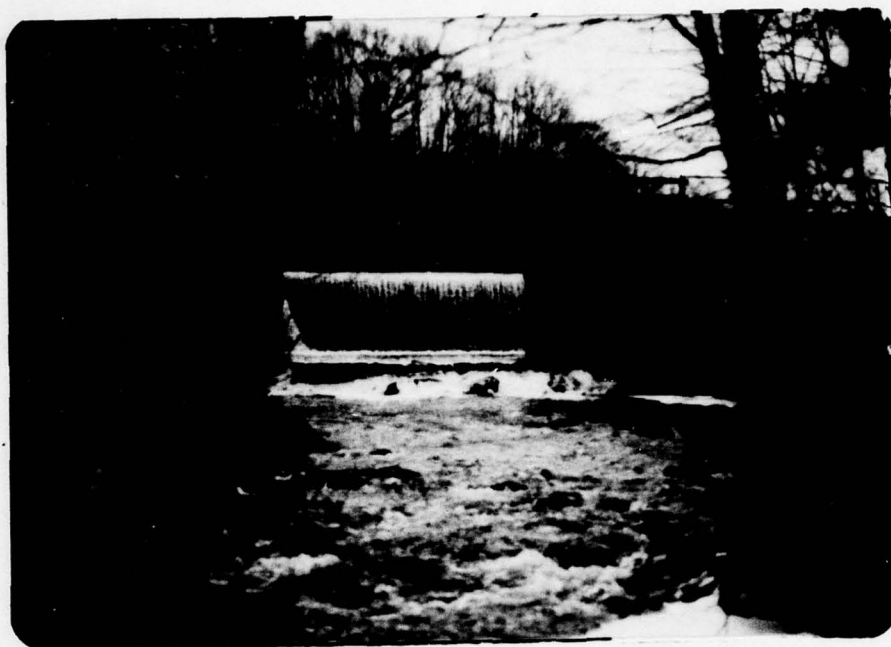
Masonry rock face of dam.  
Looking upstream.

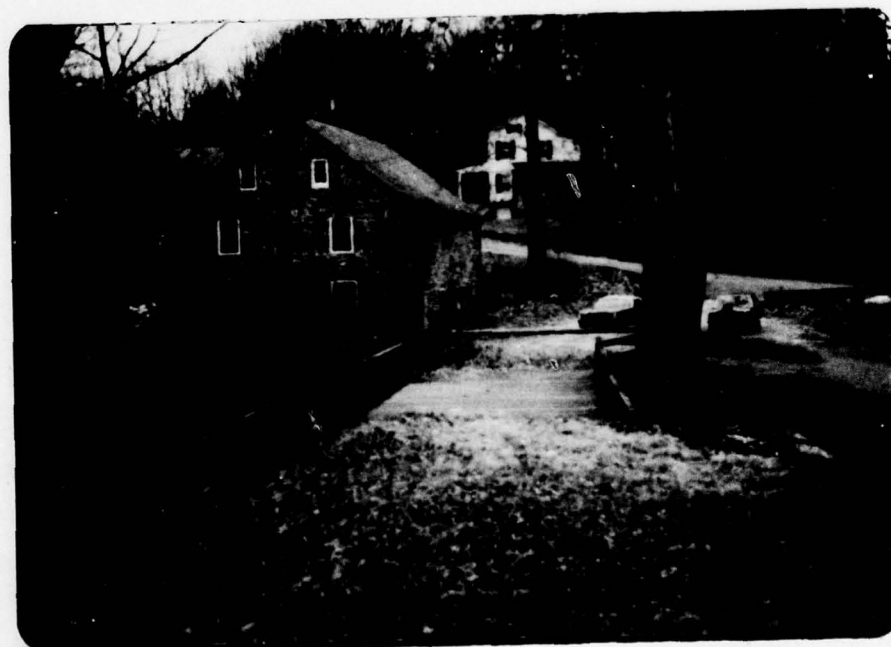
Abutments and roadway with wooden  
bridge across dam. Looking west.

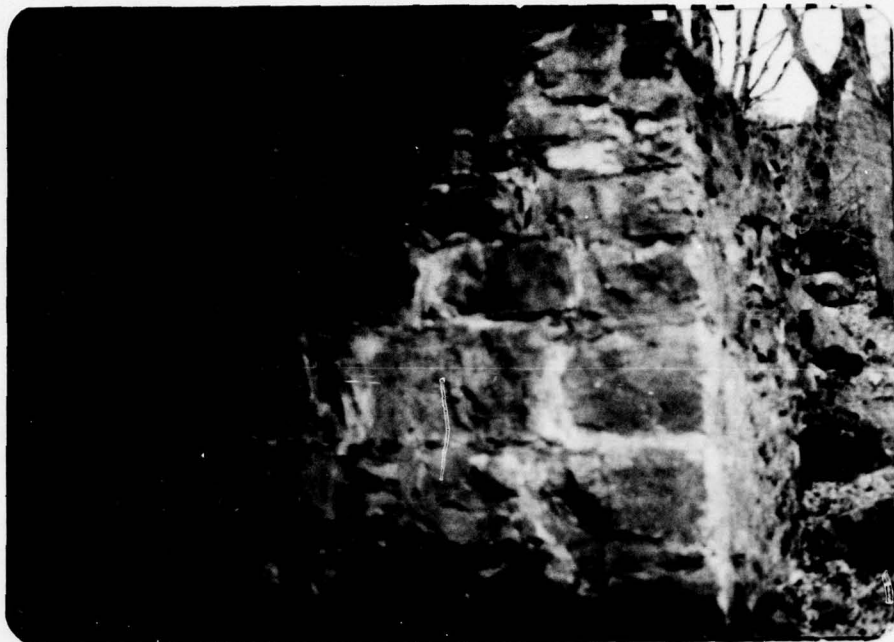
Left side of spillway discharge channel wall  
and downstream face of dam. Looking east.

4. The spillway channel masonry sidewalls and the walls along the downstream face of the dam should be repaired and if necessary strengthened. This should be done soon.

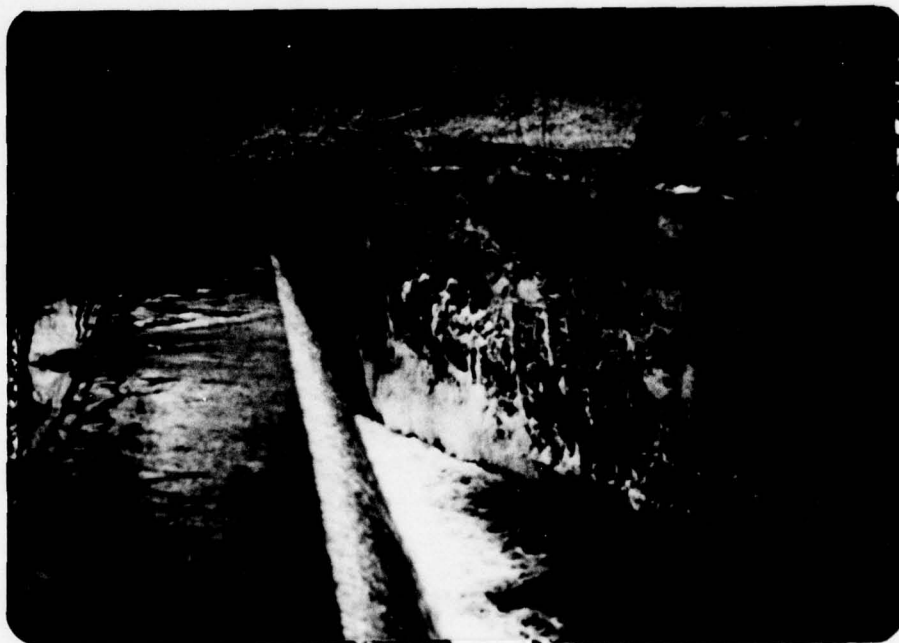
Crest of spillway and discharge channel  
sidewall upstream of center of dam.  
Looking east.
