ALLOWAY LAKE DAM

NJ 00038

PHASE 1 INSPECTION REPORT  
NATIONAL DAM SAFETY PROGRAM

March, 1979

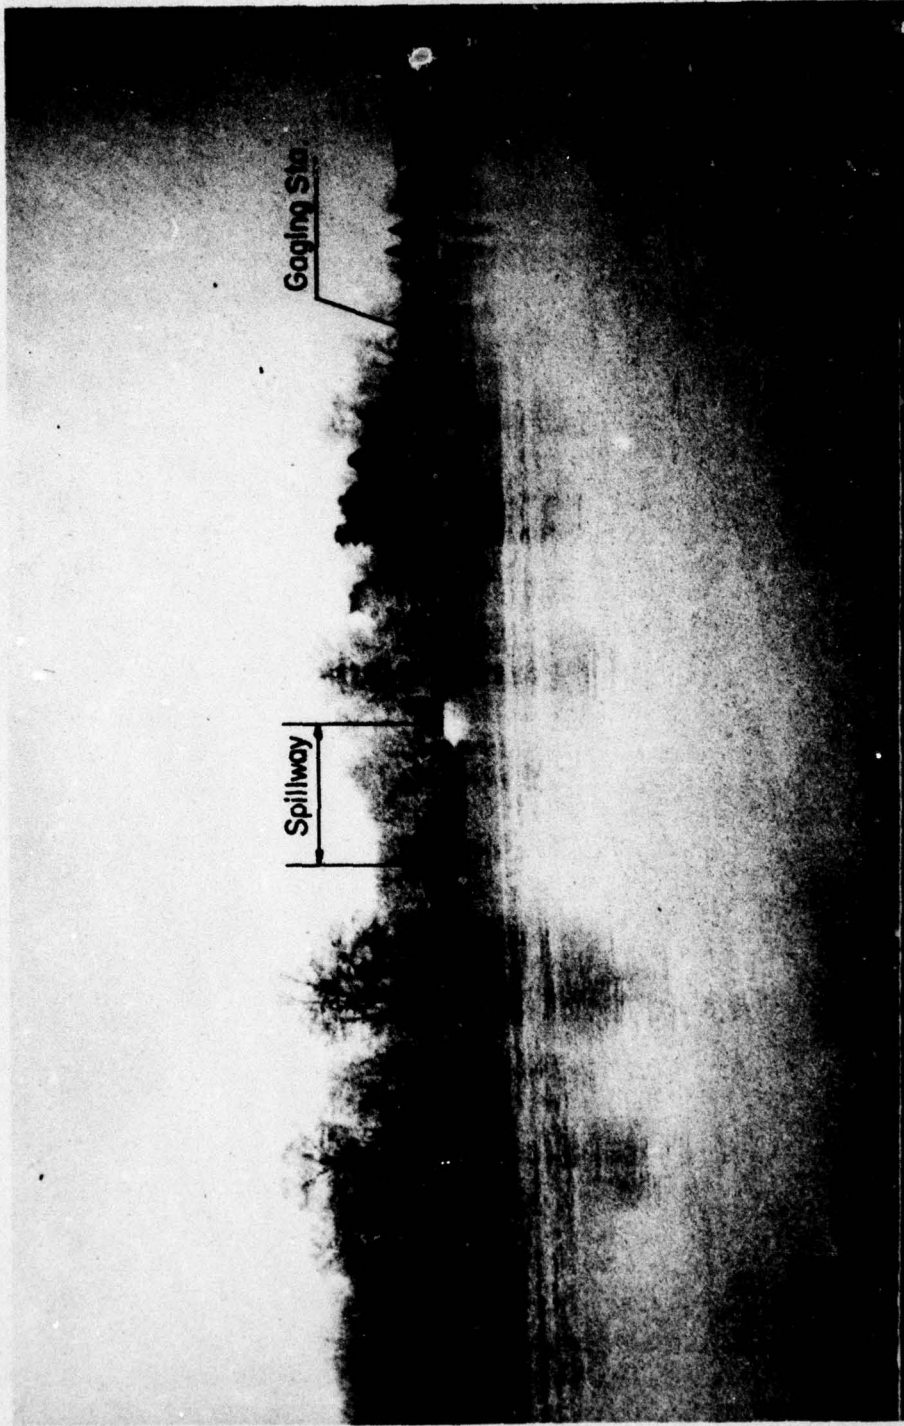
OVERVIEW OF ALLOWAY LAKE DAM

Alloway Lake Dam is assessed to be in a generally fair overall condition but refilling of the downstream stilling basin below the spillway should be undertaken very soon to preclude a collapse of the lower portion of the spillway apron. Sufficient engineering data was not available to ascertain the continued long-term stability of the embankment as three previous breachings have completely washed out wide zones of embankment and further engineering studies are recommended to be undertaken in the near future. Recommended remedial actions also to be undertaken very soon include protecting the auxiliary spillway outlet channel, regrading the dam crest and repairing the natural drainage swales on the embankment backslopes.

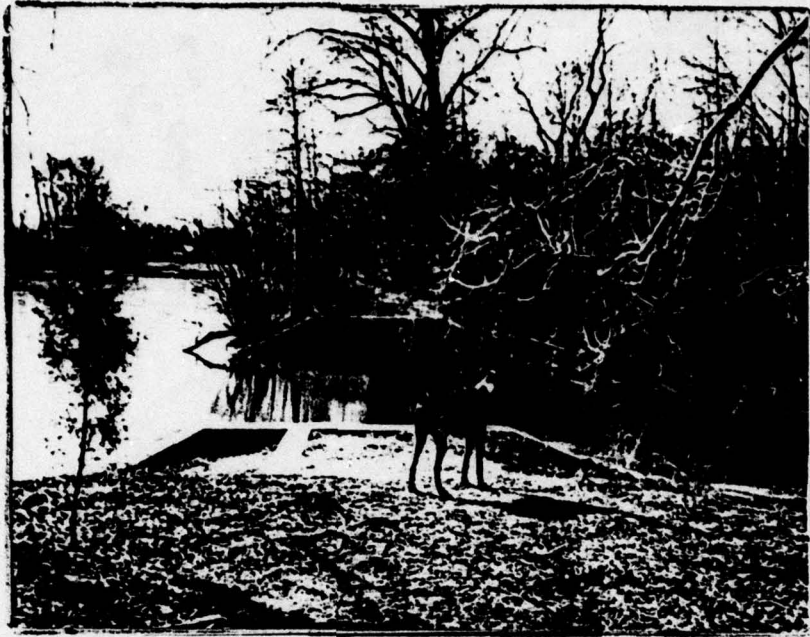
View South at spillway

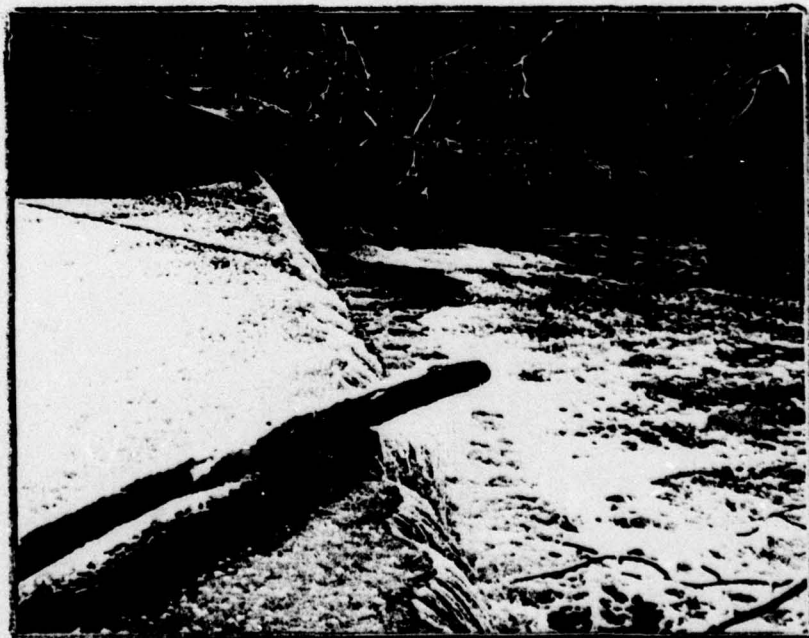
The erosion of the downstream stilling basin below the main spillway is slowly undercutting the steel sheeting driven across the bottom of the ogee apron slab. The depth of this sheeting is unknown but roughly 9 to 12 feet is exposed. The spillway was originally designed to have the outlet invert at El. +9 (flush with the spillway apron), but this did not take into account the steep natural gradient of the channel immediately below the dam. The apparent sweepout of the channel bed may have commenced immediately after the 1933 construction, leaving the spillway apron in a perched condition. Additionally, the wingwalls along each side of the apron rely, in part, on the support of the apron for their stability (their width of footing is insufficient as a free-standing gravity retaining wall) and the bottom of footing (at El. +6.0) is completely exposed at the ends, being over 6 feet above the stilling basin elevation. Further, the timber sheeting cut-off under the walls is only 8 feet long. In summary, these wingwalls are in a somewhat precarious condition and have already cracked loose from their upper connection at the ogee spillway wall and the short cut-off wall that parallels the dam axis. Should the undercutting continue it is only a matter of time before they collapse.

End of spillway slab

(1) The downstream channel immediately below the main spillway should be filled with riprap to prevent further undercutting of the concrete spillway apron. Consideration could be given to driving additional sheeting parallel and downstream of the spillway wingwalls and backfilling behind the added sheeting.

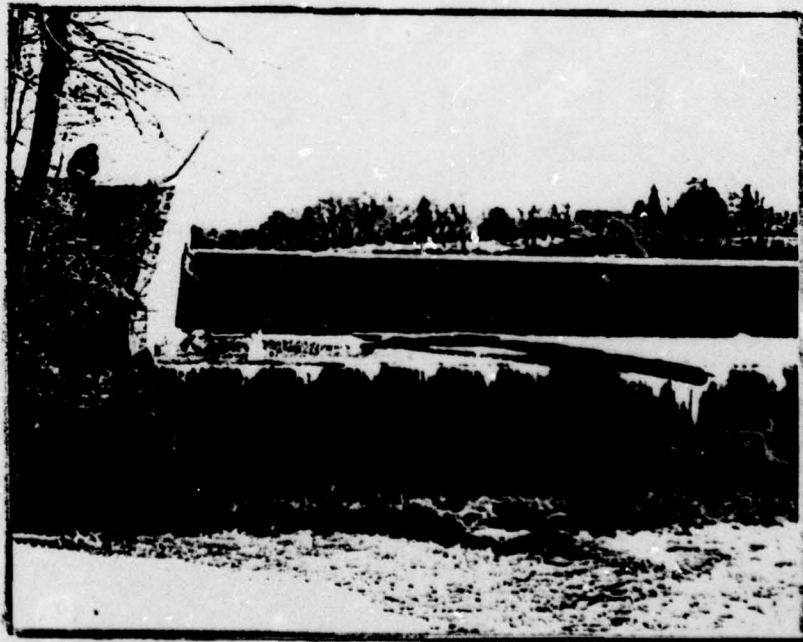
Spillway (north end)

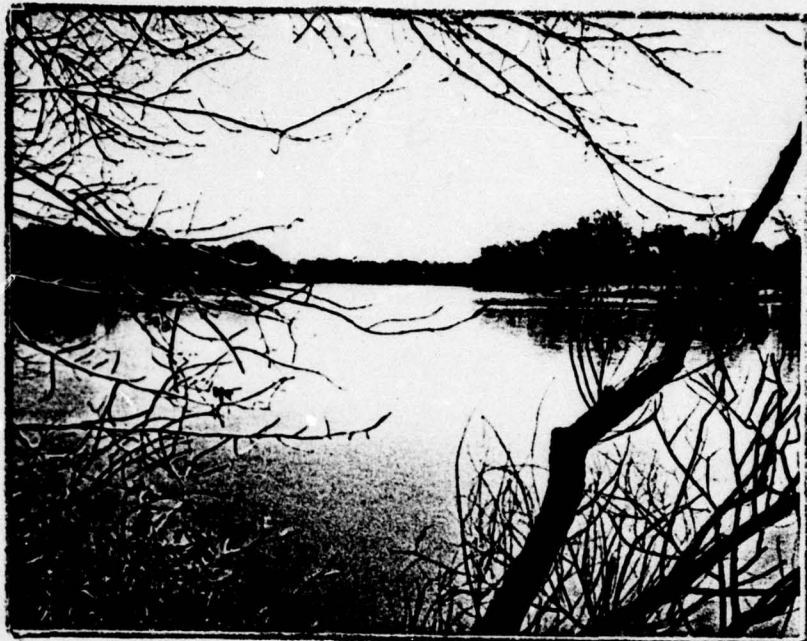
The reservoir has a stable well-defined shoreline and is fairly clear of debris. It is fed by several streams with at least 3 smaller dams in the upland areas several miles upstream. There are numerous homes built along the south and east banks but most are 6 to 15 feet above normal pool. The sedimentation condition is unknown but appears to be quite heavy in several of the upper lagoons and along the face of the dam.

Alloway Lake

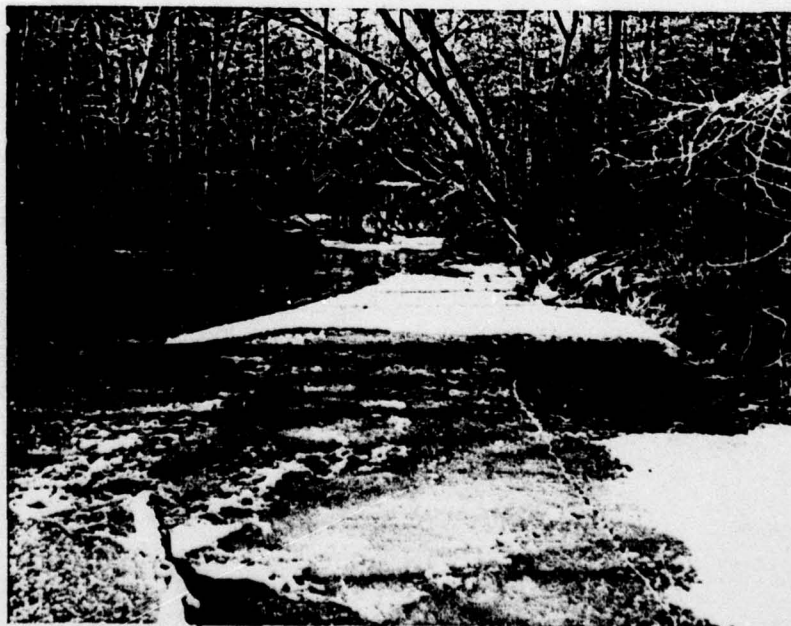
Below the main spillway, the constant overflow has eroded and caused substantial sweep-out, resulting in a cavity which extends about 20 feet beyond each side of the wingwalls. There are several ill-defined channels below the dam; one at the old spillway and another, less apparent one below the old raceway at the left abutment. All merge before passing through the Greenwich Street bridge which is located 1000 feet downstream. This is a reinforced concrete County bridge (#1028) built in 1930 with a clear opening of about 50 feet and a headroom of about 10 feet. The houses immediately to the left on Fogg Landing Road are well above flood elevation but there is one dwelling right down on the stream bank that is just a few feet above the normal flowline. Below Greenwich Street, Alloway Creek widens out into marshy flatlands over 1000 feet wide. The downstream channel stilling basin immediately below the 48" auxiliary gateway is badly undercut and has exposed the structural end of the apron. The banks of both channels immediately below the dam are fairly clear of debris but have steep, almost vertical sides of the natural black stiff clays which appear to underlie the channel.

Downstream channel

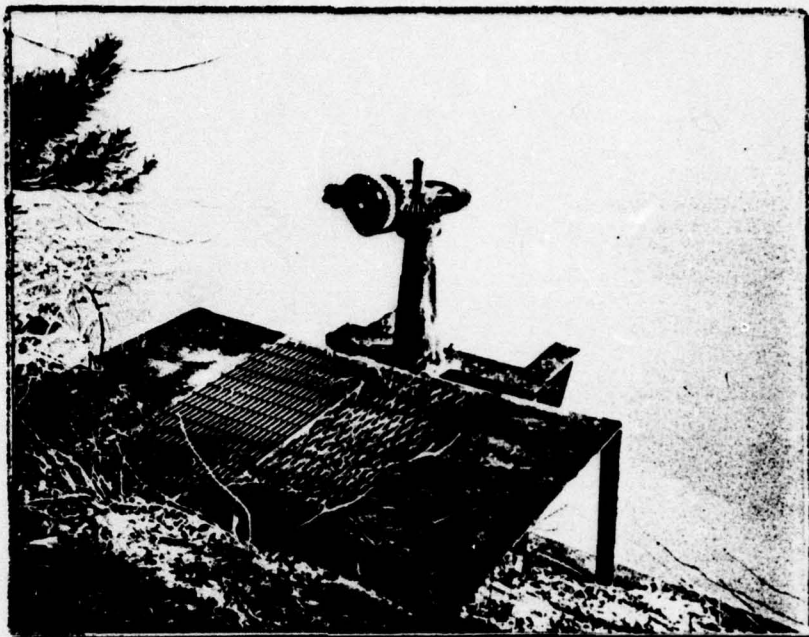
The auxiliary outlet with the 48-inch sluice gate has been additionally reinforced with steel sheeting driven along the downstream banks but the concrete slab cast between the sheeting is undermined. The steel access walk to the gate wheel is rusted but in a satisfactory structural condition. As with the main spillway channel, the auxiliary channel shows evidence of excessive outlet velocities over an extended period of time. The area of this sluiceway is where the 1950 washout occurred.

48"  $\varnothing$  vertical lift sluiceway

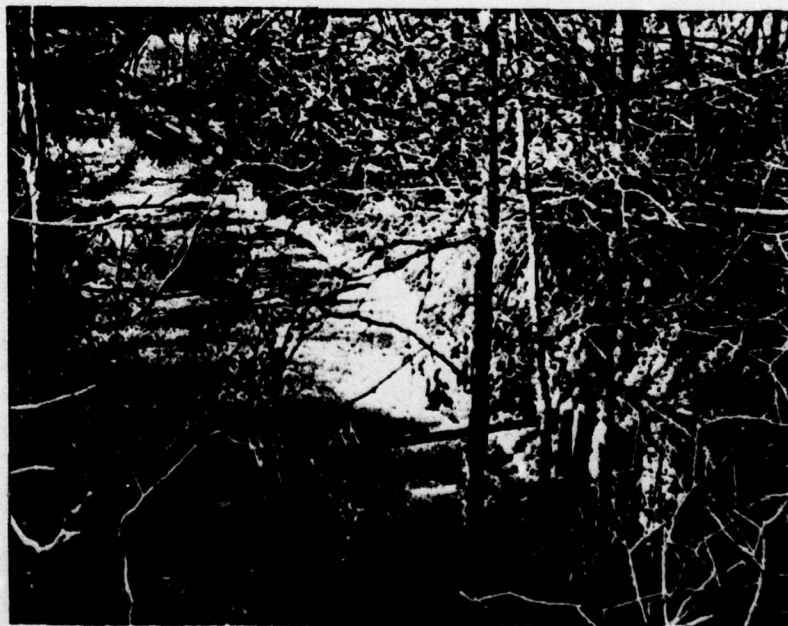
Downstream channel below sluiceway

(2) The undercut apron slab at the auxiliary gate outlet should be backfilled and channel protection dumped in the stream bed.
