CUSHMAN LAKE DAM

NJ 00447

PHASE 1 INSPECTION REPORT
NATIONAL DAM SAFETY PROGRAM

PHASE I REPORT
NATIONAL DAM INSPECTION PROGRAM

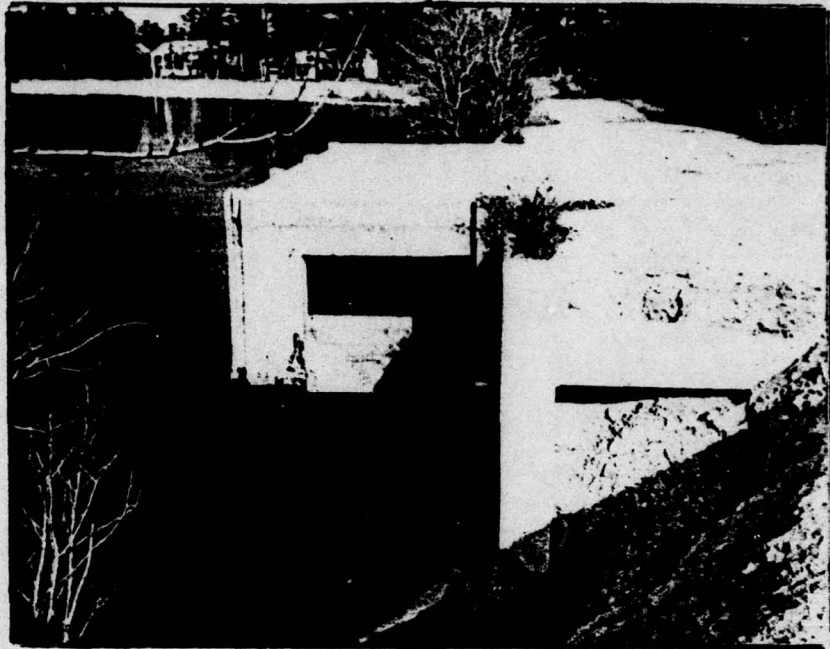
The drop inlet is a 3-sided reinforced concrete frame built monolithically into the culvert. Each of the 5 openings is 6'-0" wide and timber flashboards are positioned on vertical timber runners on the upstream face. The timber is in poor condition and the stoplogs appear to be wedged tightly into position. The concrete edges along the crest is badly chipped and spalled and there are no lifting devices for removal of the stoplogs.

Intake structure

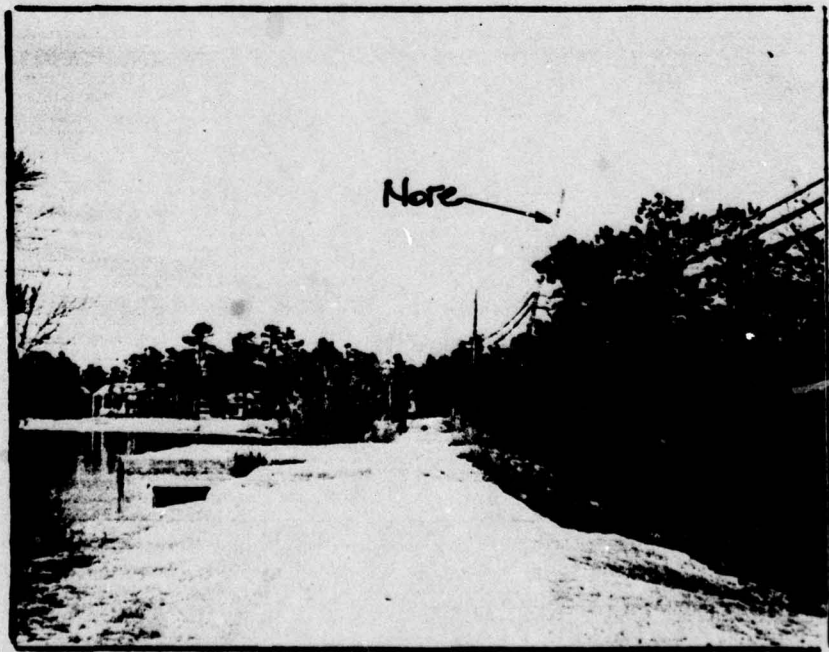
The upper zones of the dam embankment were found to be in a poor condition reflecting its age and apparent lack of maintenance. The crest has a considerable variation in width and elevation and all vestiges of its geometric design dimensions are obliterated. The lake level appears to be quite constant during most periods as the banks are fairly well stabilized and show only minor evidence of sloughing at the waterline. However, the upper zones of the dam foreslopes are badly eroded and undercut in many areas. The backslopes are partially grassed over and contain several large trees and secondary growth. There is evidence of considerable surface run-off and erosion in numerous locations below the dam crest which have incised rather deep erosion gullies, especially at the corners of the spillway wing-walls and an extensive zone north of the spillway. The steeper upstream embankment slopes are very irregular and it appears the lake has silted up considerably against the upstream face. The backslopes show evidence of numerous wet areas at the lower elevations, but most of this appears to be at the natural swamp elevation downstream and not the result of percolation through the dam embankment. The dam crest is extremely rough and requires additional clay binder in the fill material to stabilize the surface which now is in a loose condition as a result of vehicular traffic. The dam is continually being used as an illegal short-cut

Dam crest

(Note: lean of telephone pole)

The entire crest of the embankment should be immediately scarified, recompact and additional fill added to bring it up to proper line and grade. Additionally, the eroded backslopes should be filled in and protected with a suitable ground cover. On the basis of visual inspection, improvements to the present spillway should consist of repairing the exposed concrete surfaces, including sandblasting and applying epoxy-mortar coatings or dry-gunning. The joints should be cleaned out and recaulked. The keeper planks for the stoplogs should be rehabilitated. The embankment at each side of the downstream spillway wingwalls should be further protected with slope paving along the face of each wall. Other remedial measures to be taken under advisement very soon include:

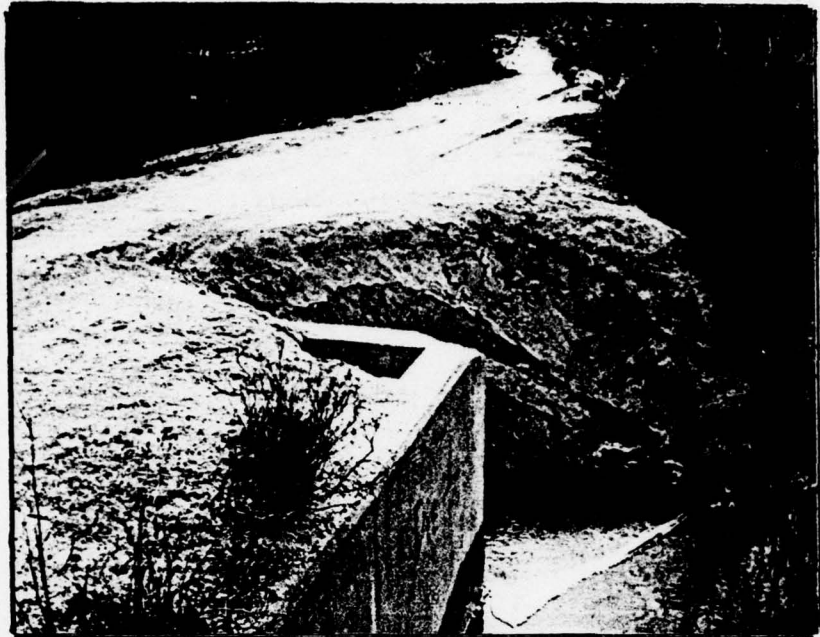
submerged). Several visible areas of the vertical walls are badly chipped and spalled and need patching. The embankment fill behind each end of the wingwalls is seriously eroded to a depth of 4 to 5 feet. As previously stated, there is an apparent lack of binder in most of the embankment fill, especially near the exposed surfaces.

Severe erosion and sloughing right of spillway

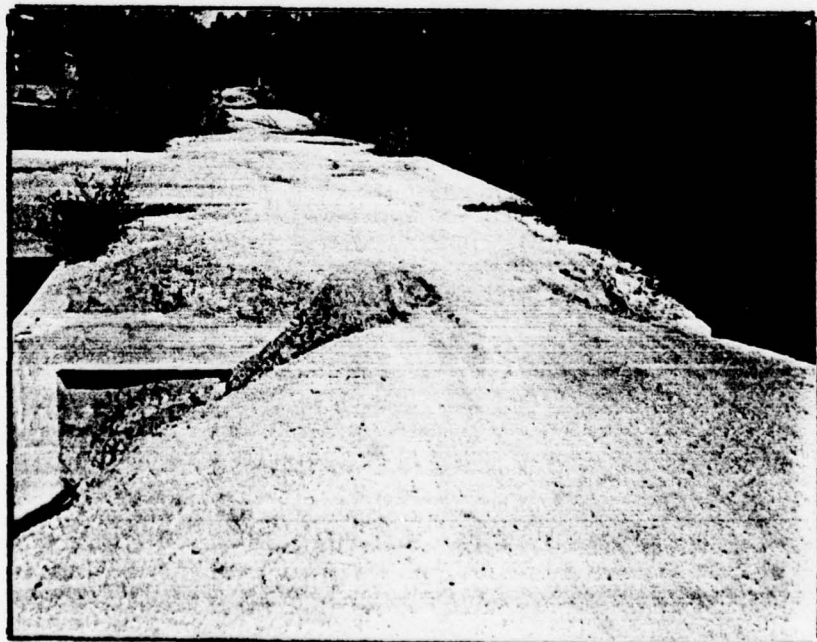
View North along dam crest

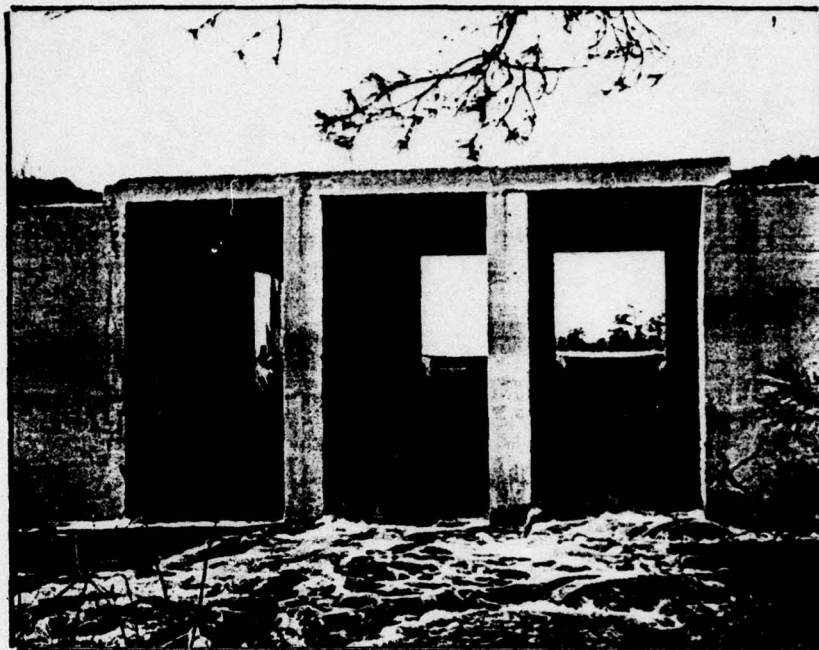
The three-celled reinforced concrete culvert is in moderately good structural condition. Each opening of the culvert has a width of 6'-0" and a clear headroom of 16'-0". The wingwalls and transverse tiebeams display numerous cracked and spalled areas but the structurally important zones are in an integral condition. Its configuration is a modification of the Soil Conservation Service type of design prevalent during the period of construction and is extremely stable and structurally conservative. However, the downstream wingwalls which parallel the axis of the dam are too short to provide adequate sloped embankment returns into the channel. The concrete invert slab is founded on timber piling as are the main footings of the culvert walls and wings. Due to the depth of flow, the condition of the invert slab, could not be observed (at a subsequent inspection trip on 23 February 1979, this invert was still

Outlet structure

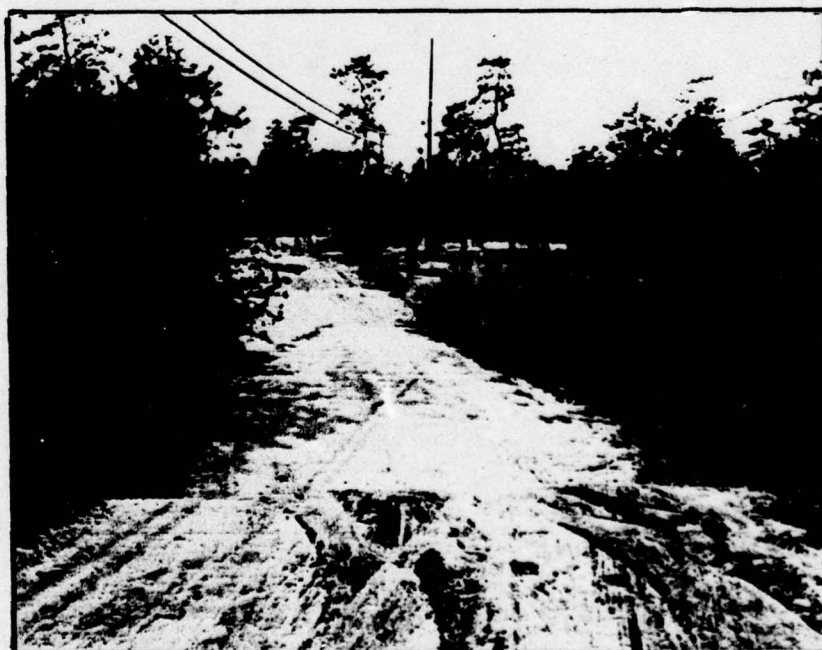
The auxiliary spillways are 90 and 100 feet wide each and are positioned near each abutment. The spillway crest near the right abutment is roughly one foot higher than the left one. Both are paved with asphalt and are in fairly good condition with only minor cracks and ravelling at the edges. A surface drainage ditch has been recently cut immediately to the south of the right auxiliary spillway and is only a few inches above the lake elevation. This apparently was built to drain the tennis court and street immediately to the south of the dam. The effective dam height in this area is very low and there are no true backslopes as the dam blends into the naturally higher surrounding terrain.

Auxillary spillway near right abutment

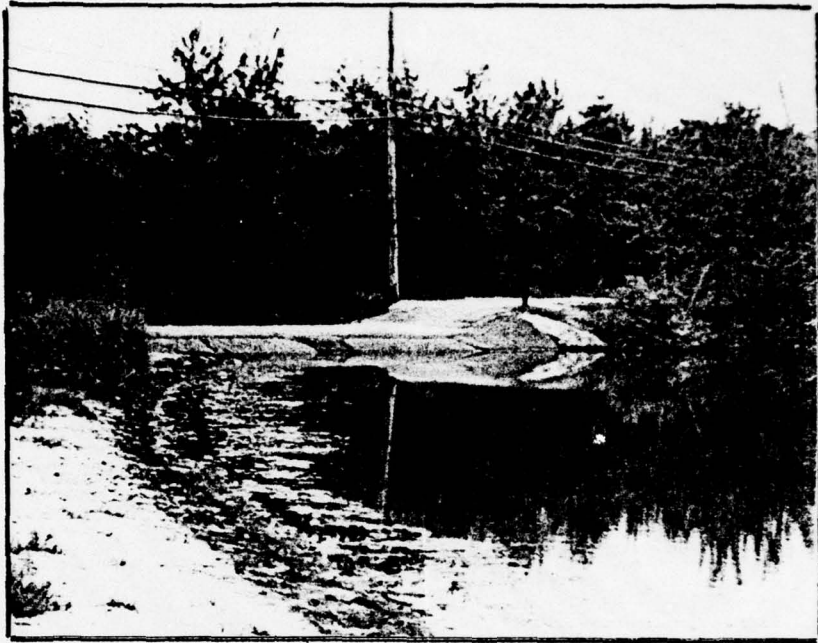
Auxiliary spillway near right abutment

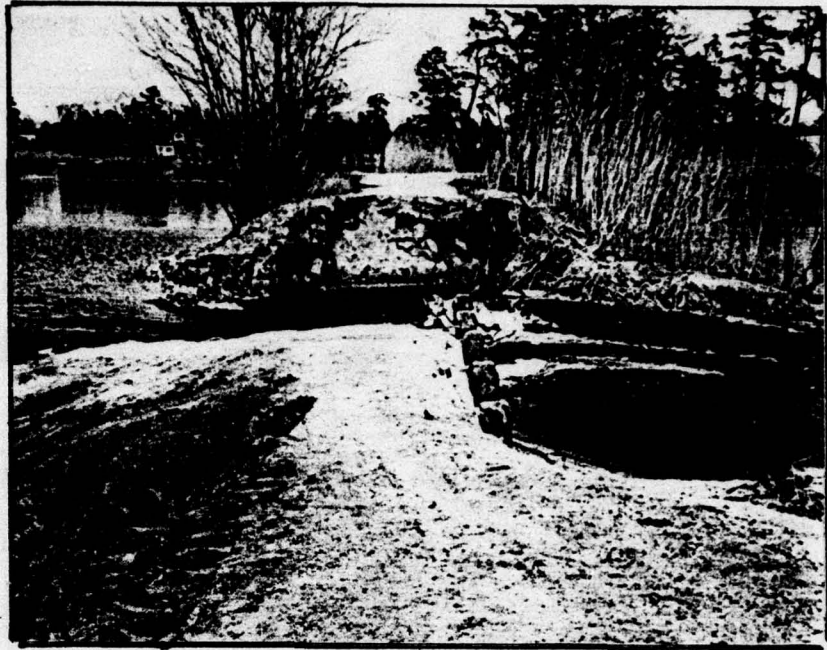
Cushman Lake extends 3,650 feet up to another earth dam where a boat landing is located. This unnamed dam normally impounds Braddock, Cains Mill and Hospitality Lakes but was breached last July (see appended photograph). Therefore, at the present time, the study dam is impounding an additional 46 acres of lake area. It is unknown whether or not repairs are contemplated for the damaged structure. As can be seen in Section 5, the condition of this dam has negligible effect on the study dam. The banks of the connecting lakes are very flat and the surrounding residential areas are only a few feet above the normal lake pool.

Upstream dam failure
