³ NANTICOKE RIVER BASIN
LITTLE CREEK, SUSSEX COUNTY
DELAWARE

² HORSEYS POND DAM

DE 00022

PHASE 1 INSPECTION REPORT
NATIONAL DAM SAFETY PROGRAM

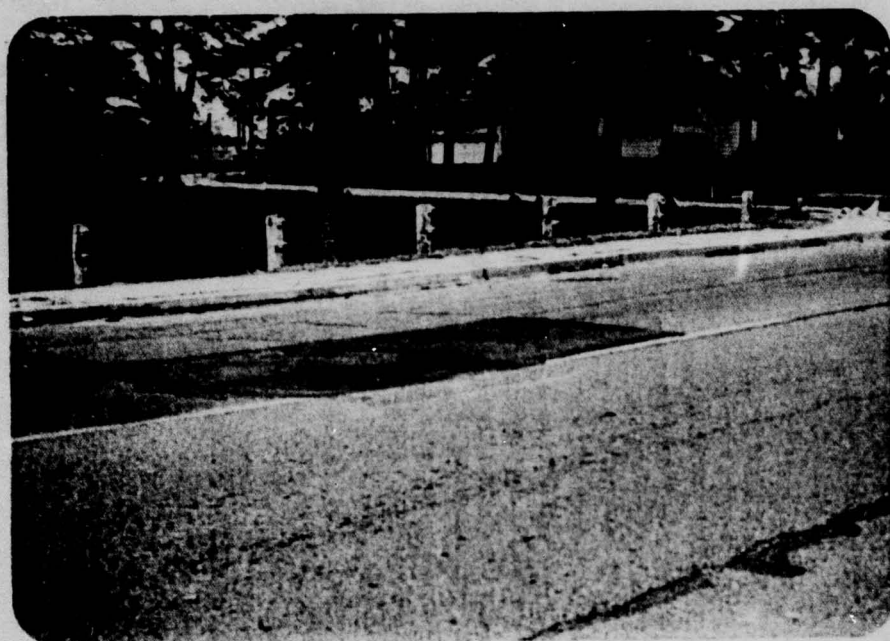
PHOTO 7 - View of house located on downstream embankment
